Representative Photographs of a topped pole with distribution underbuild

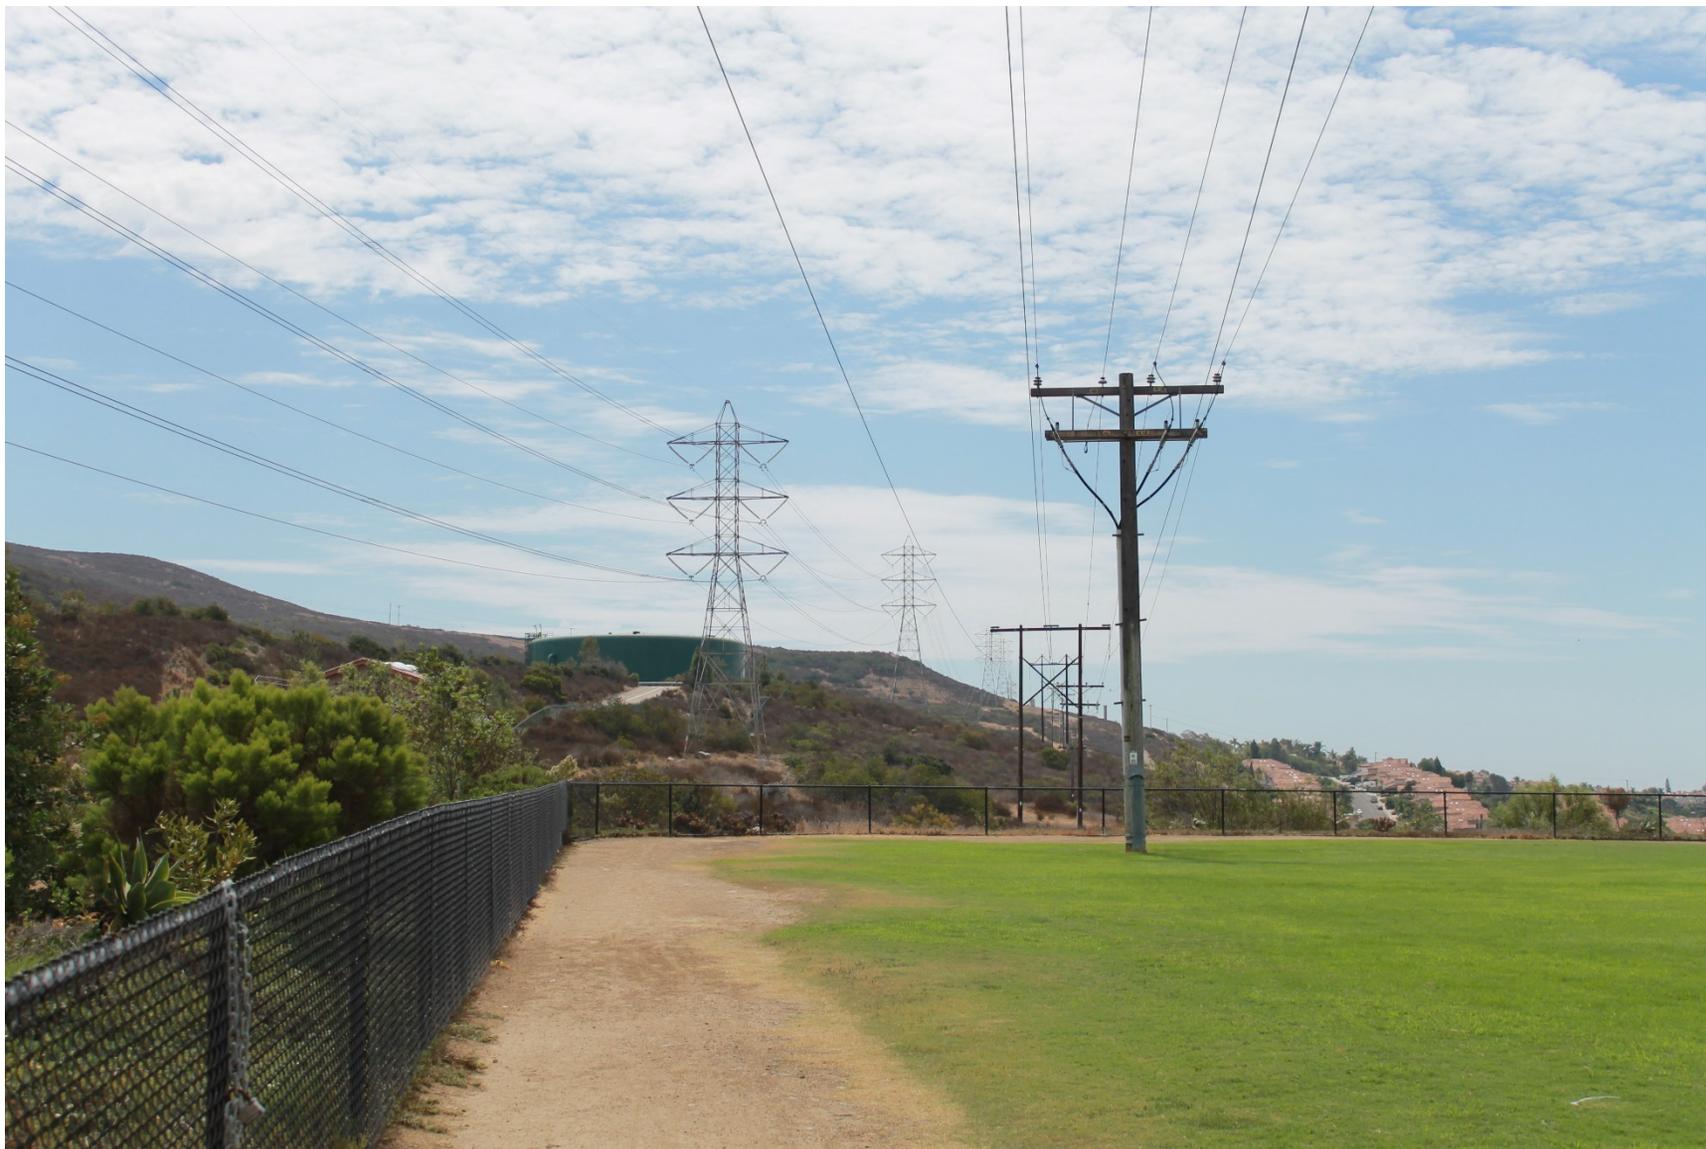
Representative Photographs of a topped pole with distribution underbuild

Note the structure shown is a cable pole
