MEMORANDUM

Date: 6/10/2010
Re: Mitigation Measure H-8a: Scour and Erosion Protection at Creek Crossings

RESPONSE TO MITIGATION MEASURE, H.8a: **BURY POWER LINE BELOW 100-YEAR SCOUR DEPTH.**

ALPINE BLVD. CREEK CROSSING

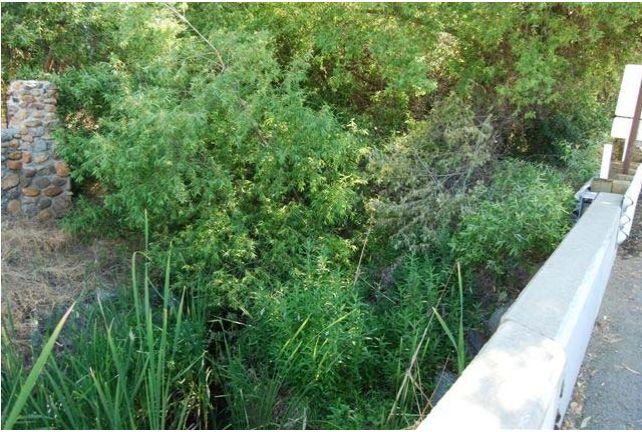
Upstream side of the creek

Response: *B&V inspected approximately 50 feet from both upstream and downstream directions. Photos are included in the Attachment. Due to the heavy vegetation at both upstream and downstream next to the culvert, the erosion conditions can't be clearly seen from pictures. No obvious erosion or scour concerns were noticed. In addition, the heavy vegetation reinforces the soil and helps to prevent erosion and scour of stream beds.*
