California Public Utilities Commission Mitigation Monitoring, Compliance, and Reporting Program

Lassen Substation Project

Compliance Status Report: 03

July 31, 2021

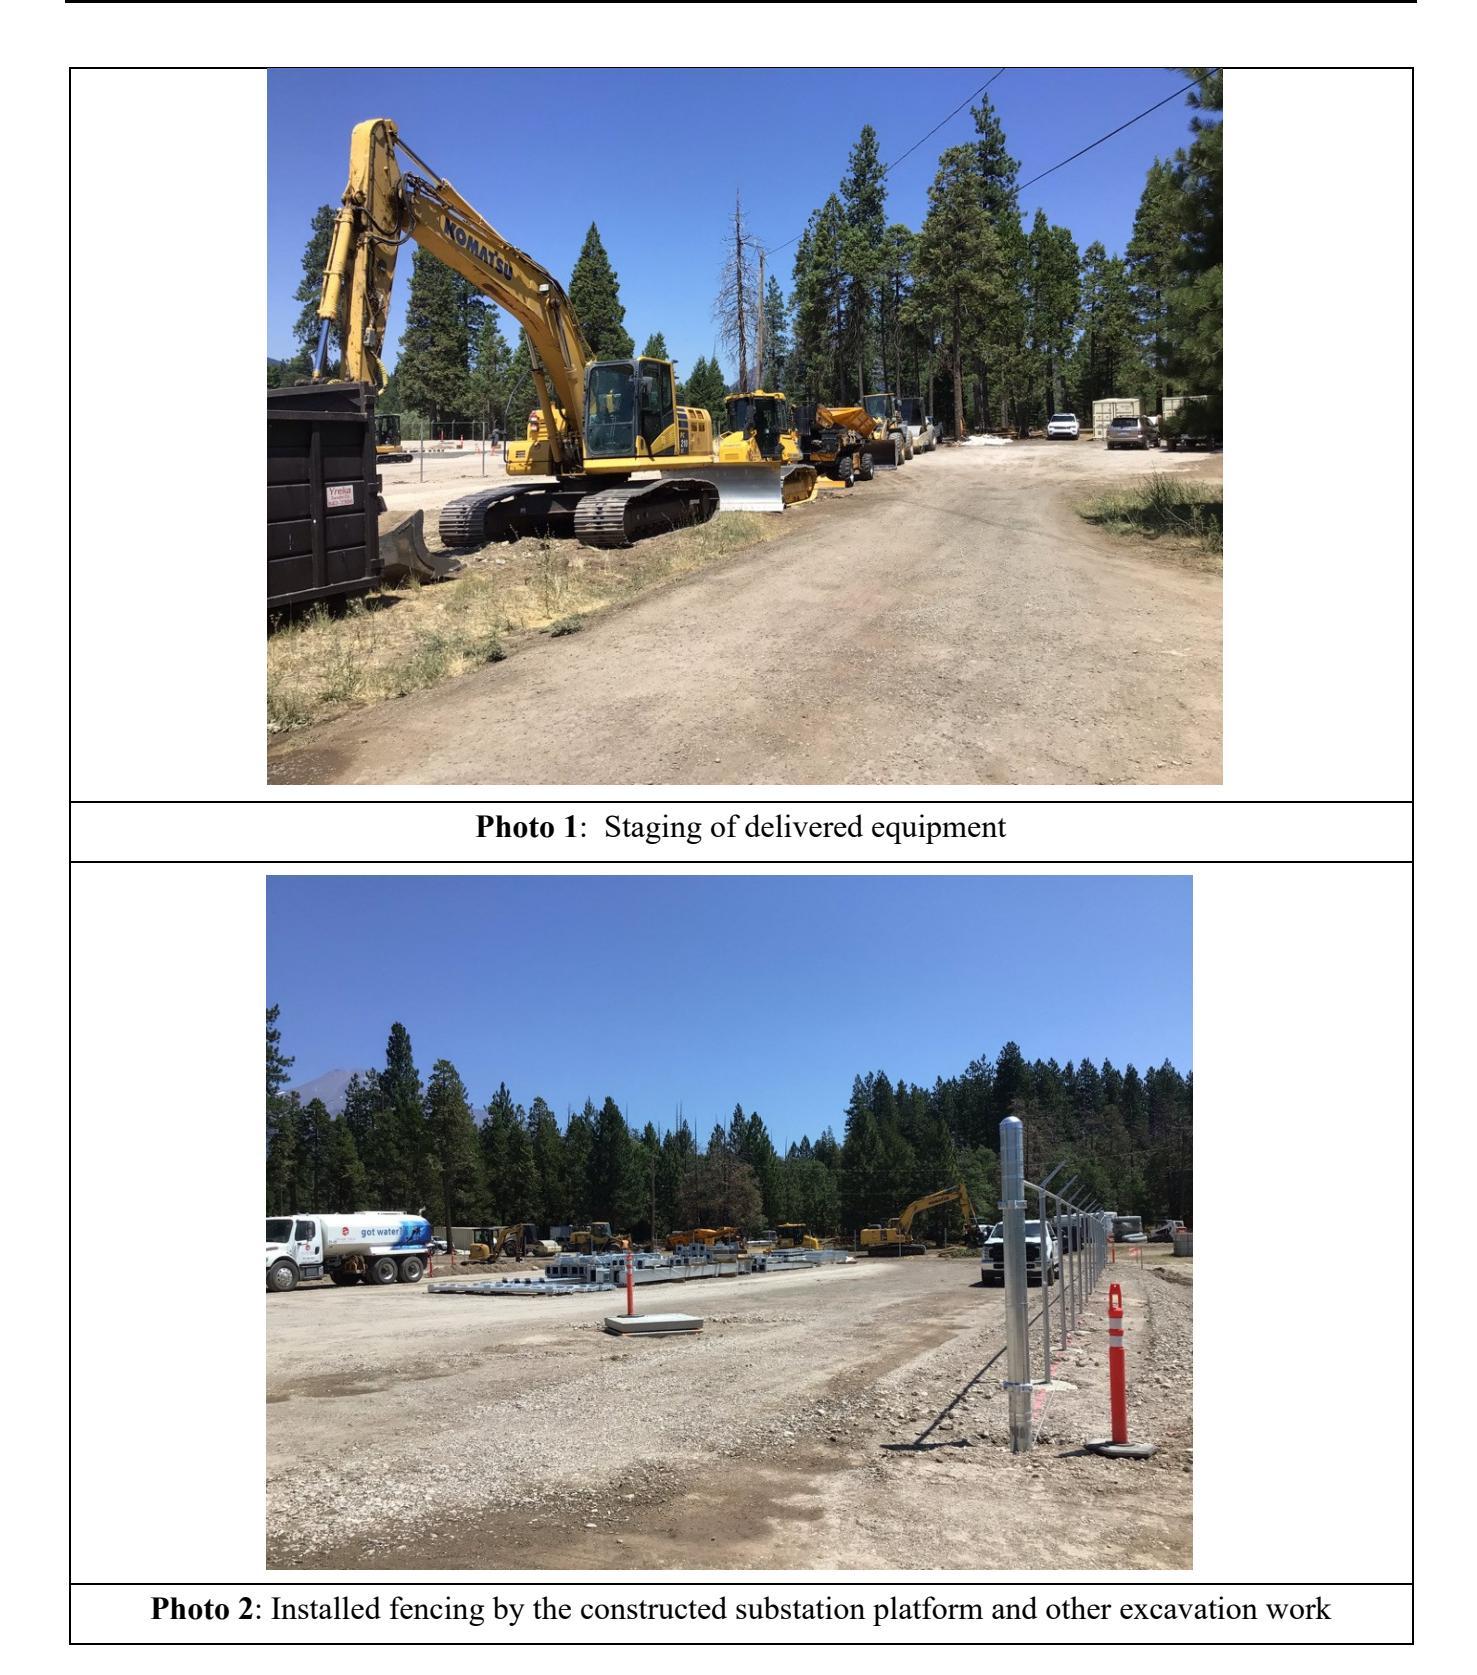
During this reporting period, crews delivered and staged equipment and materials (see Photo 1— Attachment A); installed track-out control system; performed CAD welding; performed drilling work; moved debris; hauled stumps/brush/topsoil/rocks; watered remaining topsoil and brush pile; installed conduits/drainpipes; installed the ground grid; installed grounding rods; installed cable trays; dug and backfilled trenches; poured concrete; cleaned track-out on the road; graded and contoured site; installed fencing (see Photo 2—Attachment A); installed concrete truck washout (see Photo 3—Attachment A); cut new road; shaped toe slope; rolled site; and spread and compacted based material around foundations.

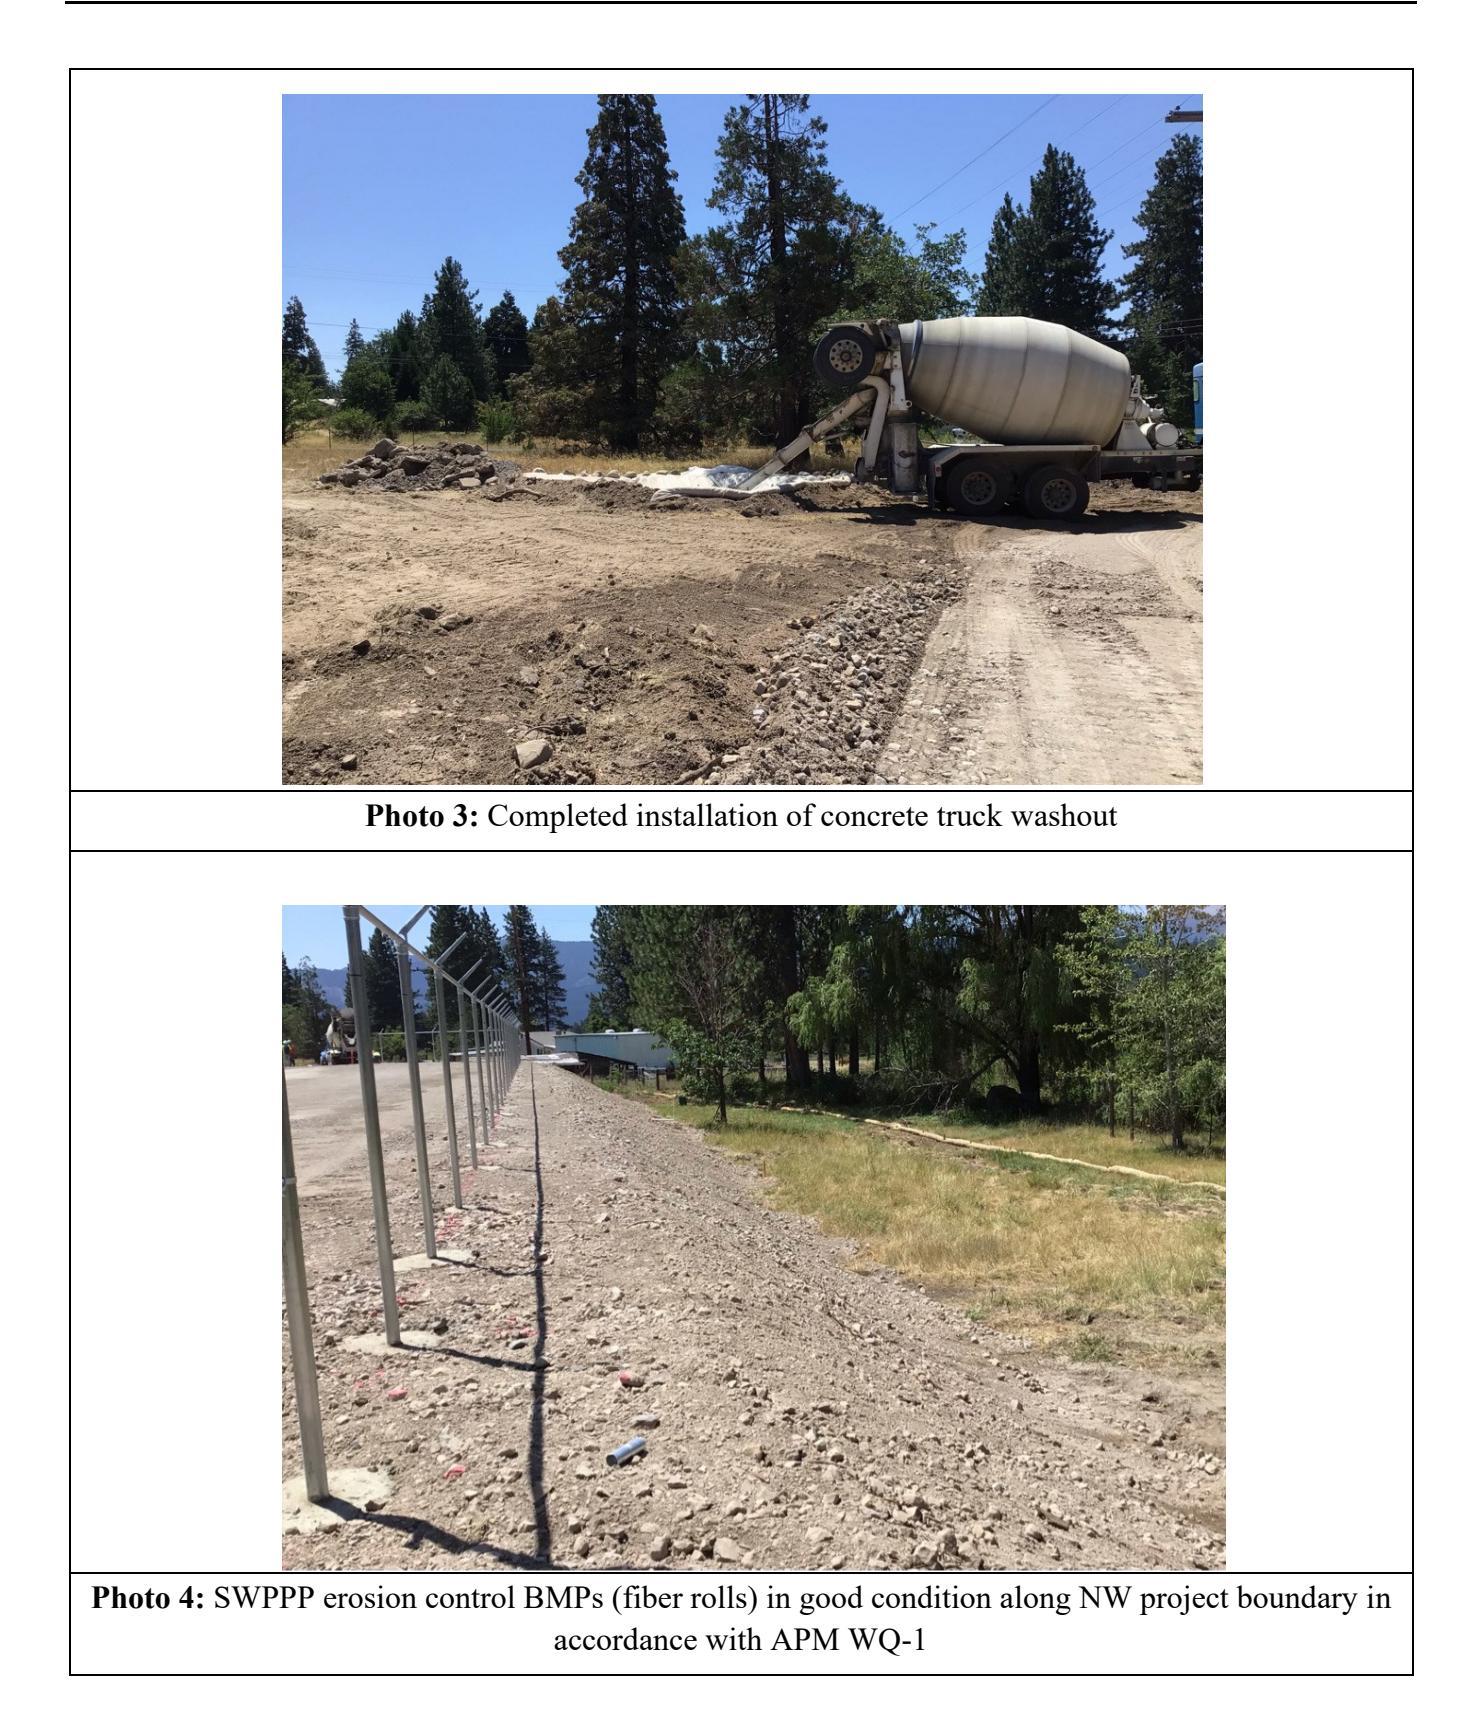
New construction vehicles and equipment brought onsite were inspected and were determined to be free of soil build-up in accordance with APM BIO-2. Access roads appeared to be sufficiently watered by water trucks to control particulate matter emissions in accordance with APM AQ-1 and use of previously established roadways was observed (APM BIO-10). The EM monitored road use and did not note any wear and damage to local roads in the immediate vicinity of project construction in accordance with APM TT-1. Erosion control BMPs, such as fiber rolls were observed to be in good condition in accordance with the locations identified in the project's SWPPP (APM WQ-1) (see Photo 4—Attachment A).

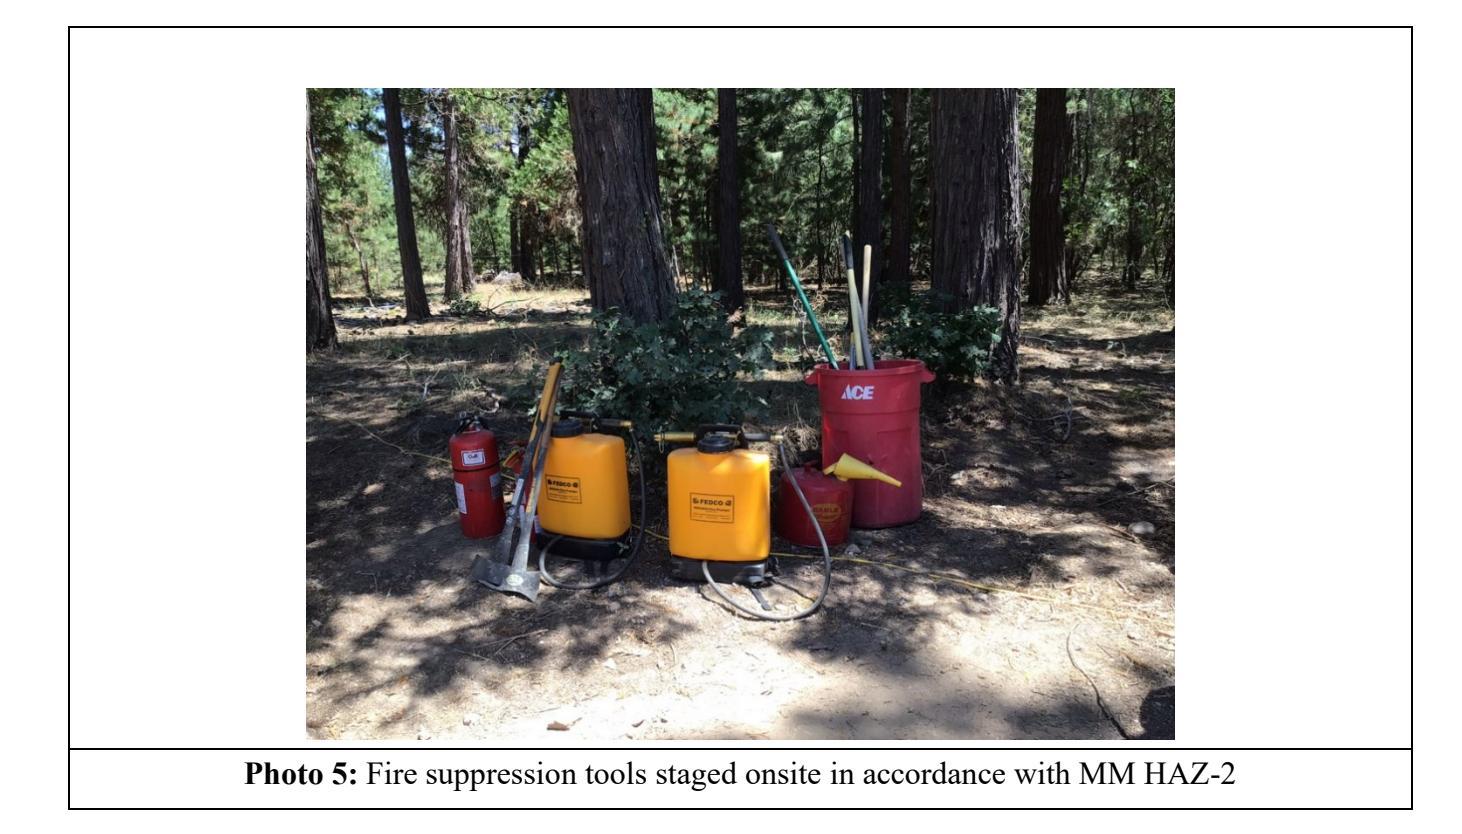
Per the Fire Plan for the project (MM HAZ-2) fire suppression tools, including extinguishers, Pulaski's, and 5-gallon pumps were observed staged on site in accordance with MM HAZ-2 (see Photo 5—Attachment A). During a site visit, the ECM reviewed Red-Flag Warning portions of Fire Plan with the EM. No required modifications of construction activities were noted.
