ZAYO'S PRINEVILLE TO RENO PROJECT

CONSTRUCTION NONCOMPLIANCE REPORT

Project: Zayo's Prineville to Reno Project Date: April 4, 2024

Reference: Response to Construction Noncompliance Report (Report No. 1); Milepost 54

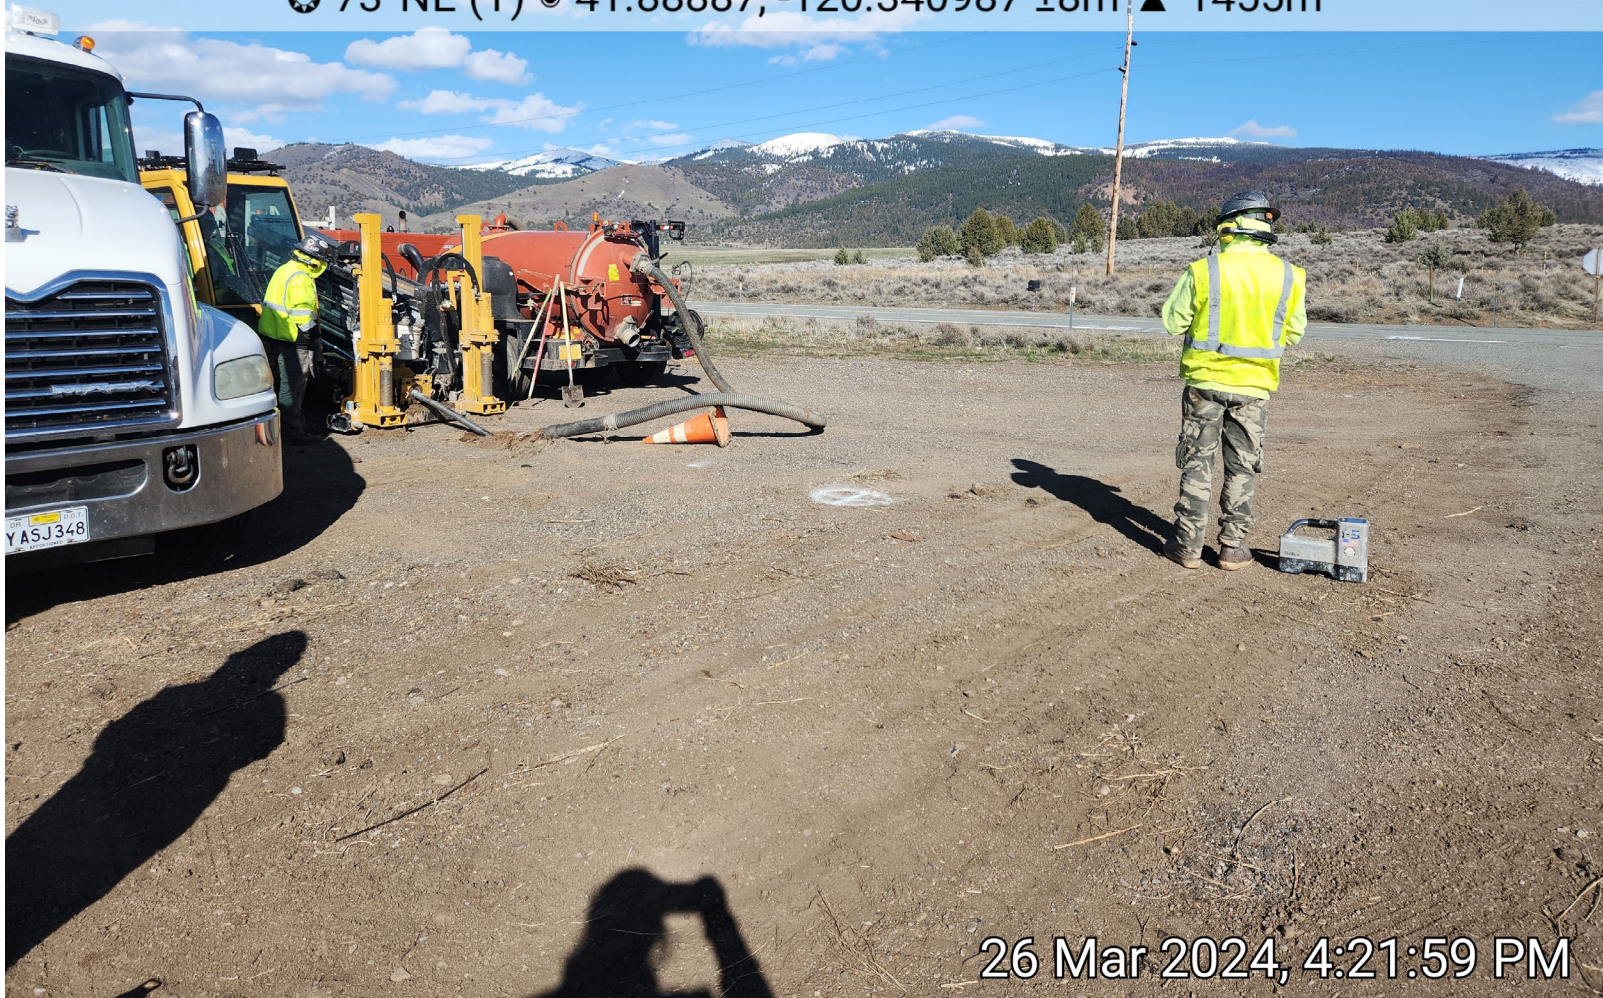
Photo 1: View of HDD at MP 54. The detector to the right shows approximate location of drill

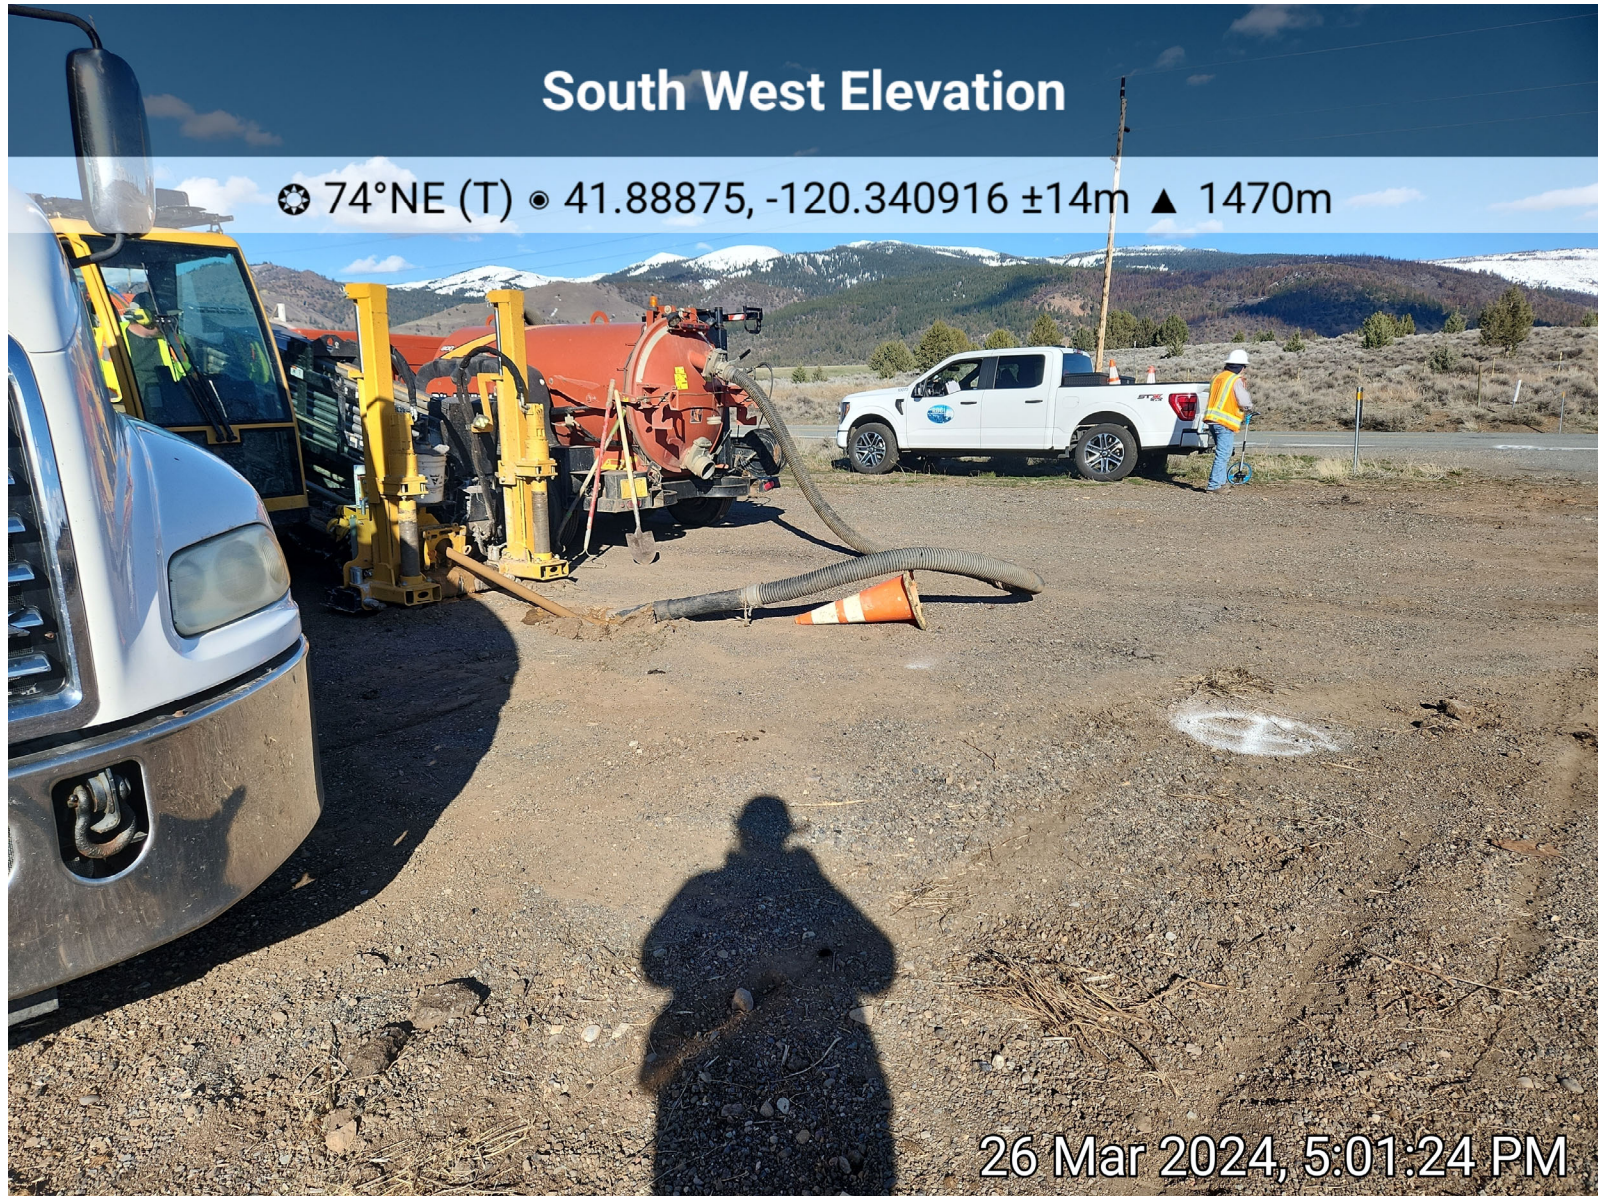
Photo 2: HDD at MP 54 with no obvious flagging. White flagging indicating bore entry and approximate exit

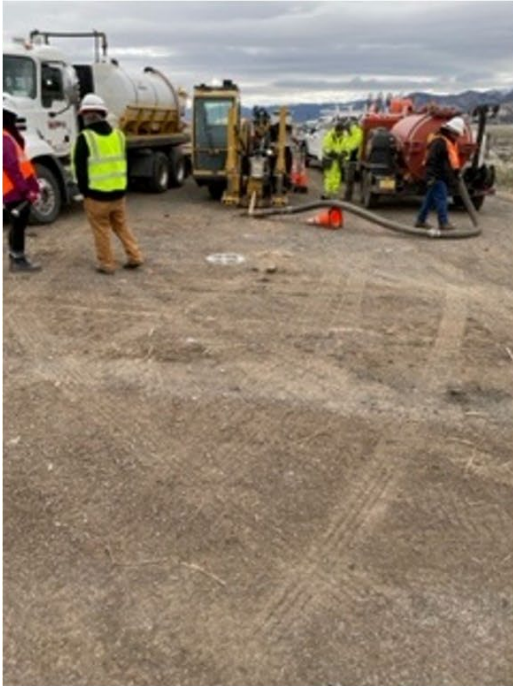
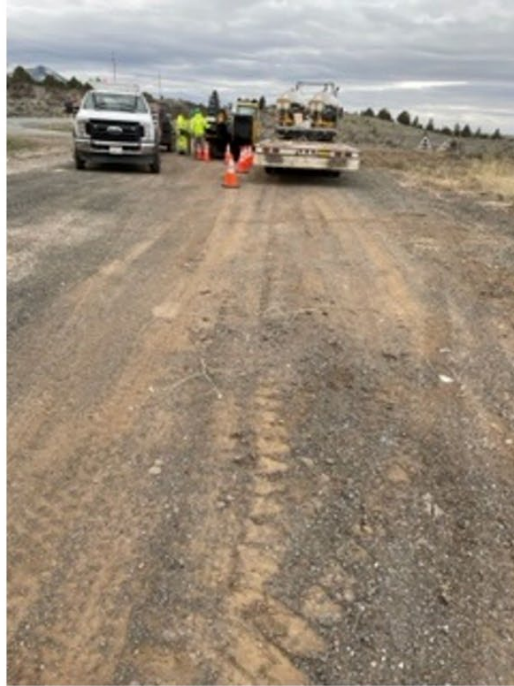
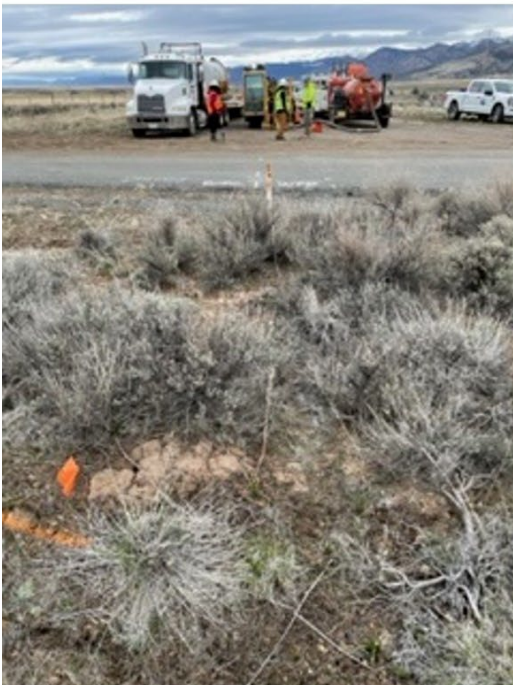
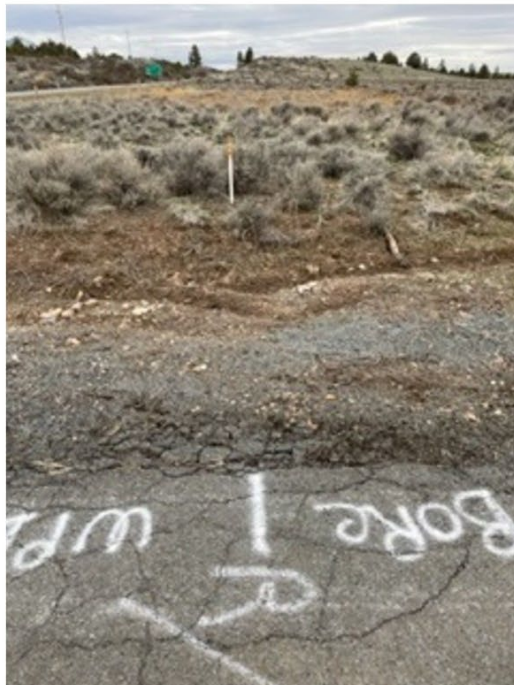
Mr. Broussard observed that the drill entry position was located in a disturbed area, in a graveled roadbed. The drilled area was visible as a depression approximately 2 feet in length, 6 inches in width, and 1 inch in depth filled with the same modern fill gravel as the rest of the work area at the starting location for the borehole. Mr. Broussard was unable to determine the extent of unmonitored drilling beyond the surface location of starting borehole. No spoils or drilling mud were observed at this surface disturbance. No fossils were observed in the roadbed or in the nearby alluvial sediments.

Due to the previous disturbance at the surface of the drilling area and vicinity, it is unlikely that fossils were present at the surface of the work area. Because bore tailings or spoils are not produced during the methodology employed by RBC, Stantec cannot determine if fossils were impacted in the subsurface by the unmonitored work on March 26.

Figure 1. Overview of work area (MP54) where direct drilling occurred without a paleontological monitor present.
