Garcia and Associates

To: Molly Sandomire
From: Heather Johnson
Date: August 21, 2015
RE: Fulton-Fitch Mountain Bat Survey

SUMMARY

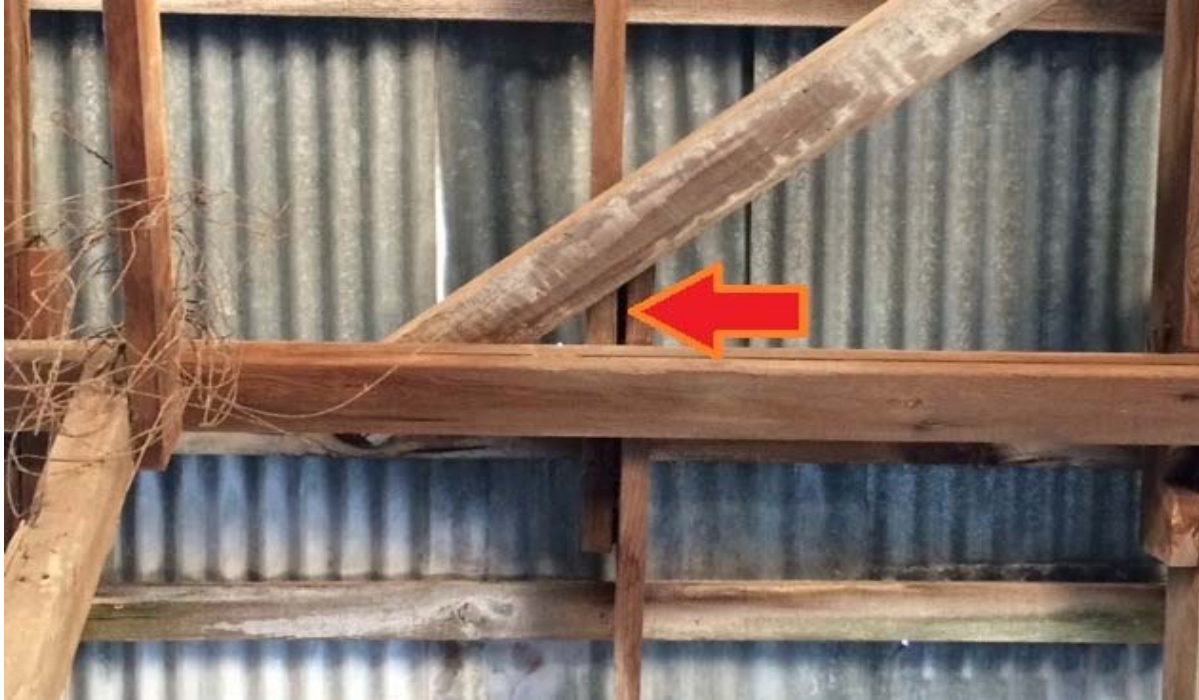
One structure near a project activity area was surveyed for bat habitat. An unused barn structure adjacent to the staging area on Shiloh Ridge Road had potentially suitable cave-like rooms with open flyway entrances, and some crevices (Photo 1); however, no bats or their sign were present.

Photo 1: Potential roost crevice in unoccupied barn; no bat sign observed.

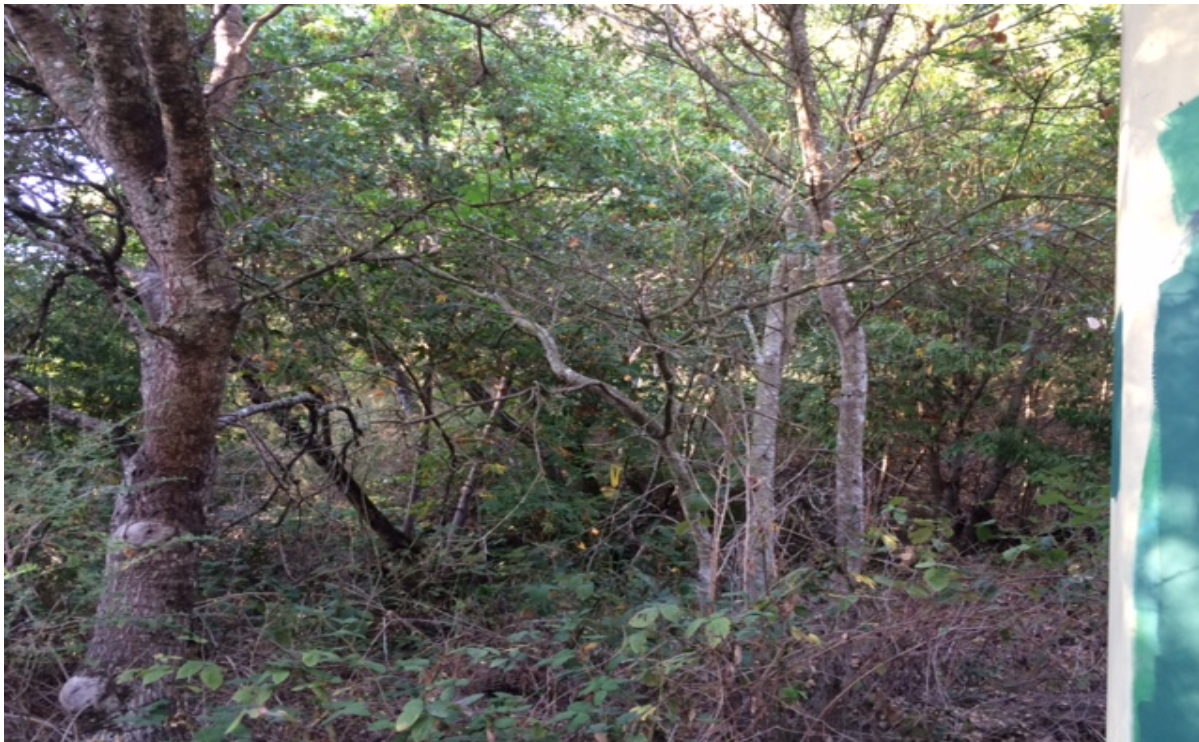
Photo 2: View north from Pole 23. Note closed canopy and dense understory lacking flyway space.

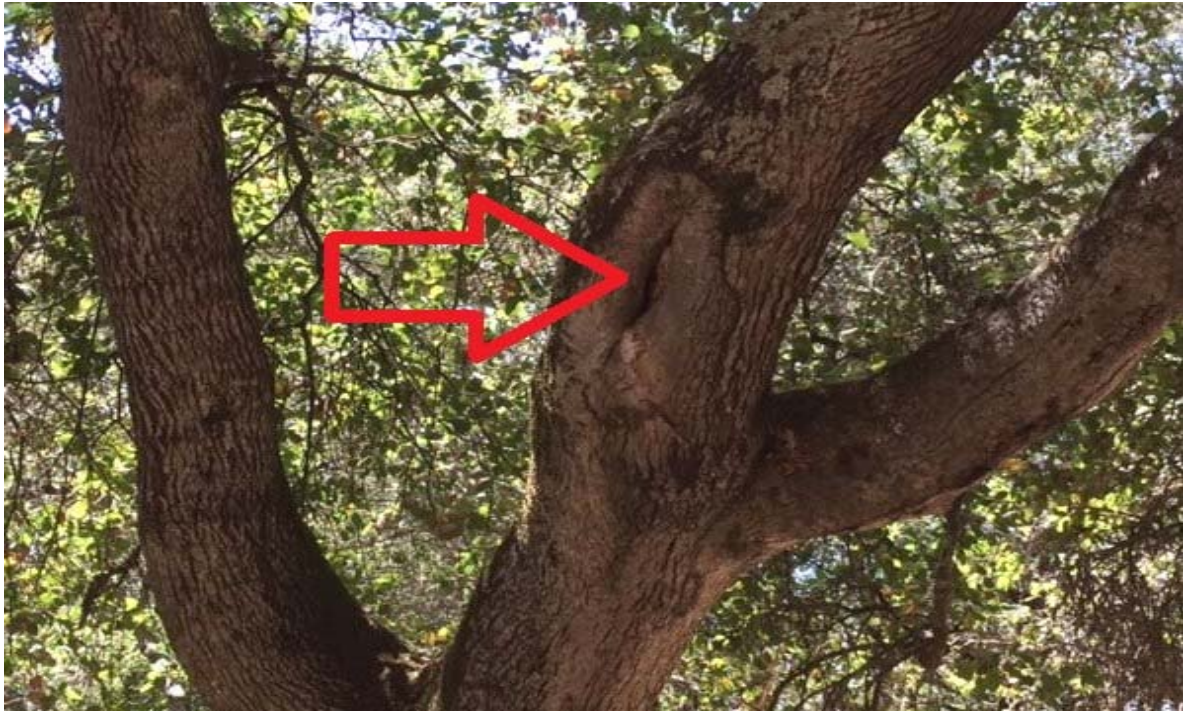
Photo 3: Potential bat habitat cavity in tree branch.

1. Cut down the trees/snags/stumps on warm days in late morning to afternoon when any bats present are likely to be warm and able to fly.
2. Create noise and vibration disturbance on the tree (e.g., concussive hitting with equipment and/or chainsaw cutting) for at least 15 minutes before carefully opening up potential crevices and cavities for inspection and clearance.
3. Request that a monitoring biologist be present to inspect crevices and cavities to the extent possible. If bats may be in a tree bole or heavy branch cavity, the biologist will attempt to expose them and allow escape. For example, if the cavity cannot be investigated by the monitoring biologist, then carefully cut successive sections above the cavity to open it,

waiting up to 10 minutes in between each cut, and determine if it is empty or allow any bats inside to crawl or fly out.

4. Determine if bats may be in branches that can be removed from the tree and set aside. Cut the branches off intact and set them upright against trees away from the work activity area to allow any bats present to passively escape.

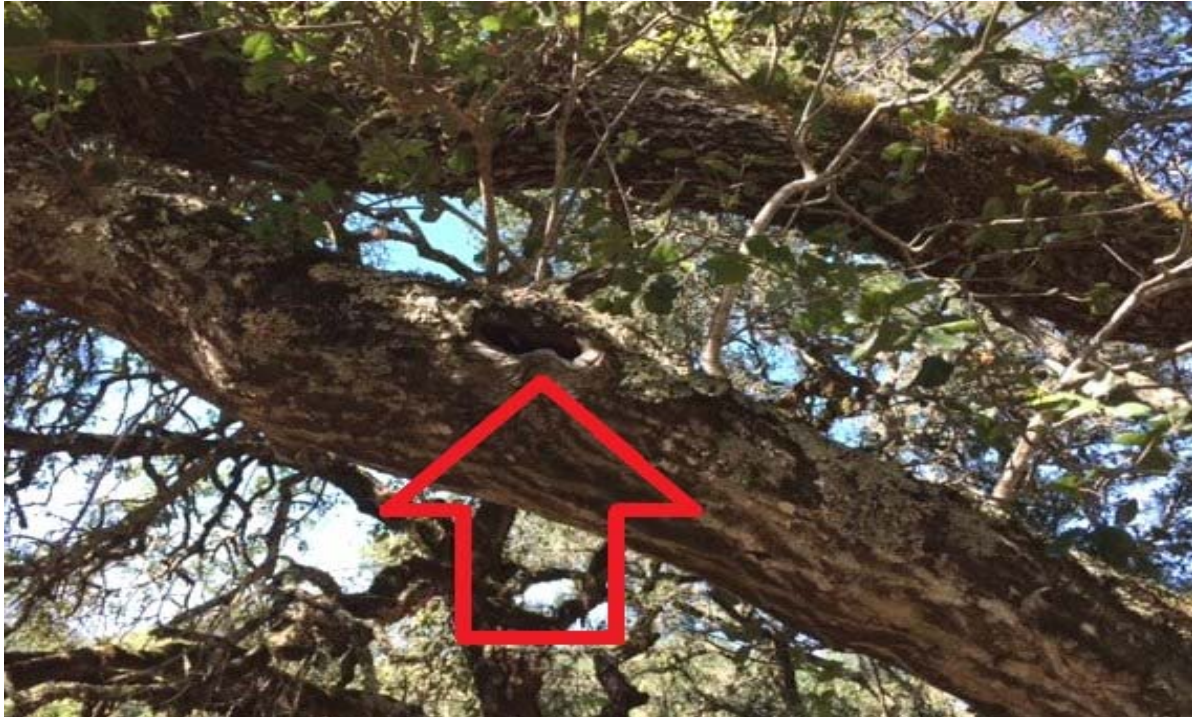
Photo 4: Cavity in tree branch that could provide bat roosting habitat.

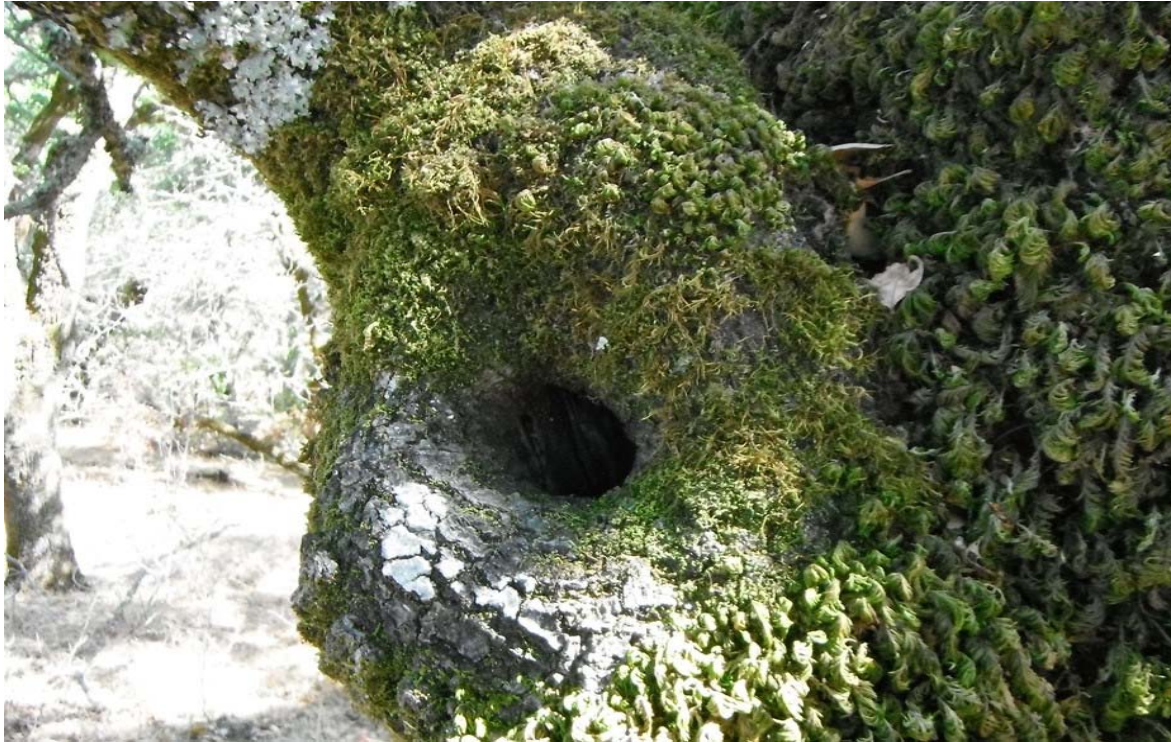
Photo 5: Cavity in tree that could provide bat roosting habitat.

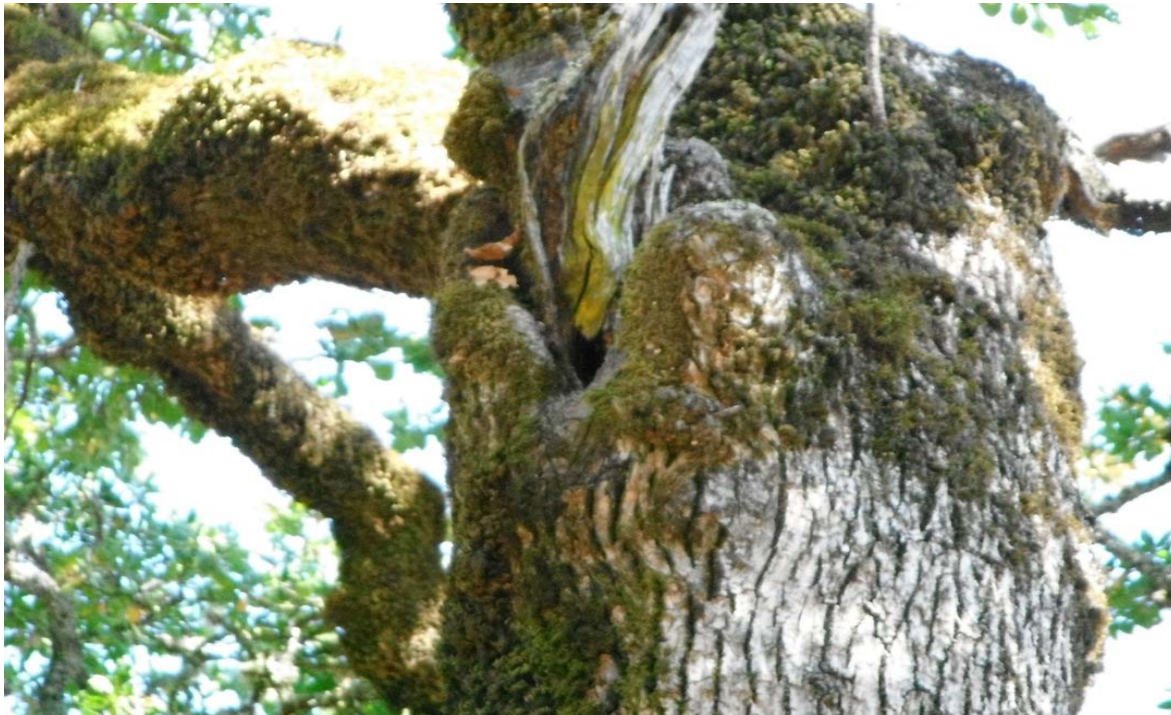
Photo 6: Cavity in tree that could provide bat roosting habitat.

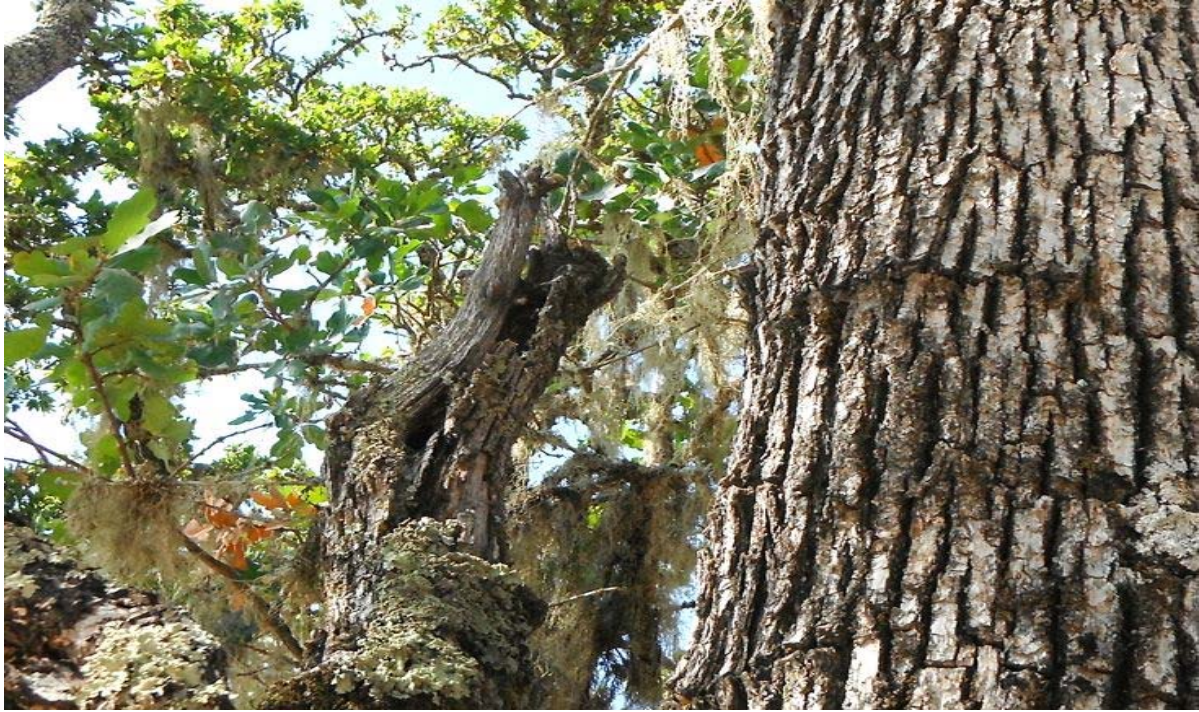
Photo 7: Cavity in tree that could provide bat roosting habitat.

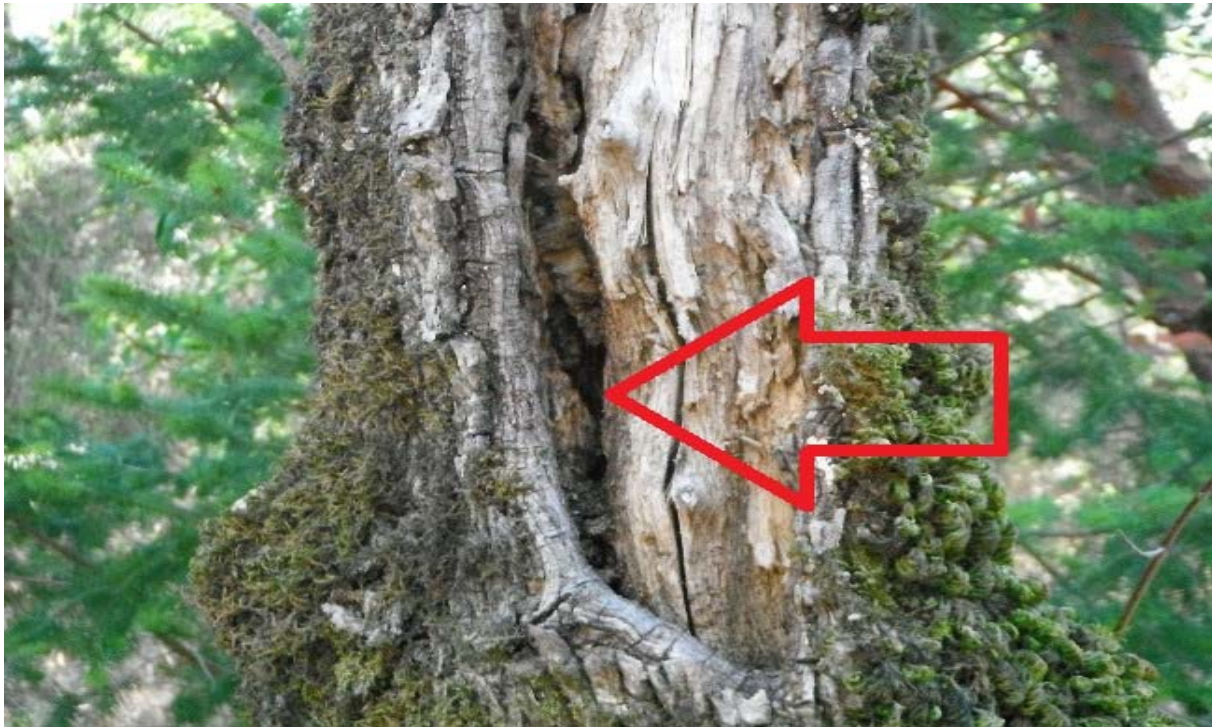
Photo 8: Cavity in tree that could provide bat roosting habitat.

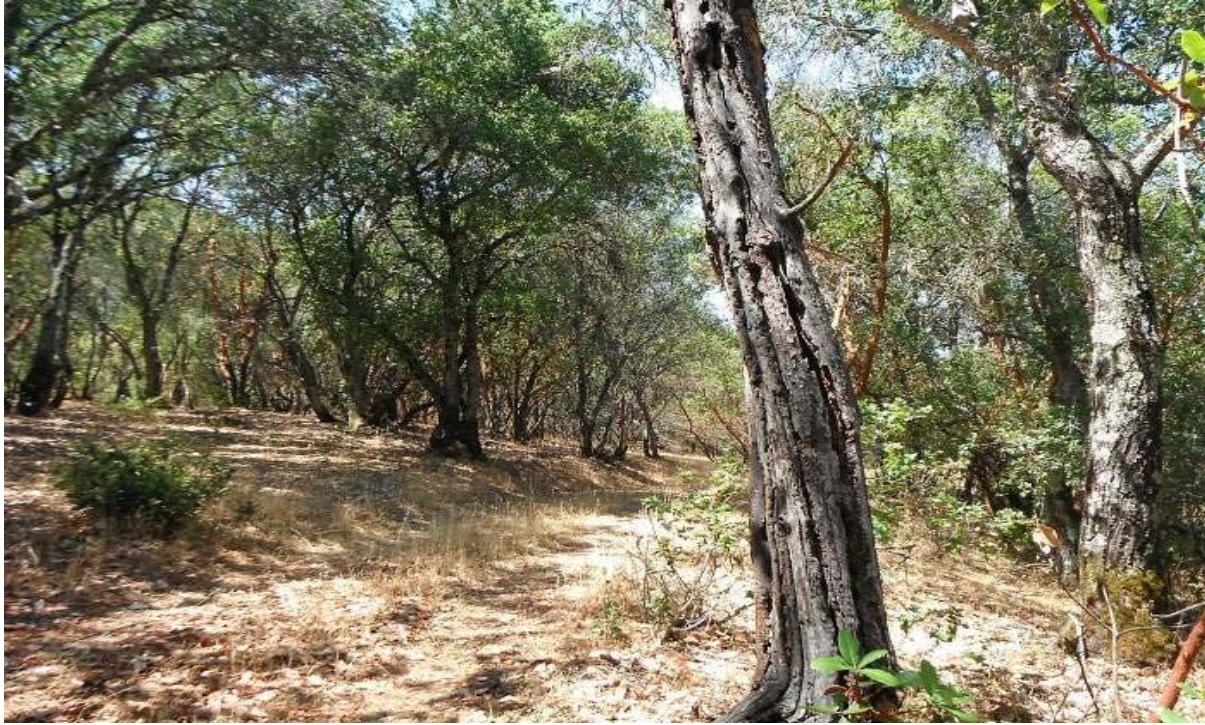
Photo 9: Snag T199 with abundant crevices and cavities.

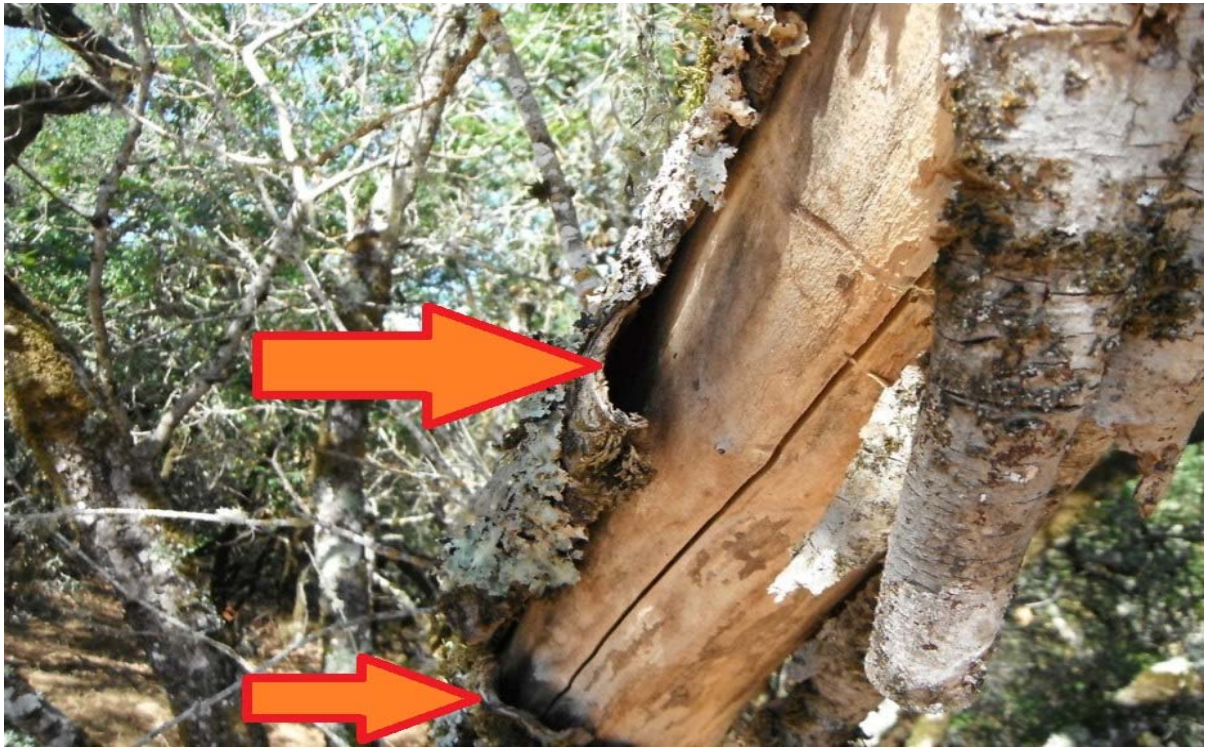
A limited number of unmarked trees identified via aerial imagery for trimming or removal were accessible in the field. Trees planned for trimming or removal in dense forest were inaccessible to survey, though they are also considered unsuitable for roosting habitat due to a lack of open canopy that allows solar warming of roosts, uncluttered flyway space, and travel corridors (Photo 2). Bats often use features such as streams, anthropogenic paths and trails, and small roads as travel corridors. Subsets of trees were located in the field based on a Google Earth kmz file and arborist's notes. Approximately 133 trees were identified and assigned a yes or no value for potential bat habitat (Table 1). Twenty-eight of the 133 trees had hollows or cavities from decay and/or bird activity (photos 3–9), or crevices underneath exfoliating bark (Photo 10) that could provide bat habitat, and were located in more open canopy near trails and small roads.

Photo 10 Potential bat crevice under exfoliating bark.

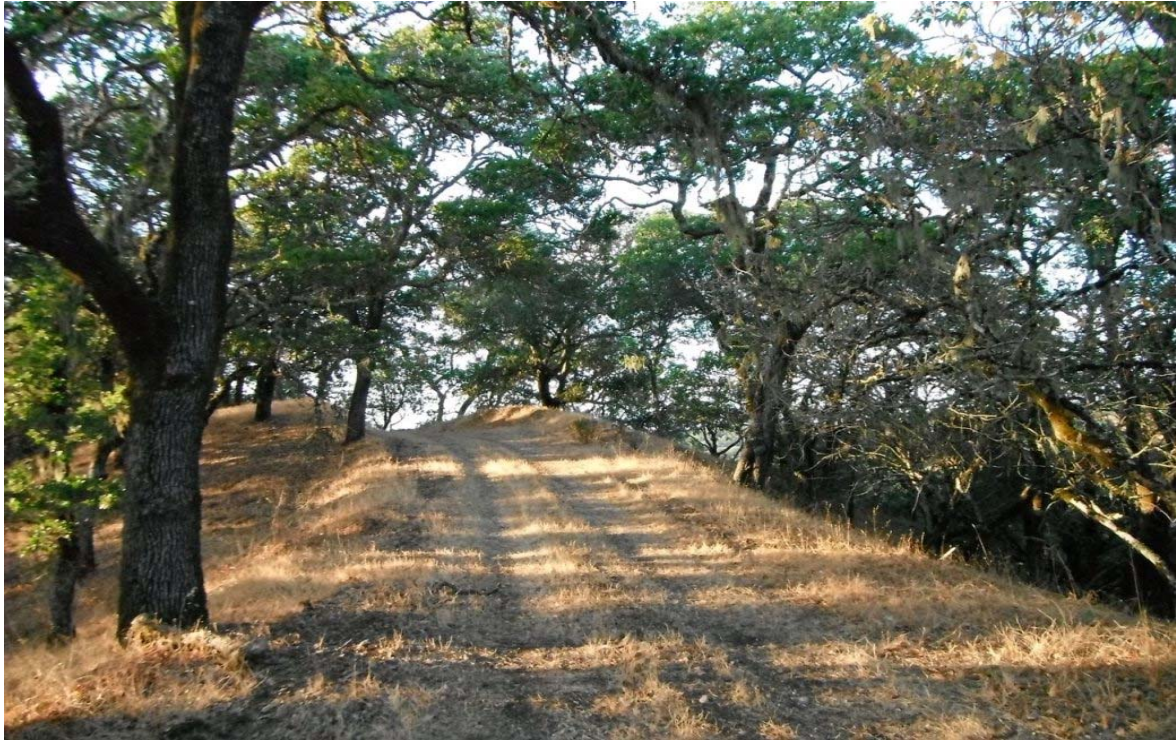
No bats were visually or acoustically detected during the emergence survey conducted by E. Jepsen at T278, T279, and T280 (Photo 11), H. Johnson near T297, T298, and T299 (Photo 12), or at a passive bat detector placed further south along the project access route at a likely travel corridor. A second emergence survey was precluded by lack of access, primarily on private land including a private gate on Shiloh Ridge Road (T152 to T182), and safety concerns due to regulations prohibiting parking after sunset on Faught Road or in the Shiloh Regional Park.

Photo 11: Habitat at an emergence survey location.

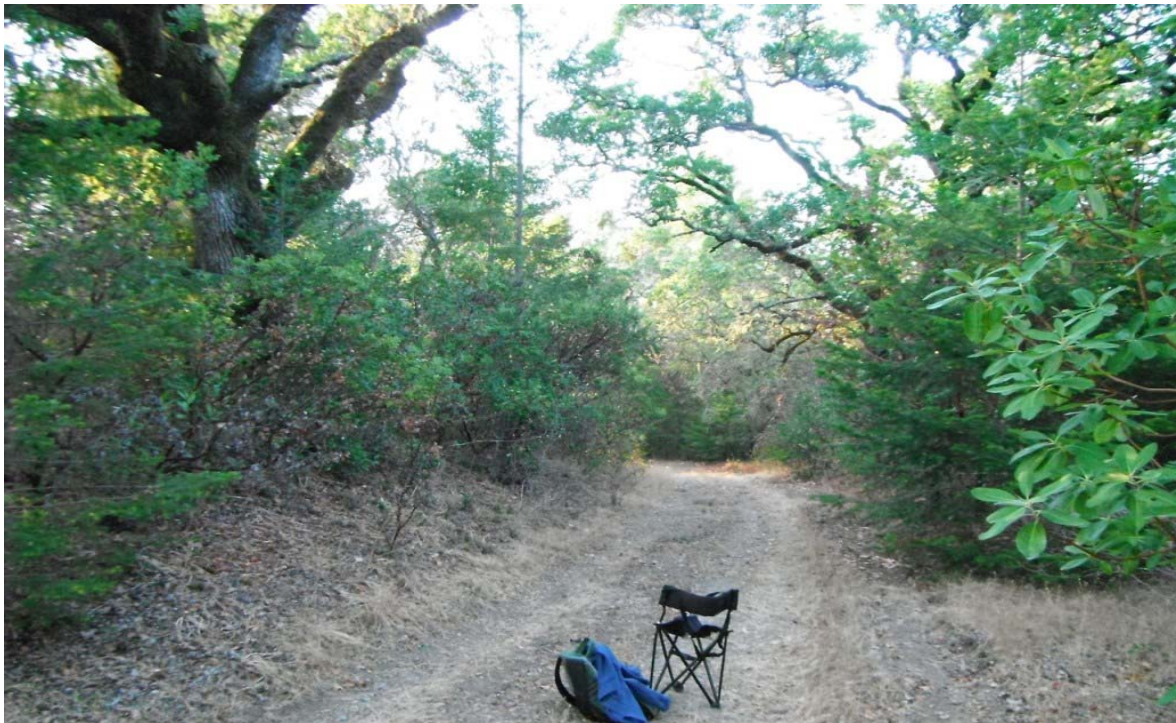
Photo 12. Habitat at an emergence survey location
