Garcia and Associates
2601 Mission Street, Suite 600
San Francisco, CA 94110
Phone: (415) 642-8969
Fax: (415) 642-8967

RE: Fulton-Fitch Reconductoring Project, Water Crossing Mapping

Appendix A. Fulton-Fitch Work Area and Crossing Photos

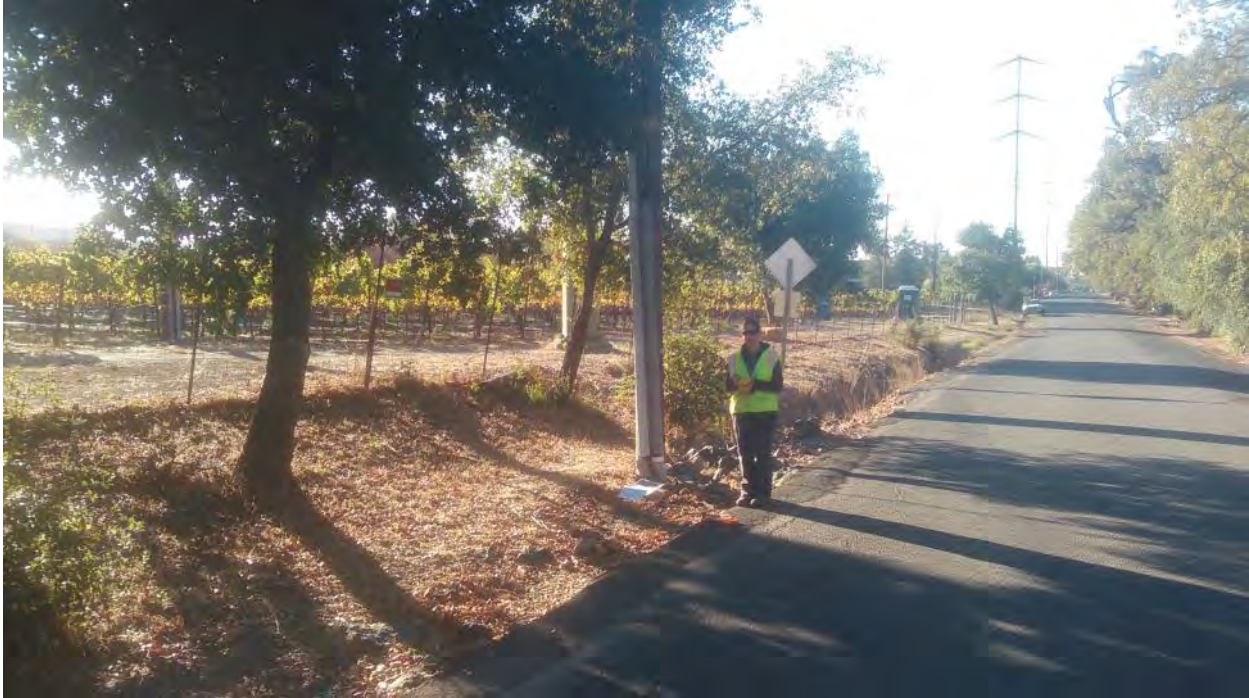
FFW1 – Pole 20; SEW41 (photo facing south)

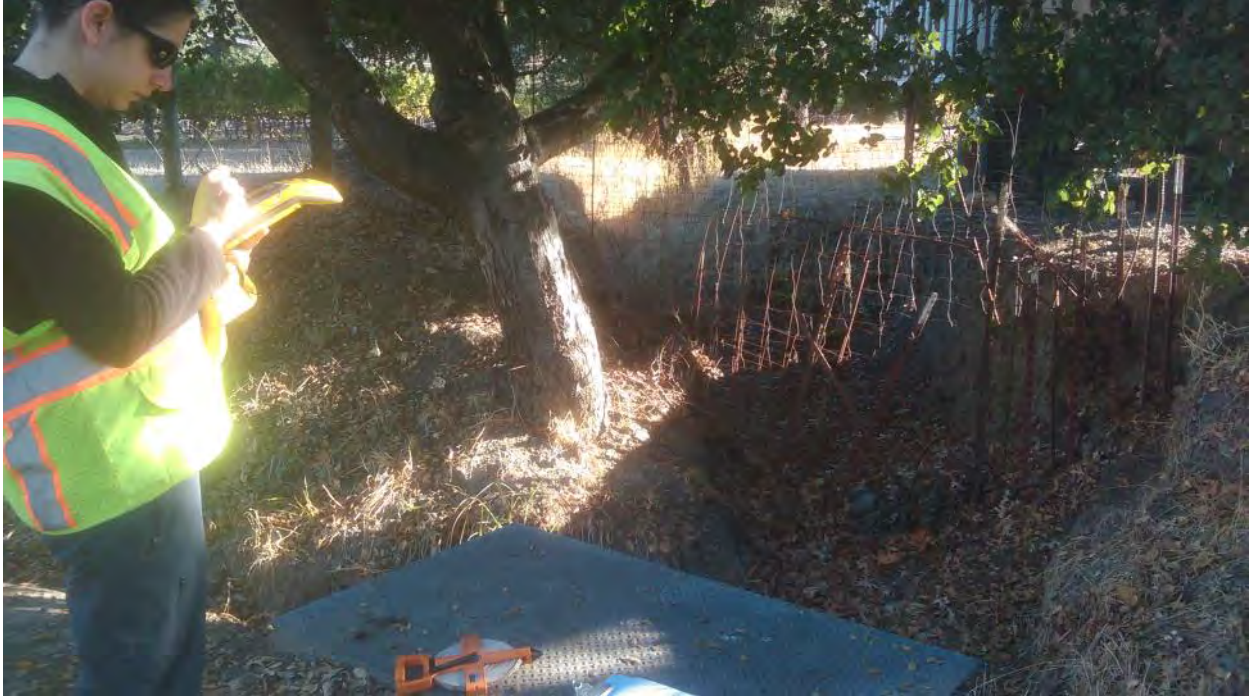
FFW1 – Pole 20; SEW41 Culvert at terminus of drainage (photo facing east)

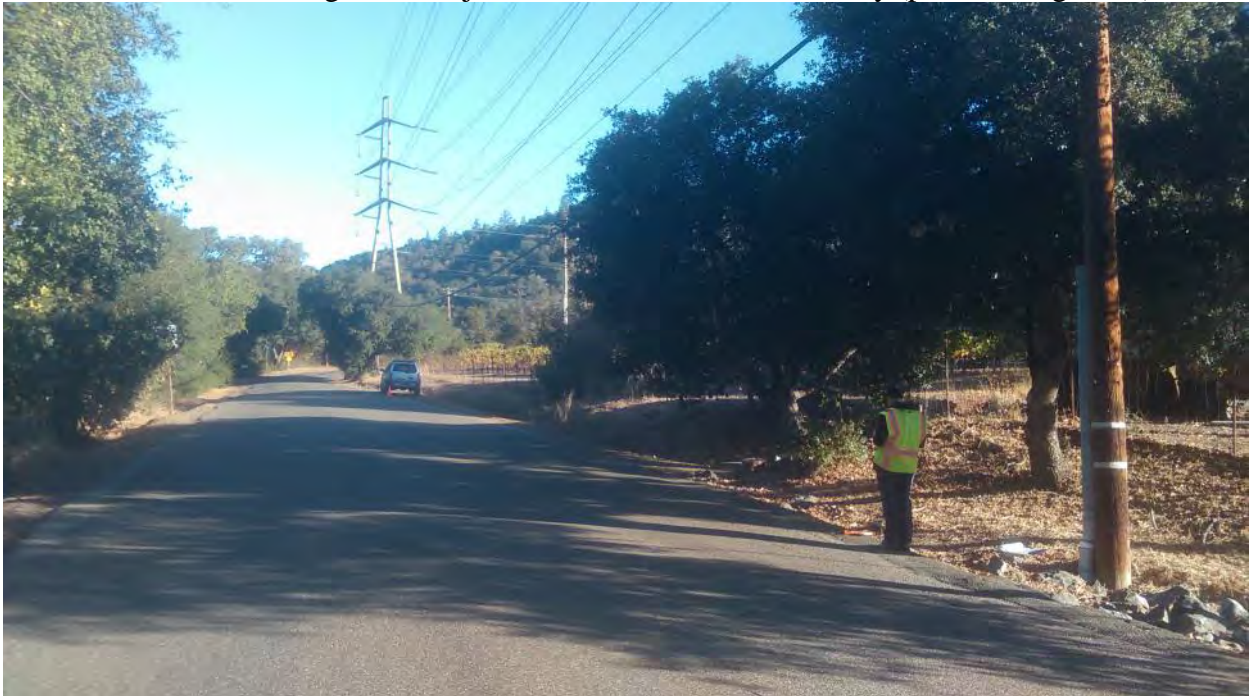
FFW2 – PS4; D4 Drainage ditch adjacent to east side of the roadway (photo facing north)

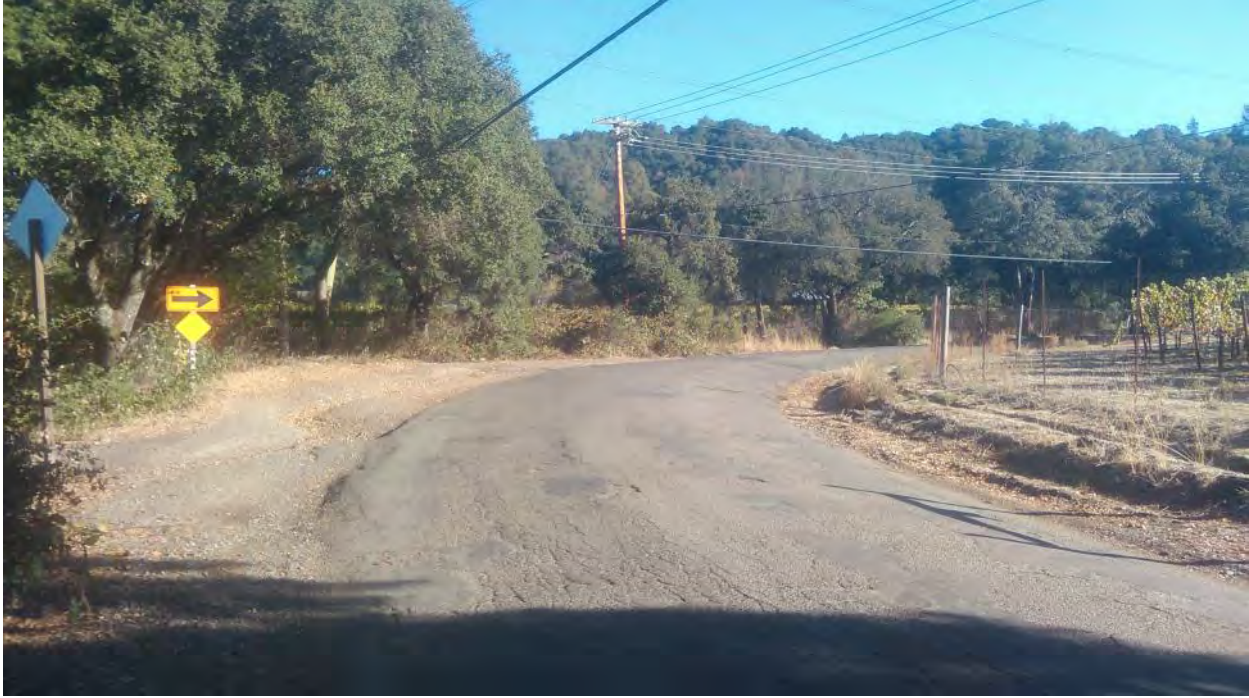
FFW3 – PS4; SEW9A (photo facing north)

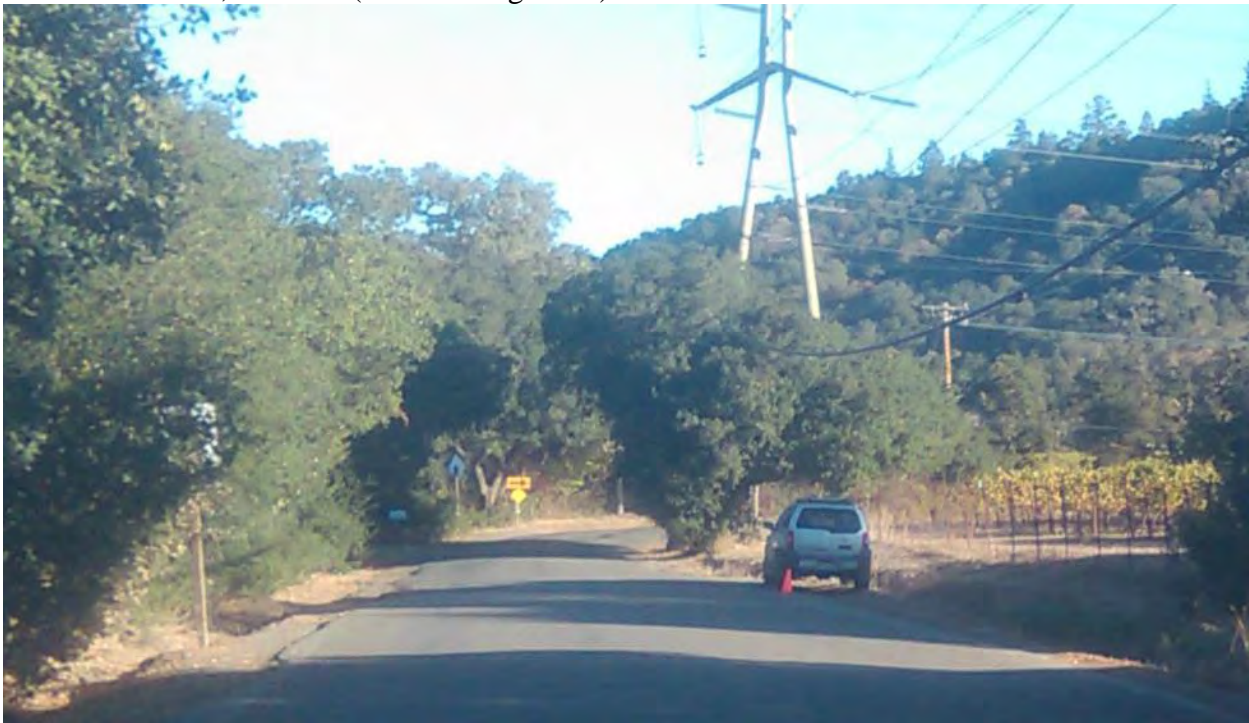
FFW4 – Pole 21; SEW9A (Photo facing north)

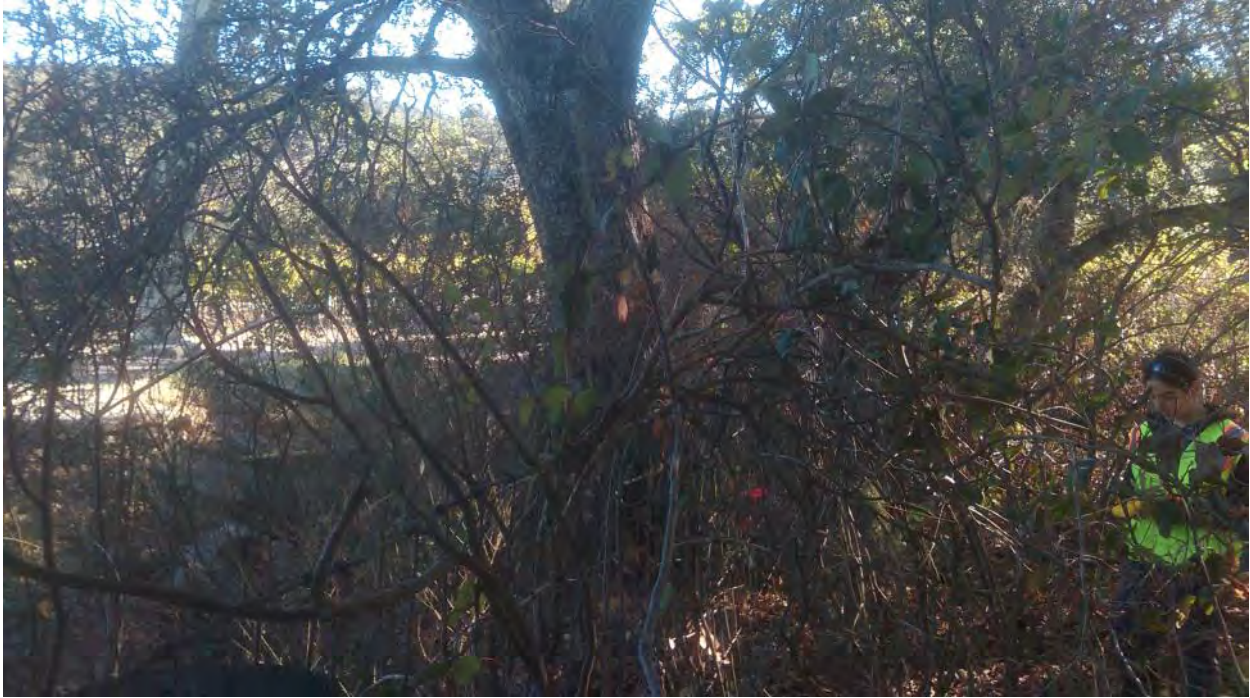
FFW5 – PS5; SEW9A adjacent to overgrown draining ditch (photo facing northeast)

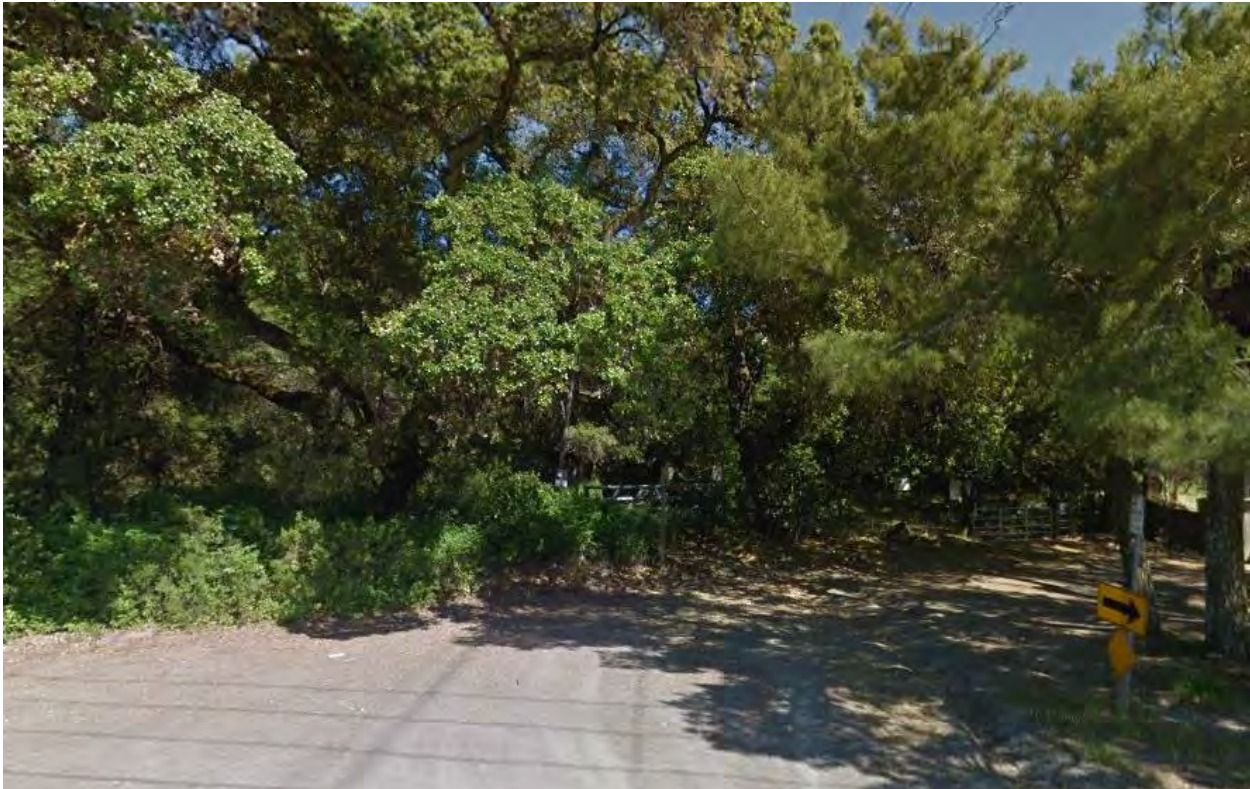
FFW6, FFW7, FFW8 – PS6; Pole 23; Pole 25 Pull-out entrance to access road (photo facing east)

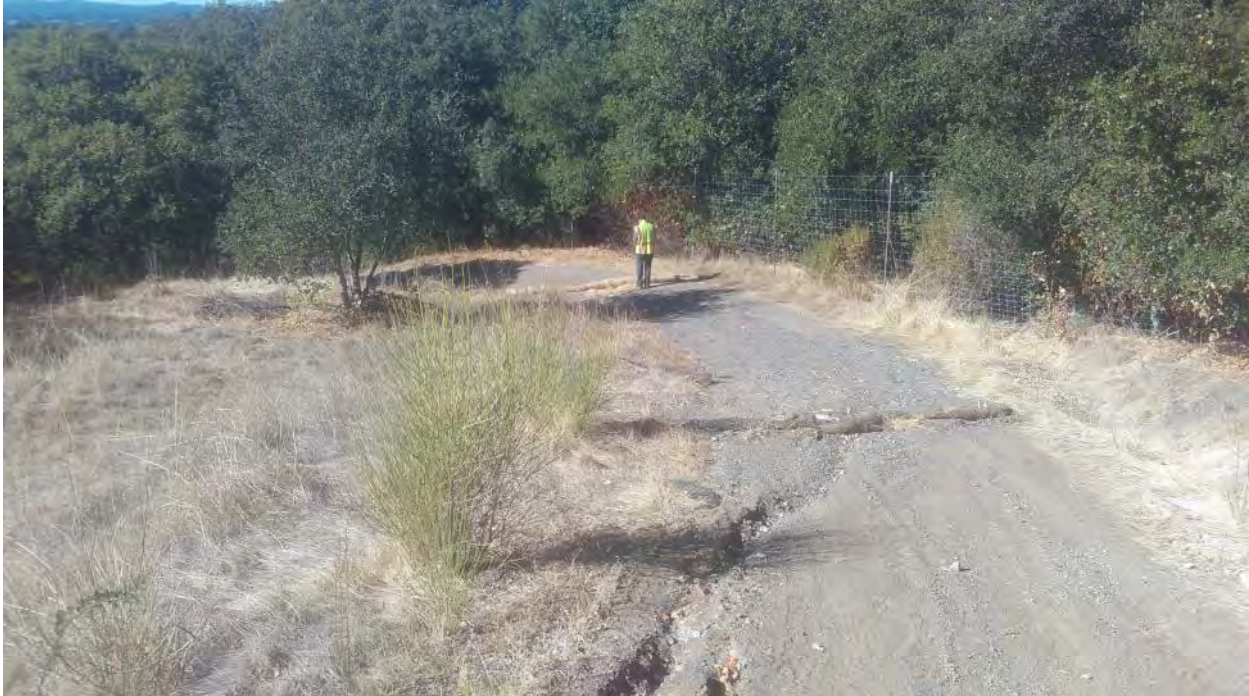
ID	Northing	Easting	Feature Name	Feature Type	Depth (feet)	Width (feet)	Description	Culvert Information	CRLF	Avoidance and Minimization Recommendation	Permit Recommendation
FFX1	4266581	519686	SEW44	Seasonal watercourse	0-1	10	Water flows from vicinity of storage tanks, sheet flow along road for approximately 40 feet, then off; wattles are in place, presumably to slow water flow (dry at time of survey)	No Culvert	Dispersal	Access when road is dry; full-size vehicles okay	No permitting required
FFX2	4268737	517974	SW1	Seasonal Wetland	1	15	Unimproved road crosses through midpoint in narrow seasonal wetland	No Culvert	Dispersal	Access during dry season; may be crossed without improvement full size vehicles okay; wet season crossing may require steel plates and/or gravel fill	USACE 404, RWQCB 401, and CDFW 1602 permits required
FFX3	4268730	518099	SEW45	Seasonal Watercourse	1	2-10	Ephemeral water course parallels road, crossing with sheet flow and some erosion for 70ft along roadway	No Culvert	Dispersal	Access during dry season; steel plates and/or gravel; full size vehicles okay.	USACE 404, RWQCB 401, and CDFW 1602 permits required

FFX1 – SEW44; Access road with seasonal surface flow and wattles (photo facing west)

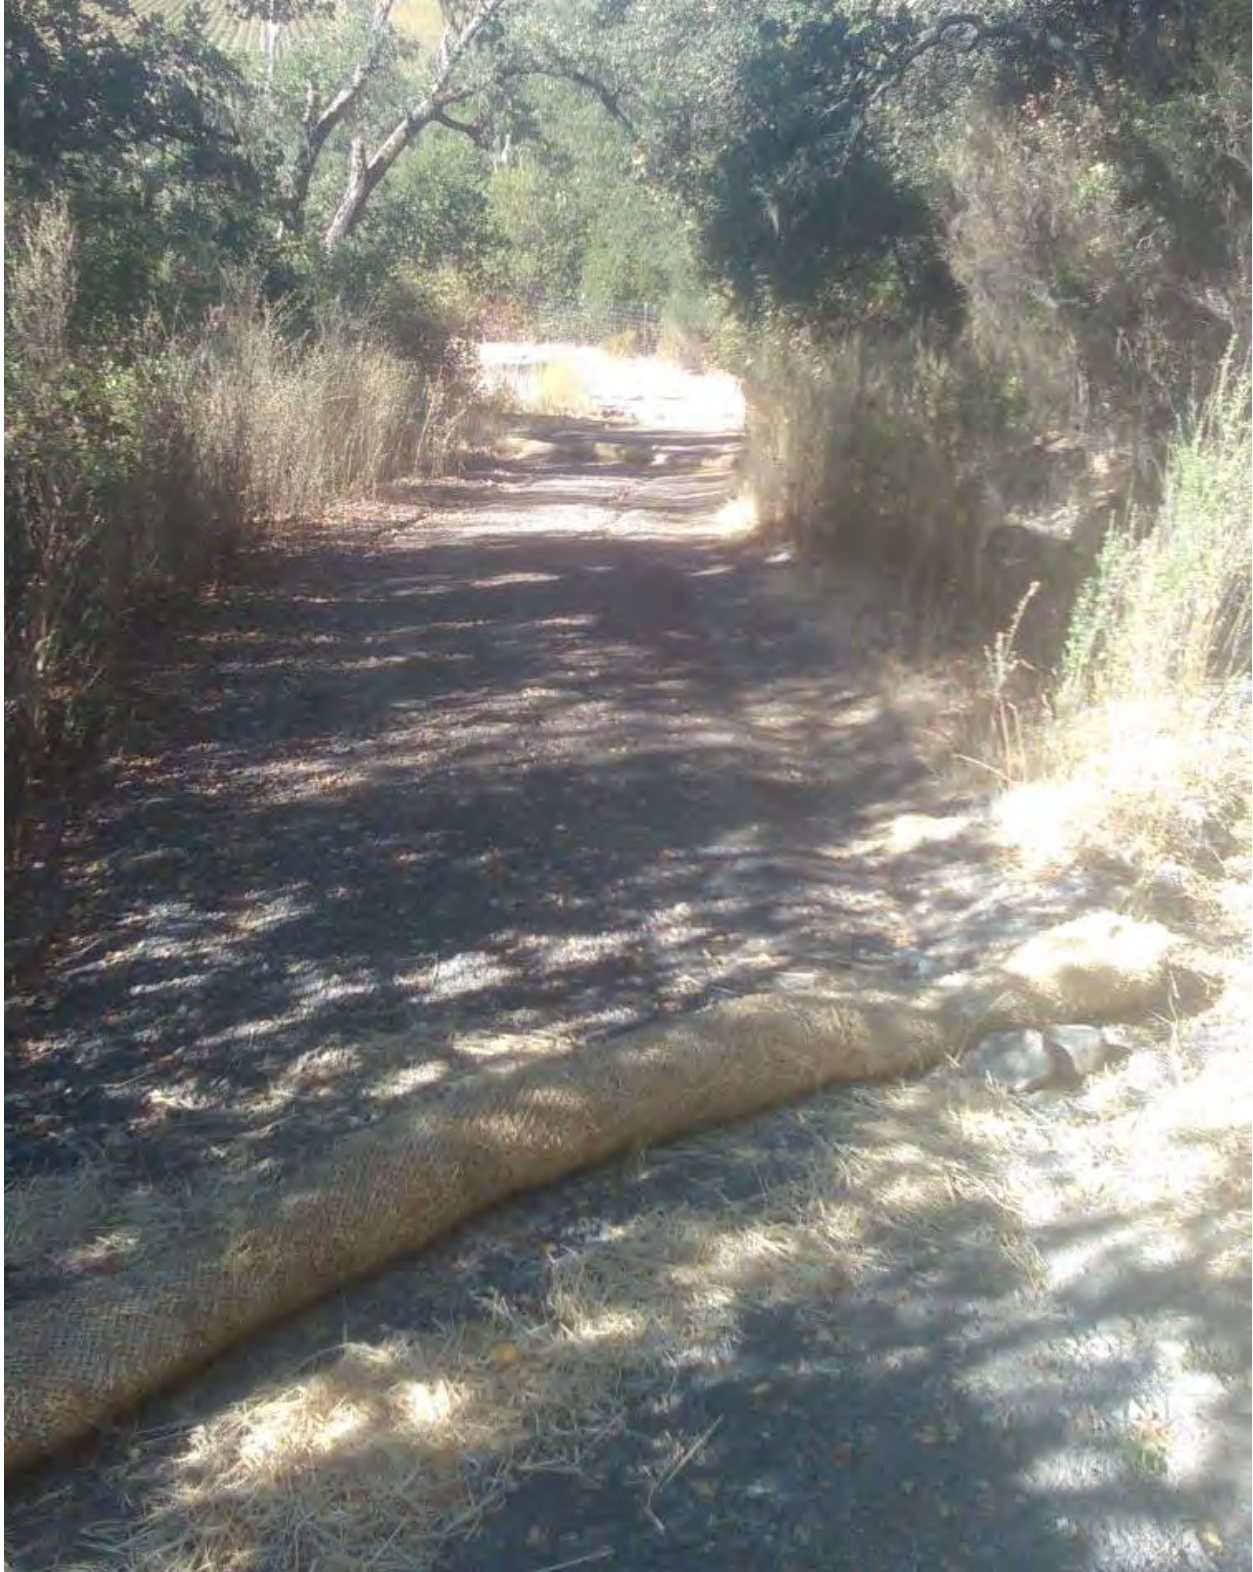
FFX1 – SEW44; Access road with seasonal surface flow and wattles (photo facing west)

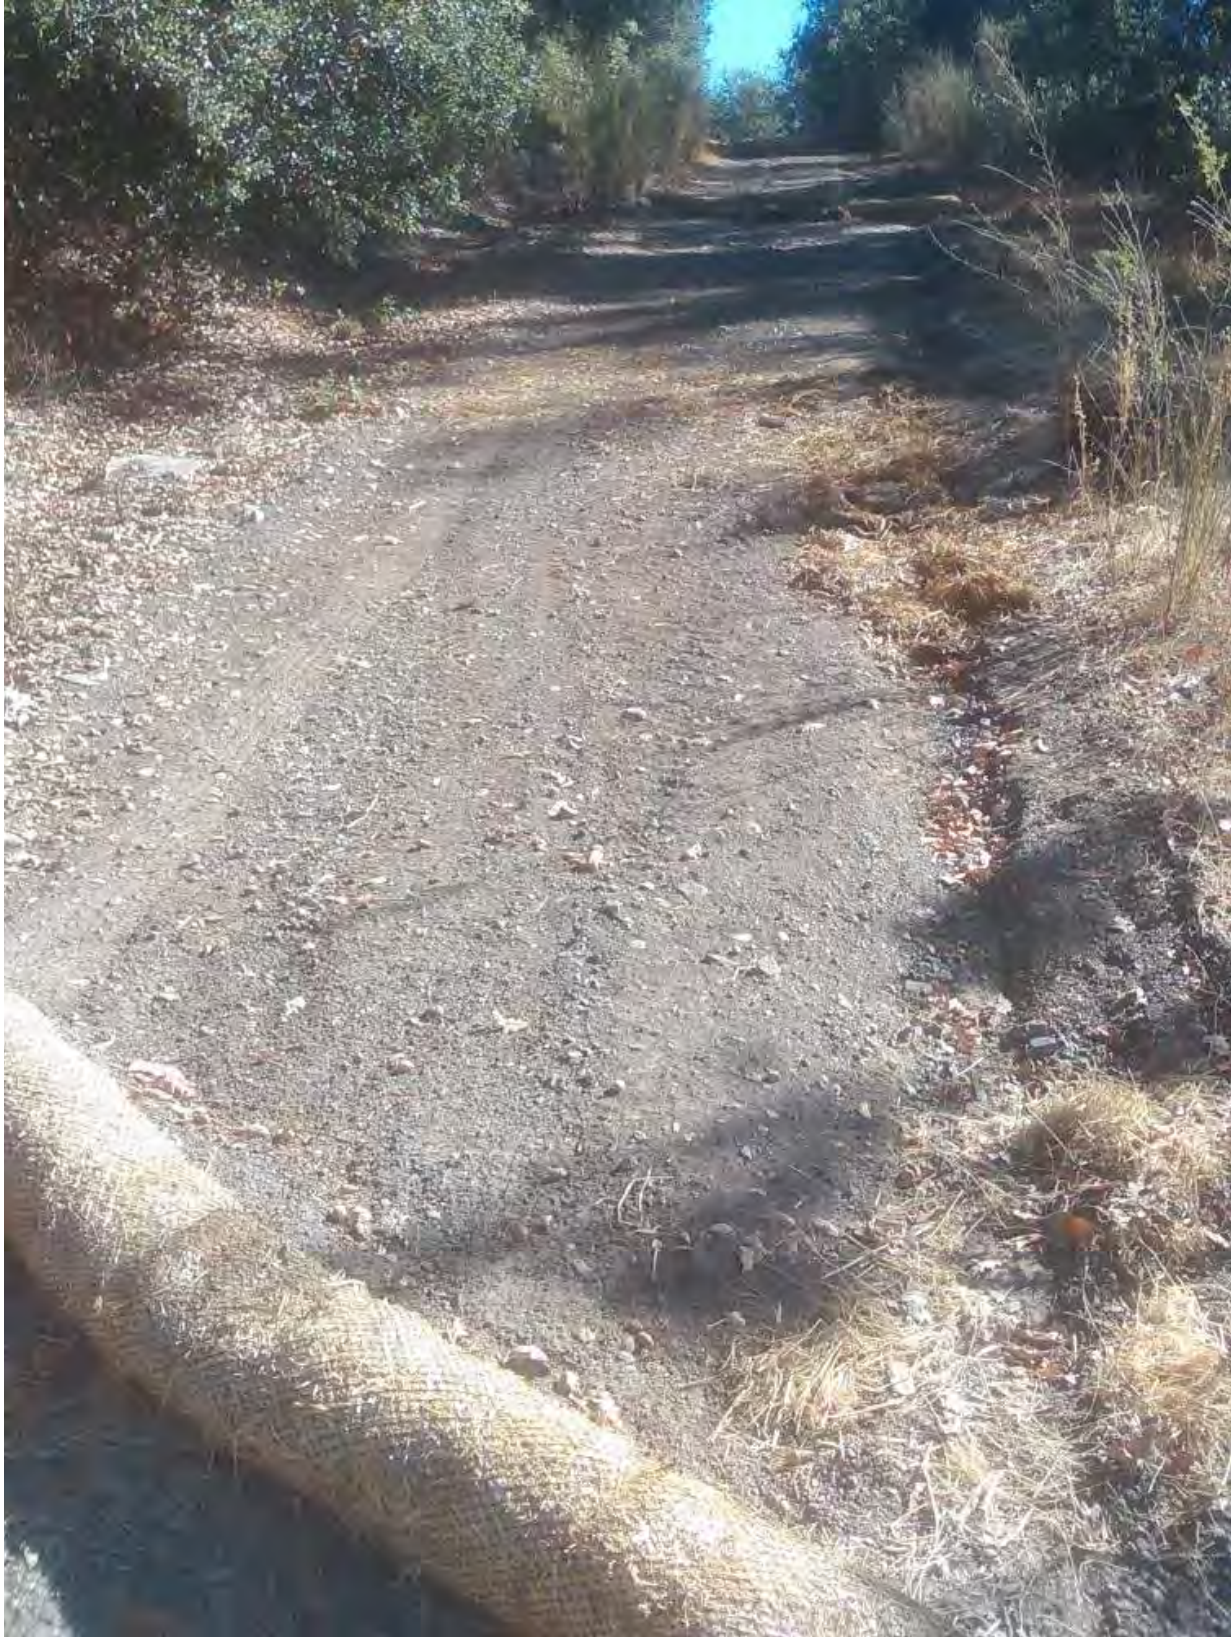
FFX1 – SEW44; Access road with seasonal surface flow and wattles (photo facing west)

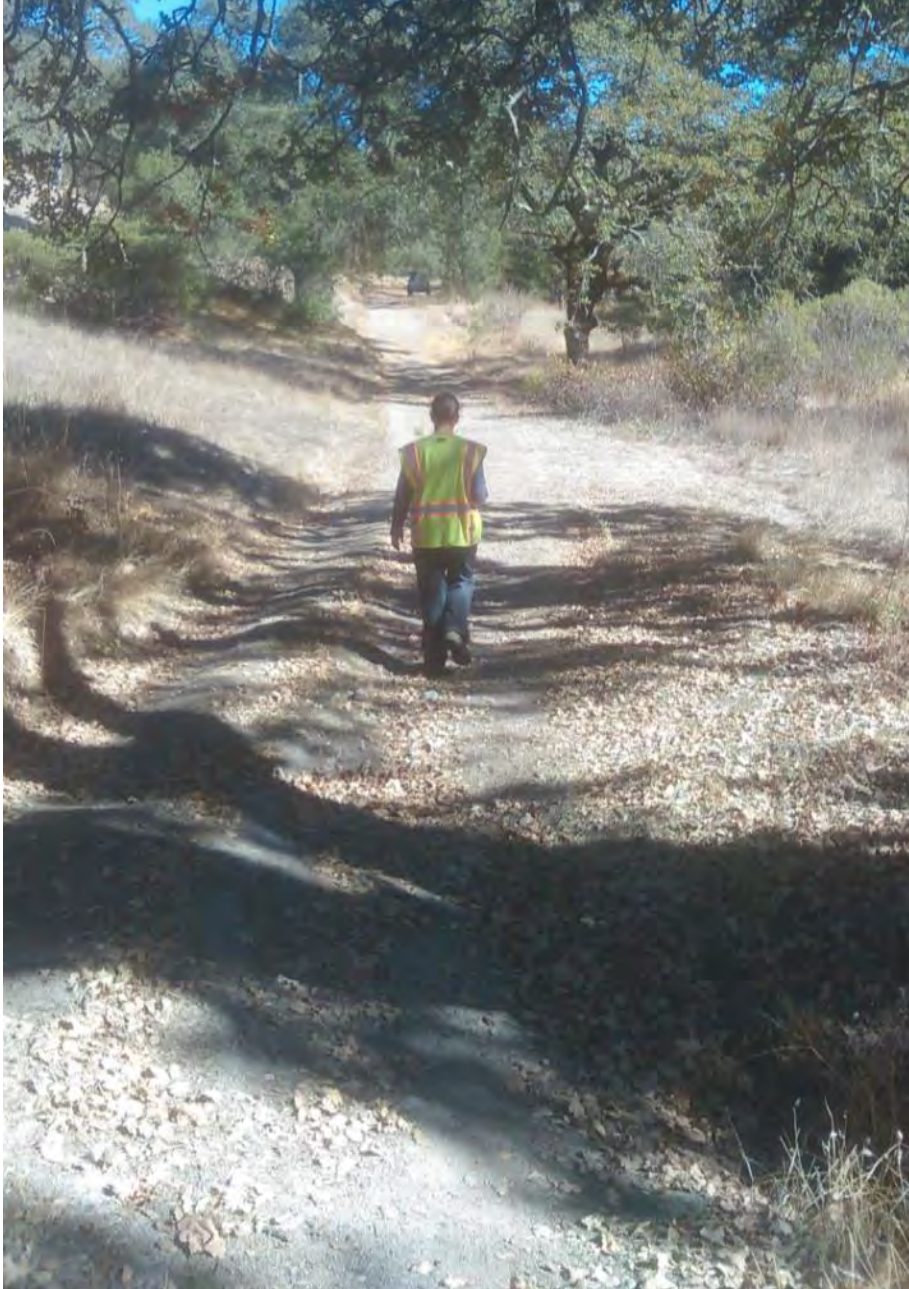
FFX3 – SEW45; Ephemeral water course, which crosses the road and has sheet flow along roadway (photo facing east)

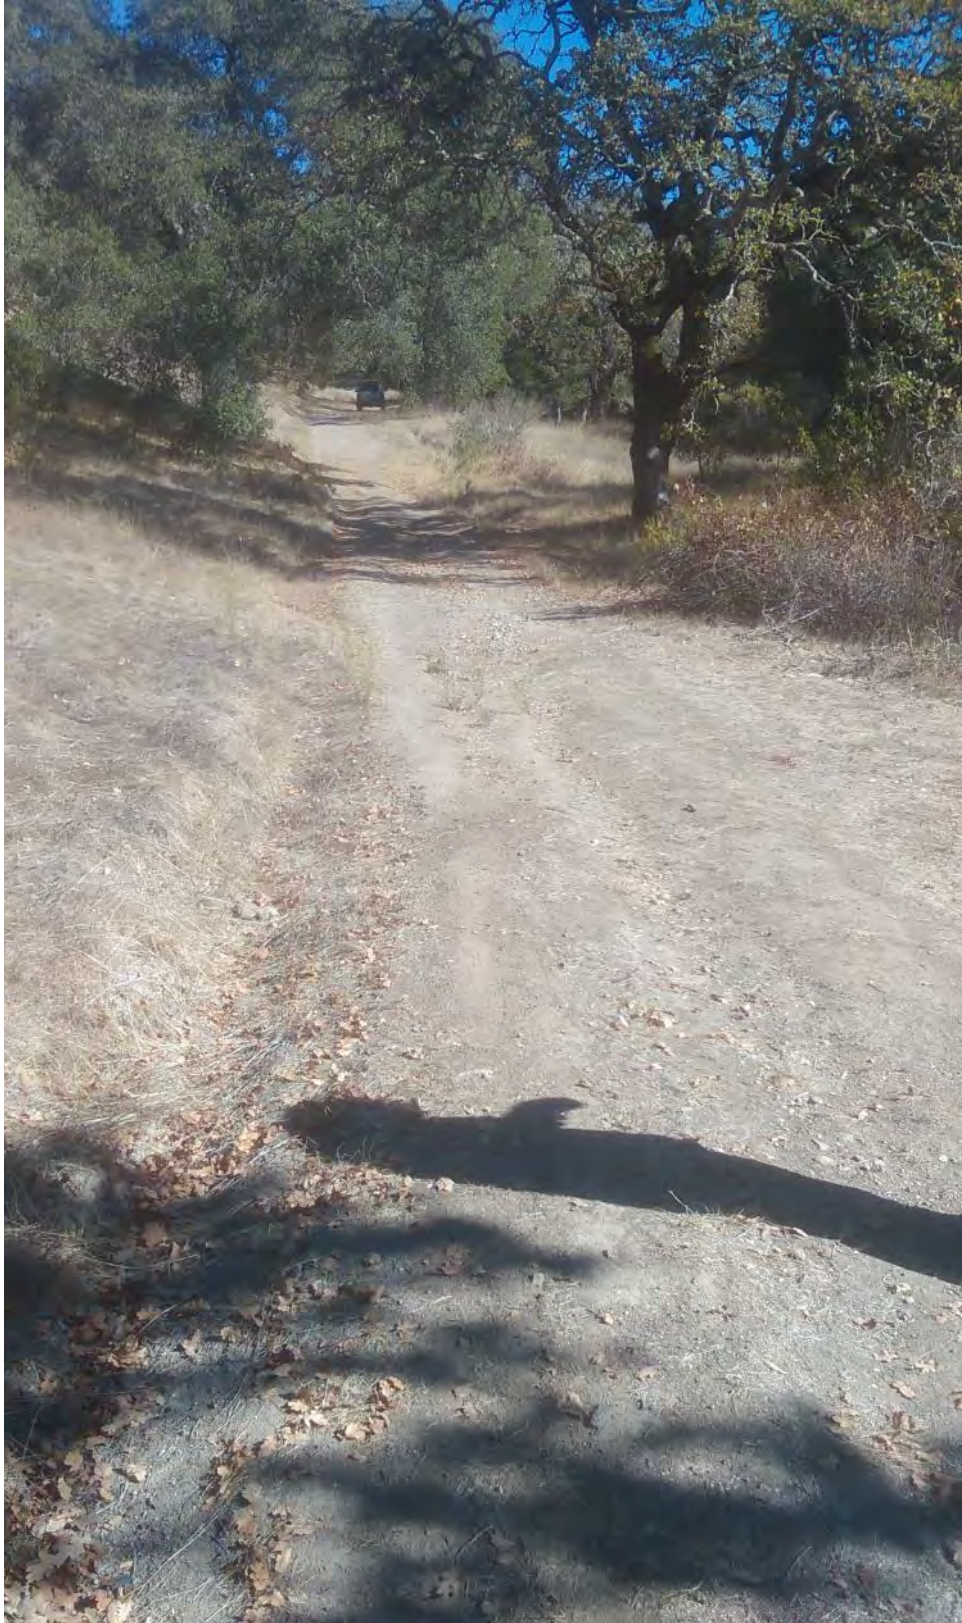
FFX3 – SEW45; Ephemeral water course with sheet flow along roadway (photo facing east)

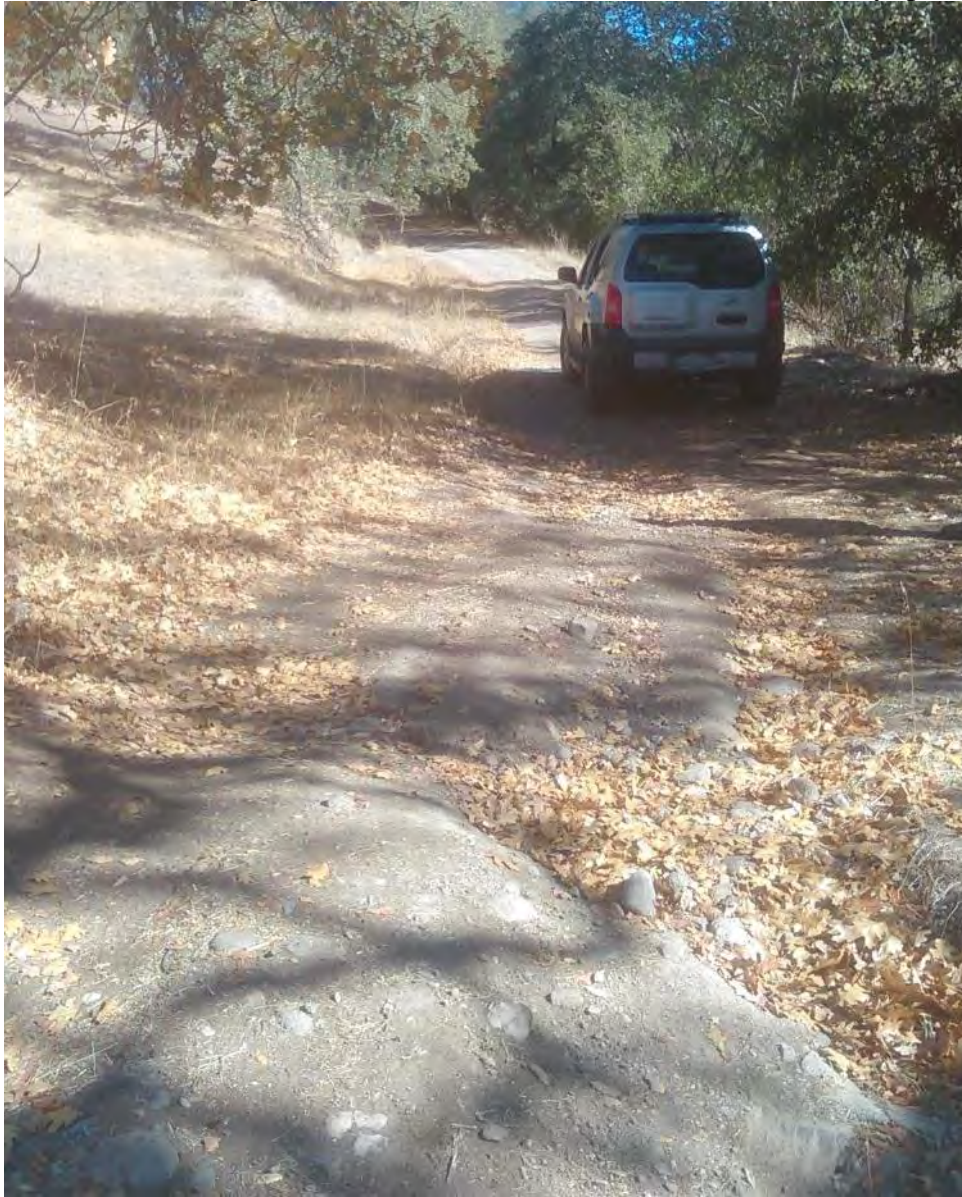
FFX4	4268738	518198	SEW45	Seasonal Watercourse	1	4	Water course parallels road, crossing and flowing for 4ft along roadway	No Culvert	Dispersal	Access during dry season; steel plates and/or gravel; full size vehicles okay.	USACE 404, RWQCB 401, and CDFW 1602 permits required
FFX5	4269100	518174	SW2	Seasonal Wetland	0	10	Water flow not evident during dry season survey	No Culvert	Dispersal	Access during dry season; steel plates; full size vehicles okay.	USACE 404, RWQCB 401, and CDFW 1602 permits required
FFX6	4269385	517946	SW3	Seasonal Wetland	0	10	Water flow not evident during dry season survey	No Culvert	Dispersal	Access during dry season; for wet season: steel plates; full size vehicles okay.	Unless vehicles can bypass wetland, USACE 404 RWQCB 401, and CDFW 1602 permits required
FFX7	4270606	517116	SEW4	Seasonal Watercourse	2	3	Not advisable; steep ravine	No Culvert	Dispersal	Not crossable with any vehicle or equipment. If a vehicle makes it down the ravine, use steel plates or similar	If a vehicle actually makes it down the ravine and crosses the seasonal watercourse, USACE 404 RWQCB 401, and CDFW 1602 permits required

FFX4 – SEW45; Ephemeral water course which crosses the roadway (photo facing east)

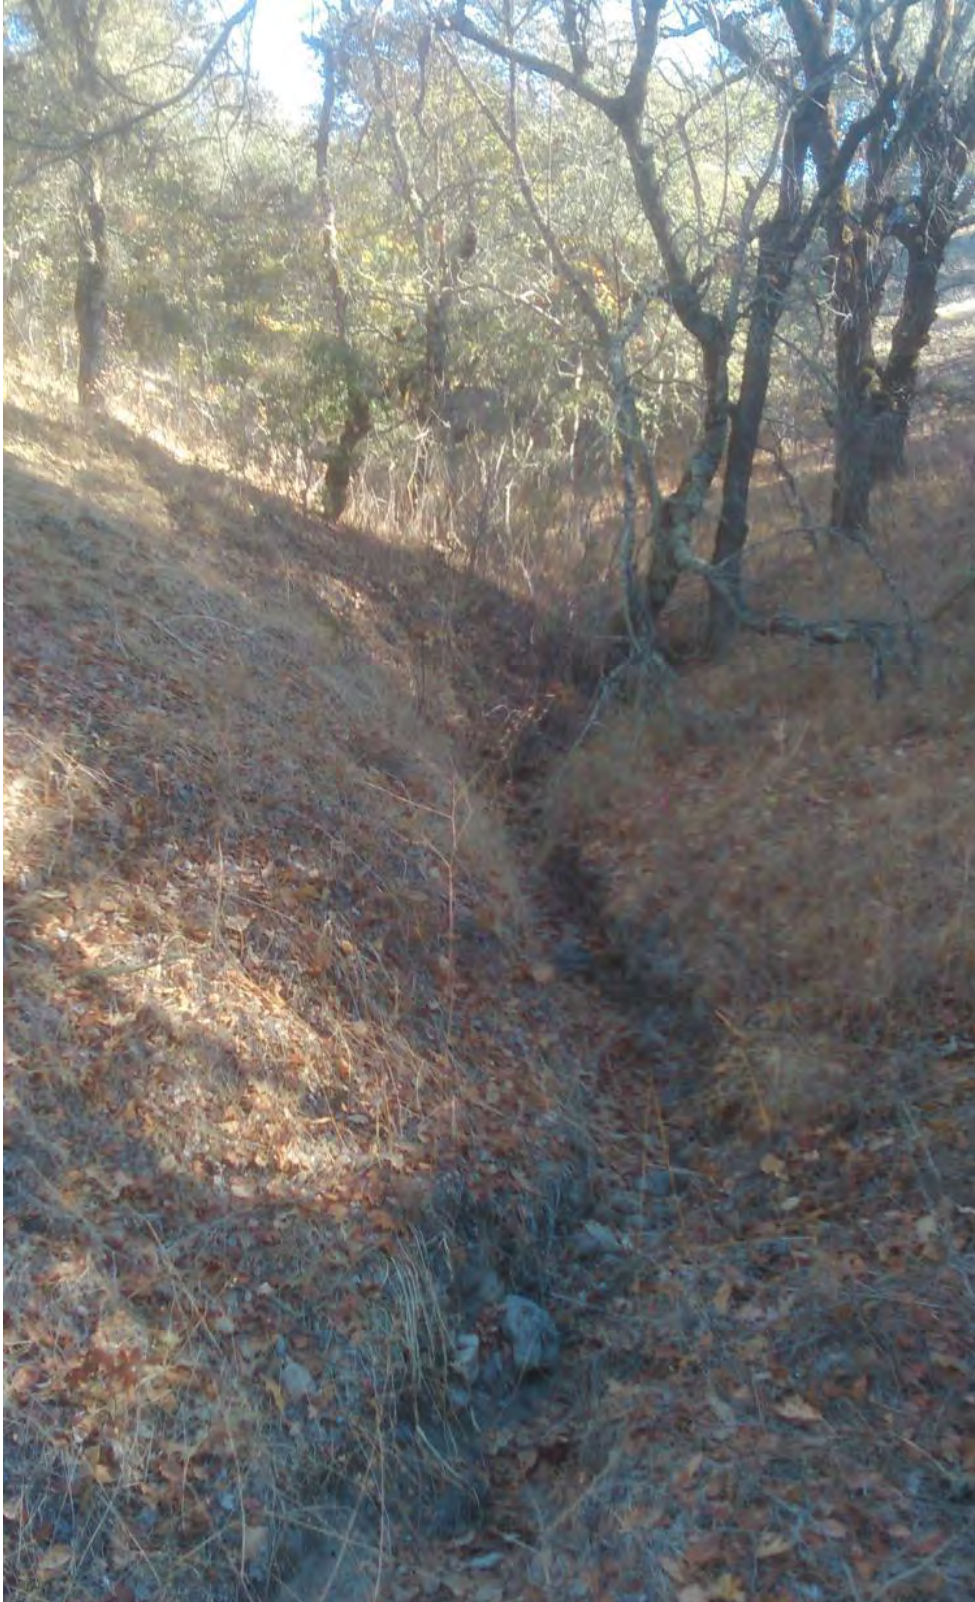
FFX7 – SEW4; Mapped access route topographically challenging (photo facing west)

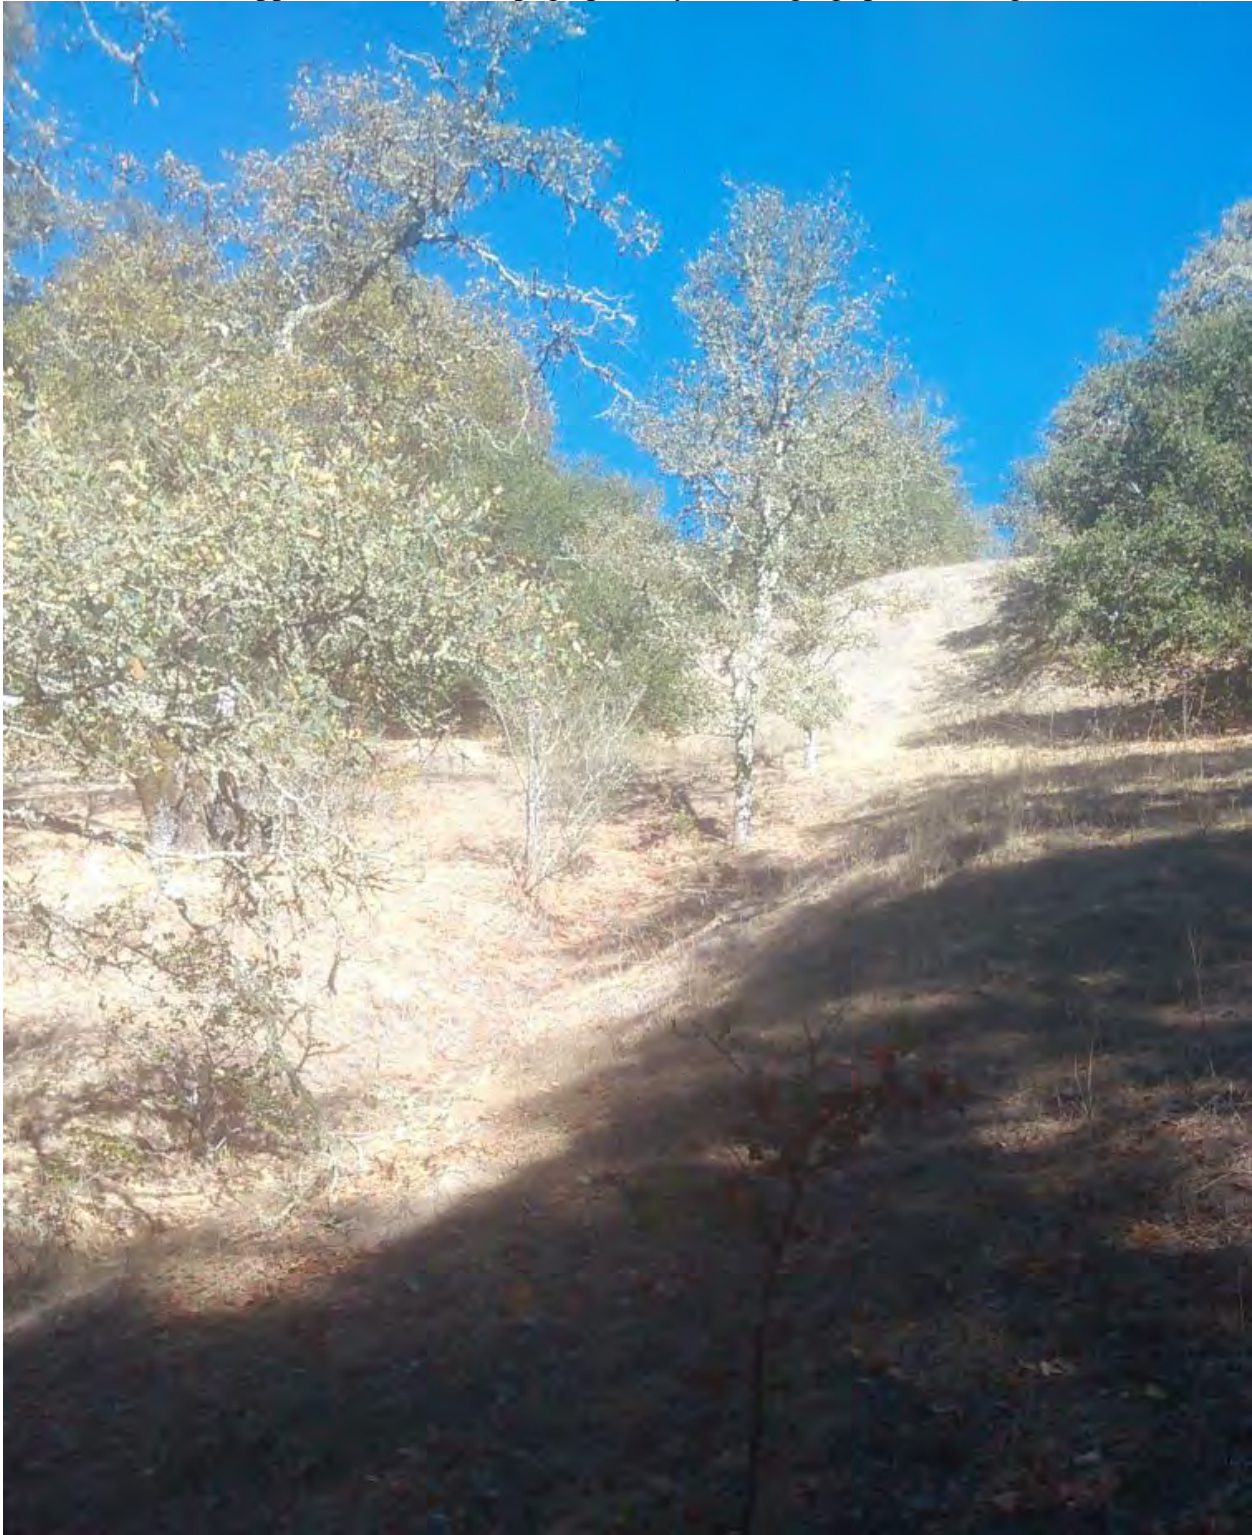
FFX7 – SEW4; Mapped access route topographically challenging (photo facing north)

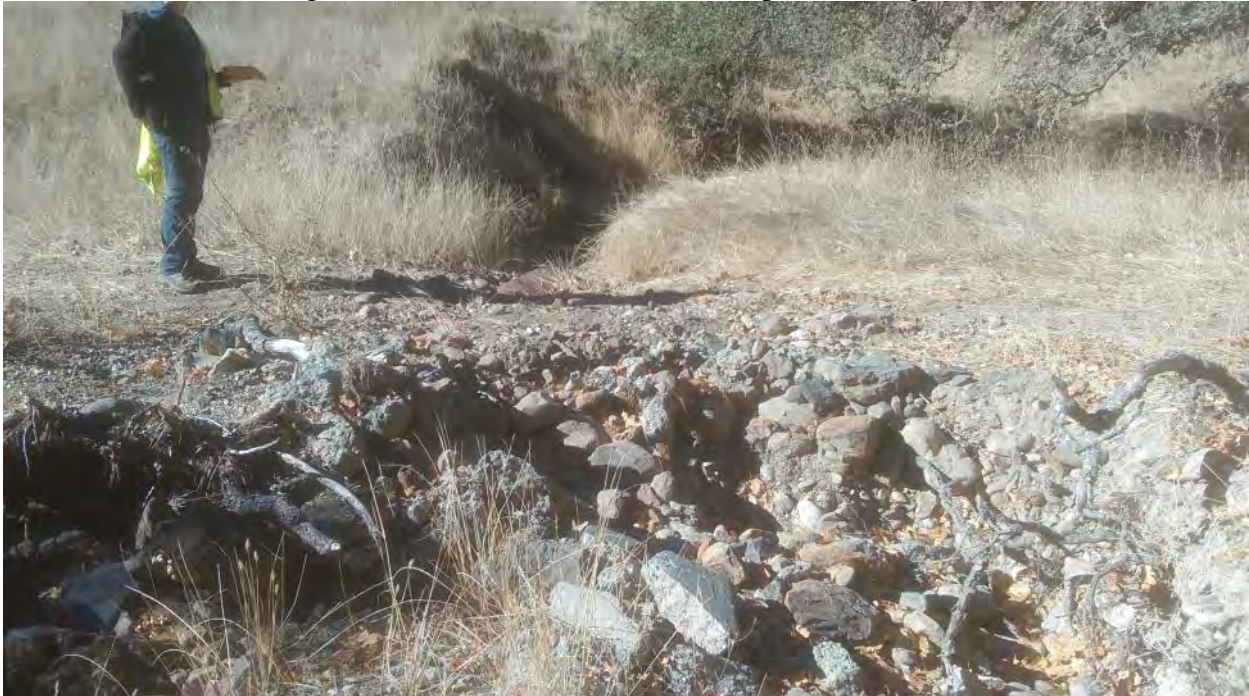
ID	Northing	Easting	Feature Name	Feature Type	Depth (feet)	Width (feet)	Description	Culvert Information	CRLF	Avoidance and Minimization Recommendation	Permit Recommendation
FFX8	4270214	517337	SEW3	Seasonal Watercourse	2-4	8	Dirt road drops into bottom of ravine and crosses seasonal watercourse/creek bed multiple times before reaching work area	2.5ft diameter by 8ft, rusted steel pipe, non-functioning (filled in with sediment)	Dispersal	Access during dry season; steel plates; full size vehicles not recommended	Recommend parking before reaching creek and walking to work area; if vehicles and road improvements are necessary, USACE 404, RWQCB 401, and CDFW 1602 permit may be required
FFX9	4270176	517349	SEW3	Seasonal Watercourse	5	6	Water parallels road and cuts into bank adjacent to road	No Culvert	Dispersal	Steel plate; shoring of the bank may be necessary; full size vehicles okay	Recommend parking before reaching creek and walking to work area; if vehicles and road improvements are necessary, USACE 404, RWQCB 401, and CDFW 1602 permit may be required

FFX8 – SEW2; Existing culvert is filled in with sediment (photo facing west)

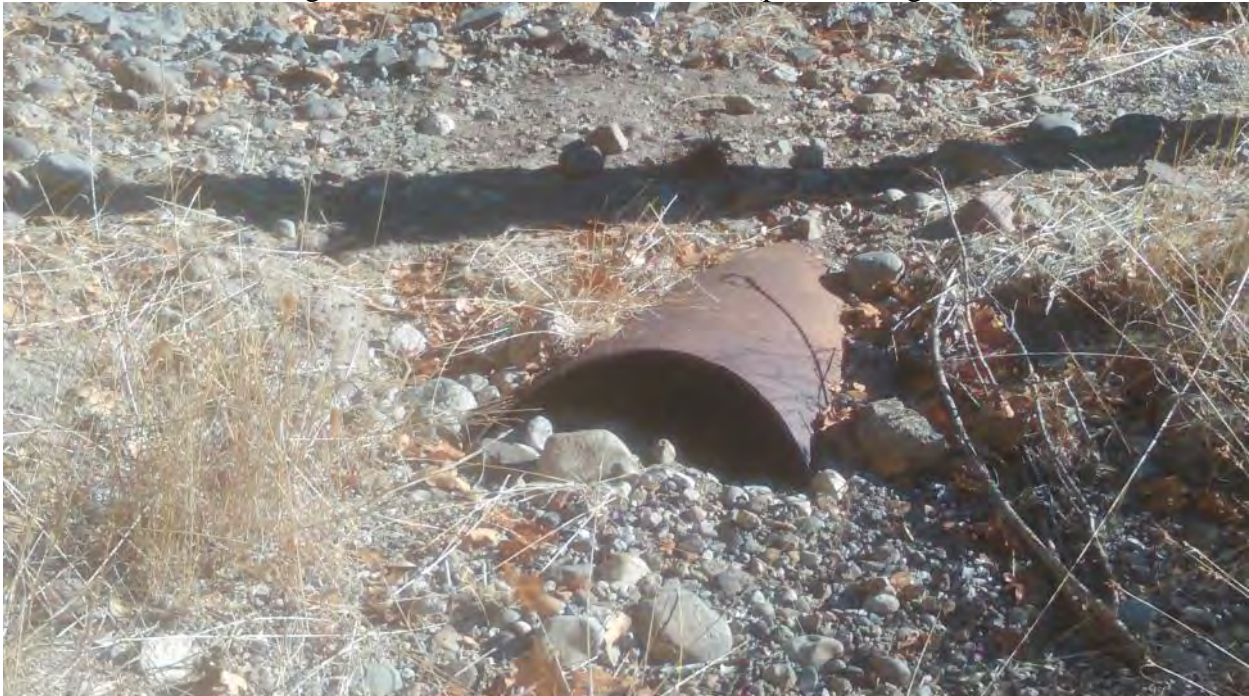
FFX8 – SEW2; Existing culvert is filled in with sediment (photo facing west)

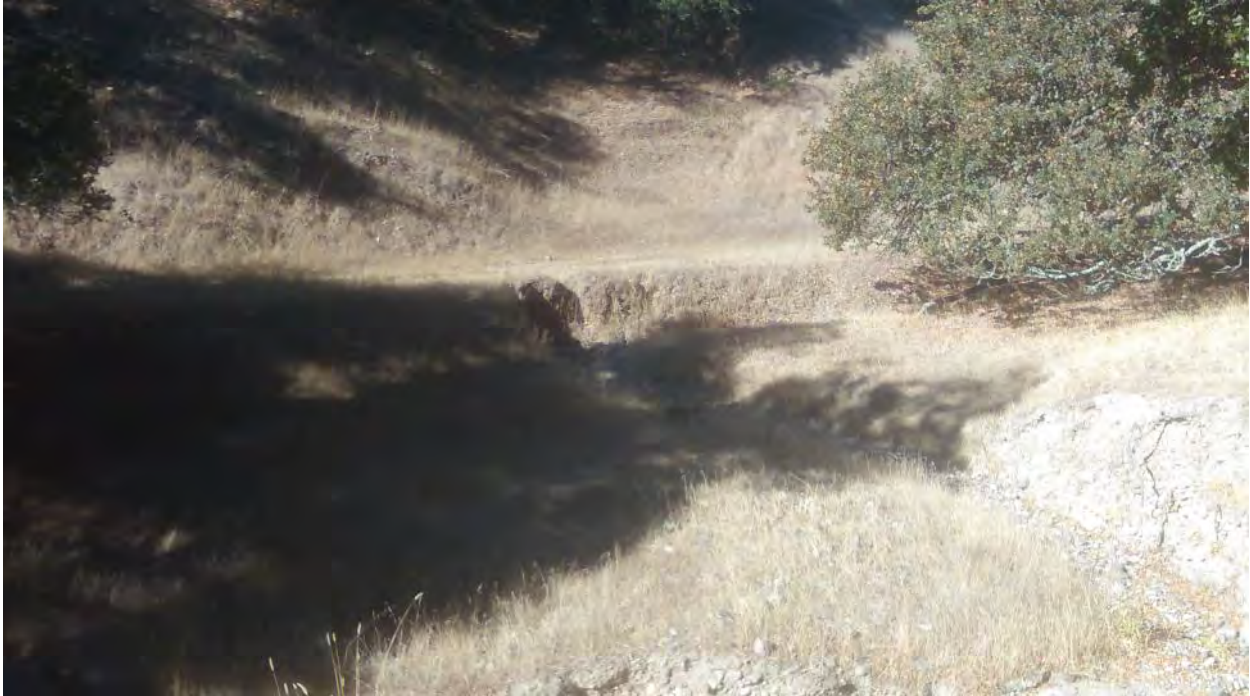
FFX9 – SEW2; Bank of adjacent watercourse eroding into road (photo facing west)
