Garcia and Associates
2601 Mission Street, Suite 600
San Francisco, CA 94110
Phone: (415) 642-8969
Fax: (415) 642-8967

RE: Fulton-Fitch Reconductoring Project, Water Crossing Mapping

Appendix A. Fulton-Fitch Work Area and Crossing Photos

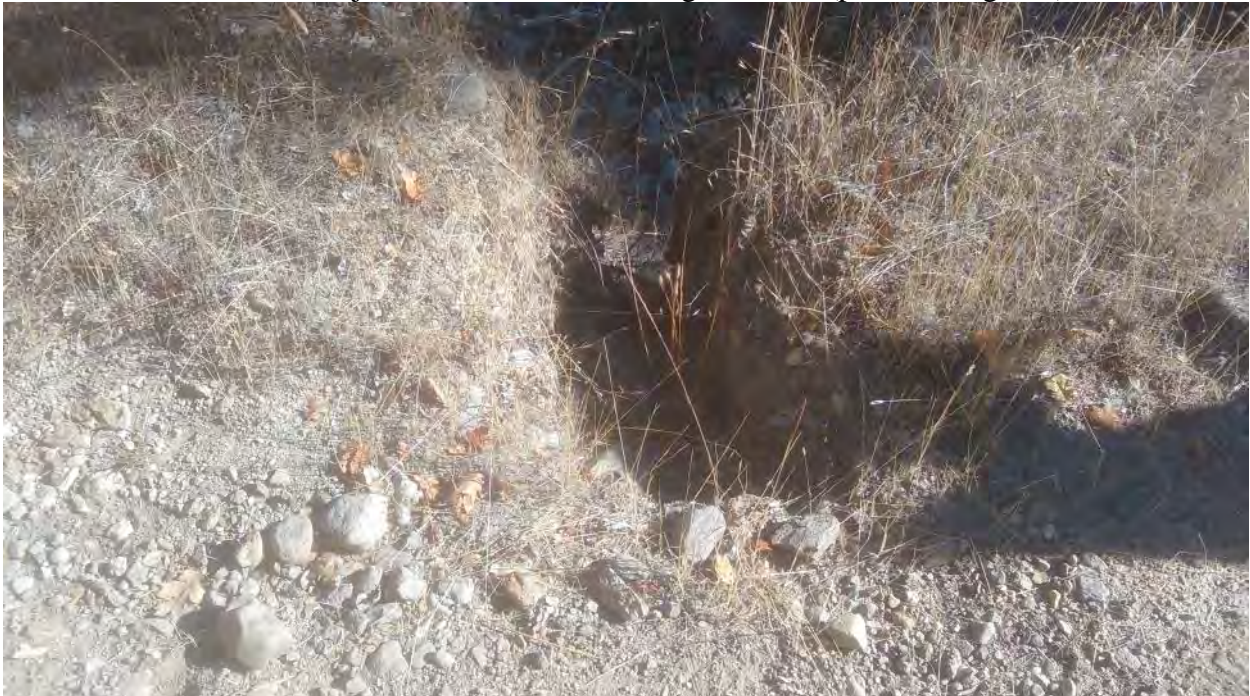
FFX9 – SEW2; Bank of adjacent watercourse eroding into road (photo facing east)

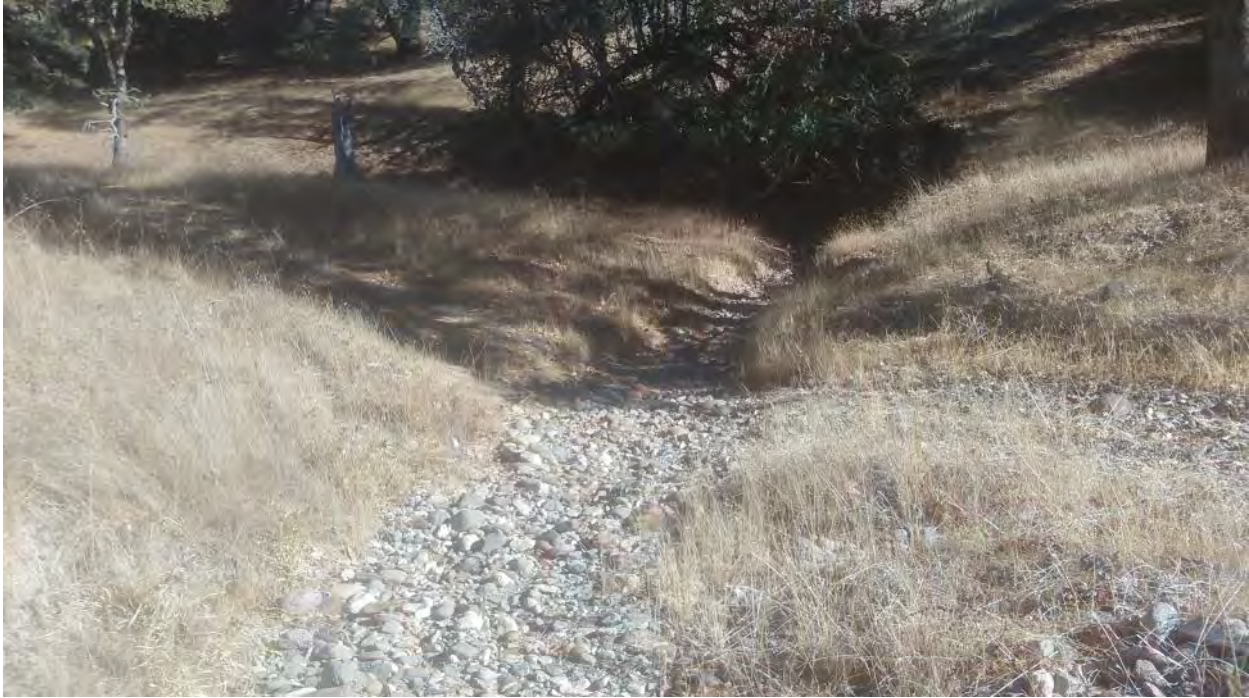
FFX10	4270116	517377	SEW2	Seasonal Watercourse	1	6	Dirt road drops into bottom of ravine and crosses seasonal watercourse/creek bed multiple times before reaching work area	No Culvert	Dispersal	Access during dry season; steel plates and/or wooden beams; full size vehicles okay	Recommend parking before reaching creek and walking to work area; if vehicles and road improvements are necessary, USACE 404, RWQCB 401, and CDFW 1602 permit may be required
FFX11	4270108	517380	SEW2	Seasonal Watercourse	0-1	2	Dirt road drops into bottom of ravine and crosses seasonal watercourse/creek bed multiple times before reaching work area	No Culvert	Dispersal	Access during dry season; steel plates and/or wooden beams; full size vehicles okay	Recommend parking before reaching creek and walking to work area; if vehicles and road improvements are necessary, USACE 404, RWQCB 401, and CDFW 1602 permit may be required

FFX10 – SEW2; Roadway crosses dry creek bed (photo facing northeast)

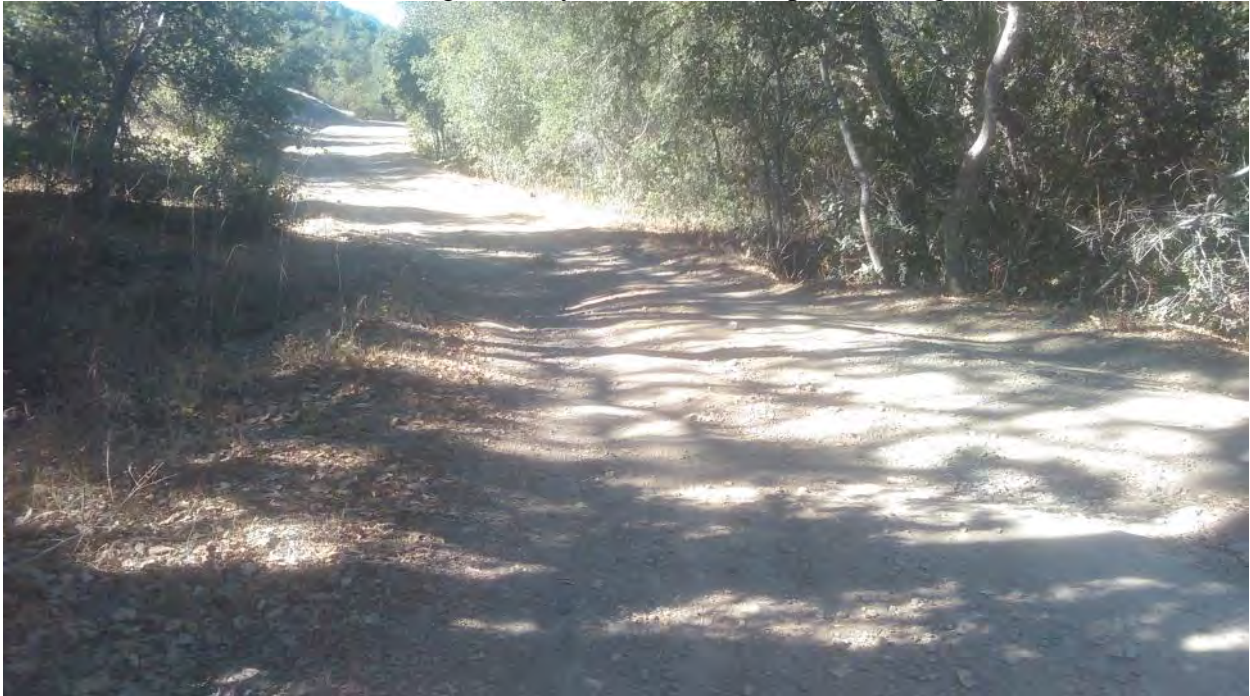
FFX12	4270976	516794	RIWO9	Riparian Woodland	3-6	5	Major access road between vineyards, crosses seasonal creek at this location	1.5ft diameter, 20ft length, corrugated steel pipe in good condition	Dispersal	No Action	No permitting required.

FFX12 – RIWO9; Culvert crossing on vineyard access road (photo facing west)

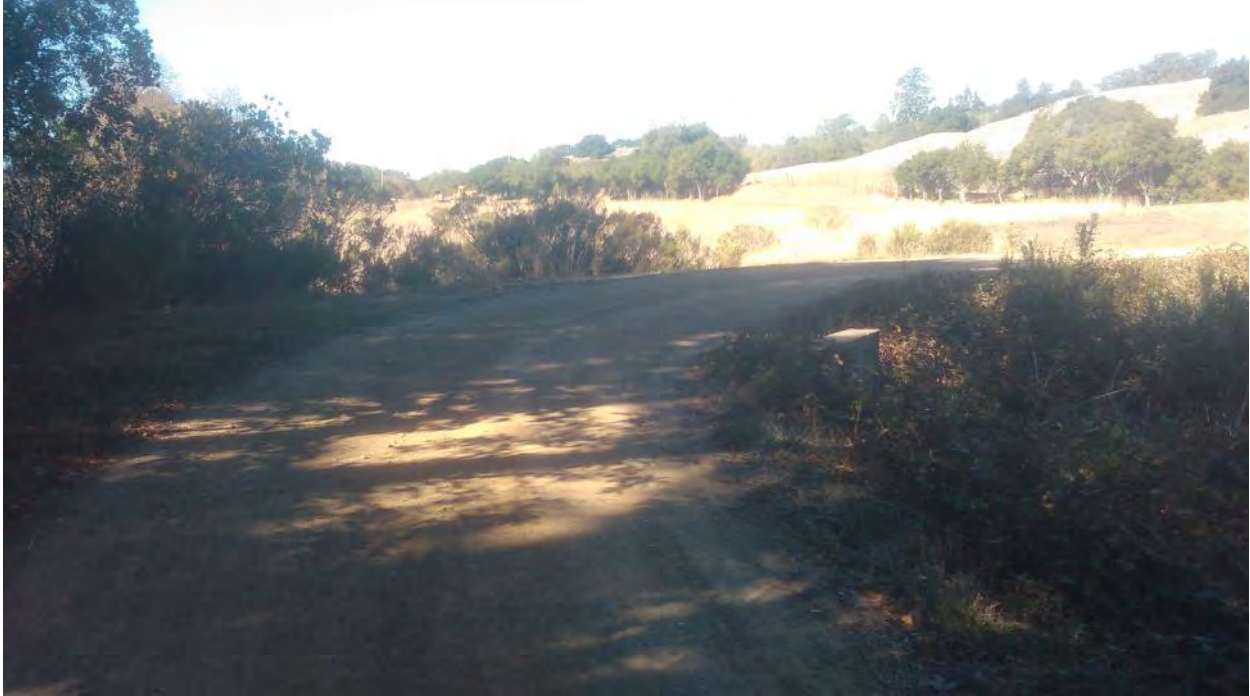
ID	Northing	Easting	Feature Name	Feature Type	Depth (feet)	Width (feet)	Description	Culvert Information	CRLF	Avoidance and Minimization Recommendation	Permit Recommendation
FFX13	4271356	516636	RIWO10	Riparian Woodland	6	4	Major access road between vineyards, crosses at drainage point of permanent pond	4ft diameter, 40ft length concrete-reinforced corrugated steel rusted at bottom	Breeding	No Action	CRLF monitor required for work occurring during breeding season
FFX14	4271561	515977	SEW8	Seasonal Watercourse	2	3	Overland access route with multiple stacks of dry, cut branches along the entire route	No Culvert	Dispersal	Access during dry season; off-highway vehicles only	Recommend parking before reaching creek and walking to work area; if vehicles and road improvements are necessary, USACE 404, RWQCB 401, and CDFW 1602 permit may be required
FFX15	4271545	516032	SEW8	Seasonal Watercourse	7	12	Bermed earth over culvert	2ft diameter, 45ft corrugated steel in good condition	Dispersal	Access during dry season; off-highway vehicles only	Recommend parking before reaching creek and walking to work area; if vehicles and road improvements are necessary, USACE 404, RWQCB 401, and CDFW 1602 permit may be required

FFX13 – RIWO10; Culvert crossing occurs immediately downstream of perennial pond (photo facing northwest)

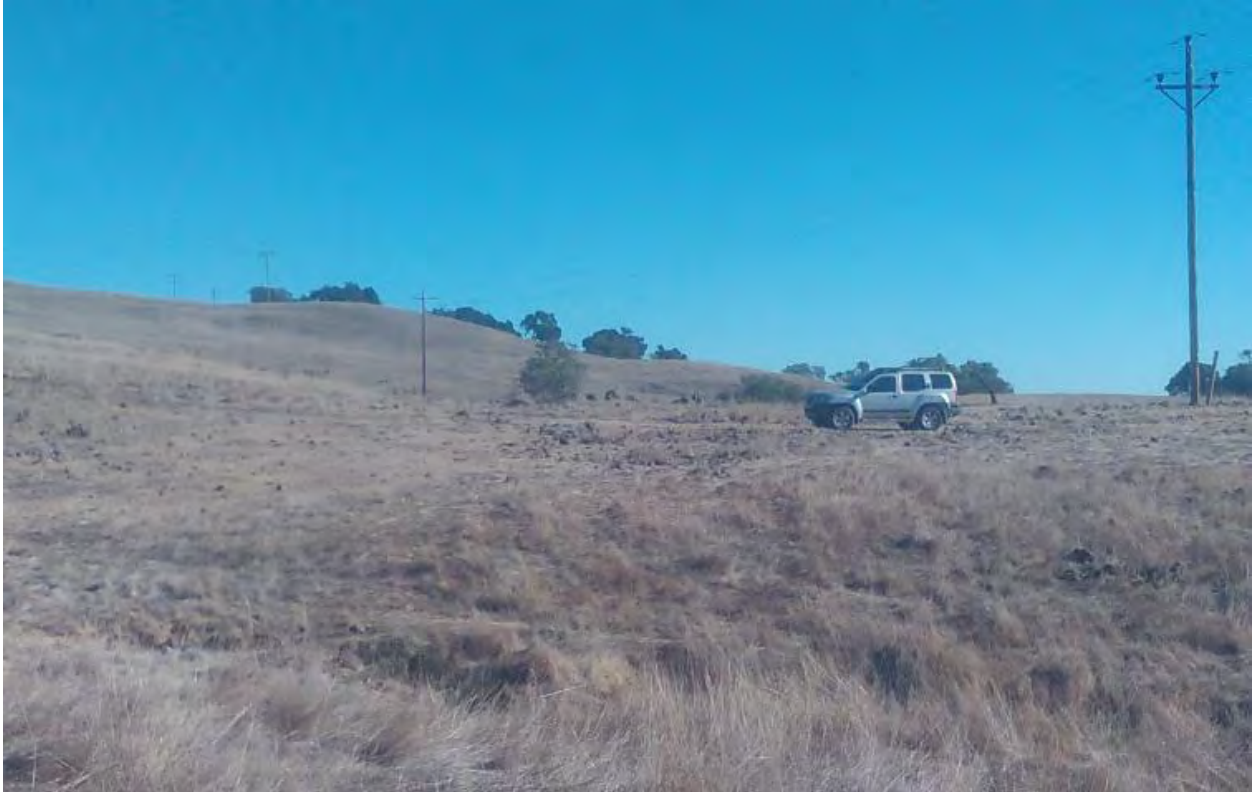
FFX22	4272703	514656	SEW5	Seasonal Watercourse	0-1	4	Overland route crossing small, ephemeral stream; mapped crossing point not suitable due to abrupt bank (see suggested alternate route)	No Culvert	Dispersal	Access during dry season; full size vehicles okay; recommended alternate overland route approximately 130 feet northeast of mapped route; stay high to avoid deep crossing	No permitting required.
FFX23	4272696	514615	SW13	Seasonal Wetland	0-1	30	Overland route crossing small seasonal wetland	No Culvert	Dispersal	Access during dry season; full size vehicles okay	No permitting required.

FFX22 – SEW5; Crossing point for seasonal watercourse (photo facing southwest)

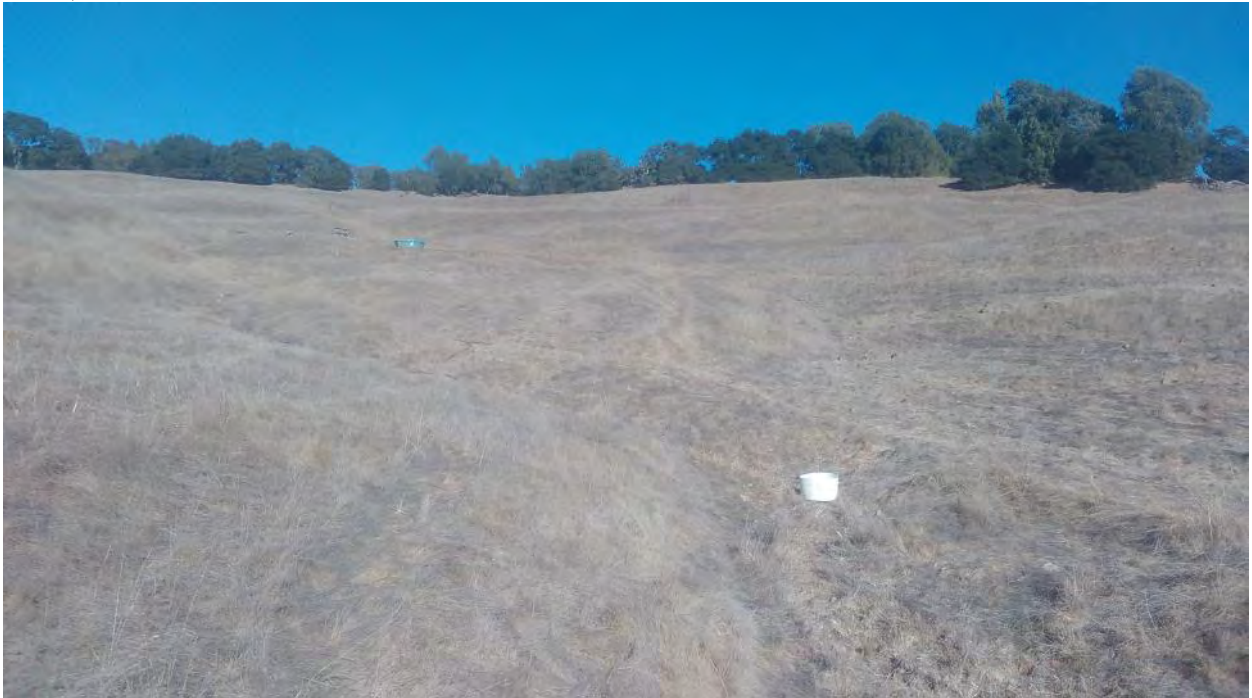
FFX22 – SEW5; Recommended alternate crossing point for seasonal watercourse (photo facing north)

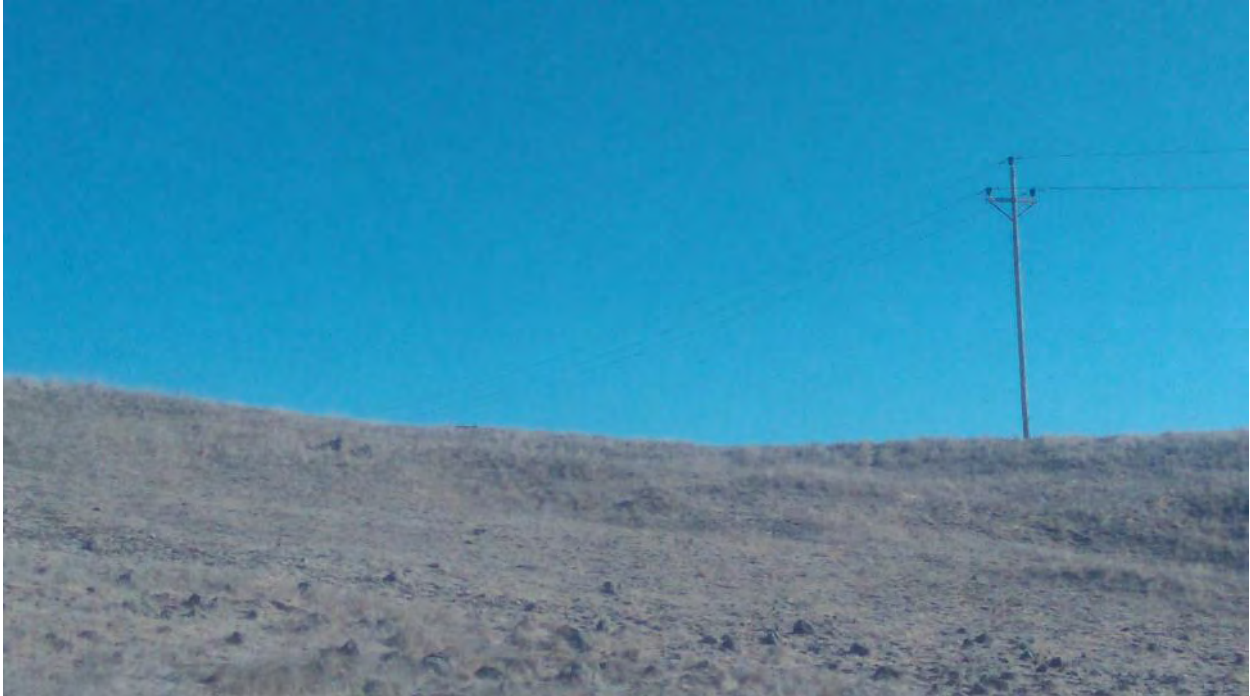
FFW22 – Pole 82; SW11; Configure work area to avoid overlap with seasonal wetland (photo facing east)

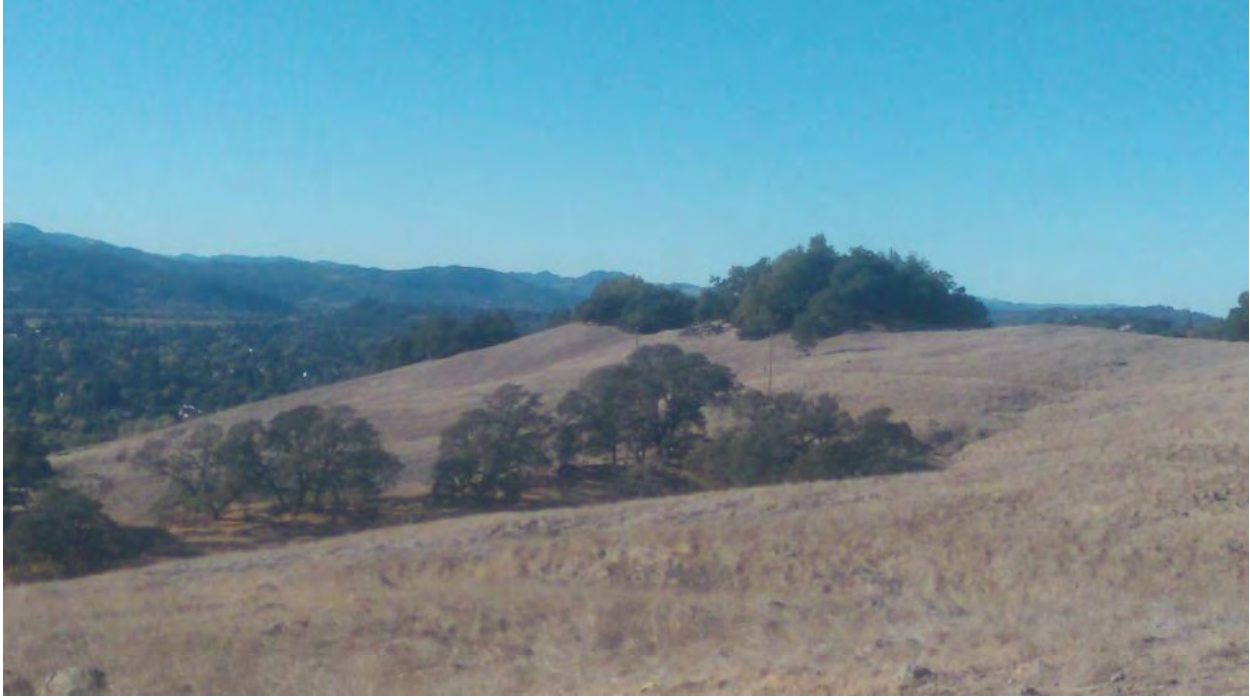
FFW23 – Pole 87; SW16; Configure work area to avoid overlap with seasonal wetland (photo facing west)

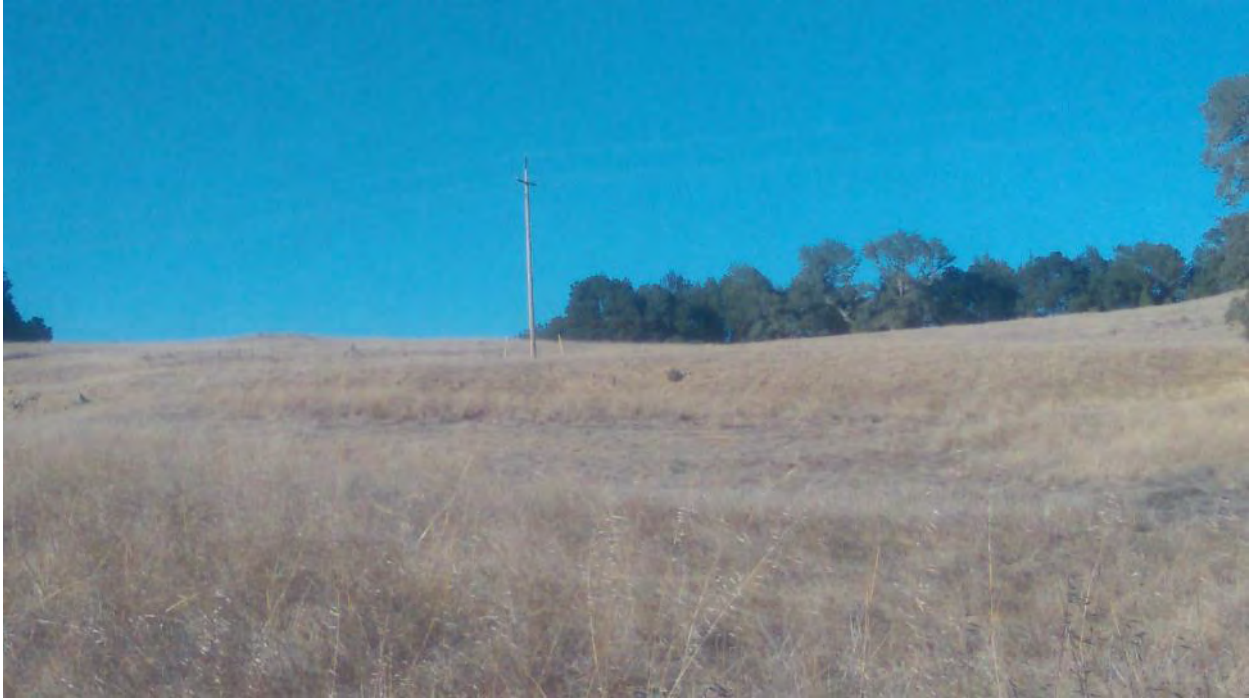
FFW23 – Pole 87; SW16; Configure work area to avoid overlap with seasonal wetland (photo facing northwest)
