Garcia and Associates

RE: Fulton-Fitch Reconductoring Project, Water Crossing Mapping

Appendix A. Fulton-Fitch Work Area and Crossing Photos

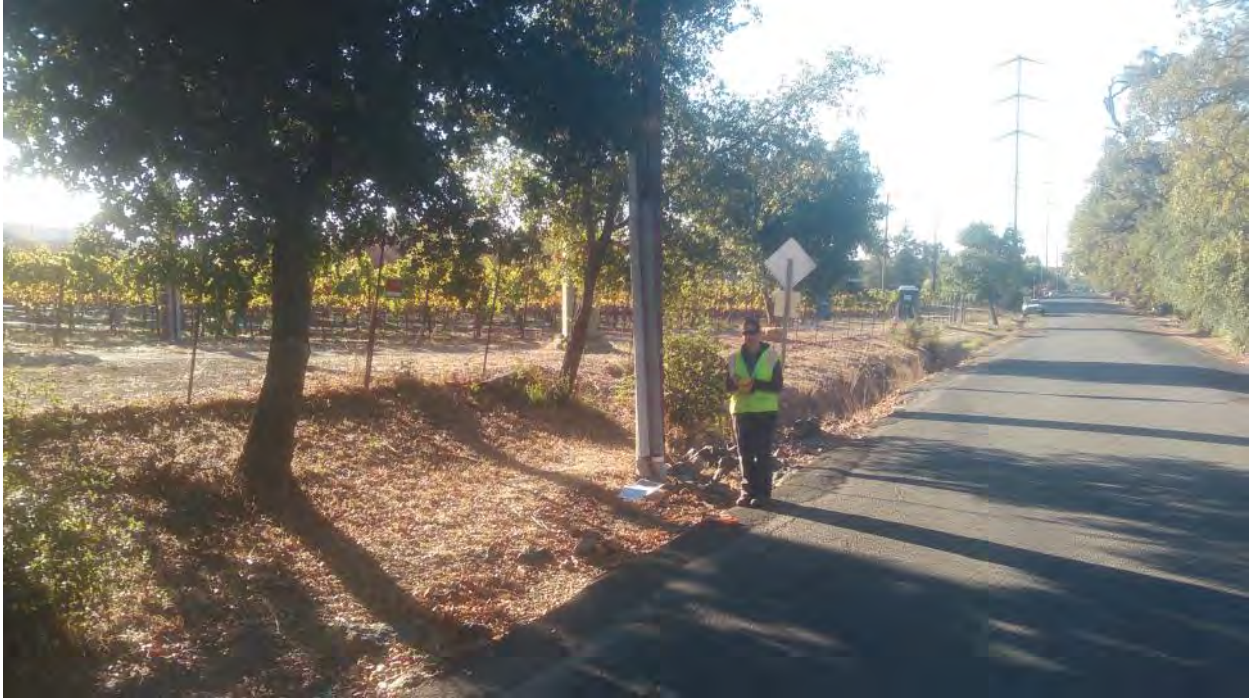
FFW1 – Pole 20; SEW41 (photo facing south)

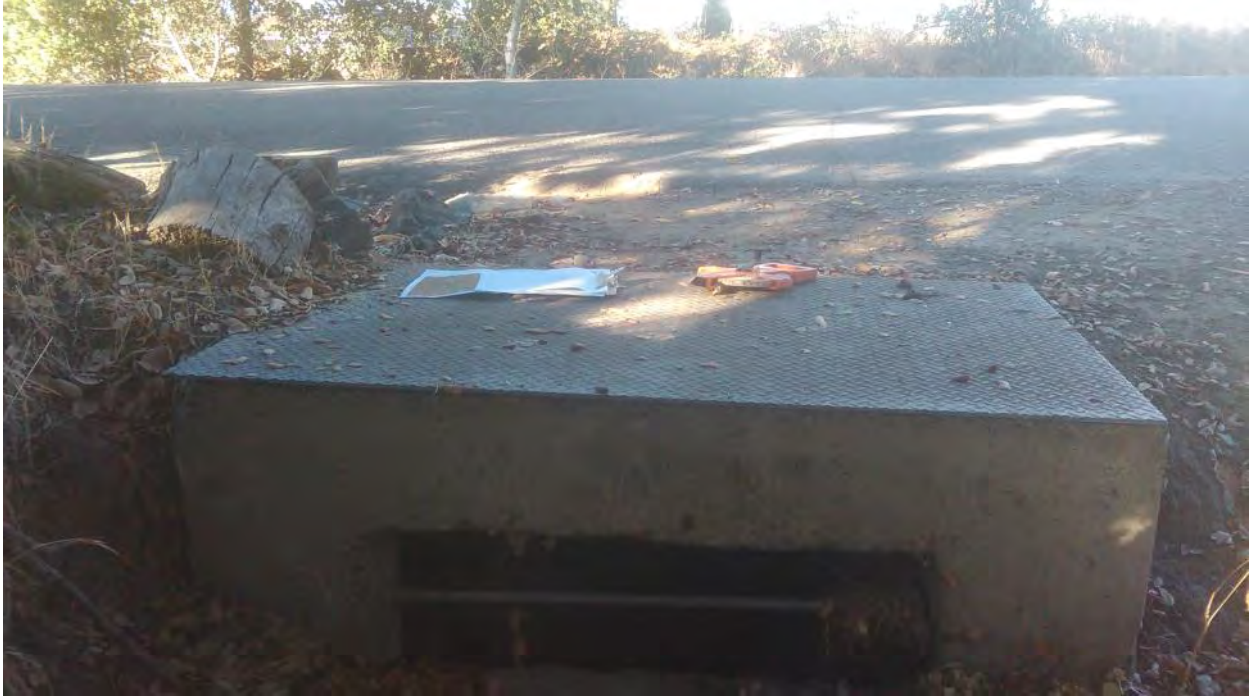
FFW1 – Pole 20; SEW41 Culvert at terminus of drainage (photo facing west)

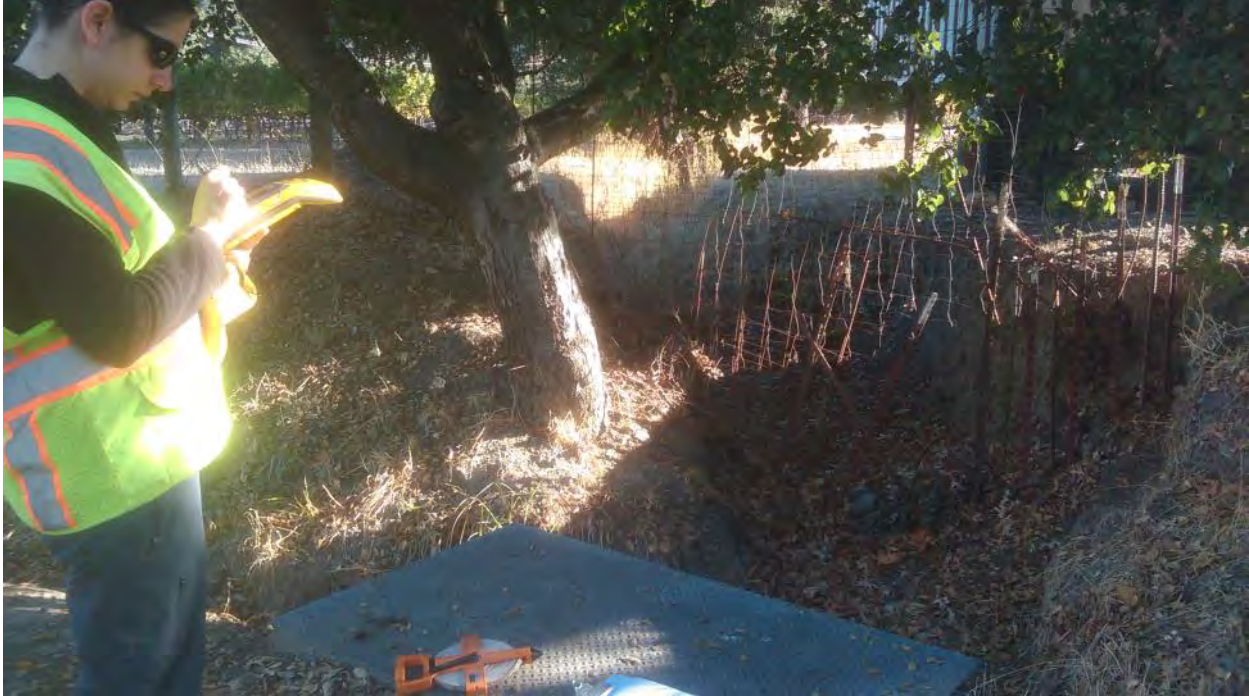
FFW1 – Pole 20; SEW41 Culvert at terminus of drainage (photo facing east)

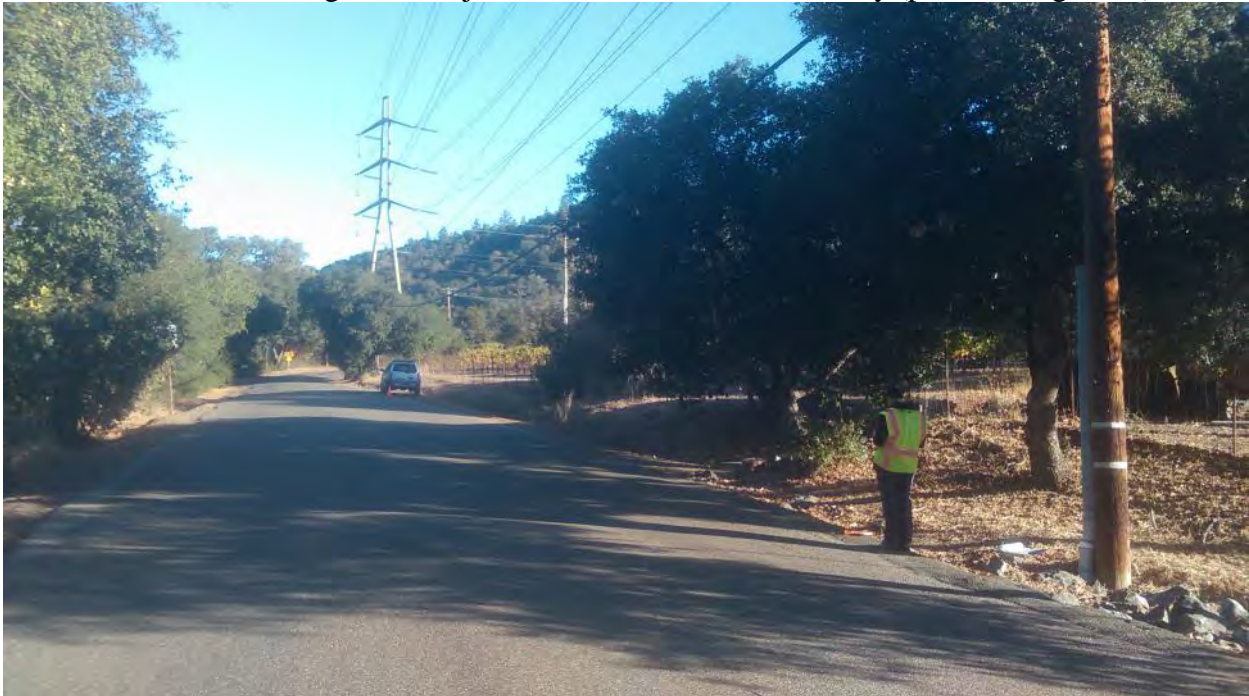
FFW2 – PS4; D4 Drainage ditch adjacent to east side of the roadway (photo facing north)

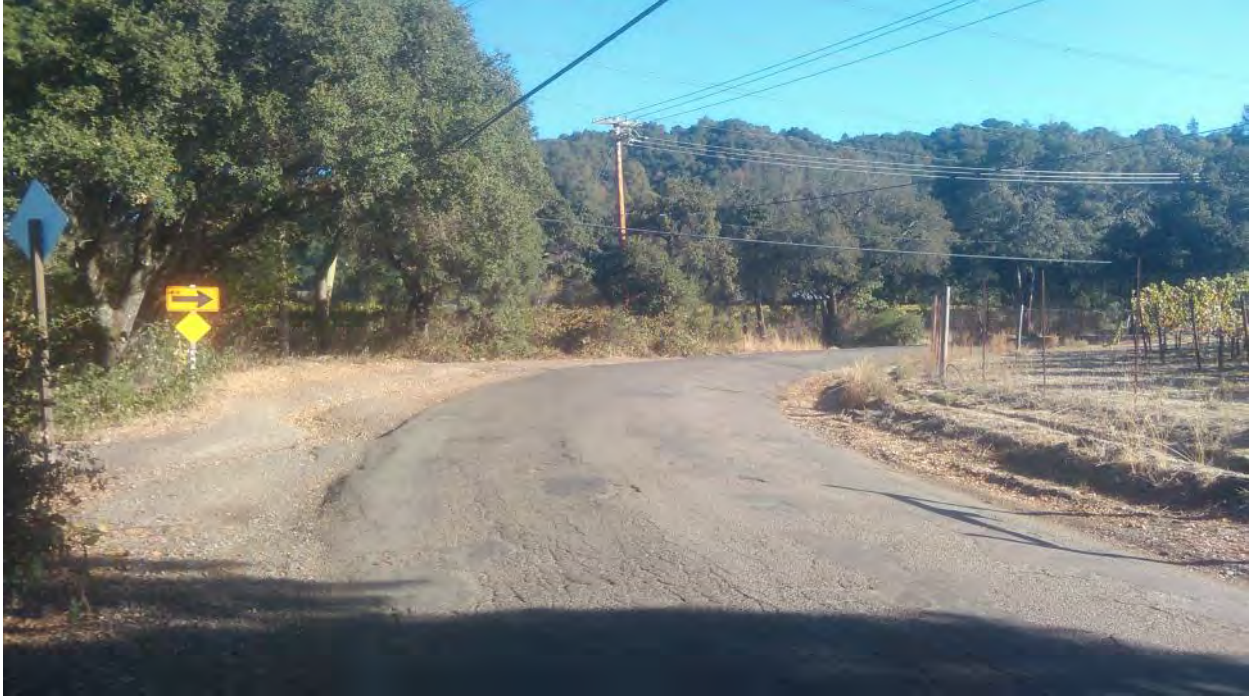
FFW3 – PS4; SEW9A (photo facing north)

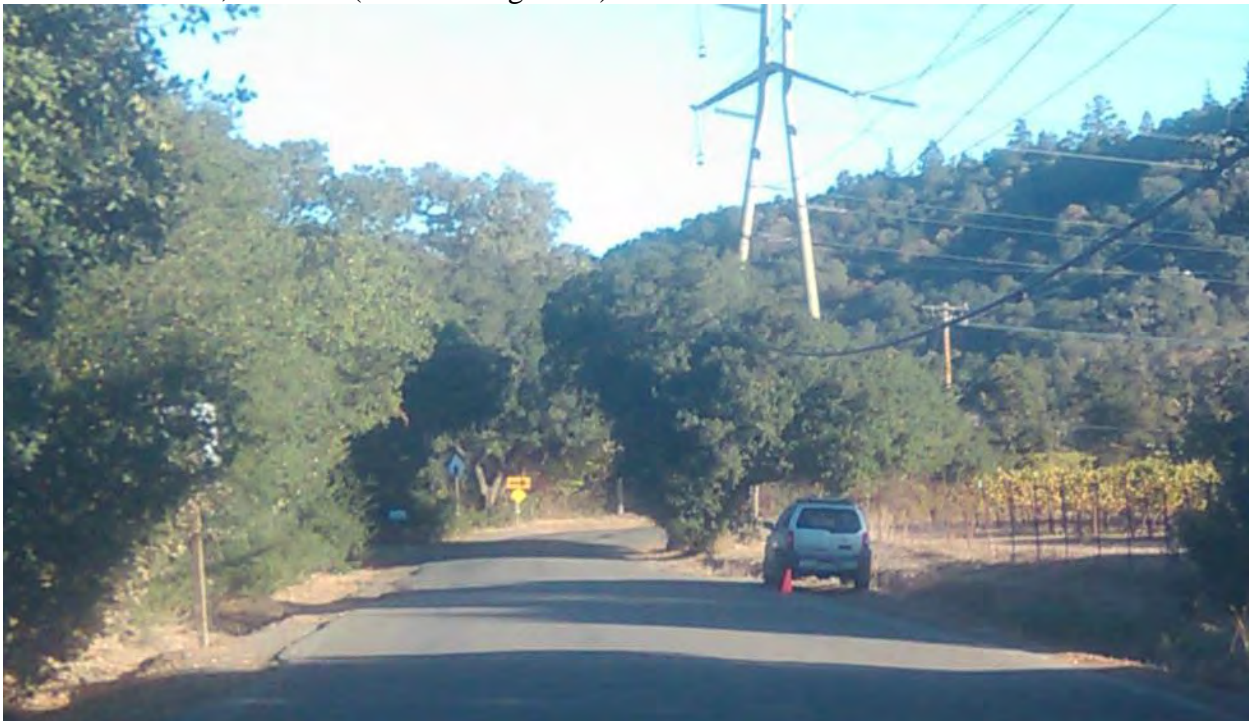
FFW4 – Pole 21; SEW9A (Photo facing north)

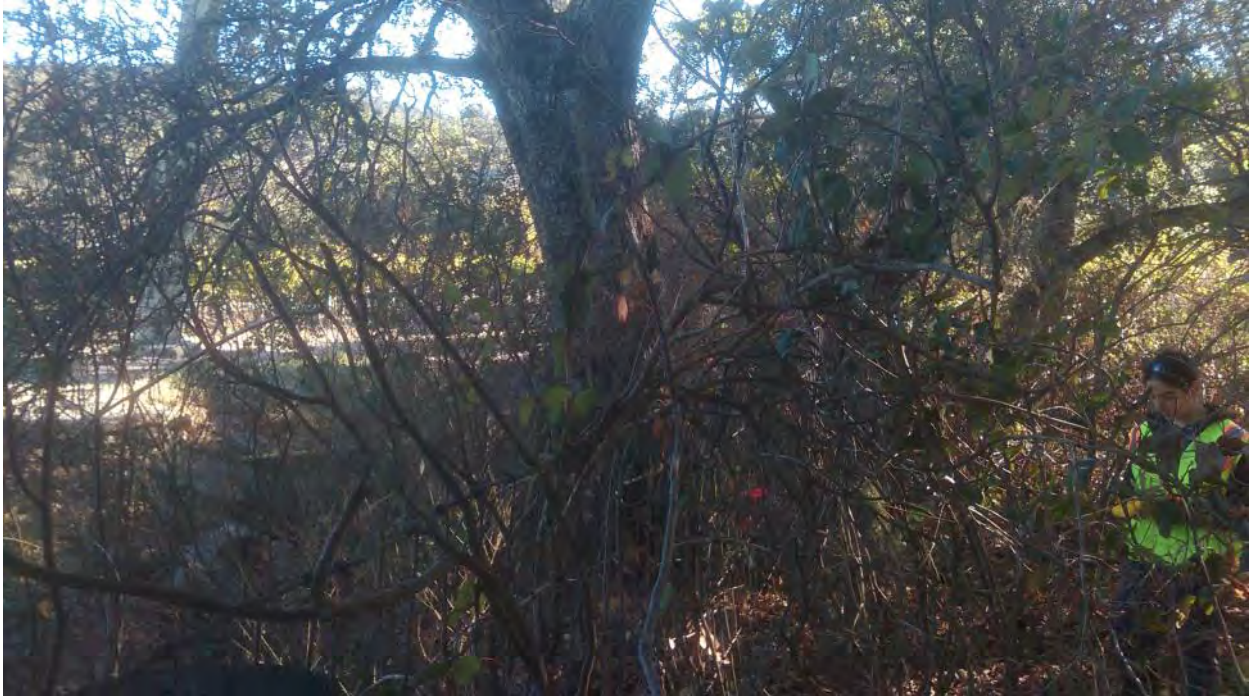
FFW5 – PS5; SEW9A adjacent to overgrown draining ditch (photo facing northeast)

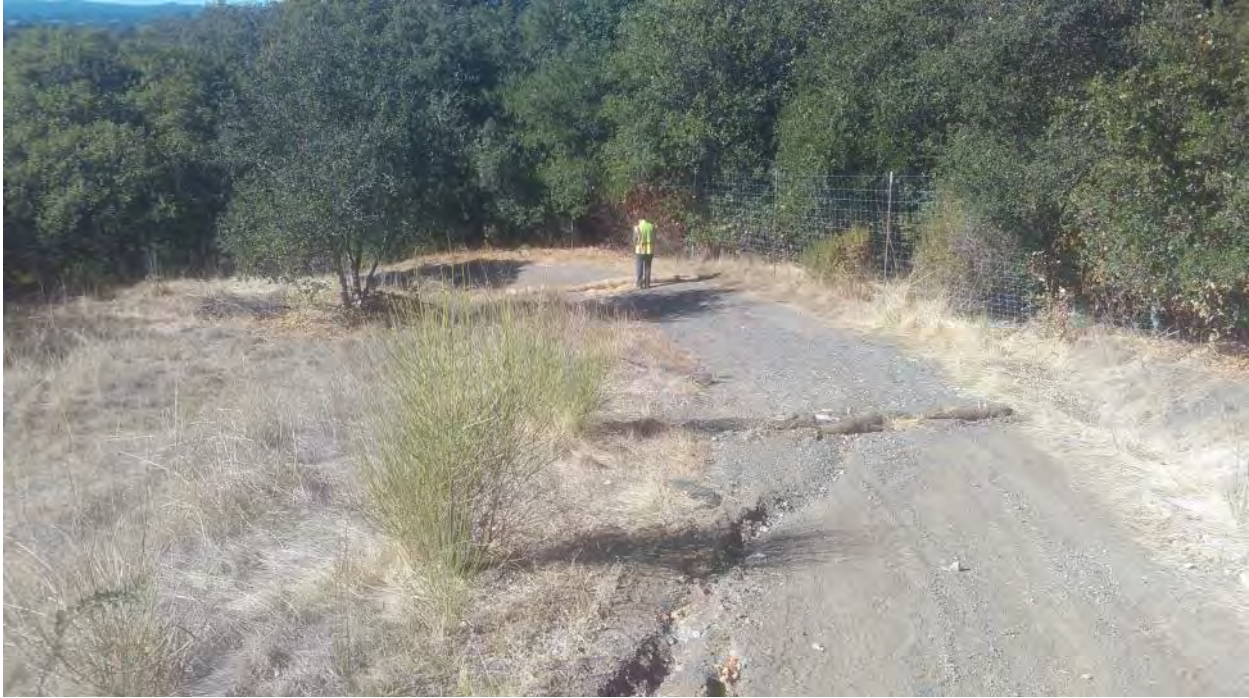
FFX1 – SEW44; Access road with seasonal surface flow and wattles (photo facing west)

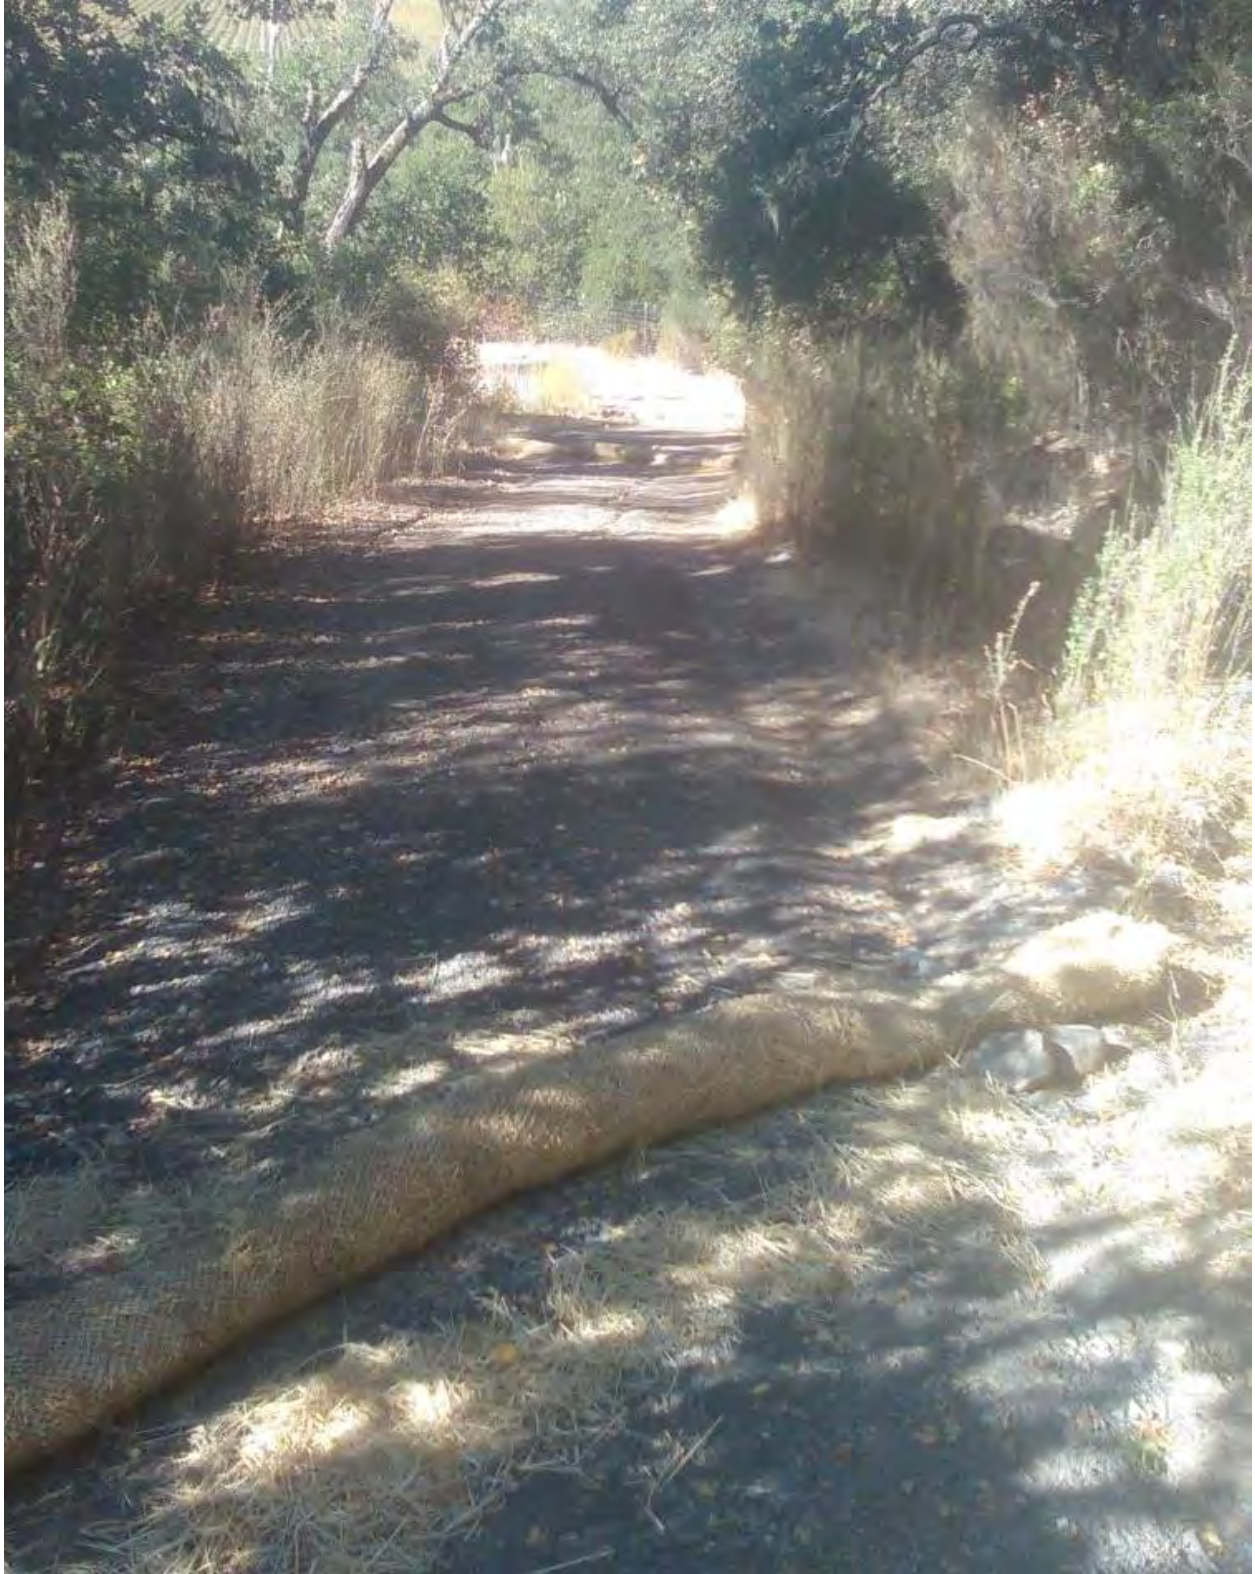
FFX1 – SEW44; Access road with seasonal surface flow and wattles (photo facing west)

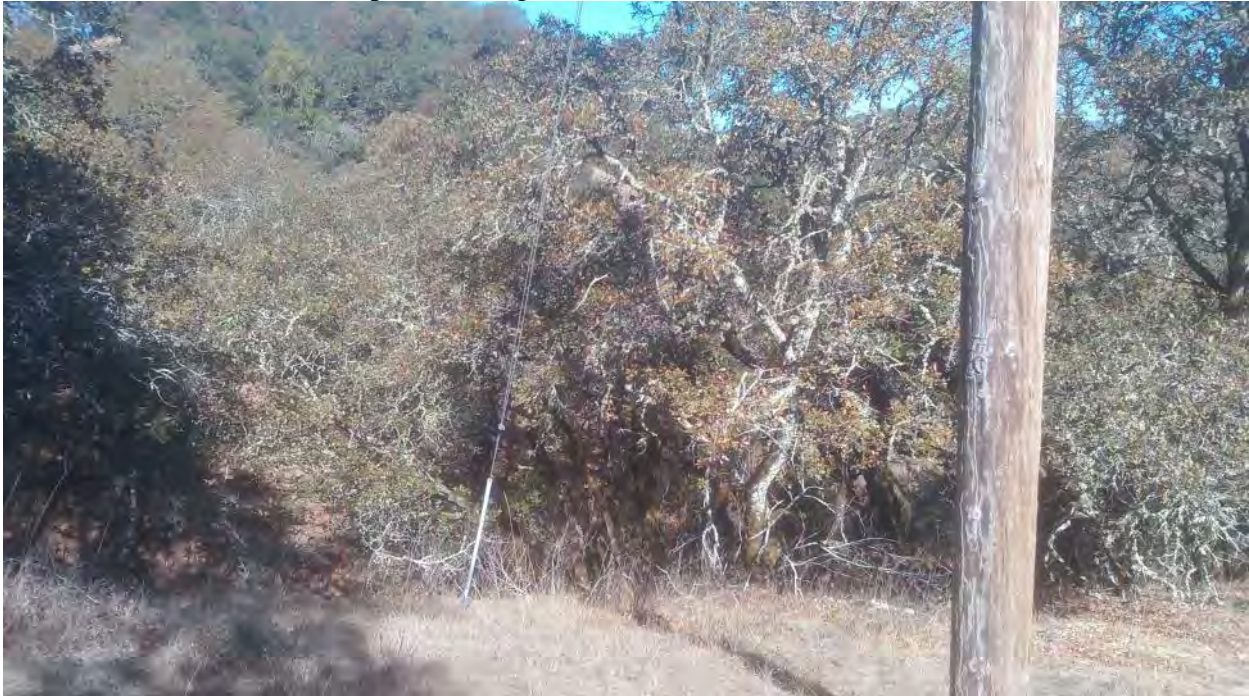
FFW10 – Pole 46; SEW16 (photo facing north)

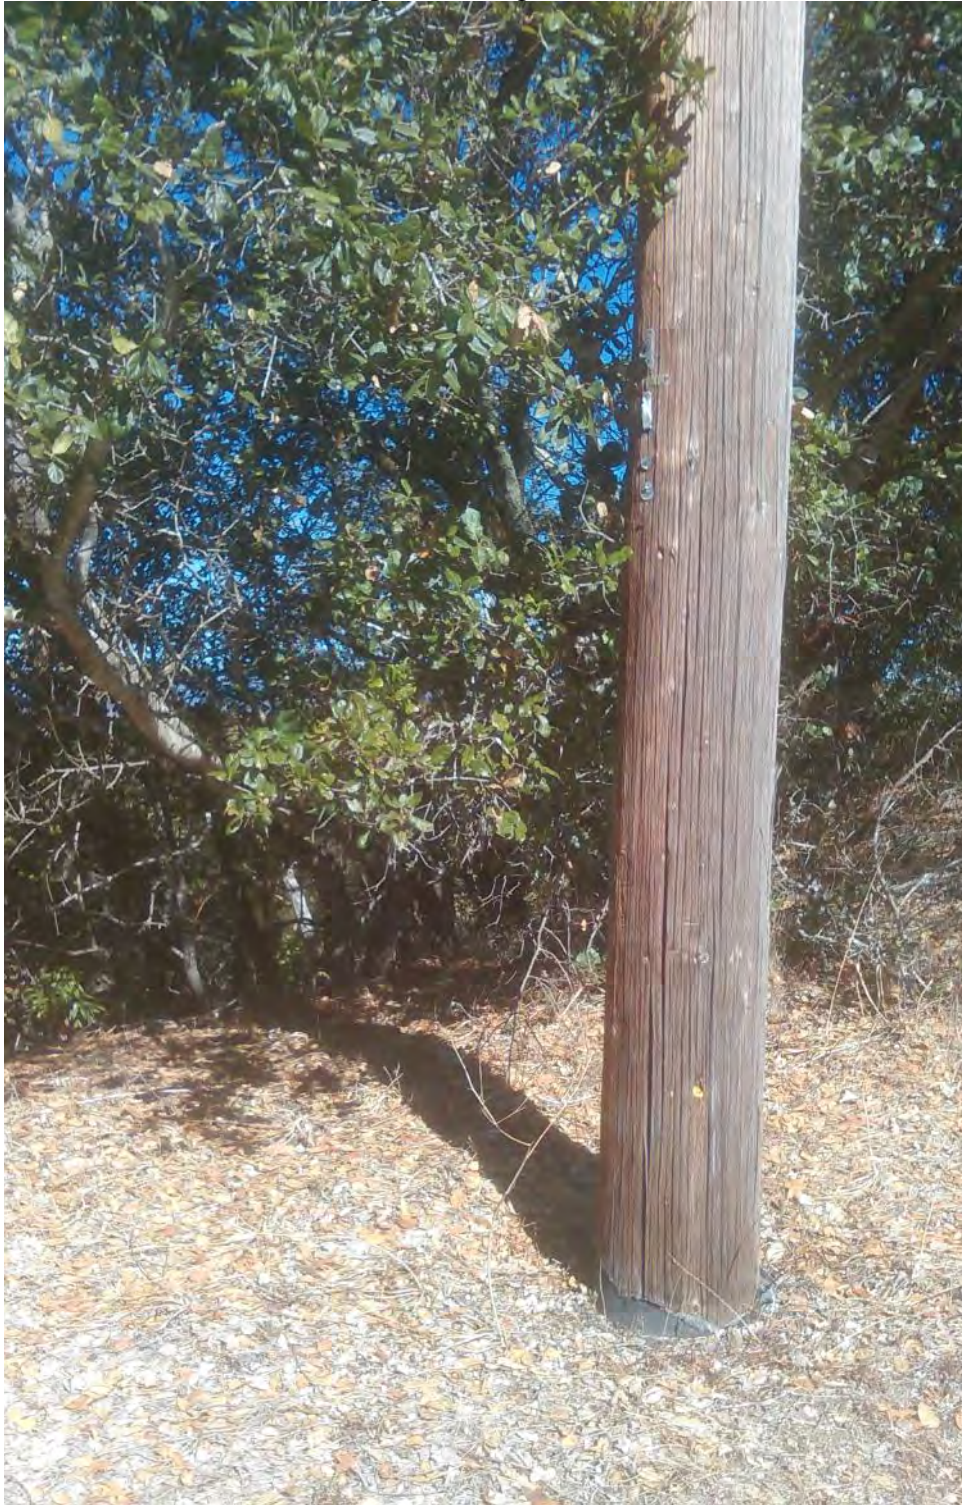
FFW11 – Pole 47; SEW19 (photo facing northeast)

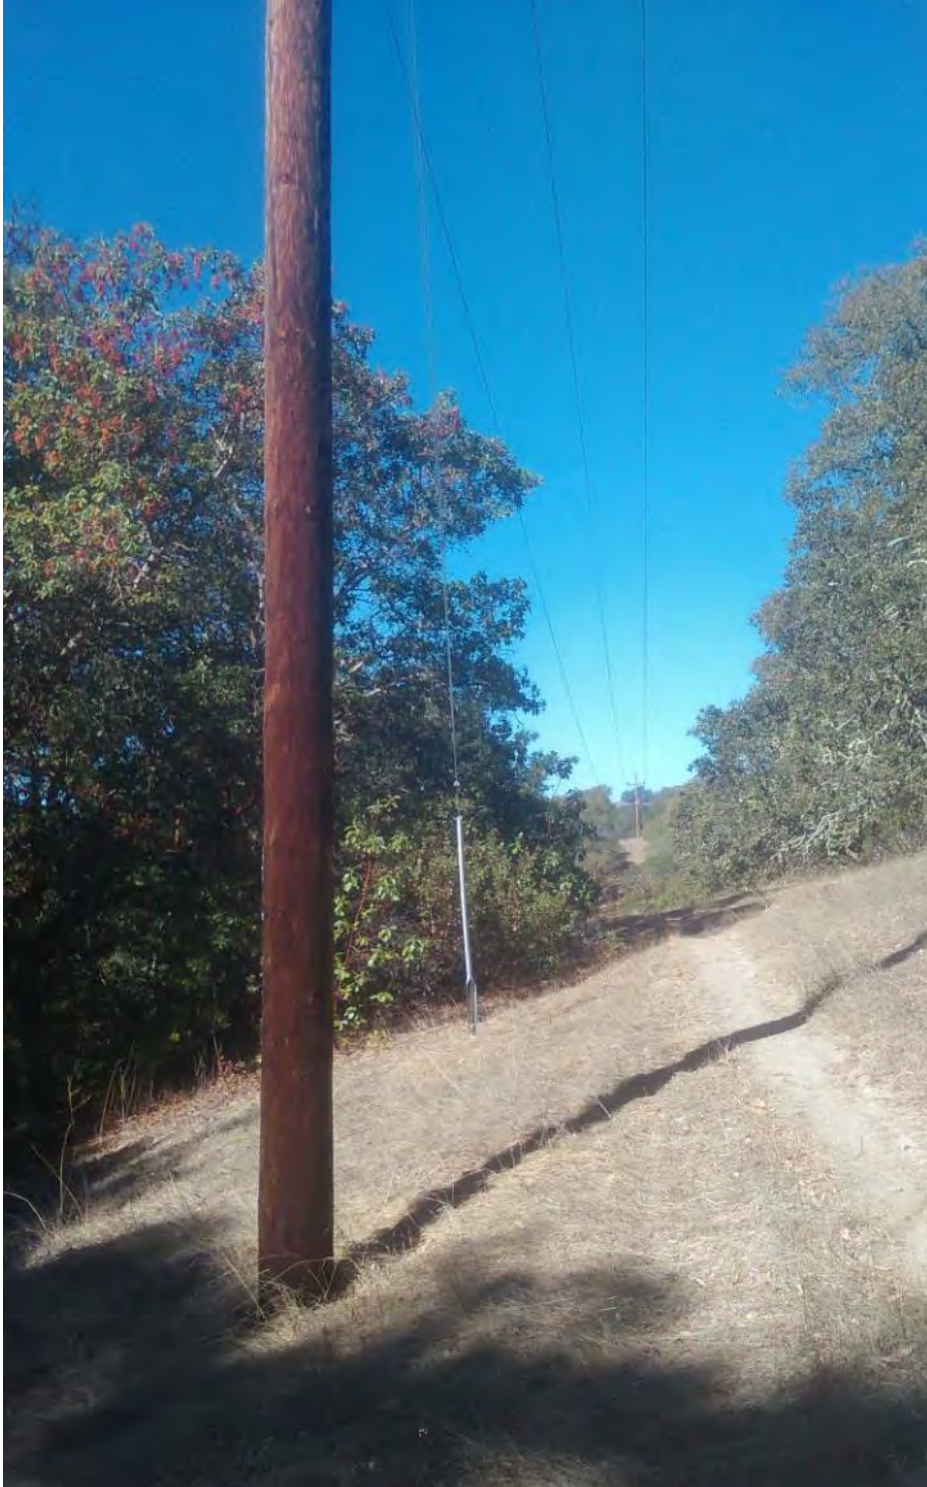
FFW12 – Pole 54; SEW22 Work area at top of small seasonal watercourse (photo facing north)

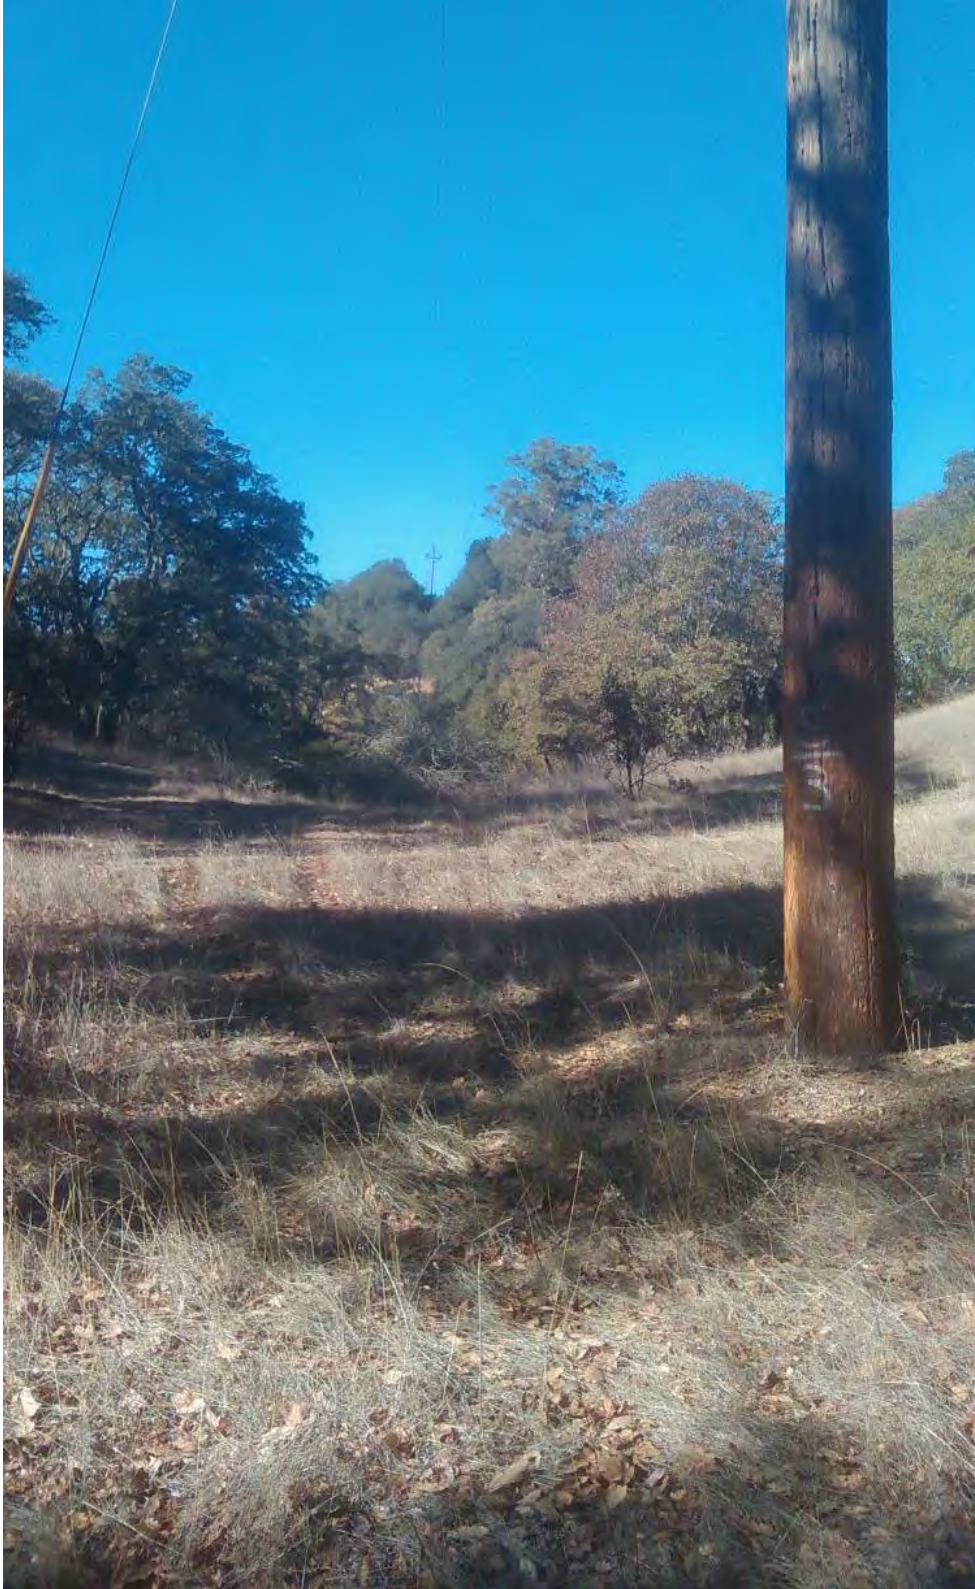
FFW13 – Pole 57; SEW24; Work area upslope from seasonal watercourse (photo facing north)

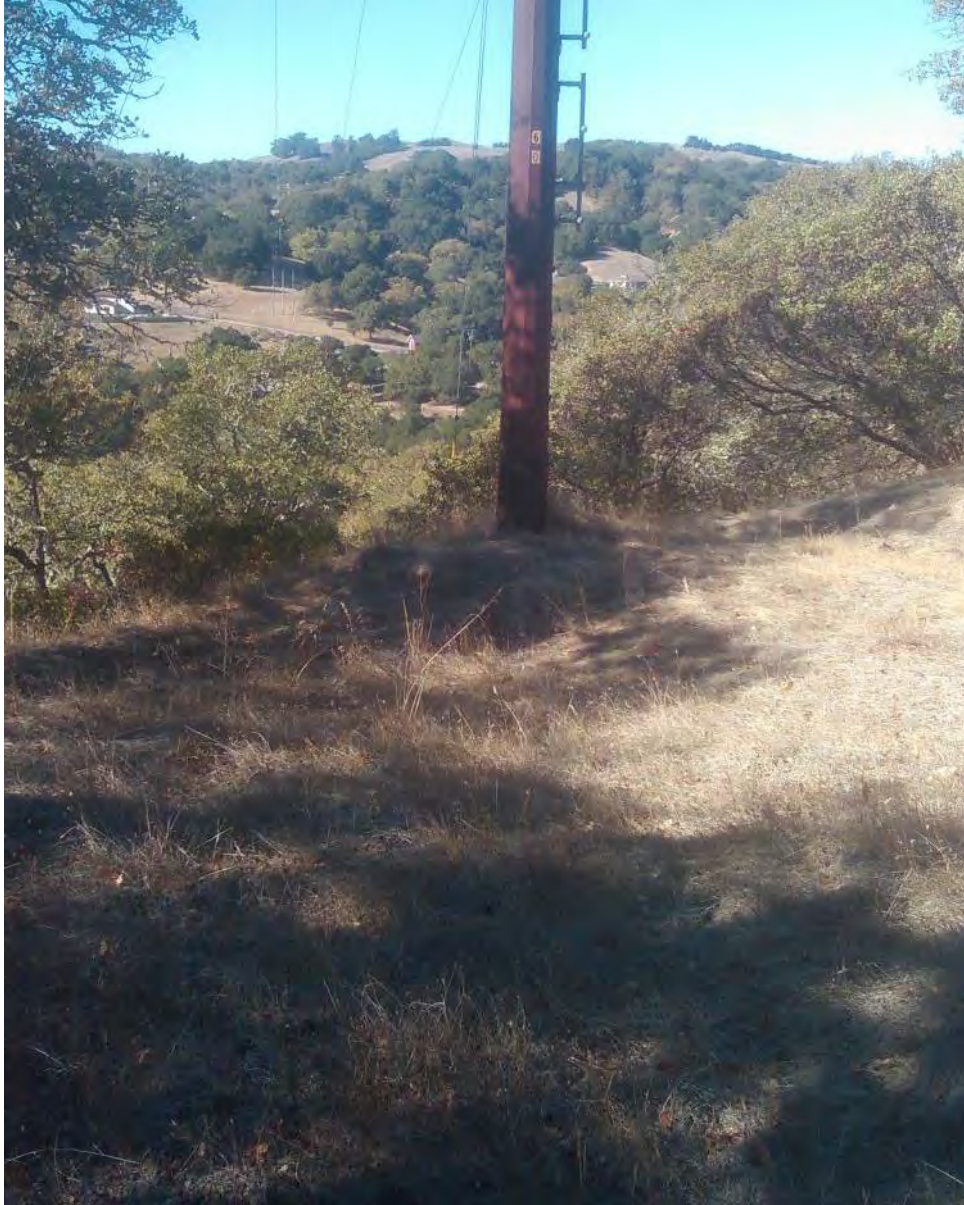
FFX6 – SW3 (photo facing north)

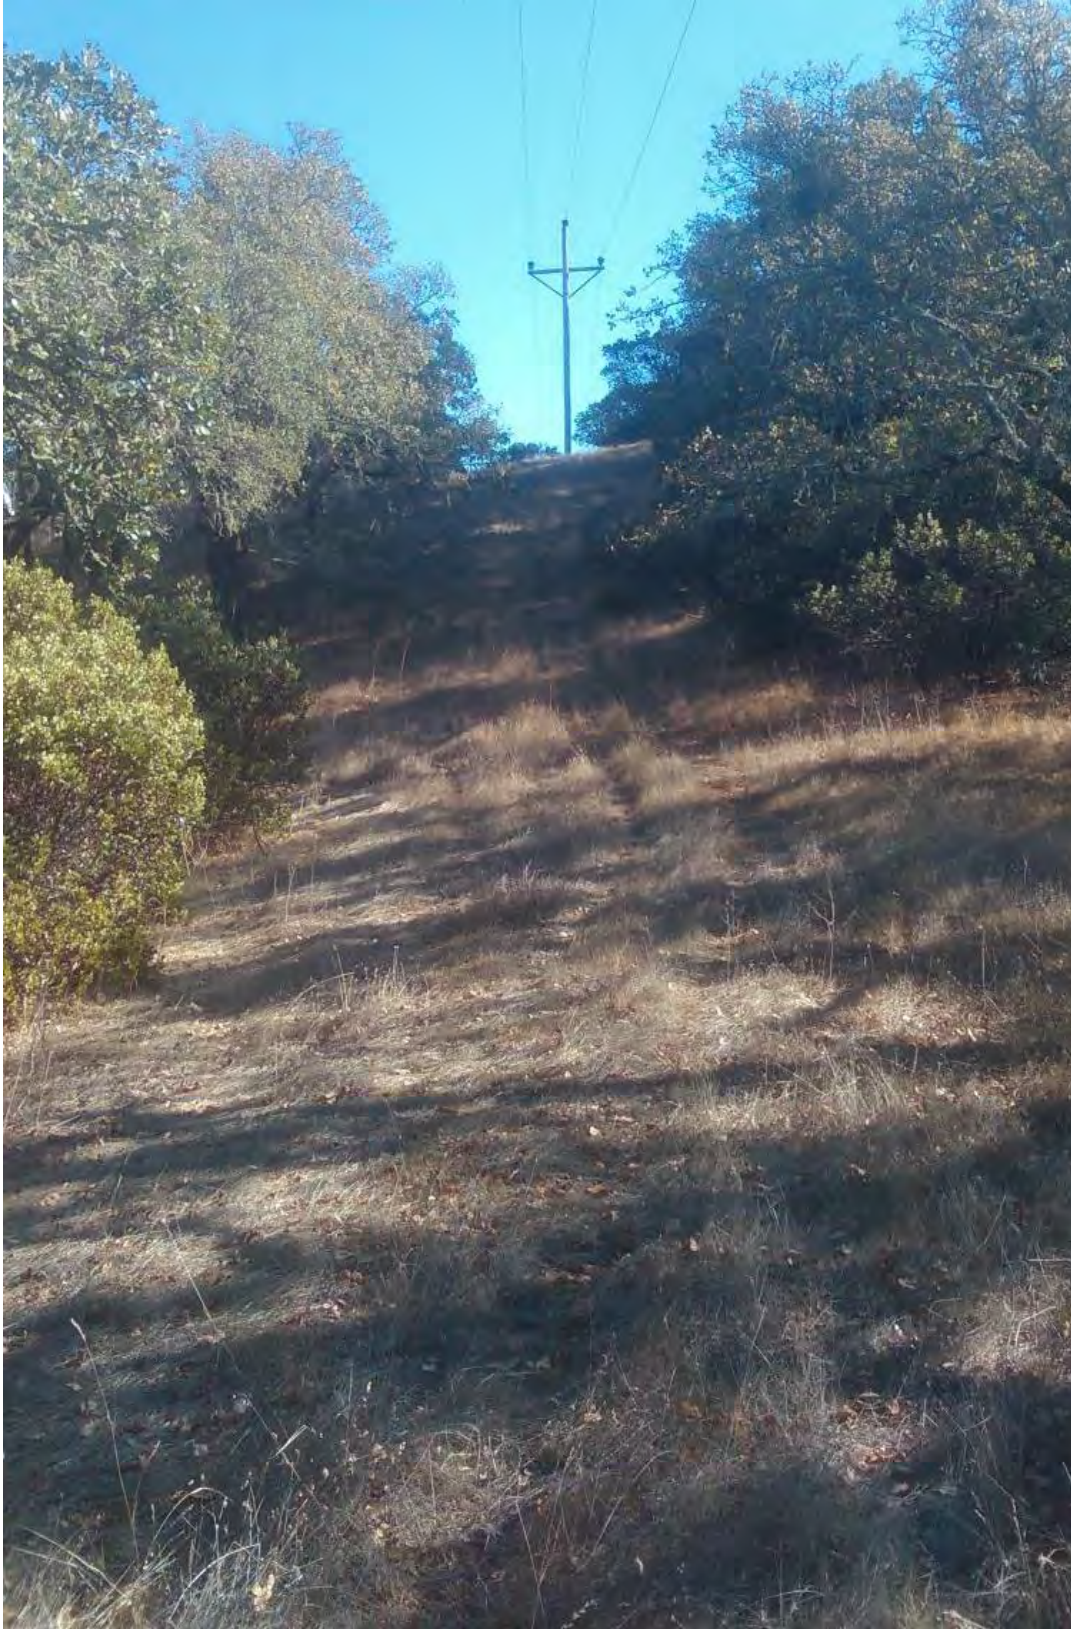
FFX6 – SW3 (photo facing south)

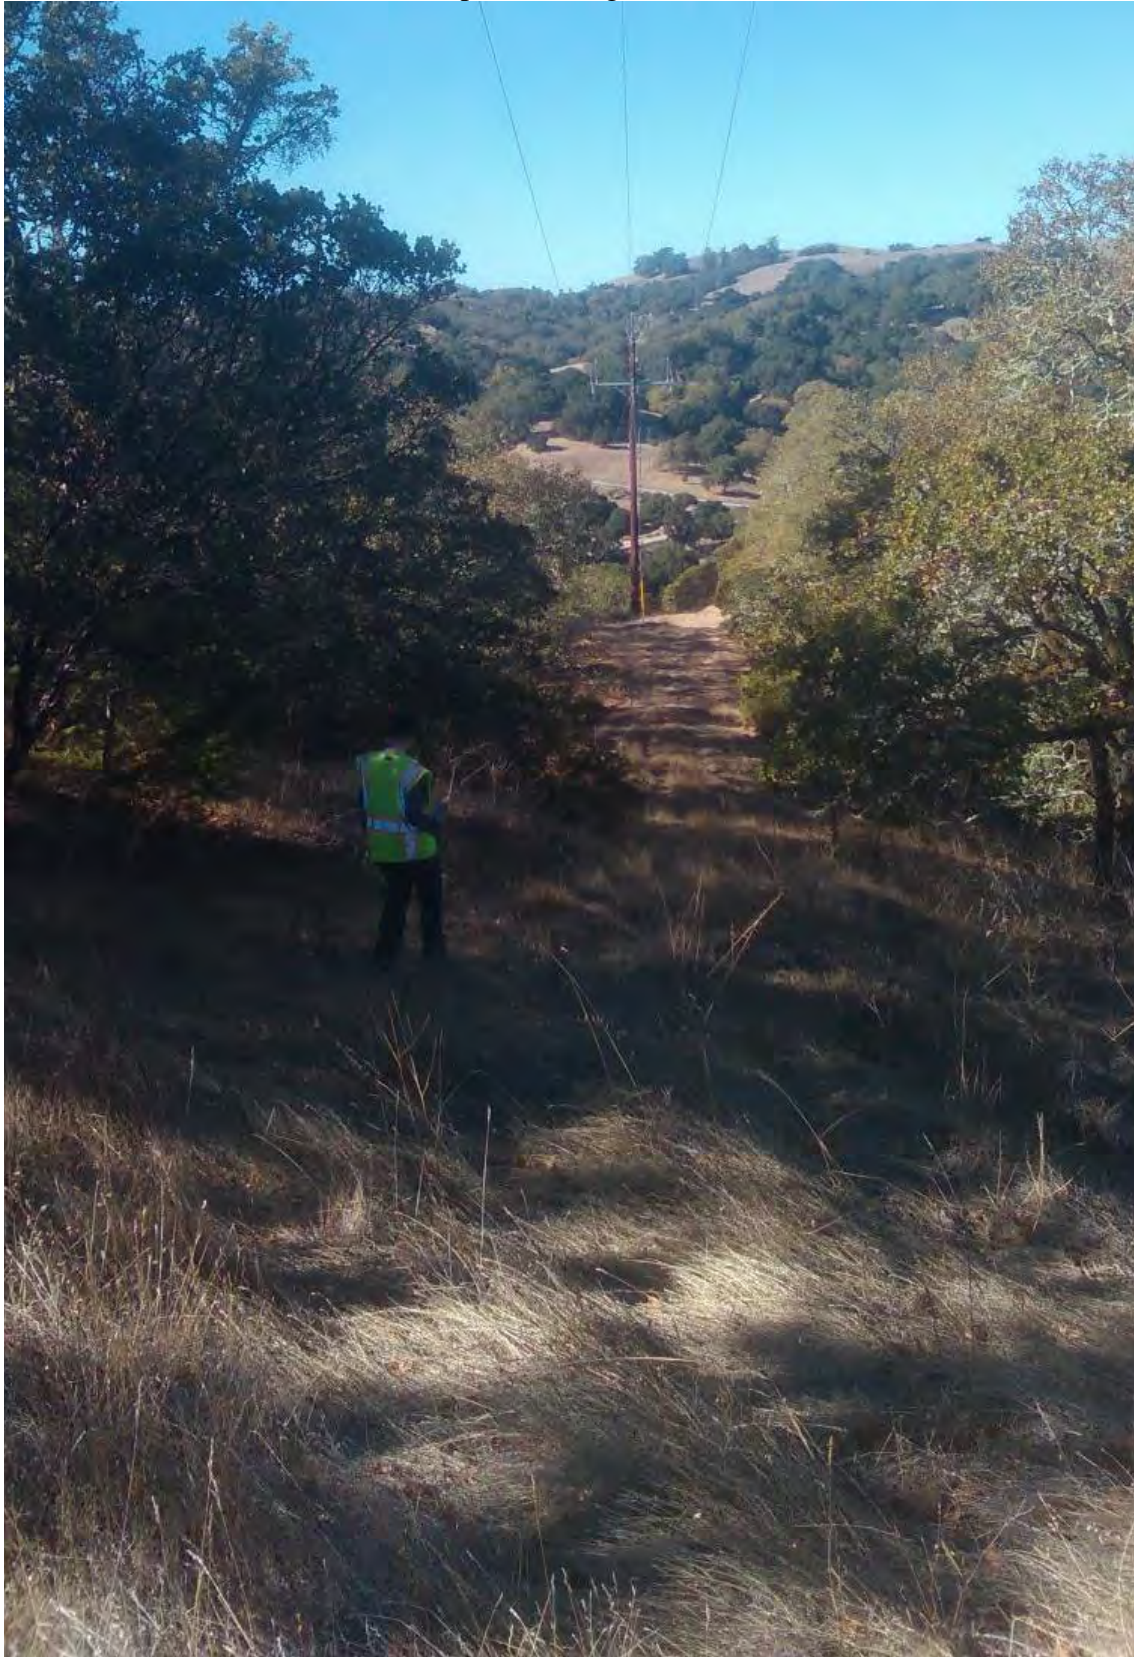
FFW14/15 – PS10; Pole 62; SW3 (photo facing north)

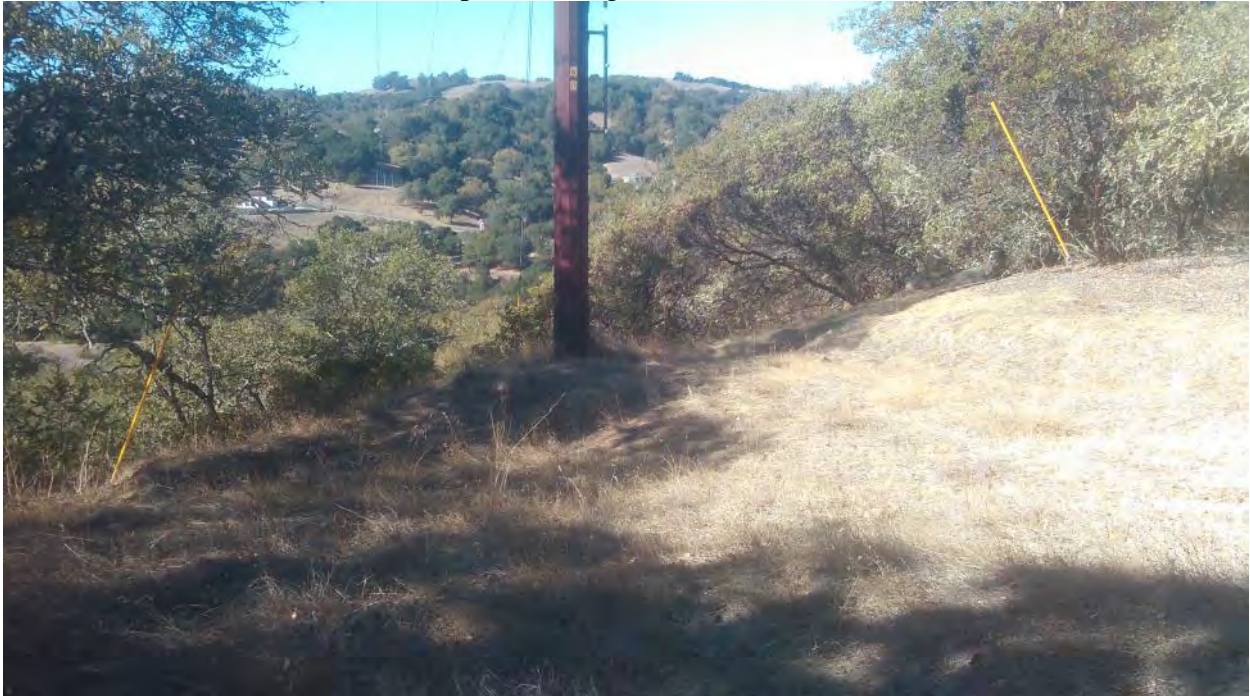
FFW14/15 – PS10; Pole 62; SW3 (photo facing north)

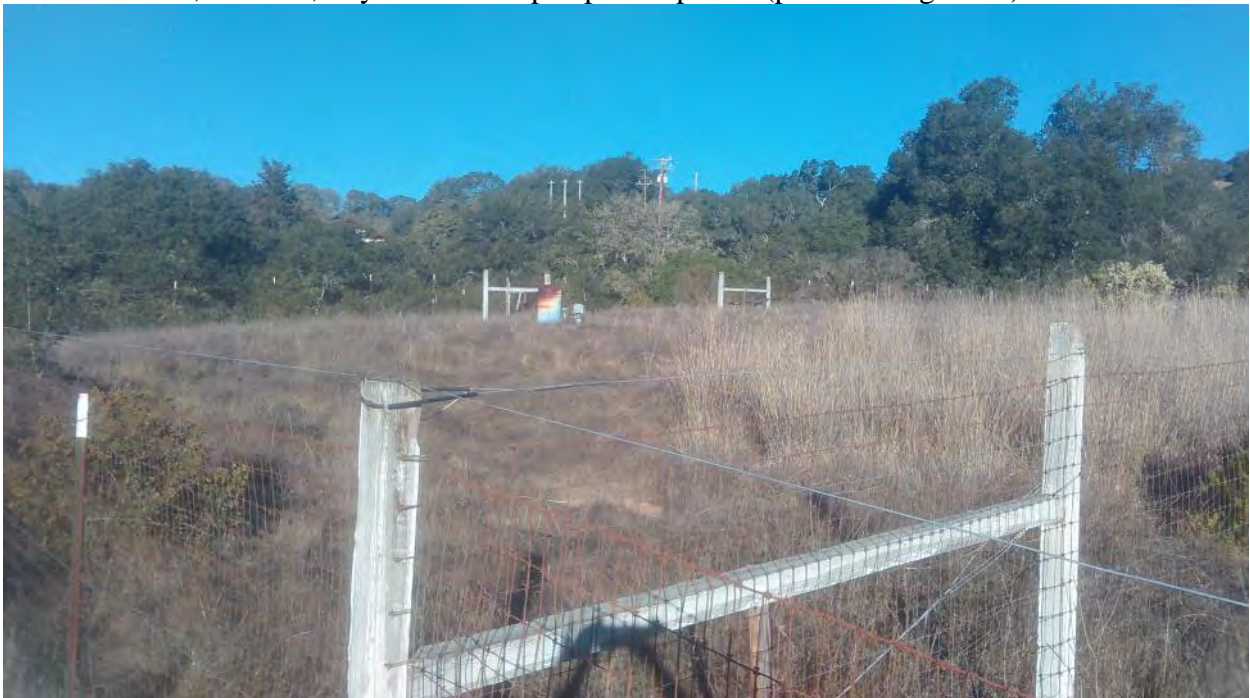
FFW16 – LZ5; RIWO8; Laydown area upslope of riparian (photo facing north)

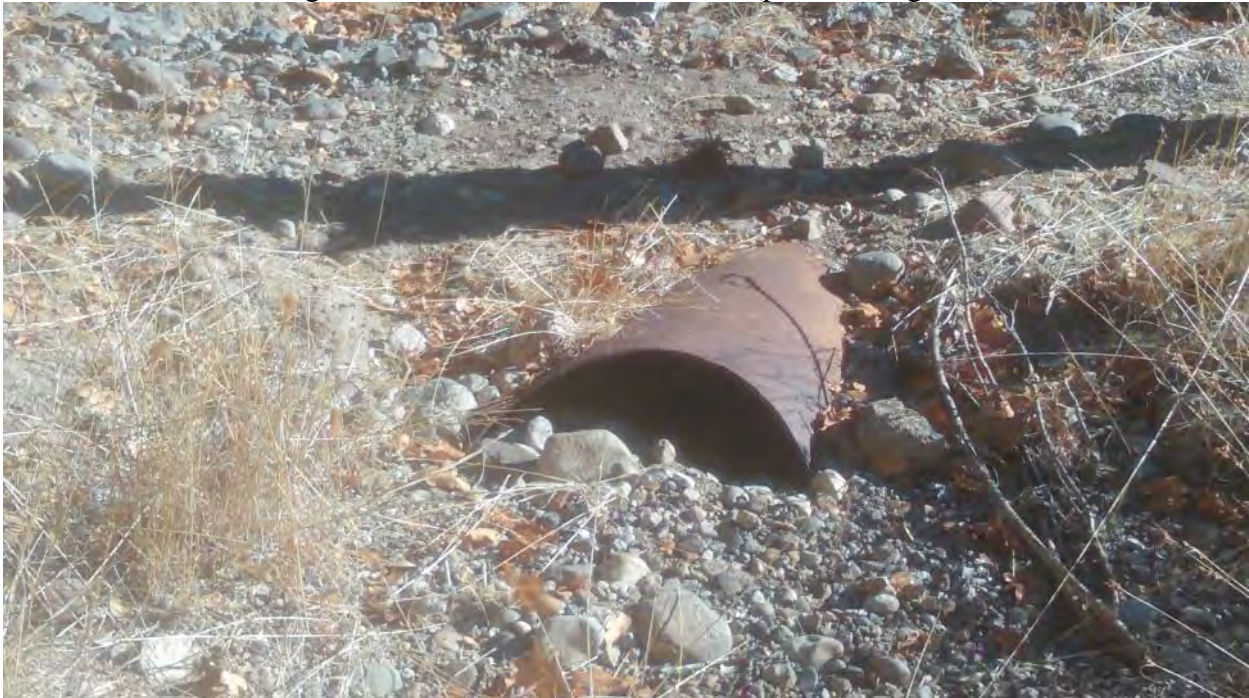
ID	Northing	Easting	Feature Name	Feature Type	Depth (feet)	Width (feet)	Description	Culvert Information	CRLF	Avoidance and Minimization Recommendation	Permit Recommendation
FFX8	4270214	517337	SEW3	Seasonal Watercourse	2-4	8	Dirt road drops into bottom of ravine and crosses seasonal watercourse/creek bed multiple times before reaching work area	2.5ft diameter by 8ft, rusted steel pipe, non-functioning (filled in with sediment)	Dispersal	Access during dry season; steel plates; full size vehicles not recommended	Recommend parking before reaching creek and walking to work area; if vehicles and road improvements are necessary, USACE 404, RWQCB 401, and CDFW 1602 permit may be required
FFX9	4270176	517349	SEW3	Seasonal Watercourse	5	6	Water parallels road and cuts into bank adjacent to road	No Culvert	Dispersal	Steel plate; shoring of the bank may be necessary; full size vehicles okay	Recommend parking before reaching creek and walking to work area; if vehicles and road improvements are necessary, USACE 404, RWQCB 401, and CDFW 1602 permit may be required

FFX8 – SEW2; Existing culvert is filled in with sediment (photo facing west)

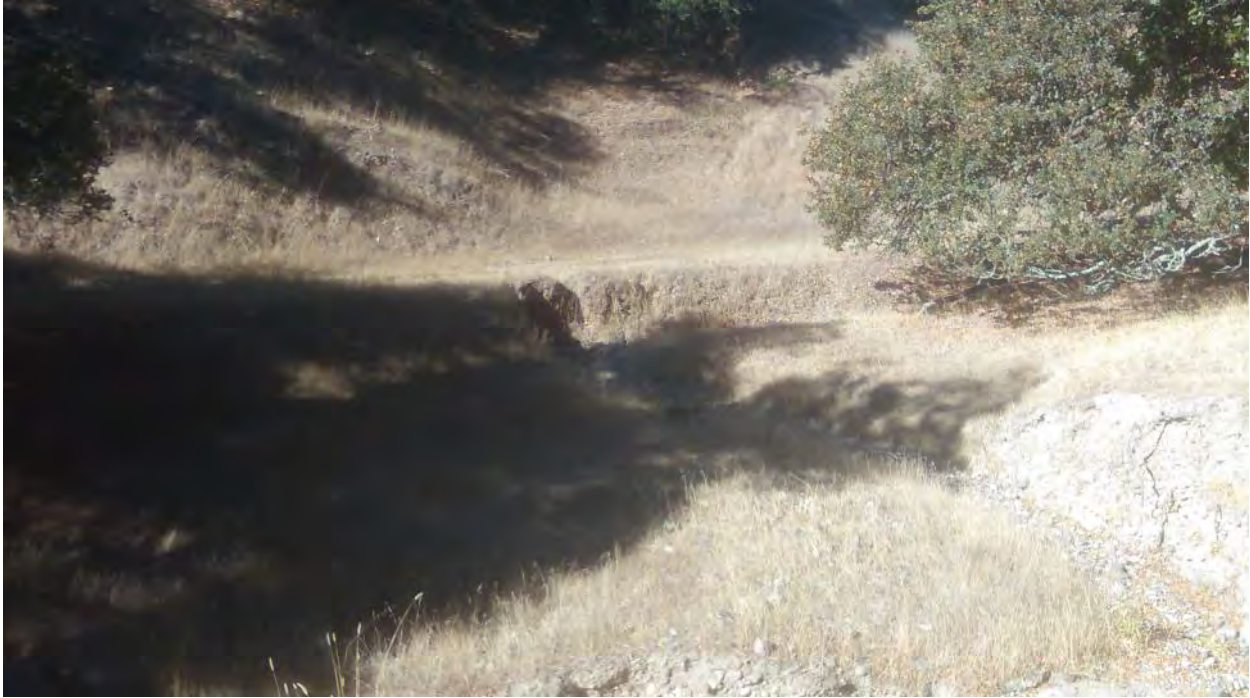
FFX9 – SEW2; Bank of adjacent watercourse eroding into road (photo facing west)
