Garcia and Associates

RE: Fulton-Fitch Reconductoring Project, Water Crossing Mapping

Appendix A. Fulton-Fitch Work Area and Crossing Photos

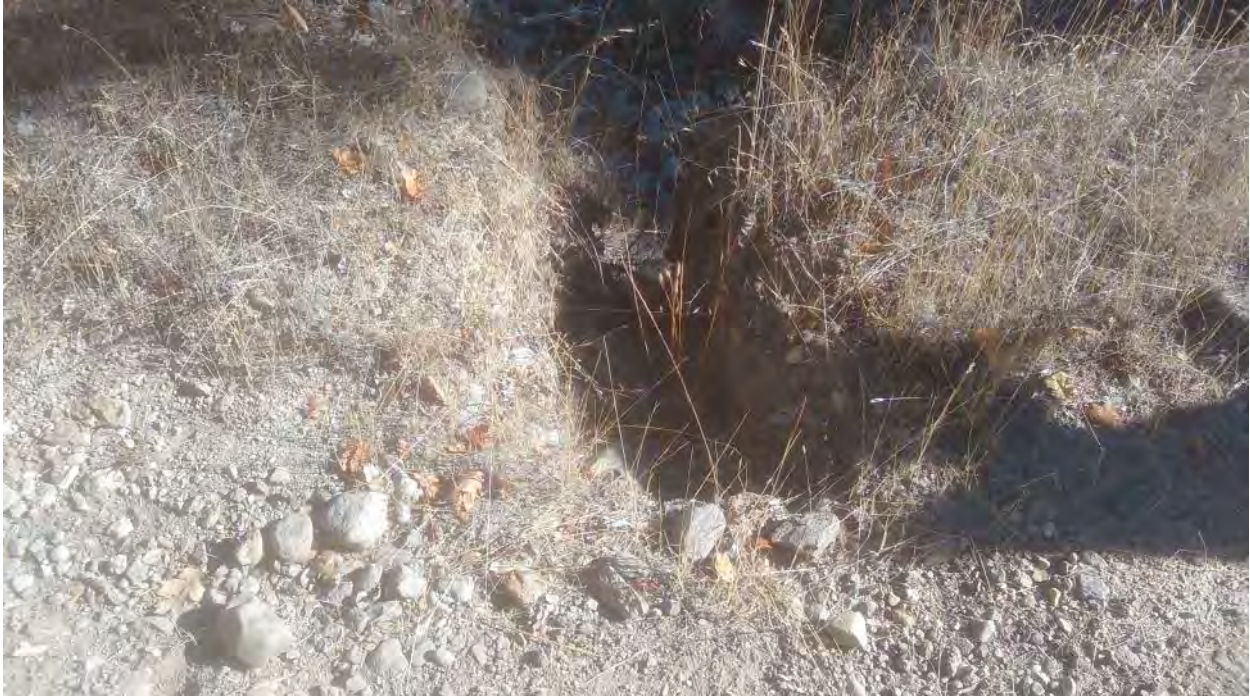
FFX9 – SEW2; Bank of adjacent watercourse eroding into road (photo facing east)

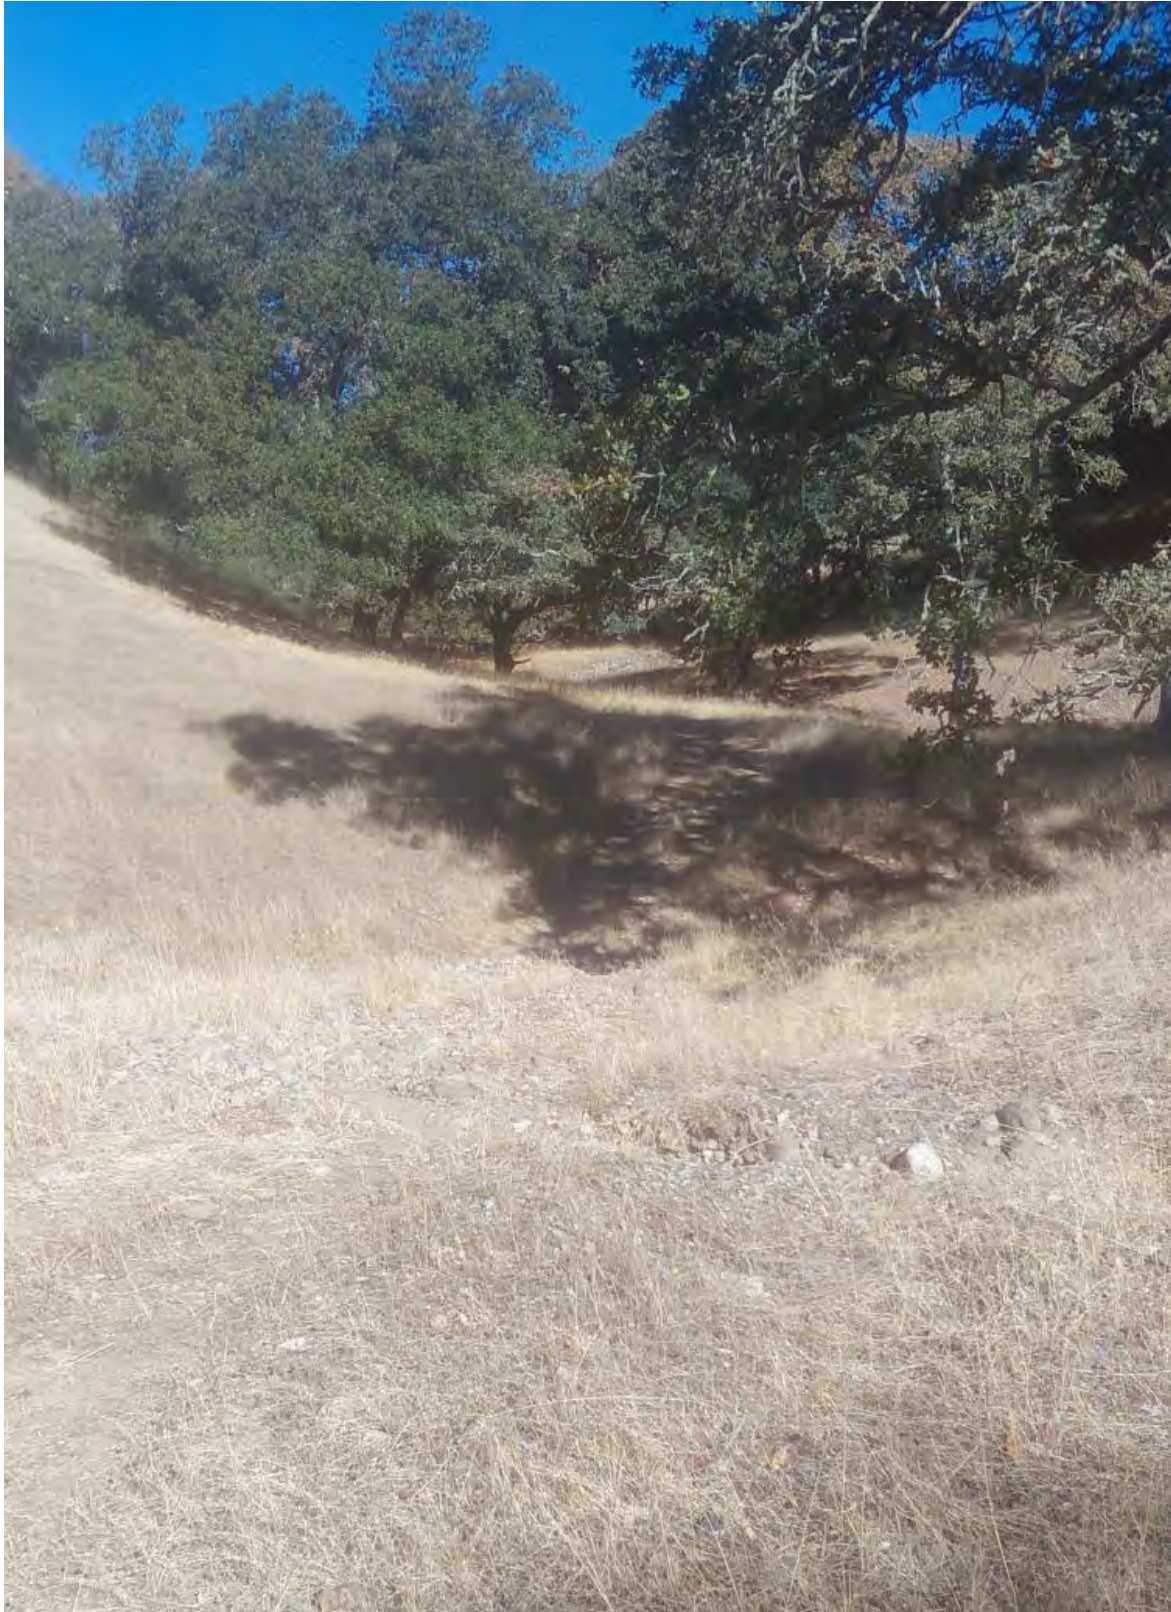
FFX11 – SEW2; Roadway crosses dry creek bed and terminates into a tributary to the seasonal watercourse (photo facing north)

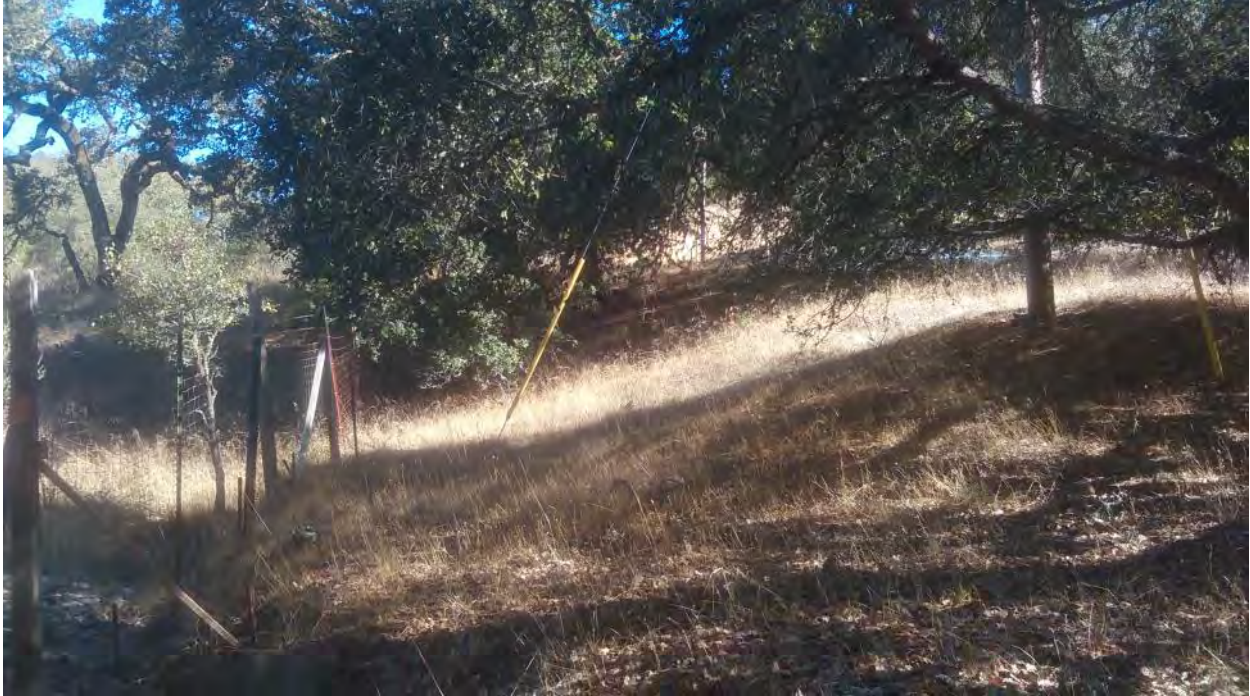
FFW17 – Pole 67; SEW30; Work area occurs adjacent to seasonal waterway (photo facing northeast)

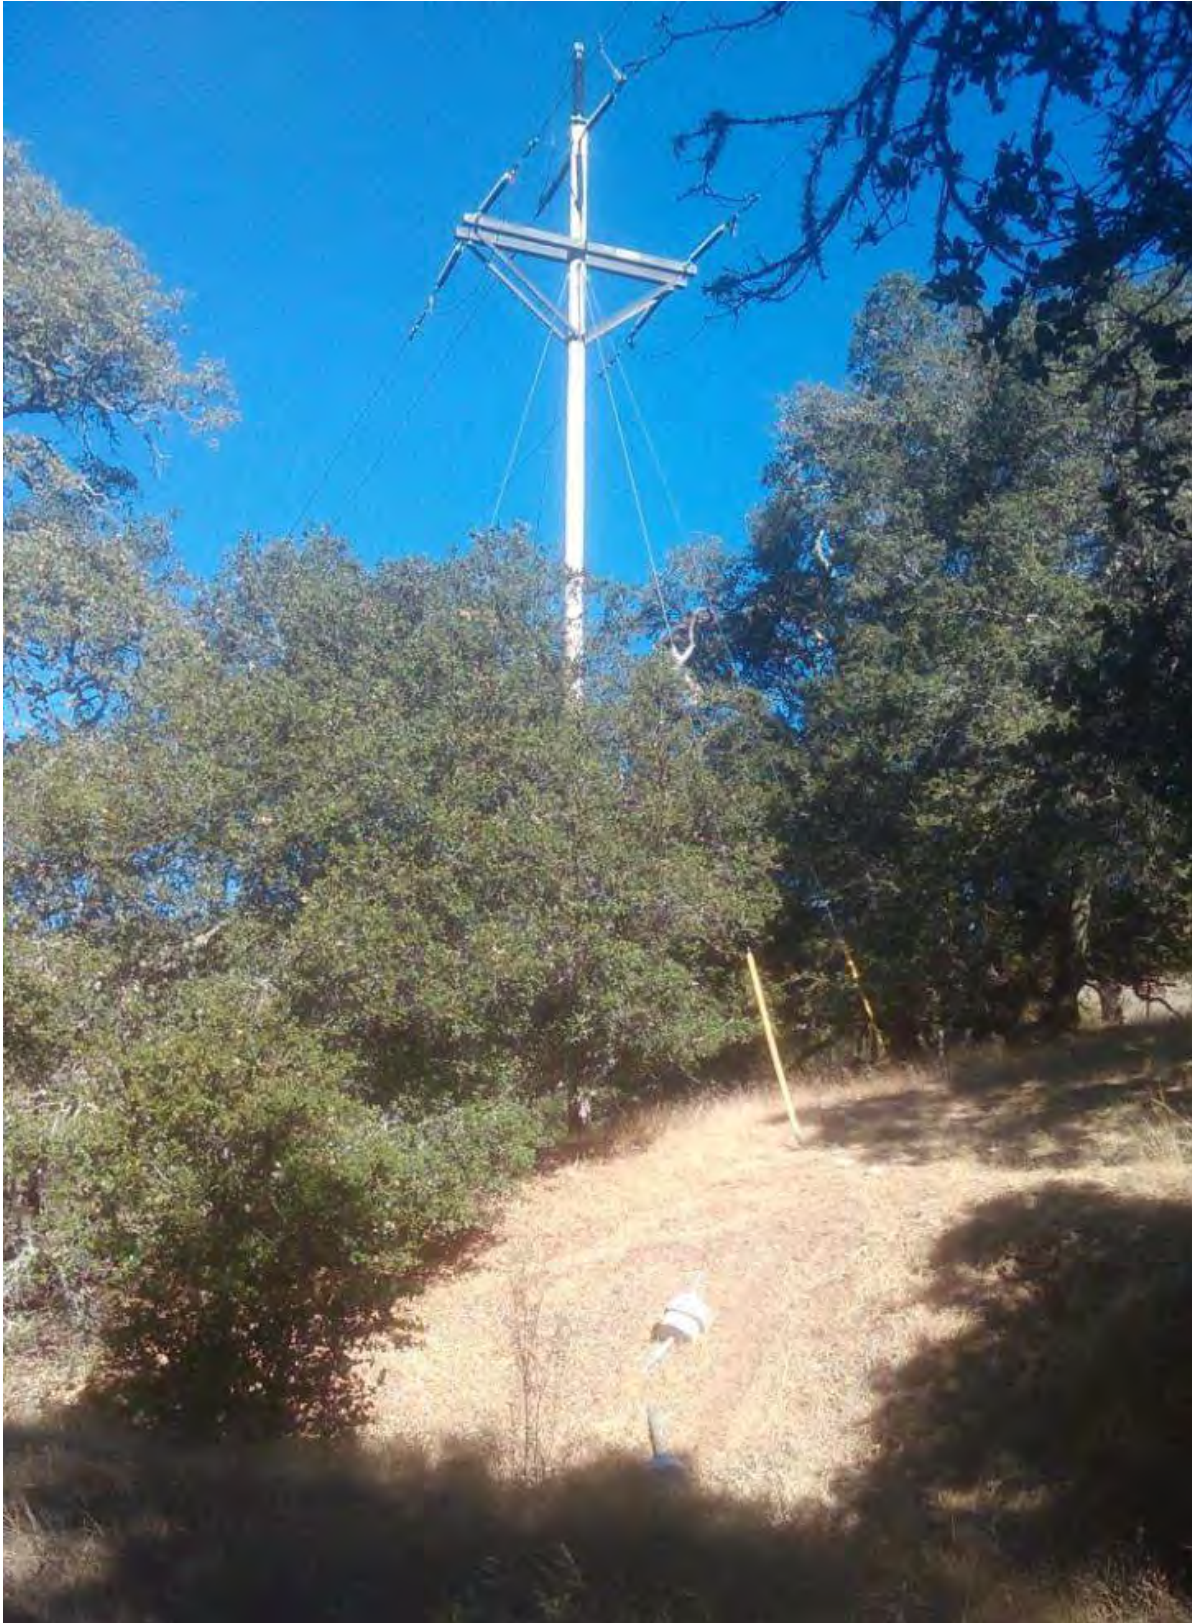
FFW17 – Pole 67; SEW30; Work area occurs adjacent to seasonal waterway (photo facing northeast)

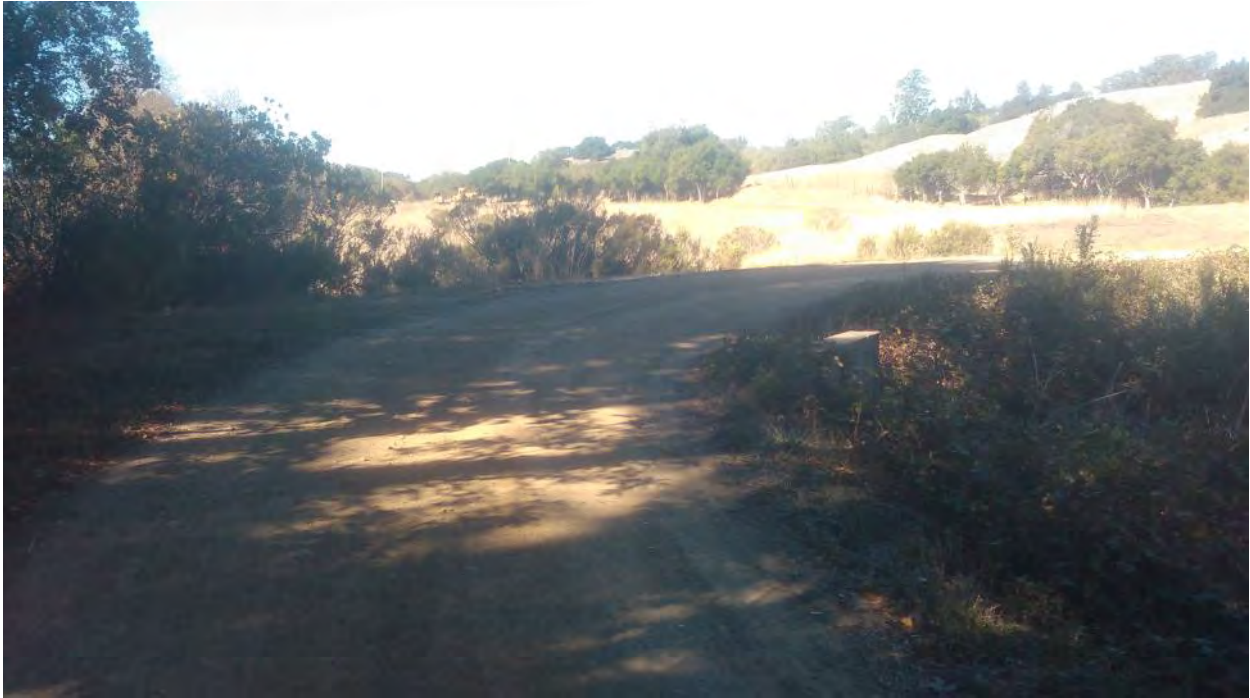
FFX13 – RIWO10; Culvert crossing occurs immediately downstream of perennial pond (photo facing northwest)

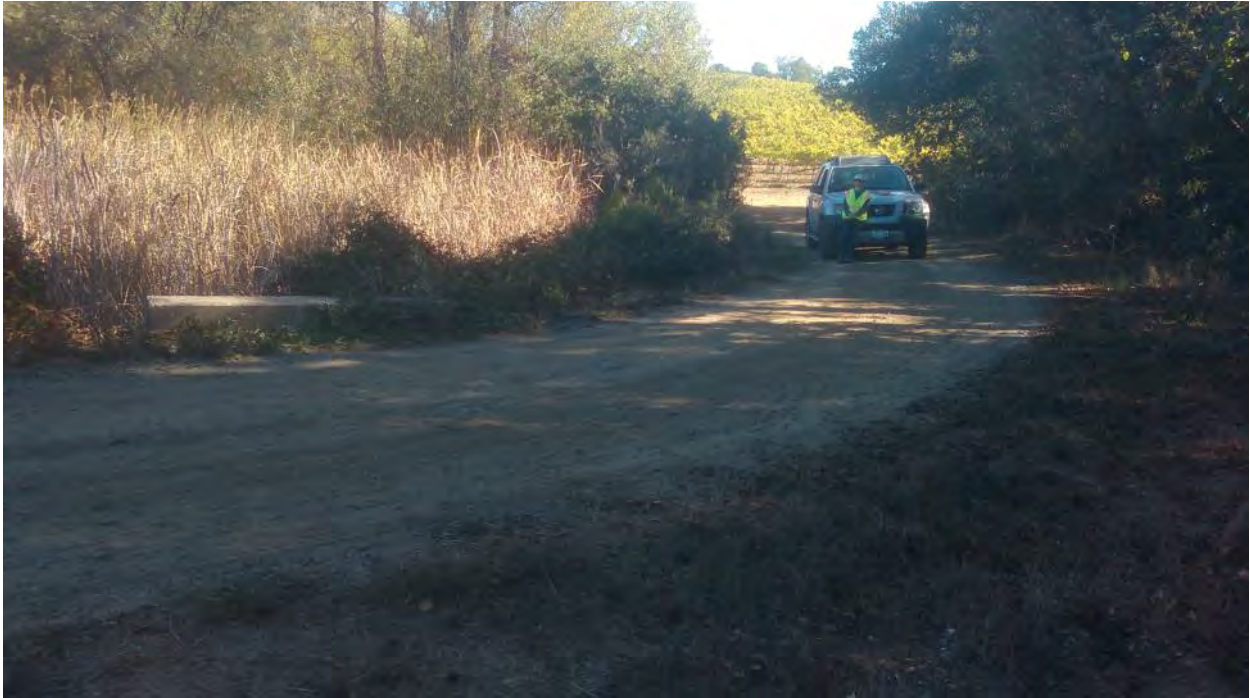
FFX13 – RIWO10; Culvert crossing occurs immediately downstream of perennial pond (photo facing southeast)

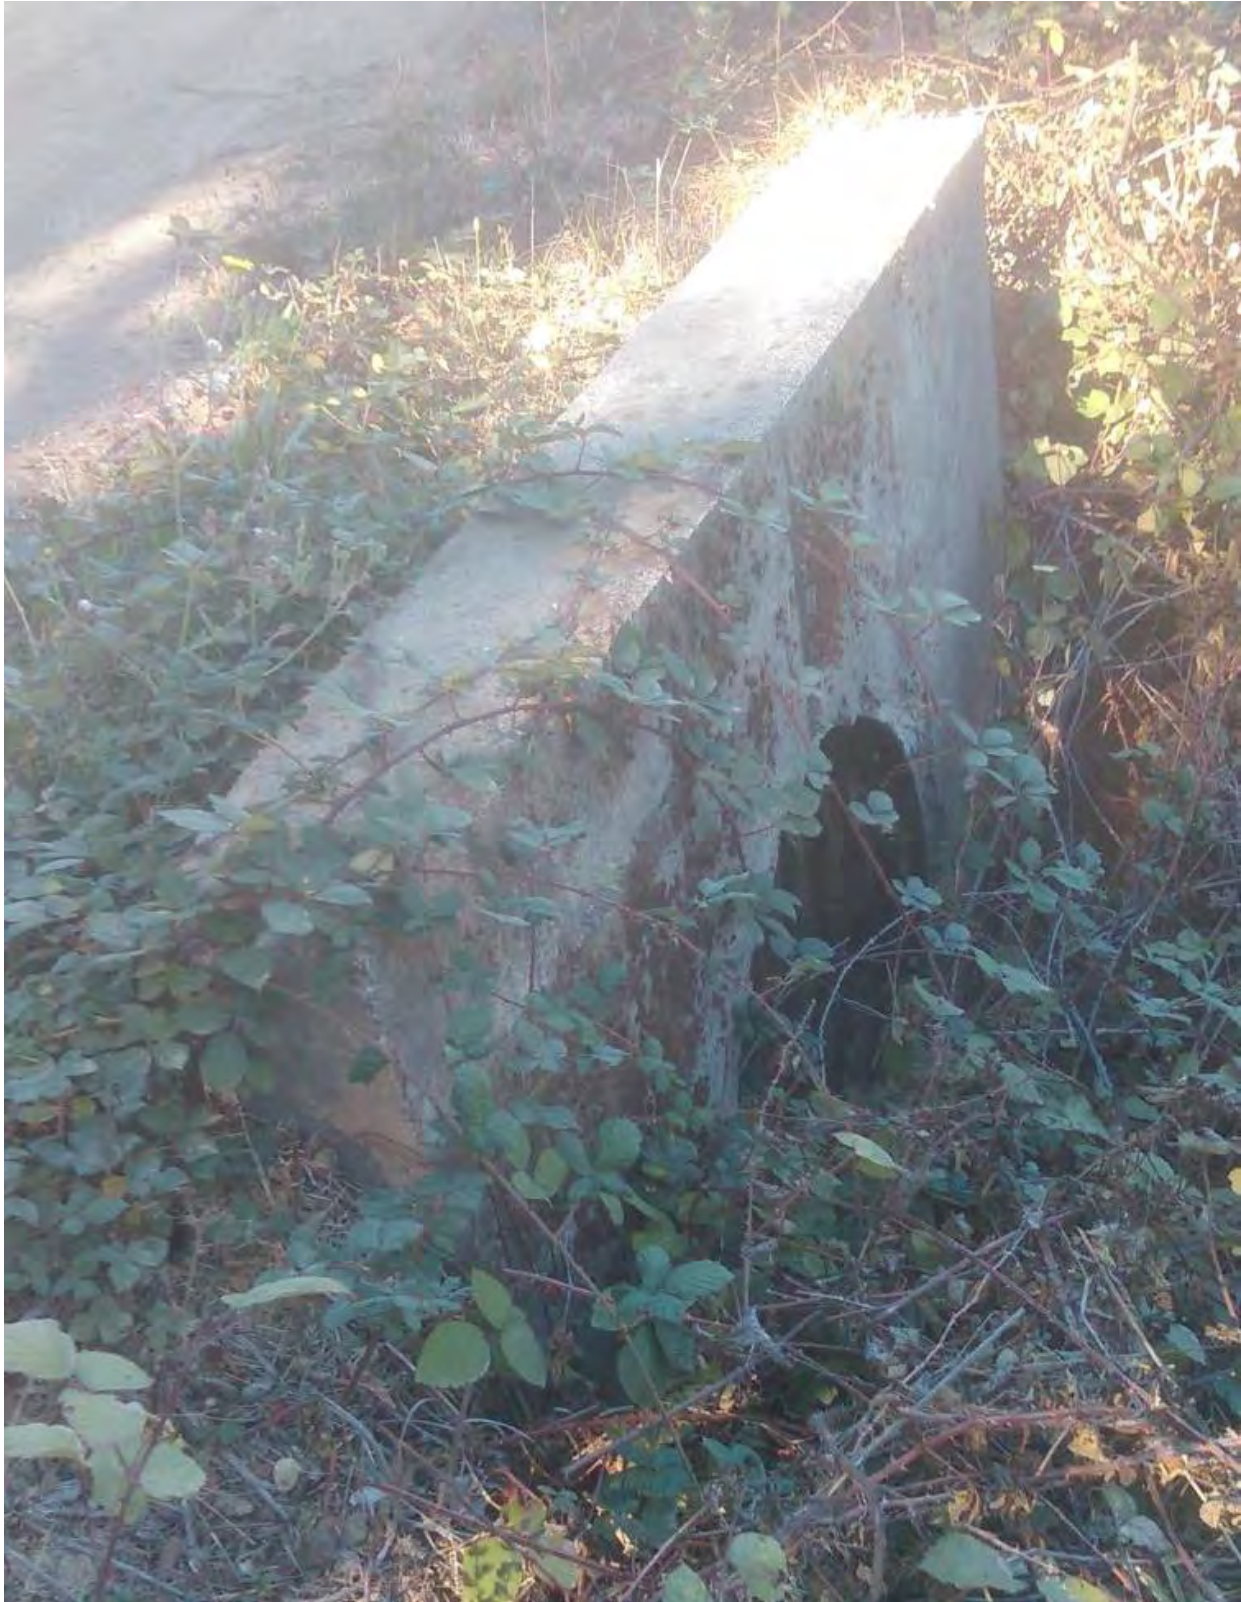
FFX13 – RIWO10; Culvert crossing occurs immediately downstream of perennial pond (photo facing northwest)

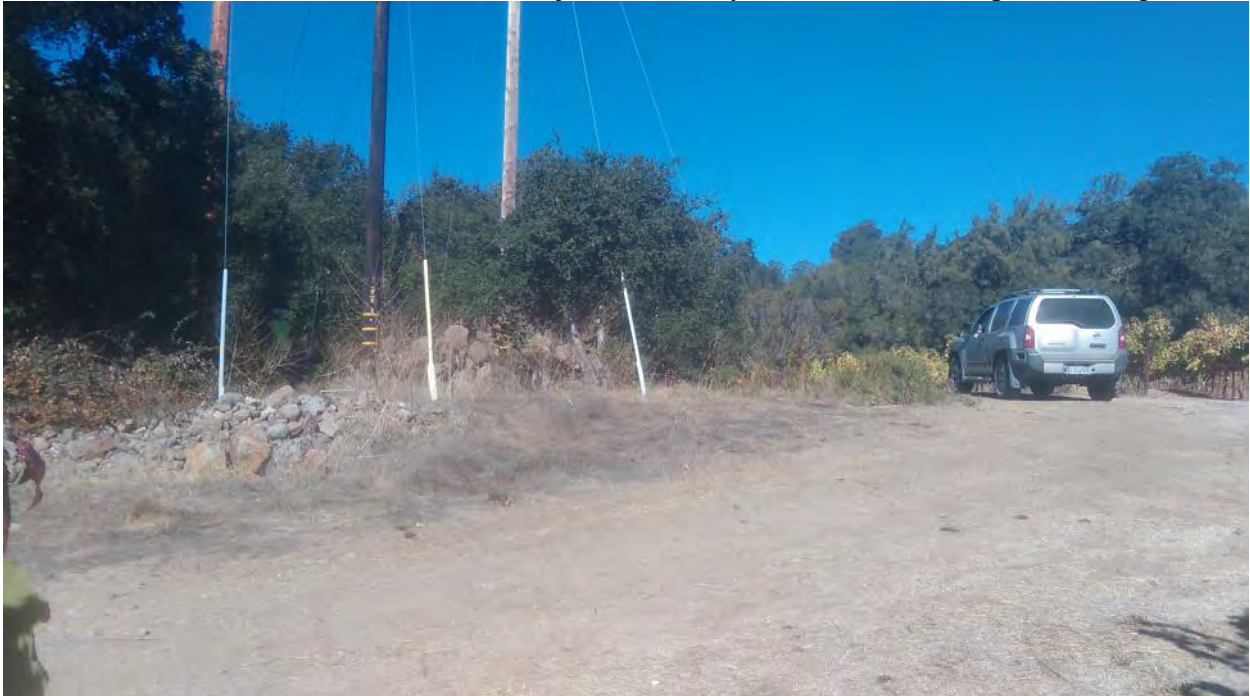
FFW18 – Pole 71; RIWO10; Work area adjacent to vineyard and woodland (photo facing north)

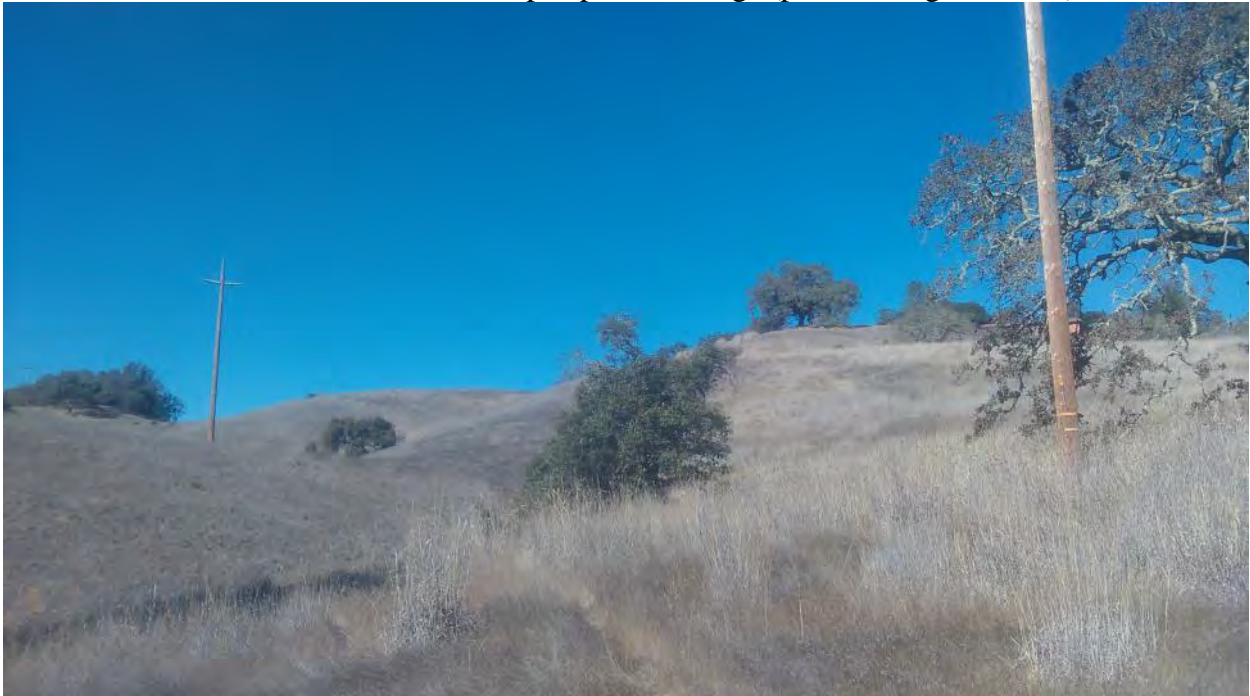
FFW19 – Pole 71; SEW35; Work area upslope of drainage (photo facing northeast)

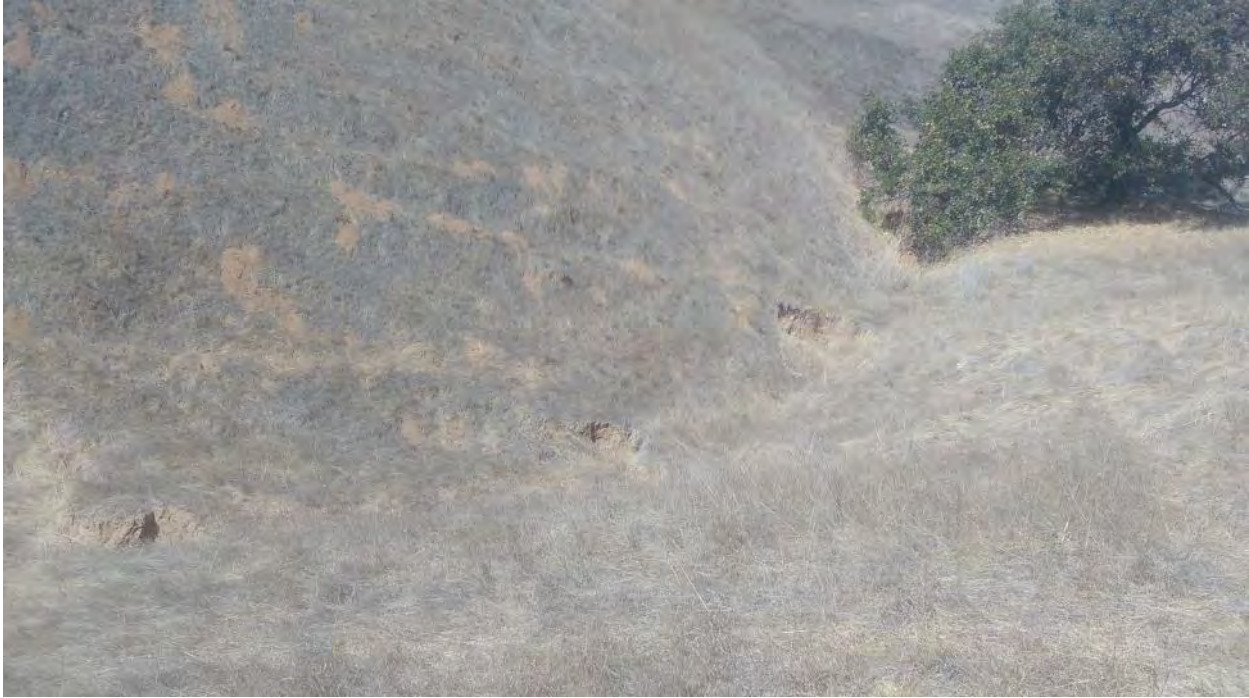
FFW19 – Pole 71; SEW35; Work area upslope of drainage (photo facing north)

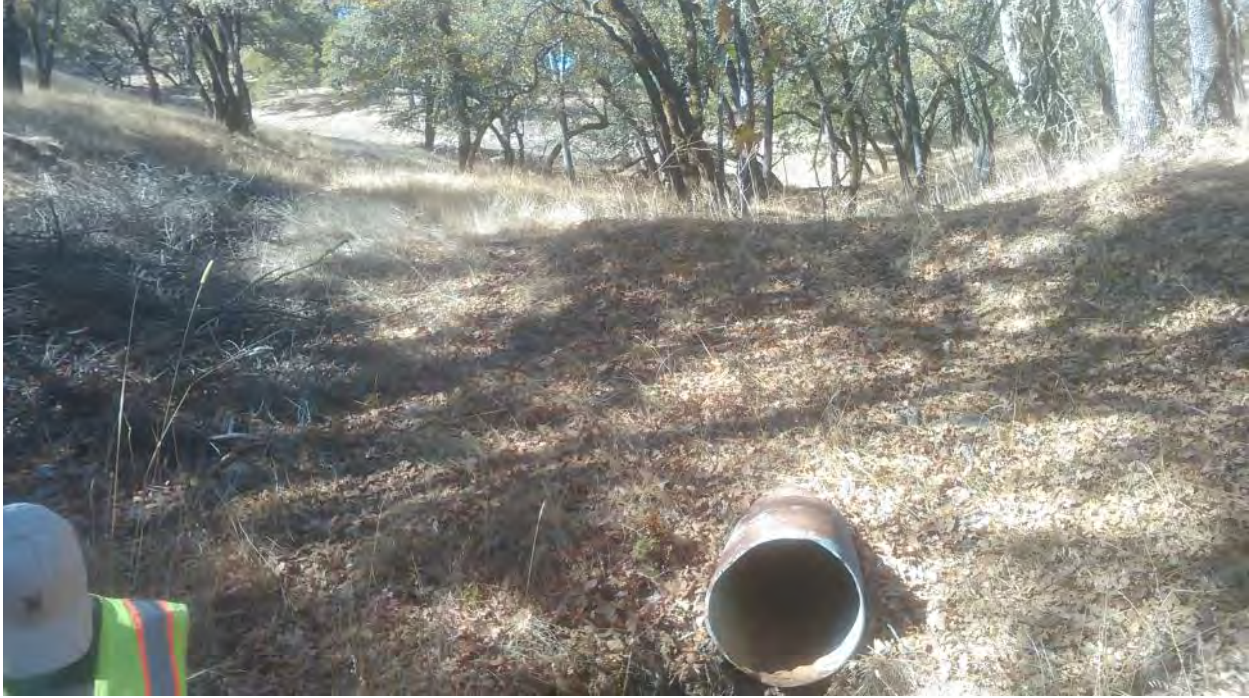
FFX15 – SEW8; Culvert crossing through bermed earth at the bottom of the drainage (photo facing north)

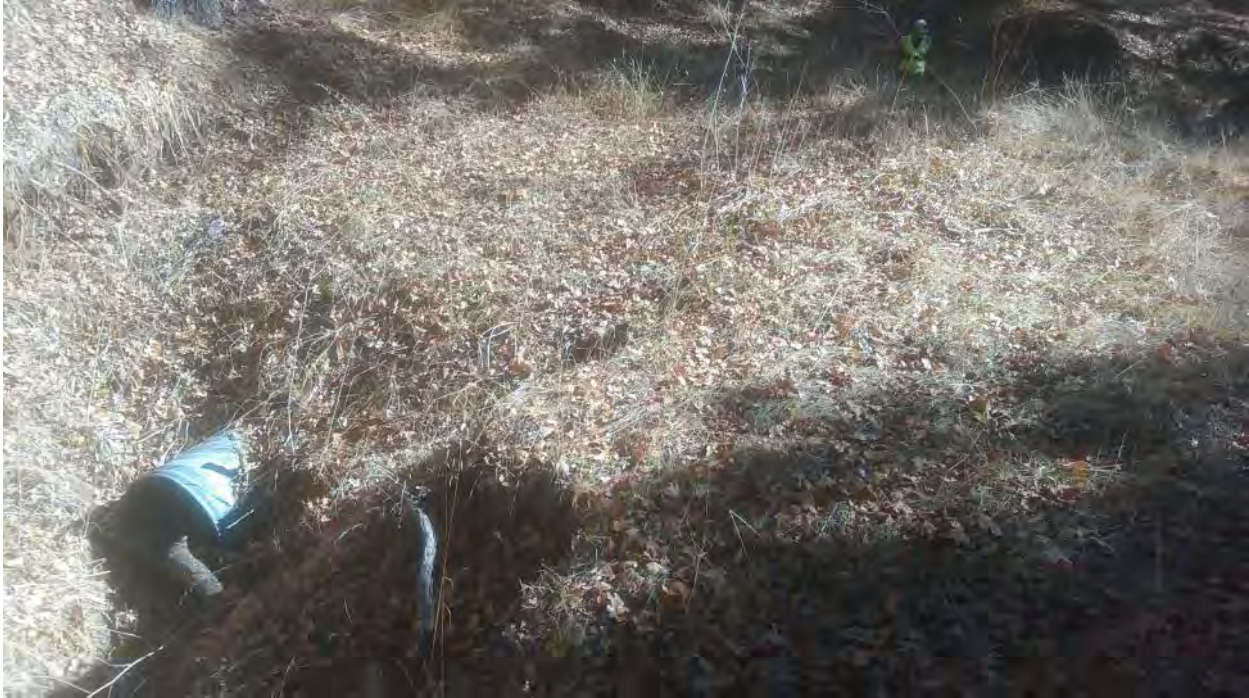
FFX15 – SEW8; Culvert crossing through bermed earth at the bottom of the drainage (photo facing west)

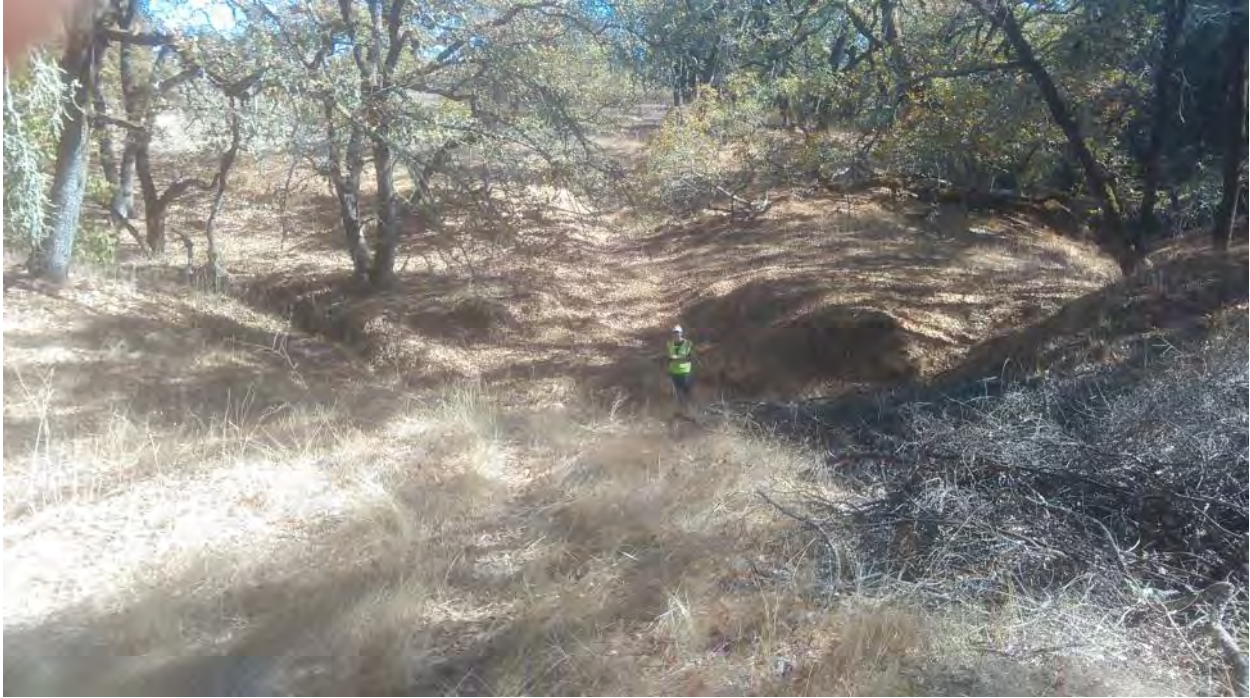
FFX16 - RIWO11; Crossing point at bottom of dry creek bed (photo facing south)

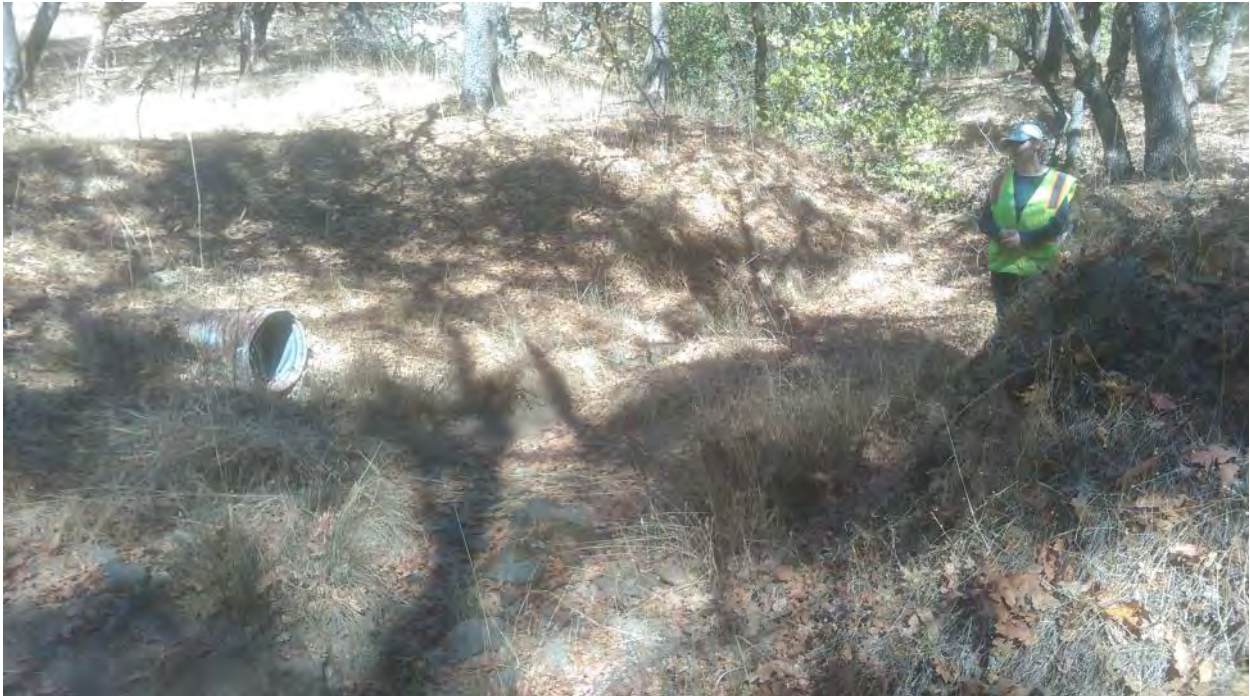
FFX16 - RIWO11; Crossing point just below culvert, at bottom of dry creek bed (photo facing northeast)

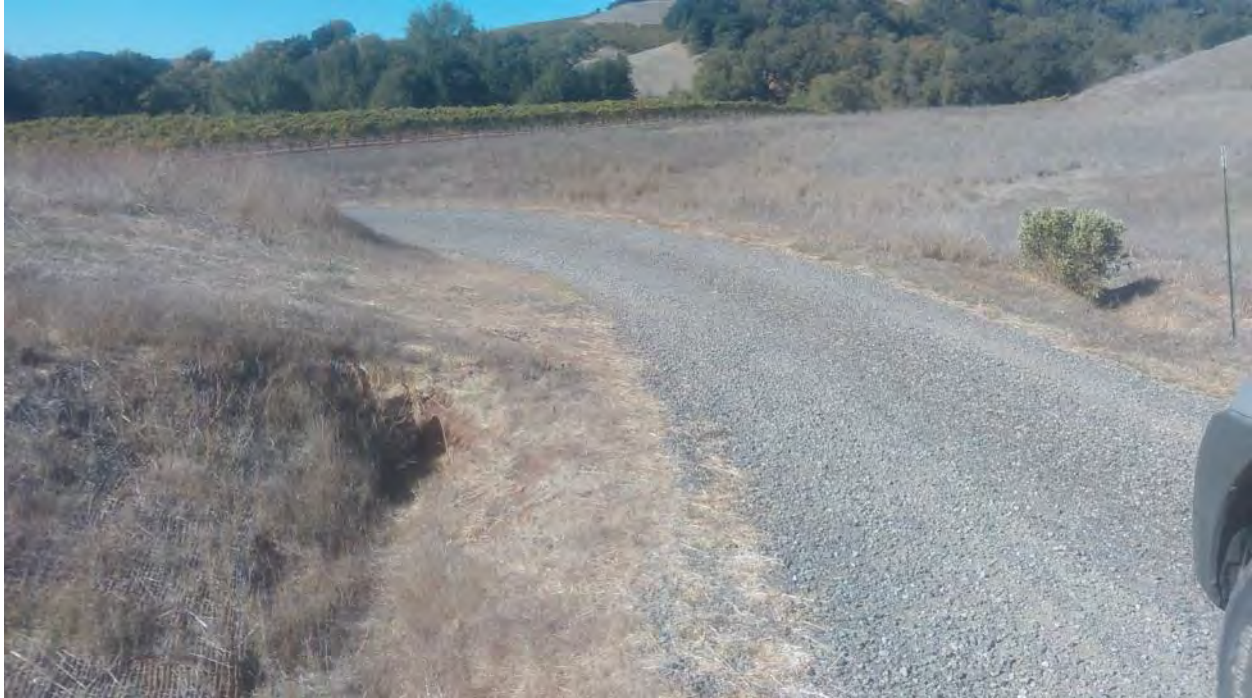
FFX17 – D5; Culvert crossing for drainage ditch under improved road (photo facing northwest)

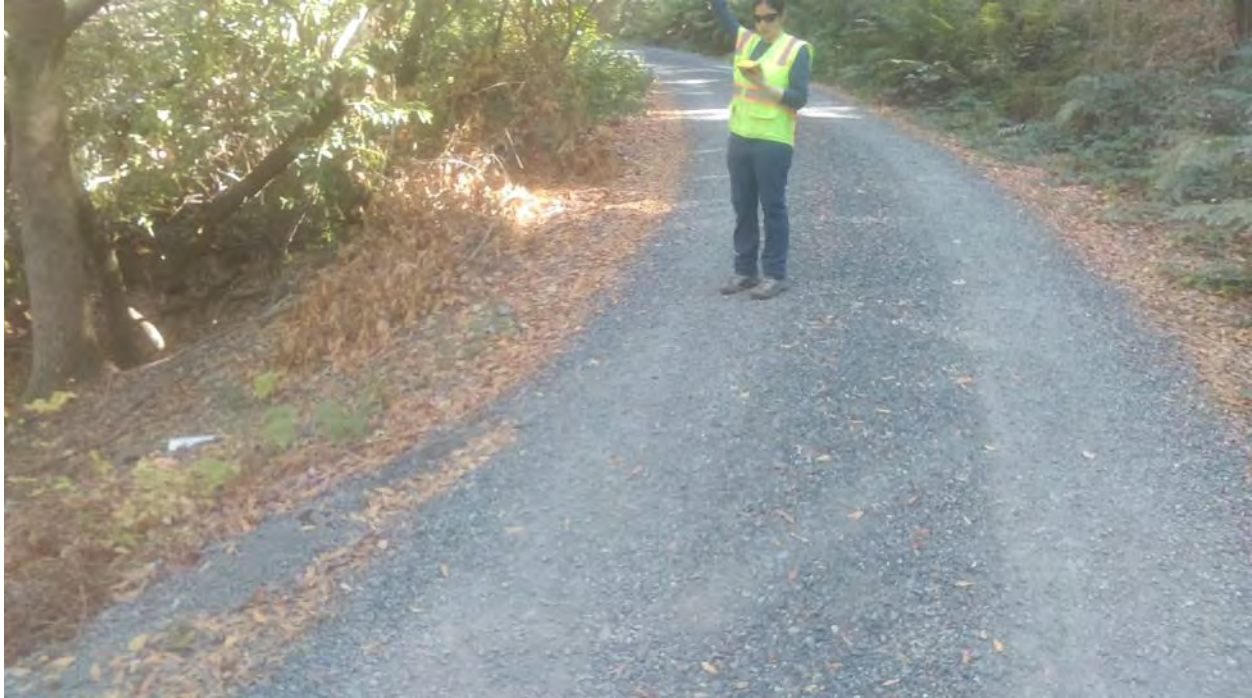
FFX18 – SEW46; Culvert crossing under improved road (photo facing east)

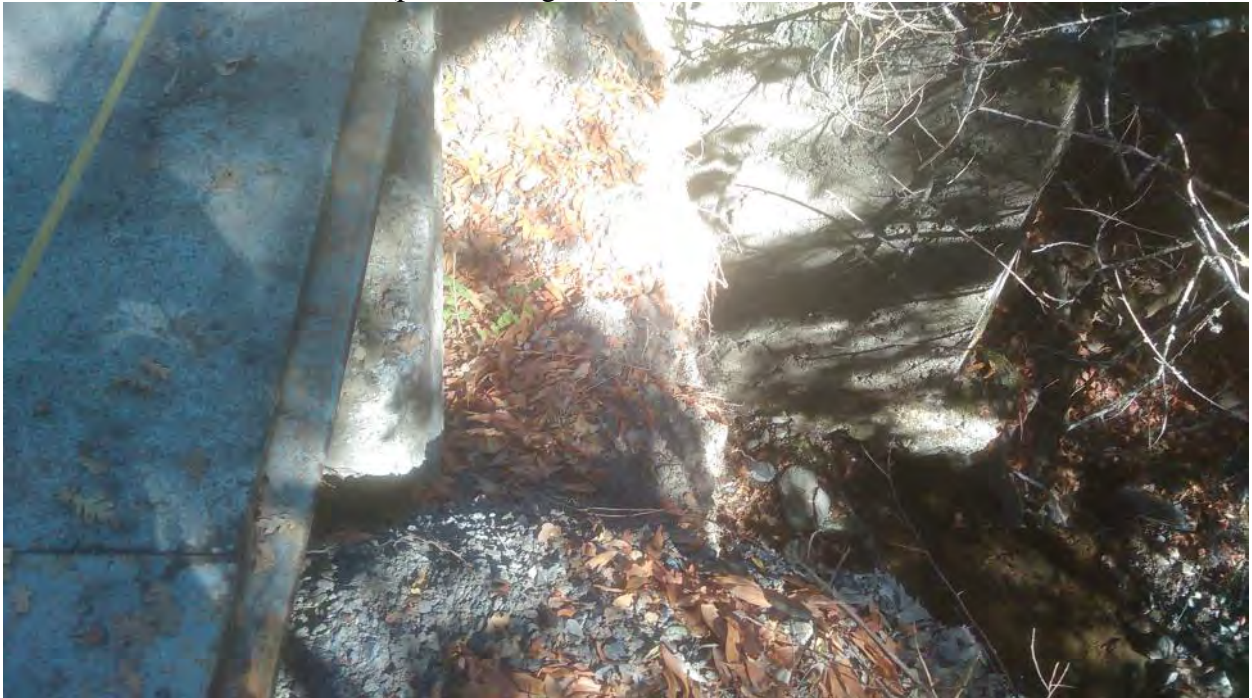
FFX19 – RIWO12; Bridge crossing over perennial watercourse within riparian woodland, on access road to Weston Ranch (photo facing east)

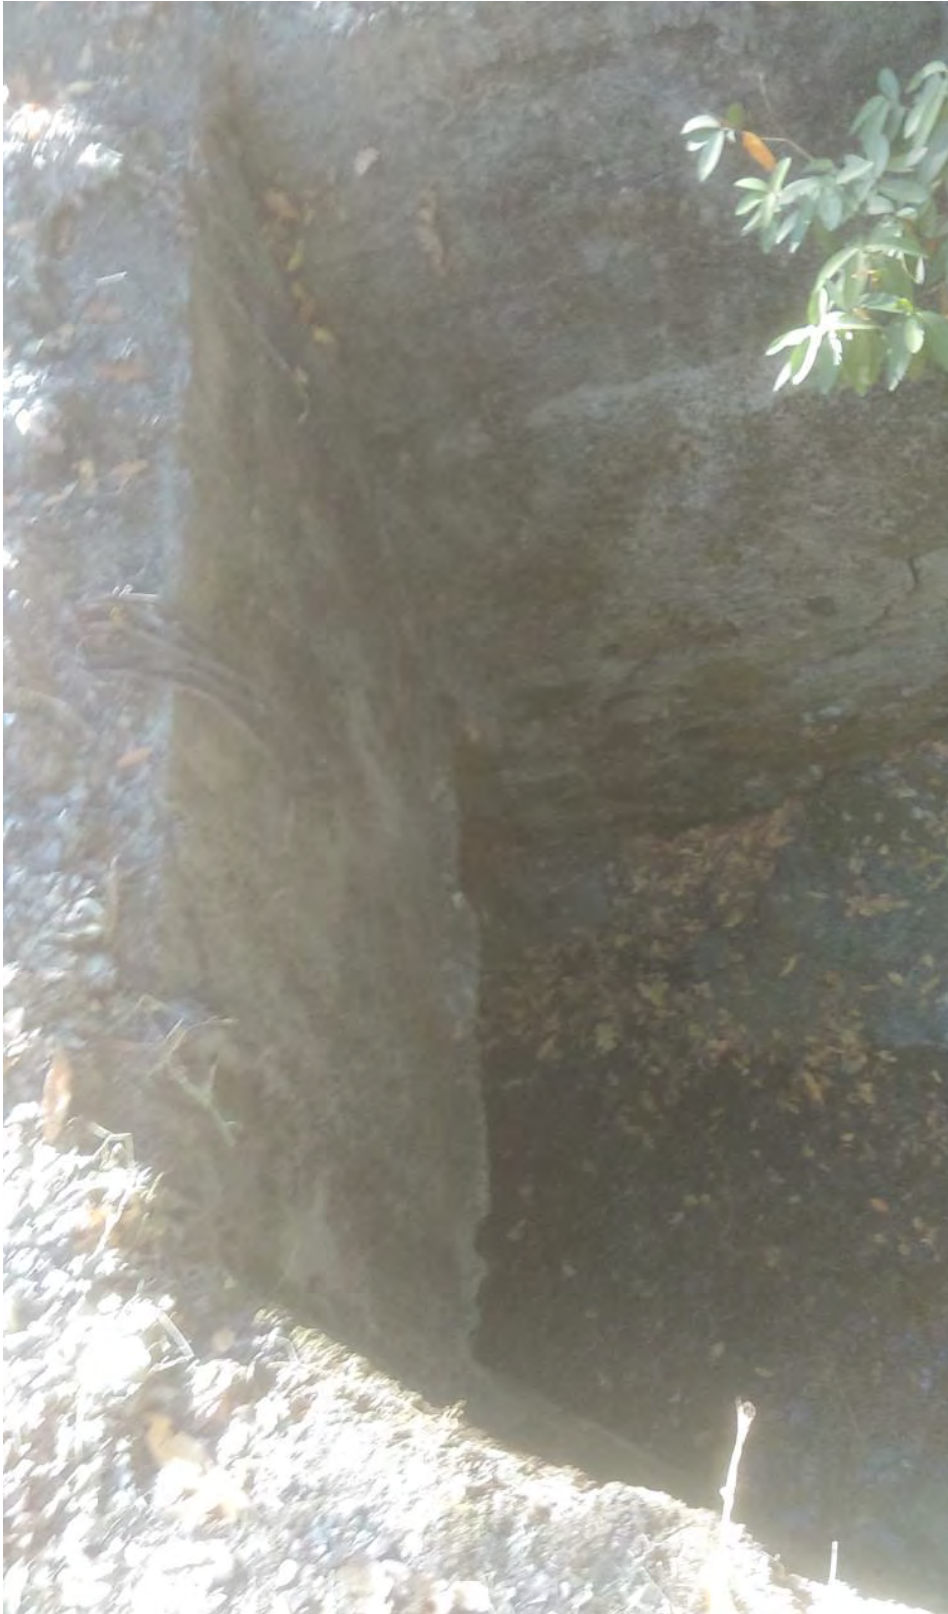
FFX19 – RIWO12; Bridge crossing over perennial watercourse within riparian woodland, on access road to Weston Ranch (photo facing west)

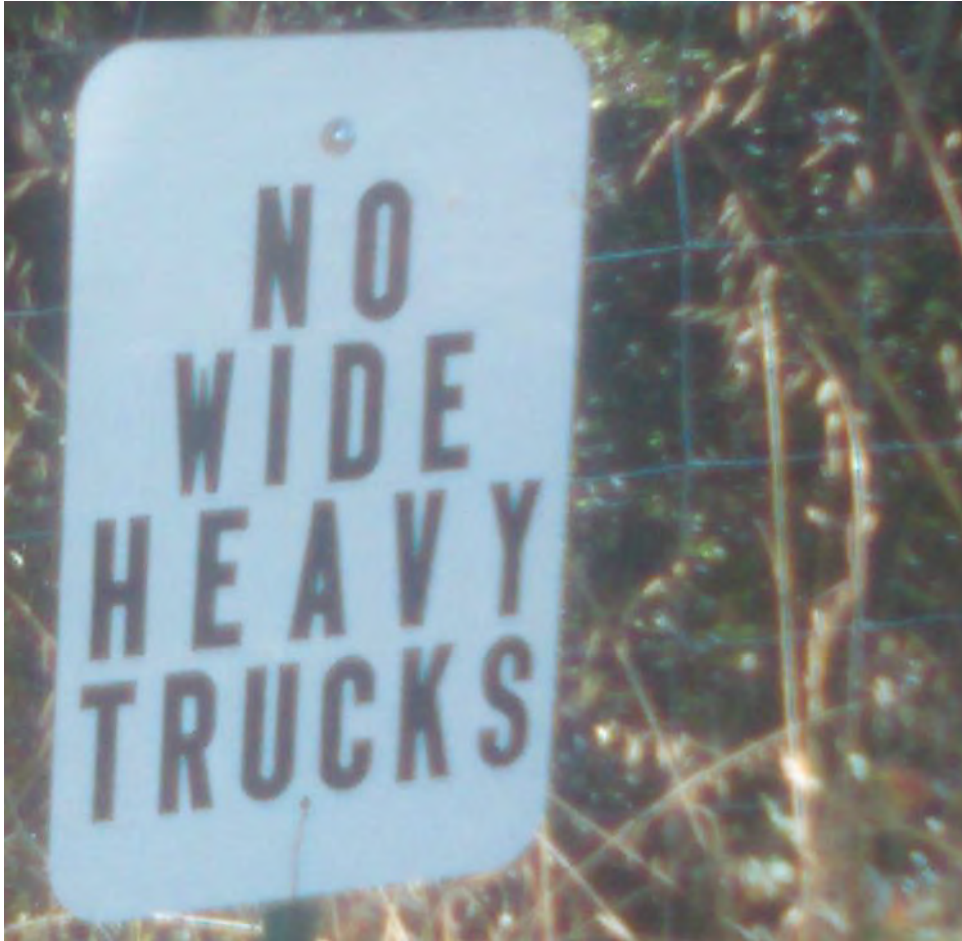
FFX19 – RIWO12; Signage for bridge crossing over perennial watercourse within riparian woodland, on access road to Weston Ranch (photo facing east)

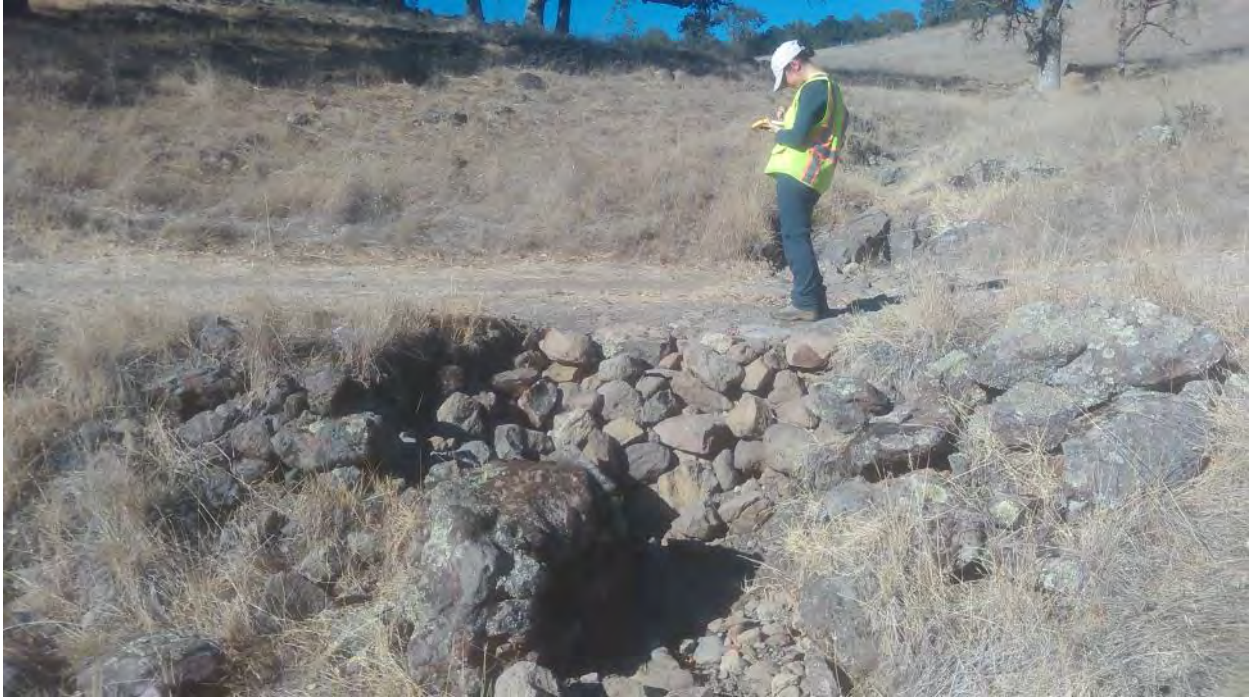
FFX20 – SEW6; Crossing point for seasonal watercourse (photo facing northeast)

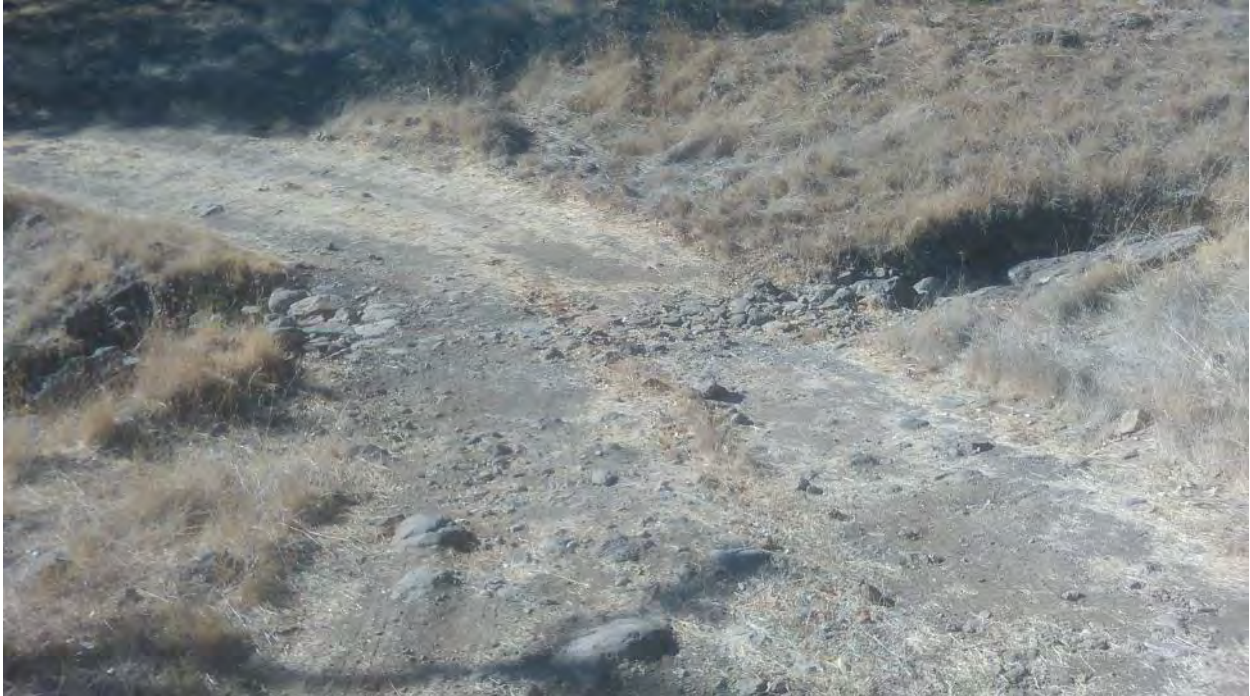
FFX20 – SEW6; Crossing point for seasonal watercourse (photo facing northwest)
