Garcia and Associates

RE: Fulton-Fitch Reconductoring Project, Water Crossing Mapping

Appendix A. Fulton-Fitch Work Area and Crossing Photos

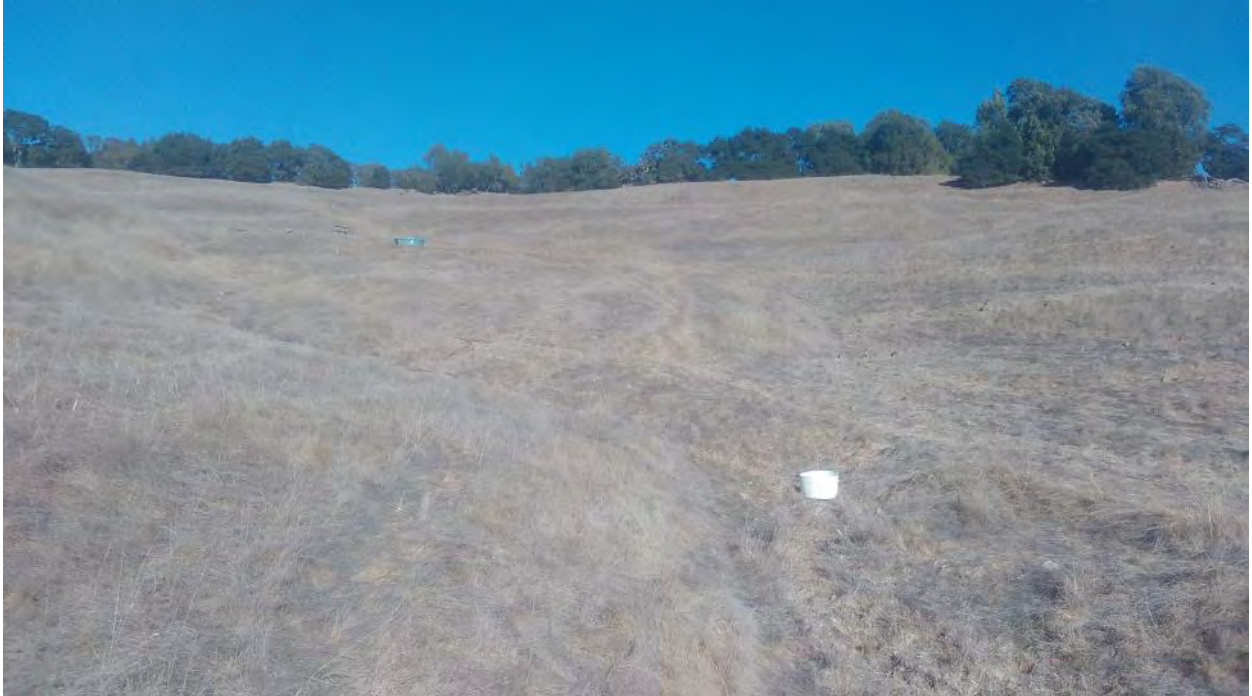
FFX22 – SEW5; Recommended alternate crossing point for seasonal watercourse (photo facing north)

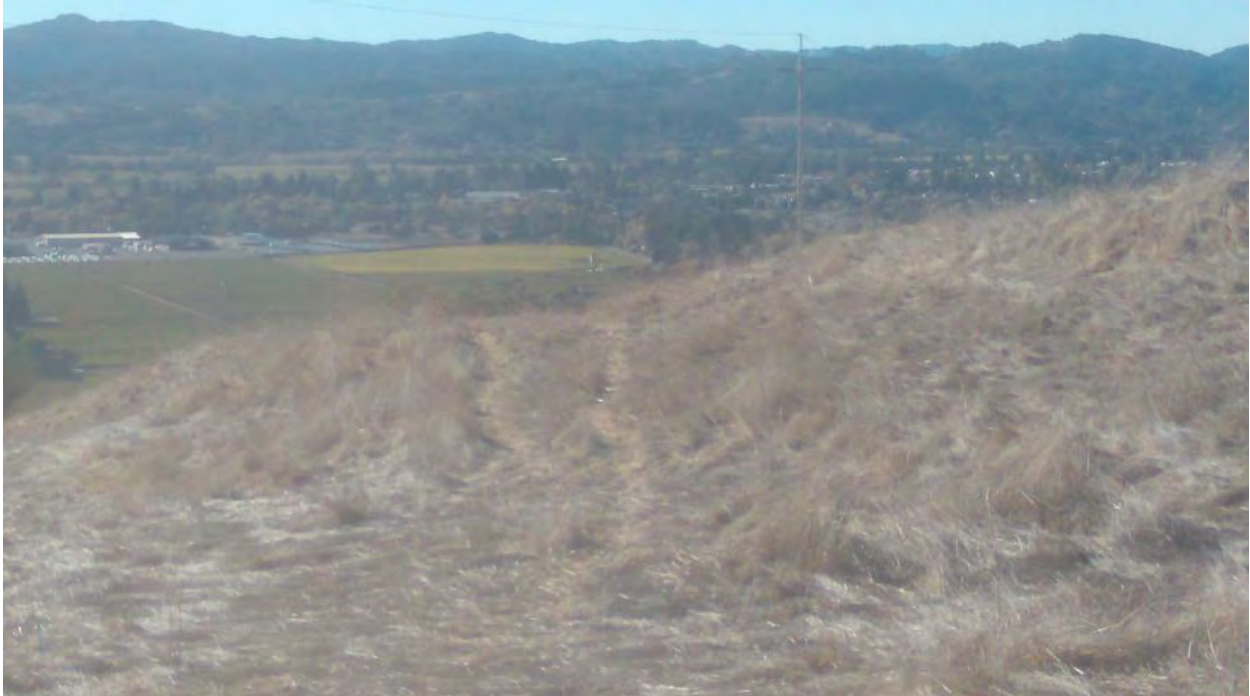
FFX23 – SW13; Overland route and crossing point for seasonal watercourse (photo facing west)

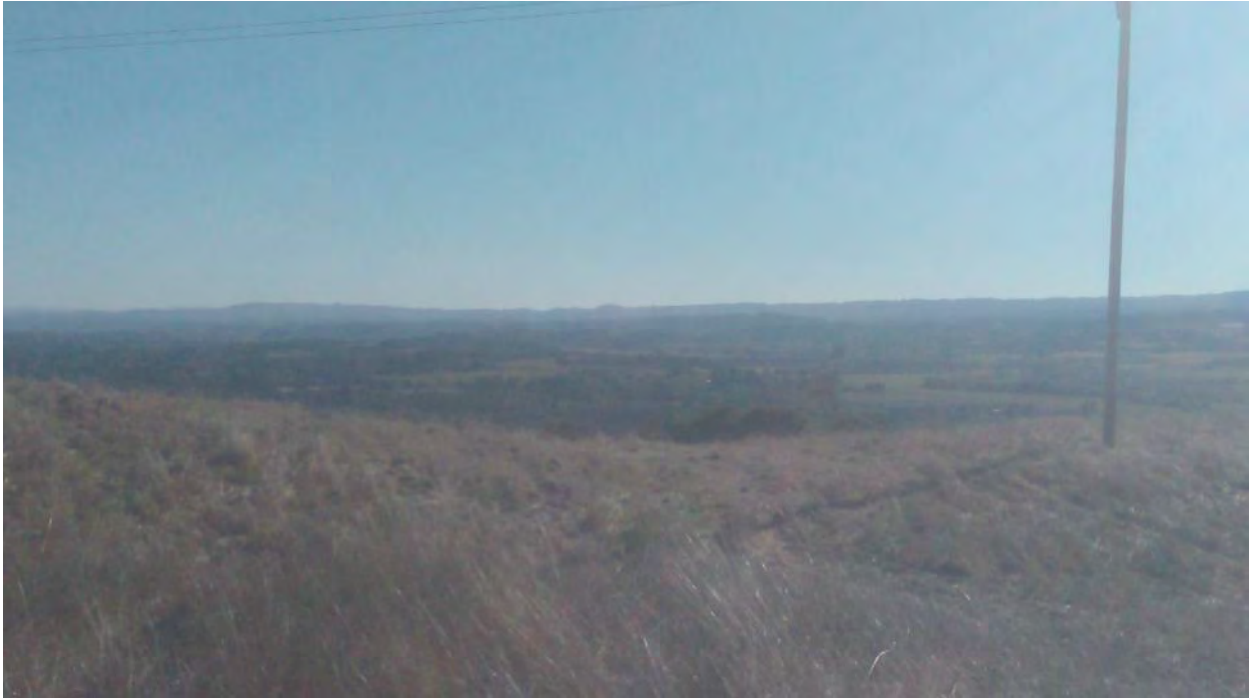
FFW21 – Pole 83; SW12; Work area is downslope from seasonal wetland (photo facing southeast)

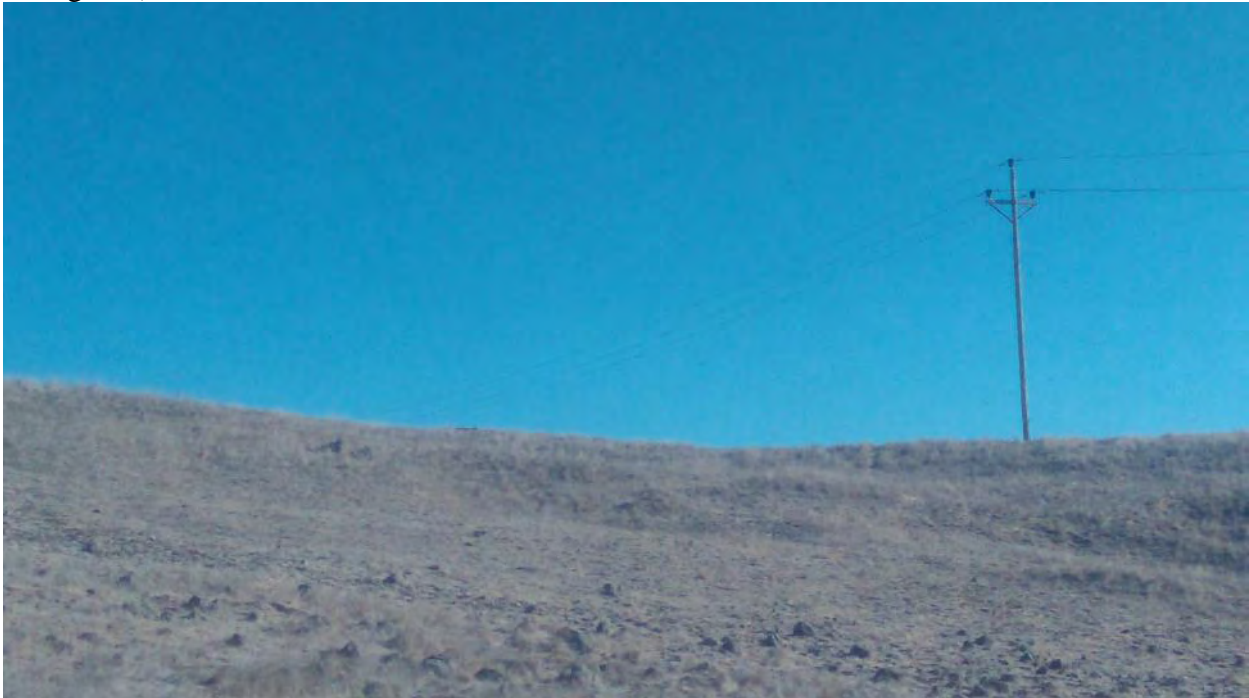
FFW22 – Pole 82; SW11; Configure work area to avoid overlap with seasonal wetland (photo facing east)
