SOUTHERN CALIFORNIA EDISON
Preliminary Geology and Geotechnical Evaluation
Riverside Transmission Reliability Project (RTRP)
Double Circuit 230kV T/L
Eastern, Western and Van Buren Suggested Routes
Mira Loma - Vista #1 230kV to Wildlife Substation
Riverside County, California

June 10, 2010
Project # 10-037
Revision 1

Subject: Preliminary Geology and Geotechnical Evaluation
Riverside Transmission Reliability Project (RTRP)
Double Circuit 230 kV T/L
Eastern, Western and Van Buren Suggested Routes
Mira Loma - Vista #1 230 kV to Wildlife Substation
Riverside County, California

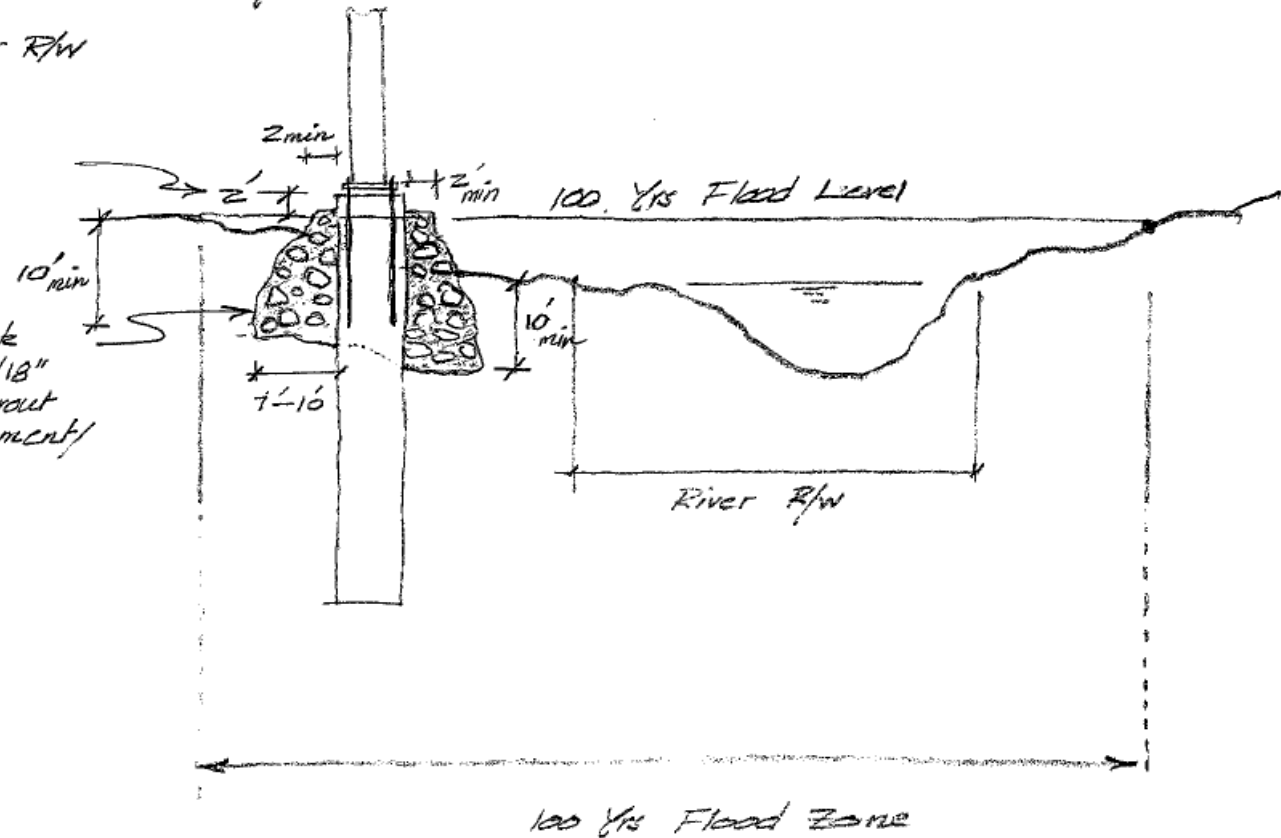
Rip-Rap Erosion Protection System

The foundations and the towers have to be protected from the flood debris impact. Risk of such impact can be reduced by building a rip-rap or concrete protection system around the foundation. Failure to protect the foundation may jeopardize the stability of the structure. Soil washout plays a major role in the stability of structures that are placed

Grouted Rock
Rip-Rap 12/18"
min. Rock grout
w 5 sack cement/
sand mix.

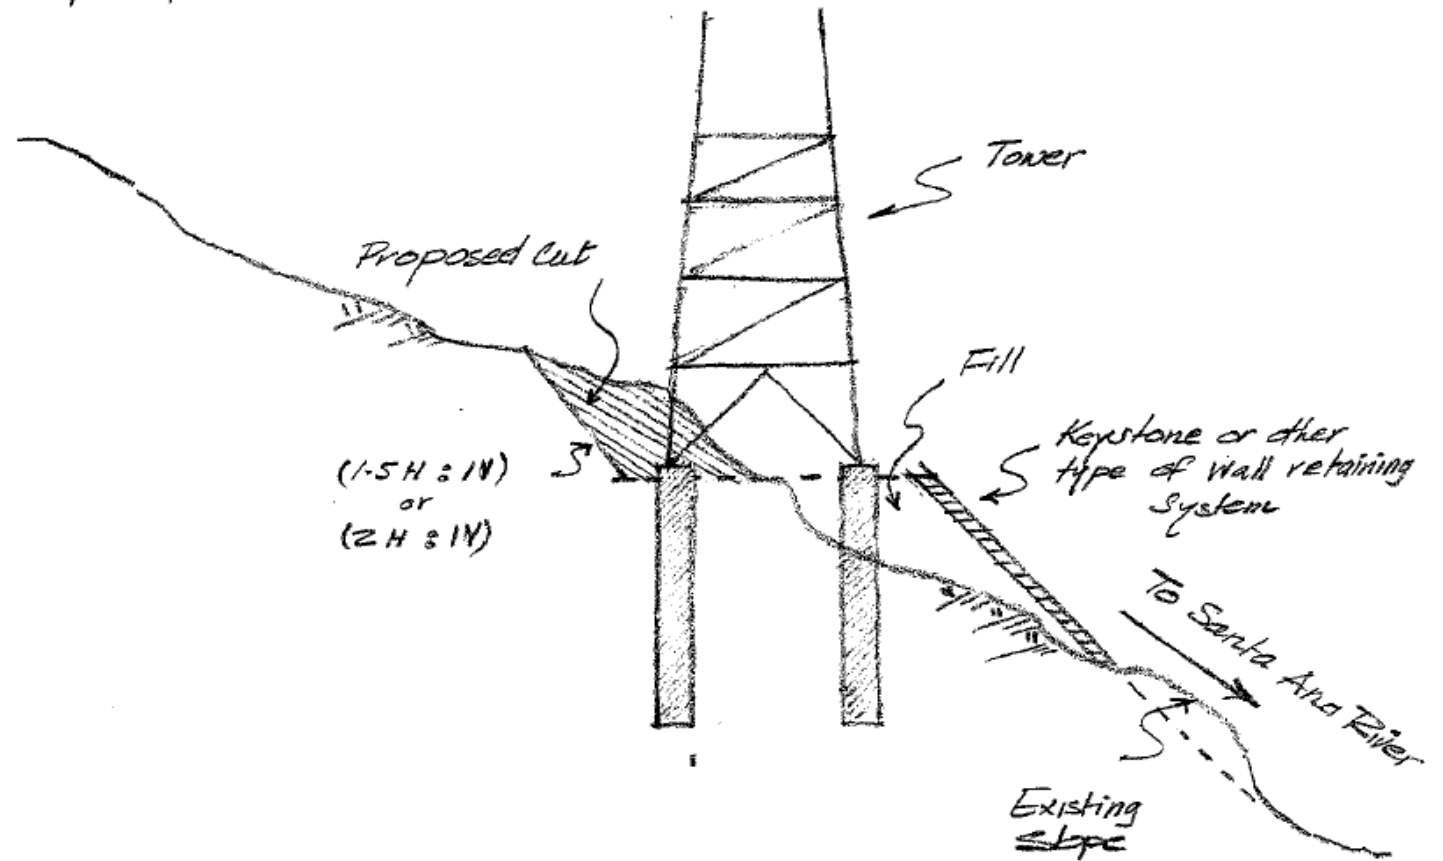
Slope Stability Repair

Most of the identified slope stability issues concern structures located close to either the top or toe of a steep slope. Most commonly these issues can be mitigated using deepened foundations (for structures located too close to the tops of slopes) or by moving the structure a greater distance from the slope, see Figures (9 & 10), *Slope Stability Repair*. Where concerns involve slopes in granitic terrain, in most cases, the mitigation will require assurance that foundations extend into firm lightly weathered bedrock. This typically might involve deepening foundations three to five feet beyond typical design depths. Where concerns involve slopes in sedimentary terrain, or on higher, steeper granitic slopes greater embedment depths – perhaps as much as fifteen to twenty feet beyond typical design depths might be required. In cases where greater depths might be indicated, it might prove more practical to relocate the structure.

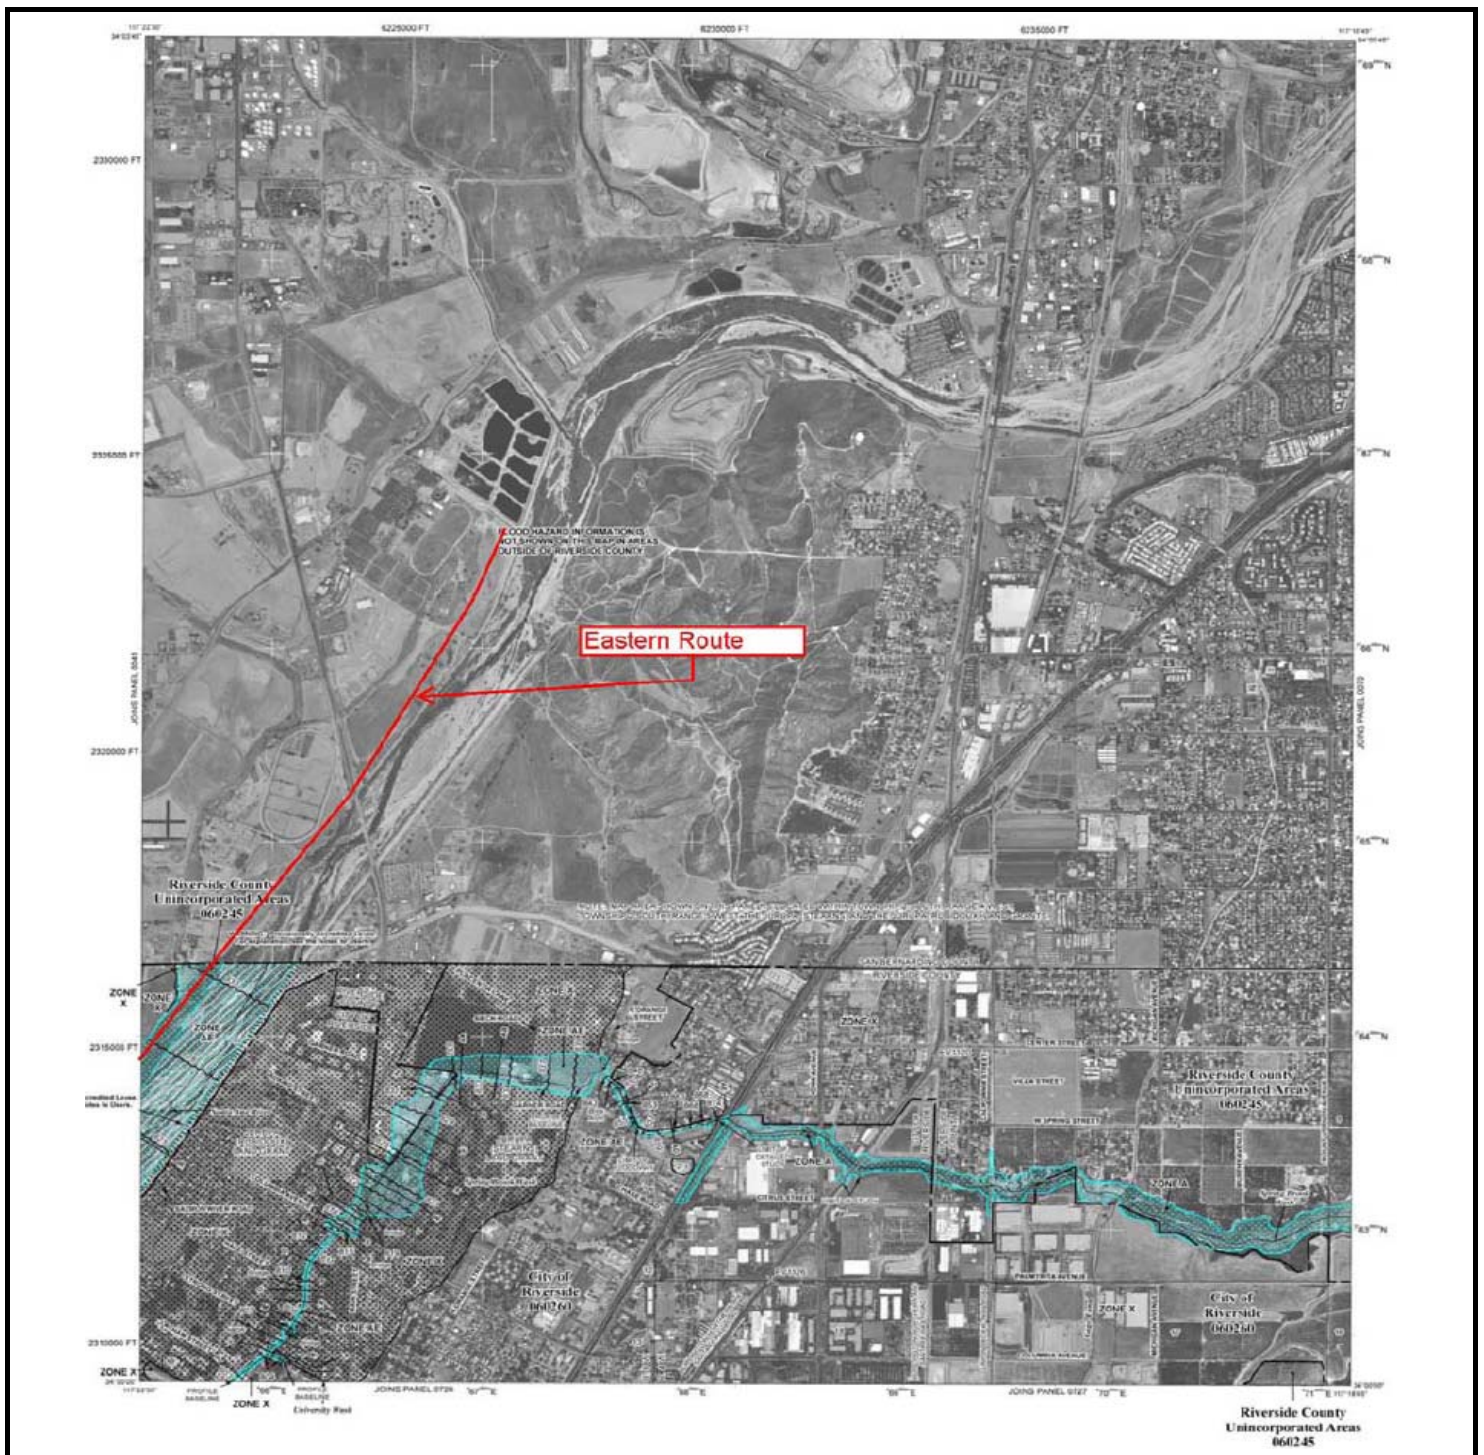
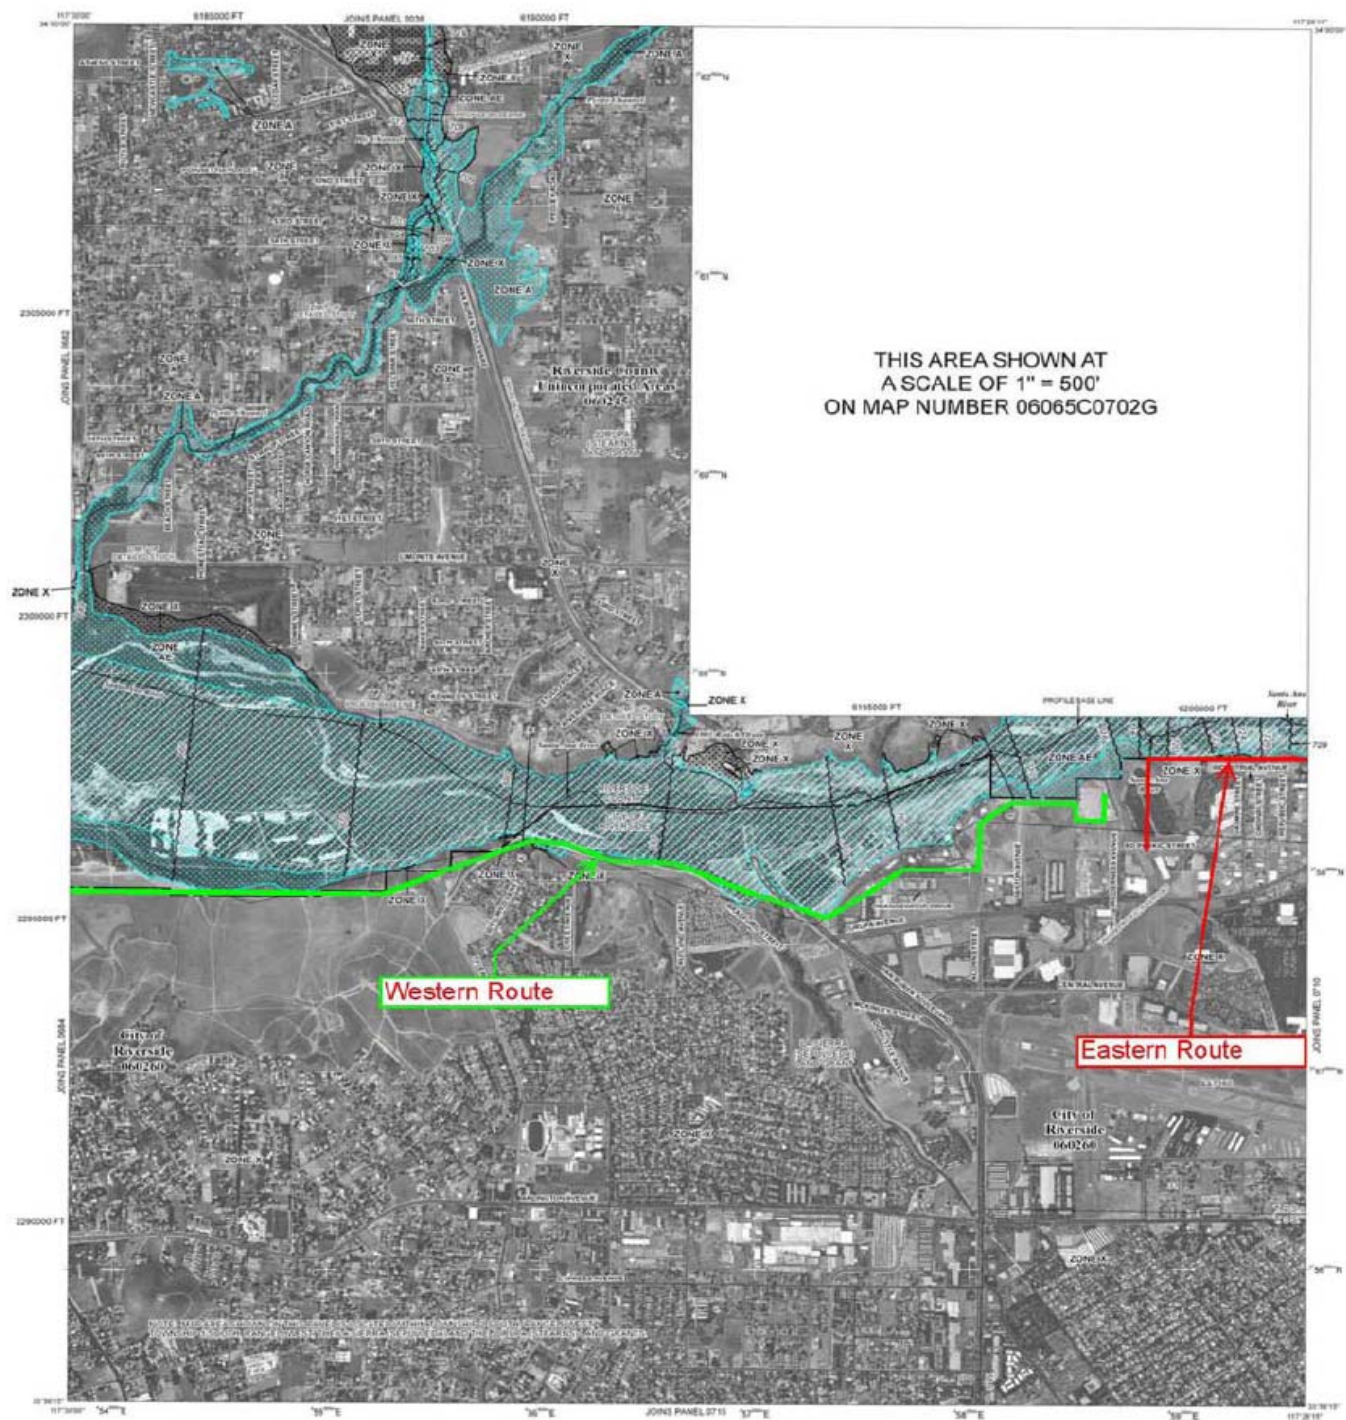
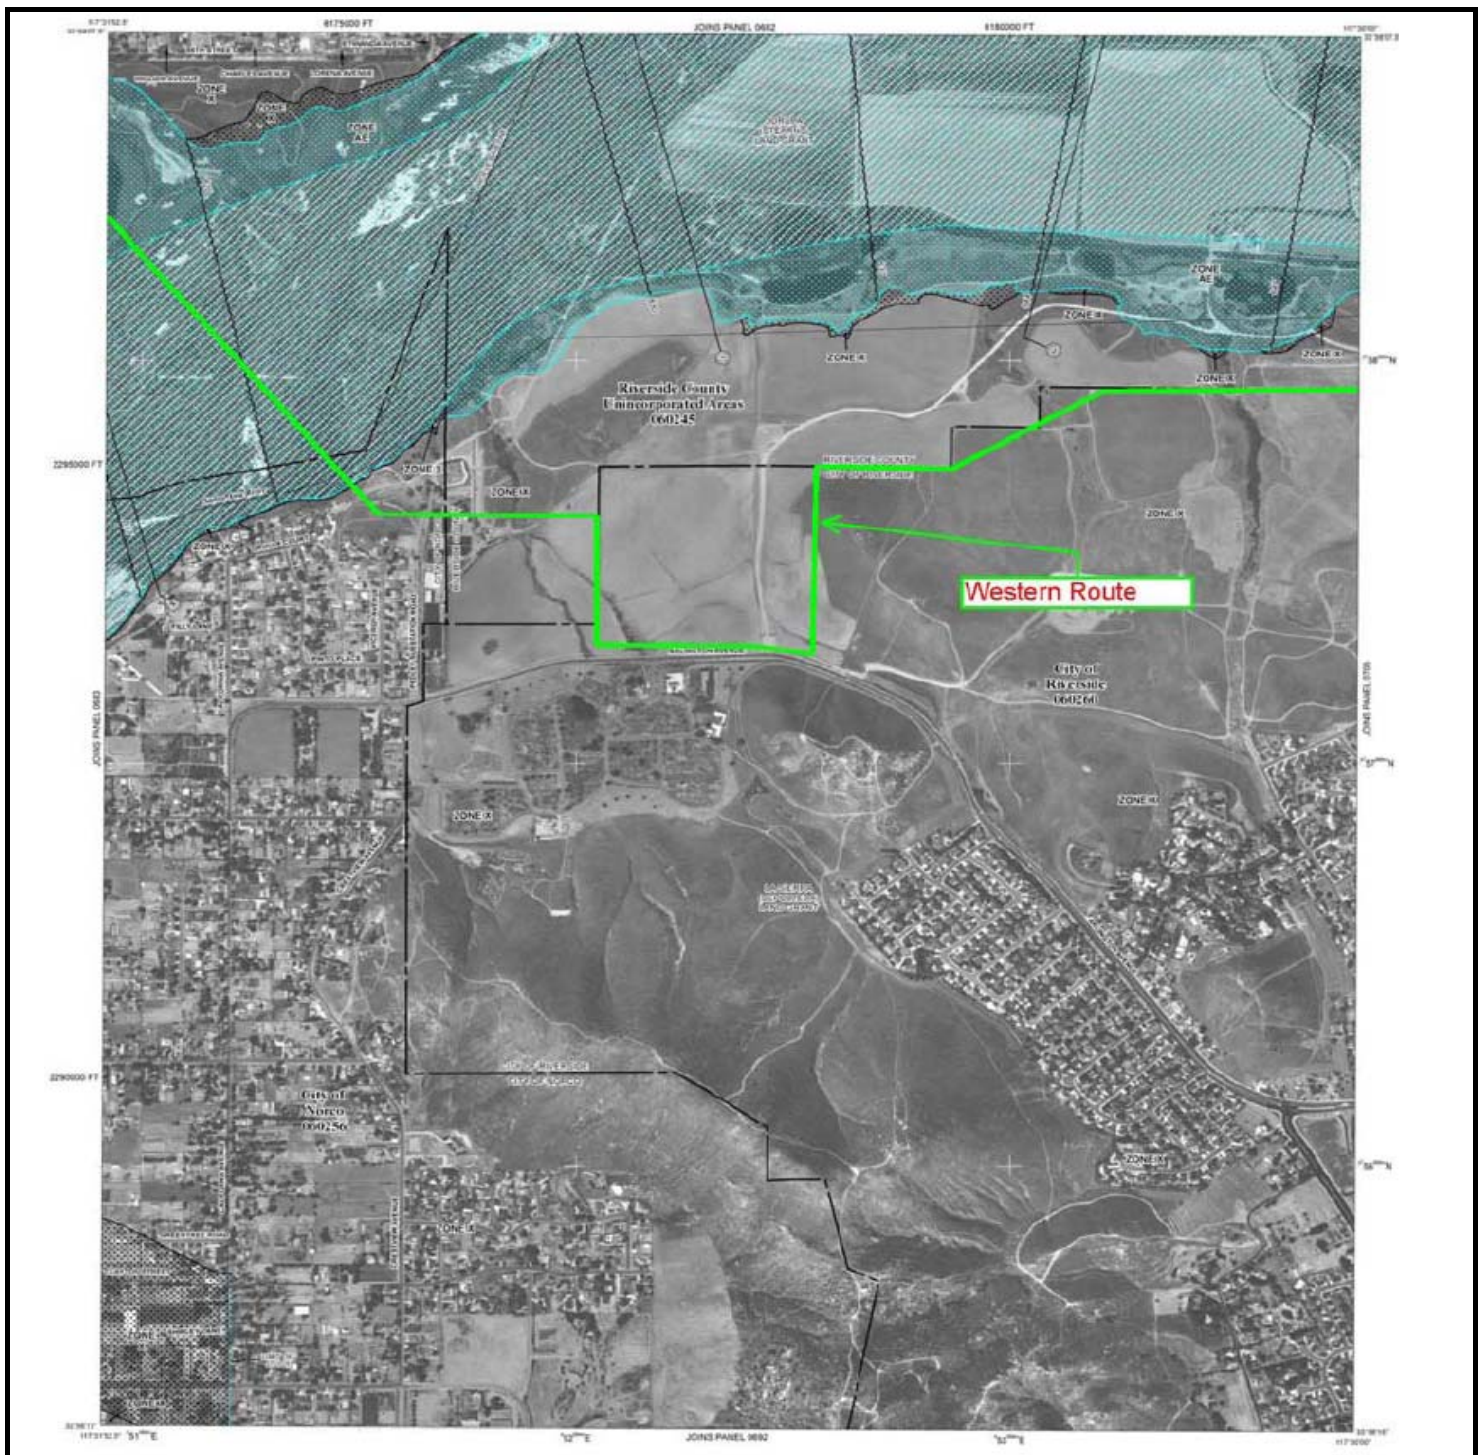
Based on the review of FEMA Maps on Figures (11-14), *FEMA Map Eastern and Western Routes*, the flood potential for each structure has been assessed. The two floodplain conditions for 100 and 500 years floodplain are considered during the study. The 100 years or the 500 years refers to the recurrence interval. Structures along the alignments occur in defined flood hazard zones as follows:

Although precise survey of the tower locations is not currently available, comparison of flood elevations indicated on FEMA maps with rough tower elevations determined using publicly available references suggest that flooding along the Eastern Alignment could occur to depths exceeding ten feet at some of the tower locations and that flood depths of five to six feet are likely to be quite common. An elevated access road design above the 100 year flood level may not be feasible due to potential instability during flood conditions. In addition, mitigation of these flood levels in a manner that would assure 24/7 access to tower locations during flood periods would require extensive modification of the floodplain to construct appropriate access roads and tower pads. Allowing vehicles and individuals on the road during flood conditions may be restricted due to safety concerns. Such extensive construction in a major floodplain would likely require permitting through numerous local state and federal agencies.

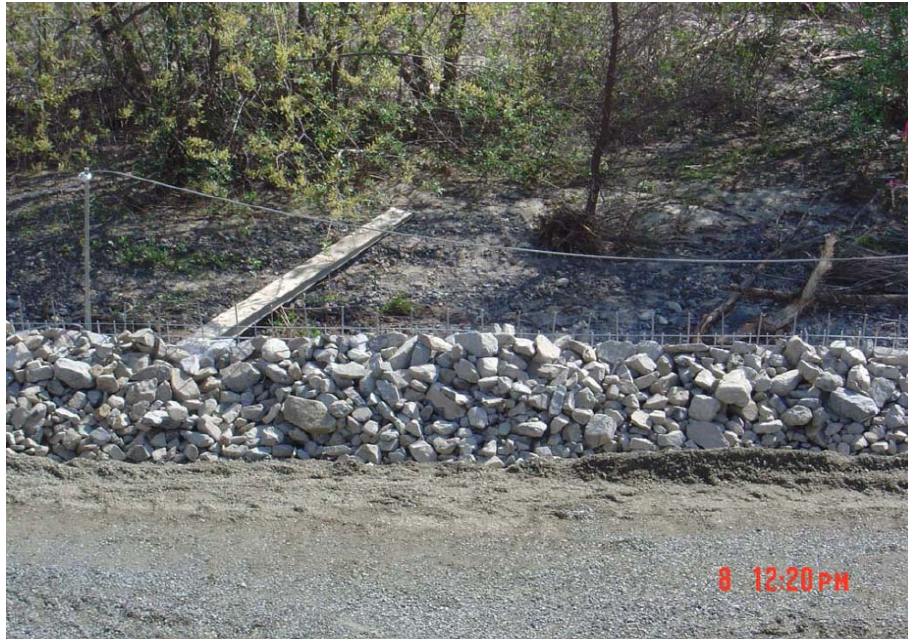
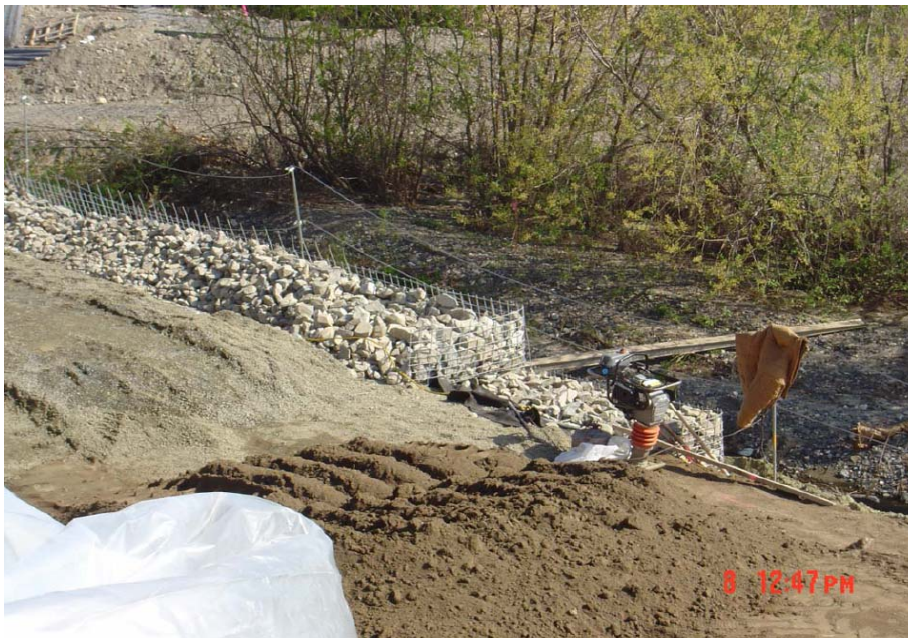
Erosion Repair

Access roads will also be under a high potential of erosion. An erosion control plan for construction sites may be required. The surface water from all sources must be conveyed off the roadway at frequent locations to control roadbed soil erosion. These roads will require routine erosion monitoring. The foundation of the structures located within the 100 year flood zone should be designed with additional scour that could be in range of 10 feet in addition to the design depth as shown in Figure (7), *Rip-Rap Erosion Protection System*. In general, risks associated with erosion might be mitigated using drainage control on building pads and along access routes. These mitigation measures can include berms and concrete swales to control normal surface runoff. Where structures will be located in areas subject to severe flooding, access routes and pads may require some combination of extensive rip-rap, shotcrete, hydro-seed and other measures to help protect the structures against serious undermining along with other damages, and to maintain appropriate access to the structures during flooding as shown in Figure (18), *Erosion Repair*.
