Pacific Gas & Electric Company's
Atlantic-Del Mar Reinforcement Project
Mitigation Monitoring, Compliance, and Reporting Program

Final Report

Prepared for:
California Public Utilities Commission

Prepared by:
Aspen Environmental Group

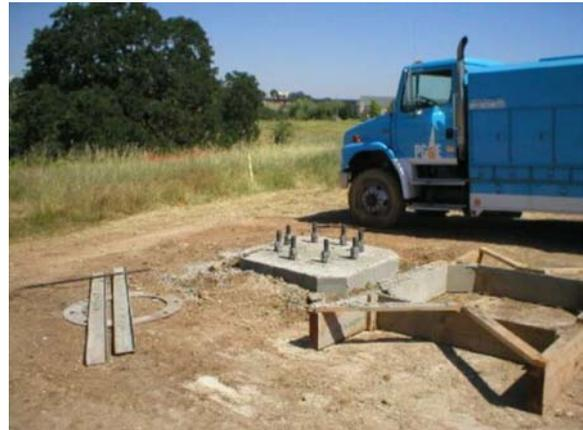
Figure 2-2. Completed foundation base at Pole #17

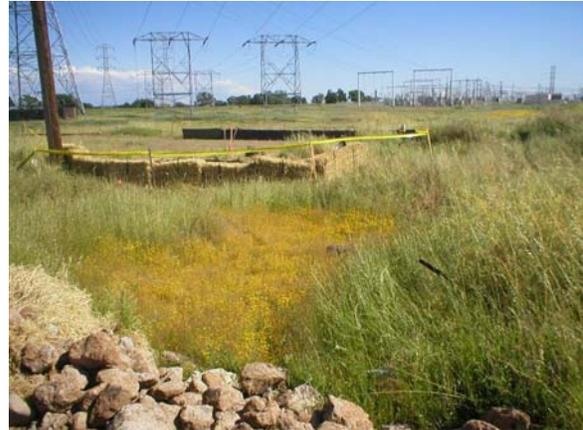
Figure 2-3. Vernal pool area (foreground) protected by installed erosion controls surrounding Pole #4

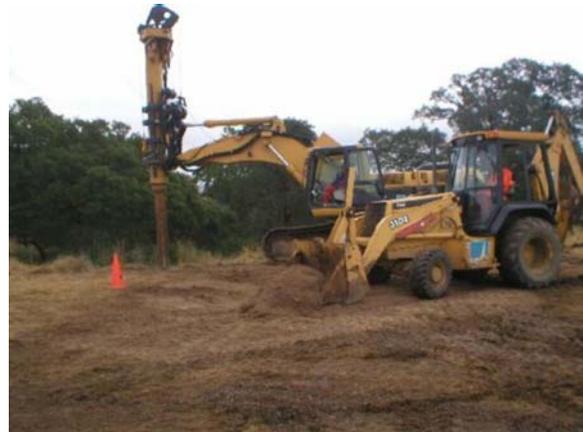
Figure 2-4. Auger of the foundation hole for Pole #20

In early June, crews augered the Pole #19 and #20 foundations (see Figure 2-4). Lots of rocks were encountered in the Pole #20 auger, which slowed progress. Existing access roads did not extend to the Pole #19 location. Variance Request #2 was submitted and ap-

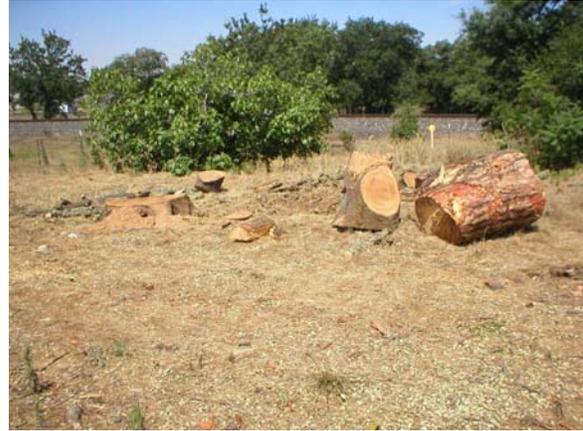
On June 22, the PG&E EI/biologist gave information that 22 large trees had been removed along the overhead segment by a PG&E contractor (the trees were slated for removal as part of the project plans and was required for conductor cable clearance). He stated that he had not been notified of the work due to a miscommunication by PG&E project management and thus he did not conduct pre-removal surveys or monitor the work (see Figure 2-5). Project Mitigation Measure B-3 states that “All tree removal activities shall occur between November 1 and February 15 to avoid avian breeding seasons . . . All trees within 250 feet of any construction shall be surveyed for active nests. If active raptor nests are found within 250 feet of tree removal

Figure 2-5. Post tree removal

. . . a construction free buffer of at least 250 feet around the nest shall be maintained.” The CPUC EM issued a Non-compliance Report (NCR) noting the out of season removals and lack of crew training, surveys and monitoring. The NCR also listed corrective measures which required that biological surveys be conducted immediately at all of the removal sites and site access areas, and that results be submitted to the CPUC and CDFG. On June 23 the PG&E EI provided that four additional trees needed to be removed prior to November 1 (as required by Mitigation Measure B-3). On June 28, Variance Request #3 was submitted requesting permission to conduct tree removals outside of the November 1 through February 15 window. Variance Request #3 was approved on July 7 and conditioned that CDFG must also approve the tree removals. PG&E submitted the NCR follow-up report July 17, and provided that no evidence of take of migratory birds or their nests had occurred. In addition, PG&E provided information that a raptor survey had been completed in March 2005, and no raptor nests had been identified at that time. The four additional trees slated for removal in the City of Roseville were removed. The EI conducted surveys immediately prior to removal and monitored the removal activities.

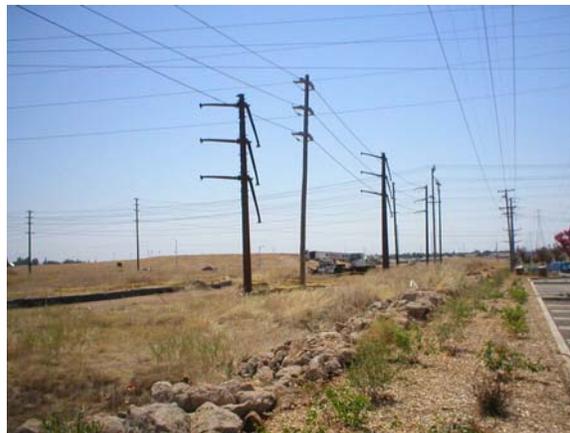
Figure 2-6. Pole installations north of the Atlantic Substation; the side arms were later erected just prior to stringing operations

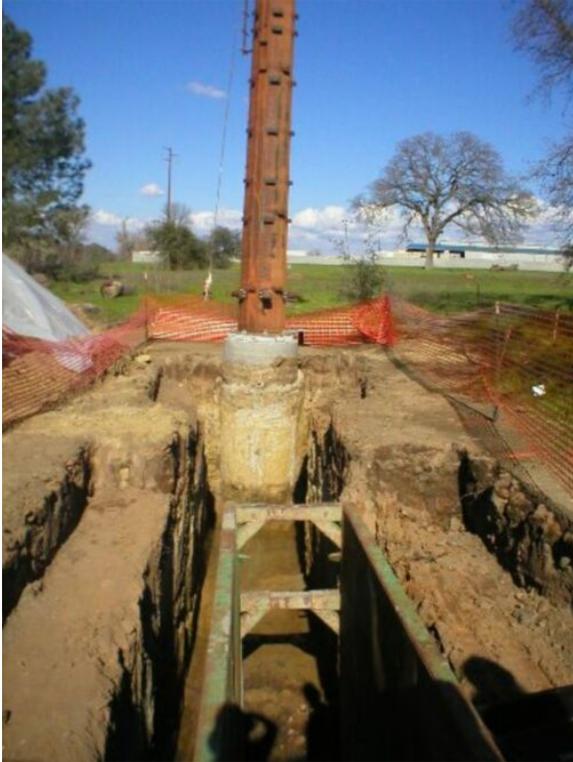
Figure 2-7. Foundation modification work at Transition Structure #9

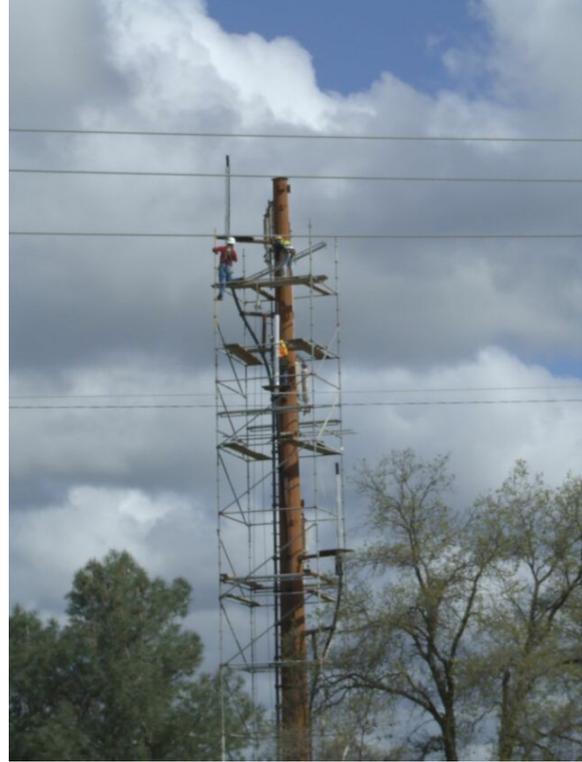
Figure 2-8. Transition Pole #10

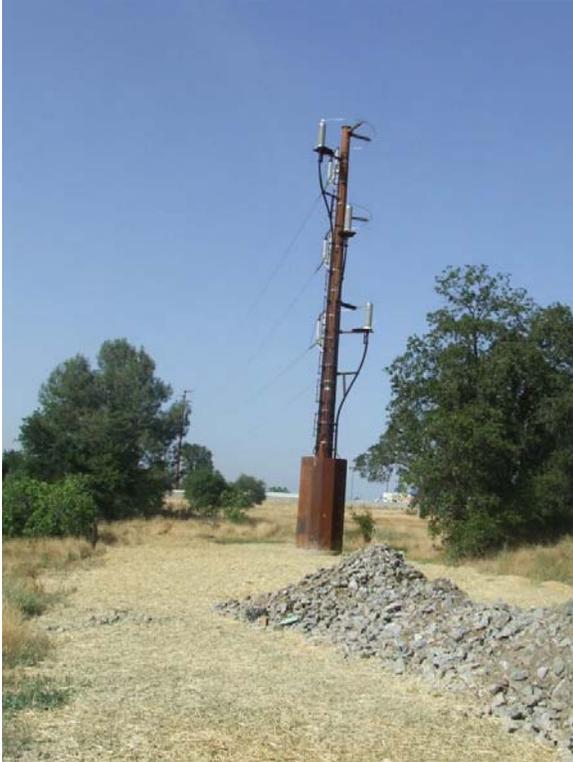
Figure 2-9. Completed Transition Pole #9

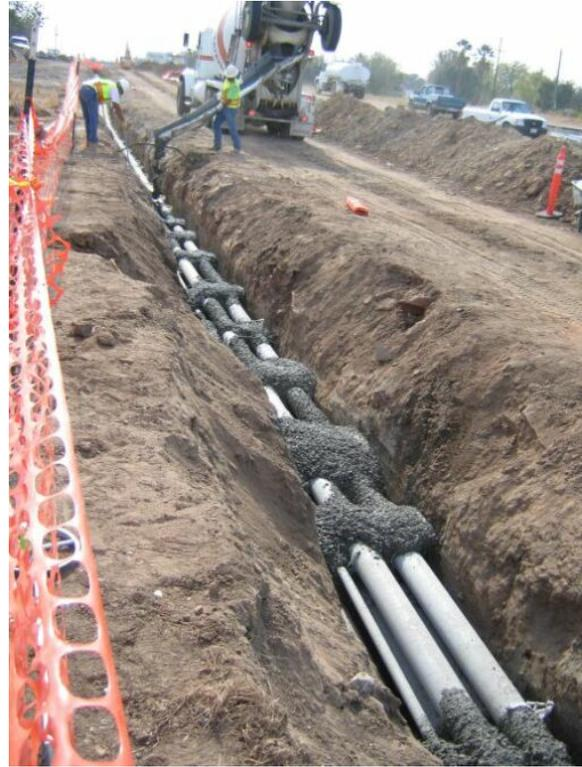
Figure 2-12. Thermal concrete pour over conduit installation north of Farron Road

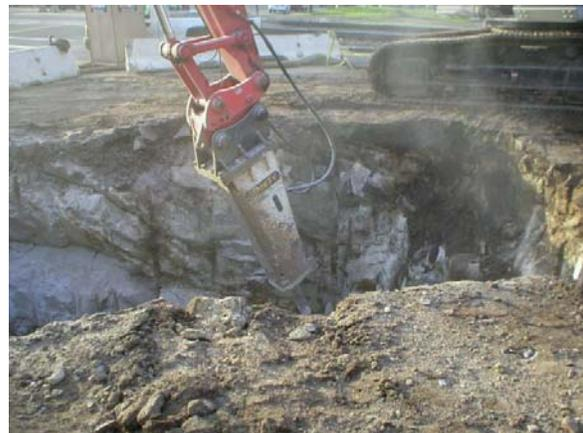
Figure 2-14. Rock hammering at Vault #3

process. The vault was set and backfilled in early January. Also in January crews used a rock hammer to break up granite along the trench north of the Vault #3 location along Railroad Avenue.

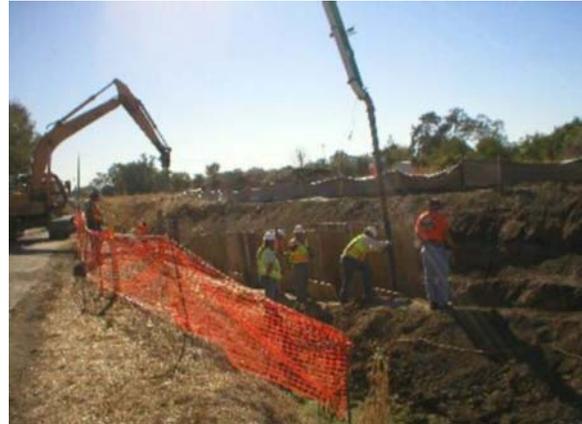
Figure 2-15. Concrete pour over the conduit installation within Drainage #30

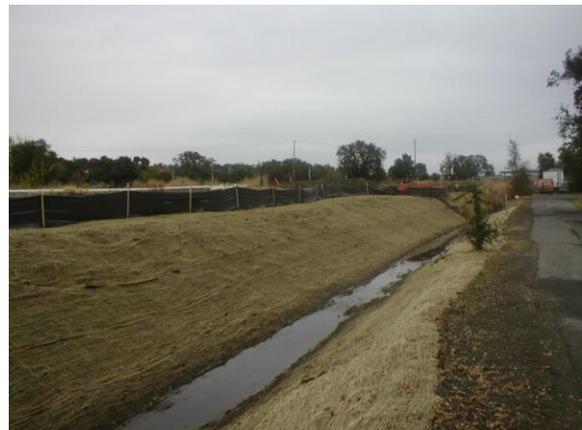
Figure 2-16. Drainage #30 restoration

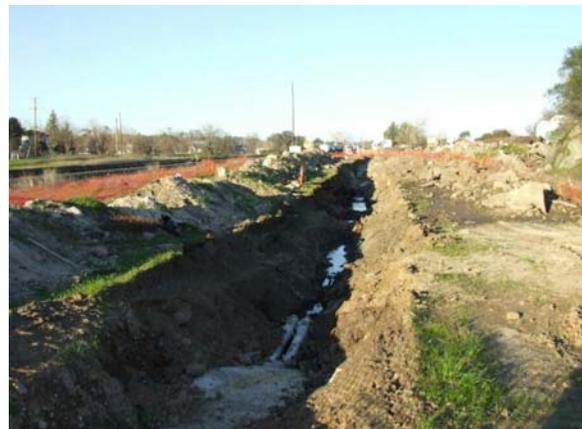
Figure 2-17. Excavation and conduit installation north of Rocklin Road

temporarily went on to work at other areas. In early February, north of Rocklin Road, crews again encountered unstable soils (see Figure 2-17). Wilson engineered plans to deal with the unstable soil conditions throughout the underground alignment. West of Rocklin Road and north of Farron Road, crews installed drainage rock to bridge the unsuitable ground/substrate. This method was used on the other unstable locations as well. Because of the substrate variability, throughout trenching operations, Kleinfelder tested the native spoils, and depending on the results, they were used for back-fill of the trench and compacted, or were taken off-site for disposal.

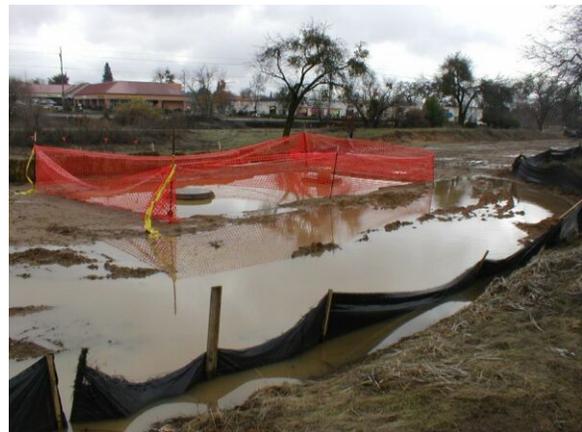
Figure 2-20. Stormwater inundation at Vault #2 location

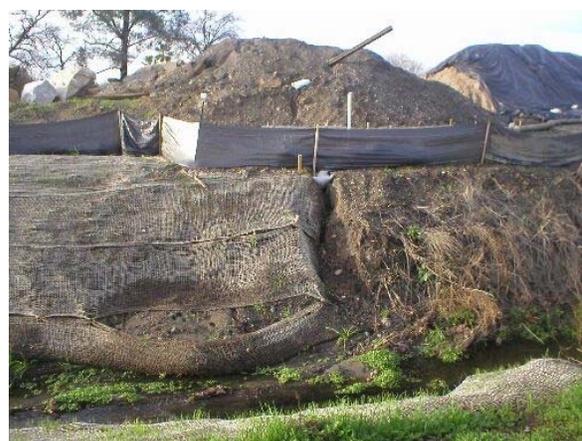
Maintenance of erosion controls became an ongoing issue. The PG&E EI had to repeatedly request that crews maintain the erosion controls throughout the project, including the existing erosion controls at Seasonal Drainage #37, #5, #6, #12, and #30 which needed repair due the excessive and

Figure 2-21. Drainage #30 stored spoils and bank erosion

persistent wind and rain. Due to the repeated complaints by the PG&E EI, as well as the CPUC EM notifications and write-ups, Wilson contracted a third-party erosion control specialist to maintain erosion controls throughout the underground project.

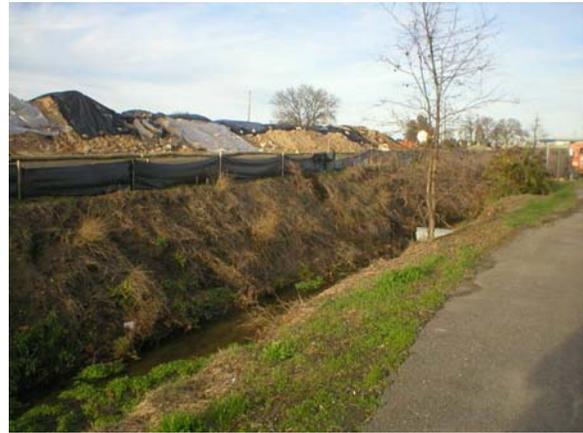
Figure 2-22. Spoils piles adjacent to Drainage #30

On January 6, 2006 a Project Memorandum was issued because large spoils piles were being stored in close proximity to Seasonal Drainage #30 without adequate erosion control measures, which was a violation of Applicant Proposed Measure 7-2. The erosion control along the drainage was in disrepair, which led to silt from the spoils piles being emptied into the CDFG drainage. Siltation entering the drainage is a violation of Condition #2 of the CDFG SAA. Because notification had not been made, the CPUC EM notified CDFG of the occurrence.

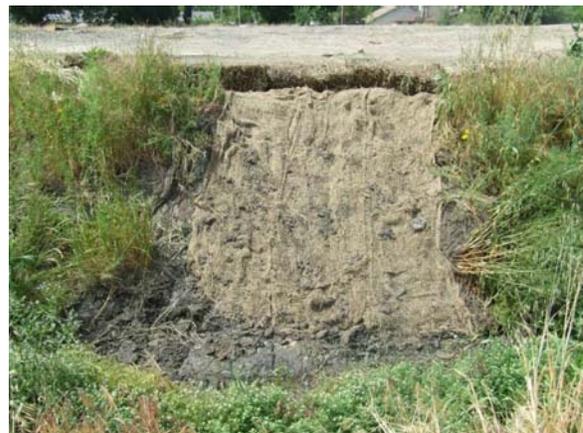
Due to the continuing rains throughout the winter and spring, a section of sediment fence installed to protect Drainage #30 was again undercut in late March 2006. This section was the same which had been impacted previously. The water flow cut parallel to the original erosion and caused additional damage to the bank. Wilson crews installed additional erosion control devices to repair the undercut section and attempted to direct water flow away from the location. The PG&E EI notified CDFG of the potential impacts. Additional repairs were made to Drainage #30 after April 15, when heavy equipment was allowed back in the area. The contractor carefully removed soil from the low section of the bank and placed it in the eroded area and compacted it. A seed mix was dispersed and jute netting was re-installed (see Figure 2-24). Straw bales were placed at the top of the bank.

Figure 2-24. Final repair of Drainage #30

Repairs were made to Drainage #30 (after April 15 heavy equipment was allowed back in the area.) The contractor carefully removed soil from the low section of the bank and placed it in the eroded area and then compacted it. A seed mix was dispersed and jute netting was re-installed. Straw bales were placed at the top of the bank.

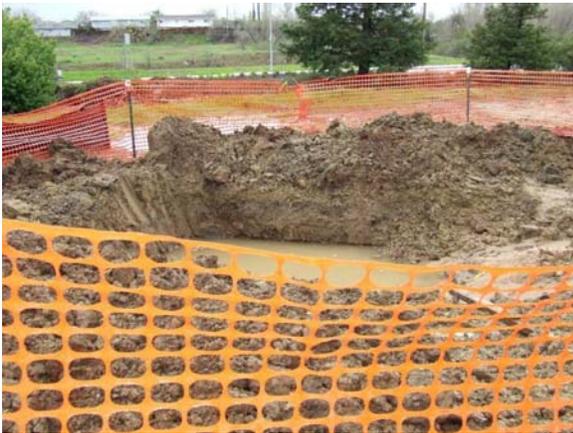
Figure 2-25. Detention pit used for dewatering

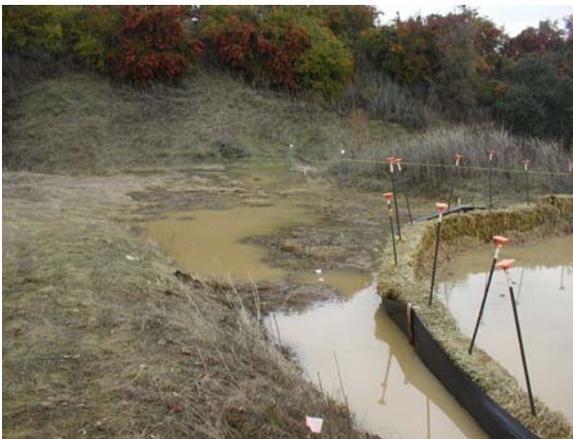
In early April 2006, tie-in work occurred at Transition Poles #9 and #10. Cable work continued at Vaults #1 through #4. On April 6, the CPUC EM notified crews that sediment was breaching the installed erosion controls around Wetland #2 (see Figure 2-27). Crews spread straw, filter fabric was laid out, and additional hay bales were added which remedied the problem of sediment-laden water entering the sensitive area.

Figure 2-27. Sediment-laden runoff into Wetland #2

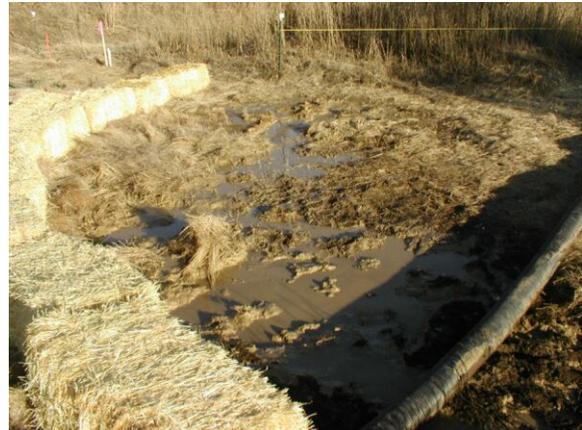
The PG&E EI held a tailgate meeting outlining allowable work hours and conditions of the Frac-out Contingency Plan. Boring operations commenced November 18, 2005 (see Figure 2-28). A continual frac-out occurred into Wetland #2. The frac-out was isolated with hay bales, a vac-truck arrived at the site, and the bentonite was removed from the wetland area (see Figure 2-29). On November 19, a second frac-out occurred 100 feet off the centerline into Wetland #3. The drilling mud rose to the surface and was immediately removed. Impacts to Wetland #3 were not covered by the Army Corps permits. Per Essex, both the Army Corps of Engineers and the CDFG were notified of the frac-outs into the resource areas. A retroactive permit was obtained from the Army Corps of Engineers concerning Wetland #3. Essex also filed an incident report.

Figure 2-29. Frac-out into Wetland #2

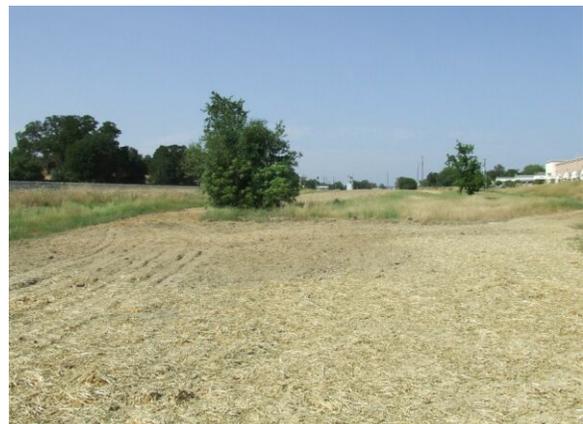
Figure 2-32. Restored area along the underground alignment

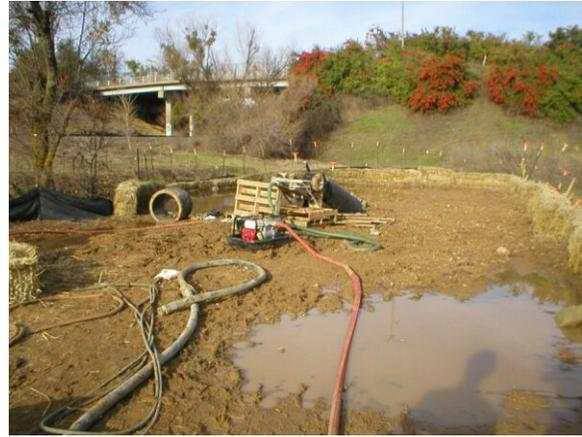
In preparation for tie-ins to the bore segment, on January 5, the CPUC EM found that Zayas (not the bore contactor) was pumping infiltrated water from the installed HDPE pipe and dewatering into Wetland #2 without proper testing. The violation was noted in a Project Memorandum issued January 6. Notifications to the Army Corps of Engineers were required. A Baker tank was subsequently brought to the site for dewatering.

On January 5, the CPUC EM found that Zayas crews were pumping infiltrated water from the installed HDPE pipe and dewatering into Wetland #2 without proper testing (see Figure 2-33). The violation was noted in a Project Memorandum issued January 6. Notifications to the Army Corps of Engineers had not been made and were required by the Memorandum.

Figure 2-33. Dewatering the bore pipe into Wetland #2
