PROJECT MEMORANDUM PG&E ATLANTIC-DEL MAR REINFORCEMENT PROJECT

To: Jensen Uchida, CPUC
From: Vida Strong, Aspen Project Manager
Date: May 24, 2005
Subject: Weekly Report #5: May 15, 2005 – May 21, 2005
CPUC Environmental Monitor (EM): Anne Sweet

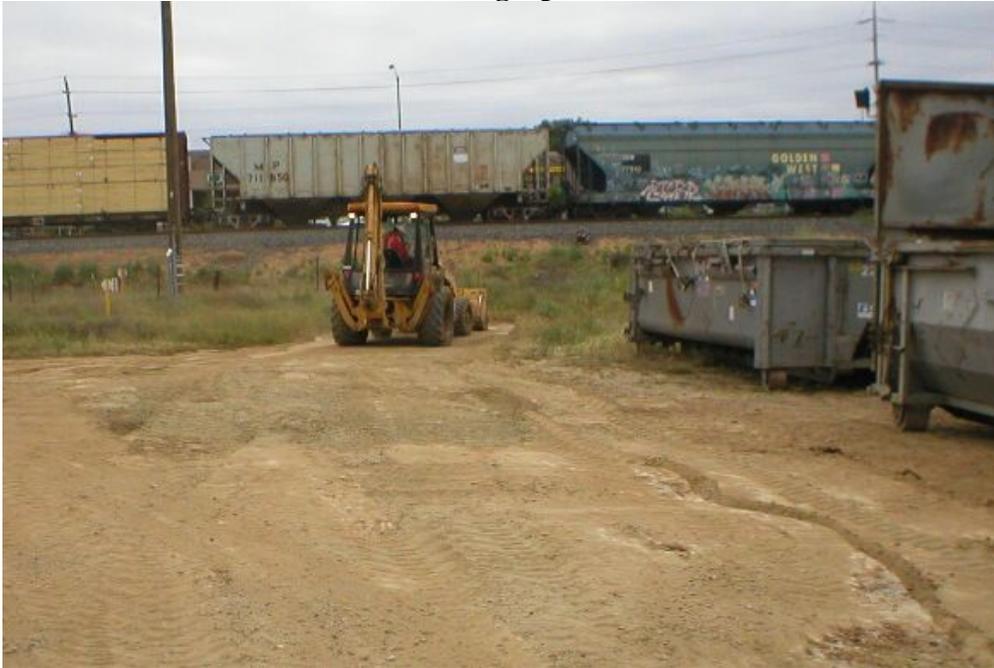
The access road near the Pole 2/16 location goes over a culvert which on May 12, the crew Foreman said would be crushed by passing heavy equipment. However it was decided to bridge/reinforce the area over the culvert to allow travel. The CPUC EM confirmed that clean gravel could be brought in to stabilize and level the area in order to lay down steel plates. However, on May 17, the CPUC EM found that a crewman was scraping and grading over the drainage with a backhoe in order to fill in depressions and level the area (see Figure 1). No erosion controls had been installed to protect the drainage. The EM called the PG&E EI and informed him of the problem. He said that he was unaware of what the crewman

On May 17th, the CPUC EM toured the access road drainage area near Pole 2/16. It was noted that the area had been graded and that no erosion controls were installed around the resource. The PG&E EI was notified and had the problem corrected by the end of the day.

Figure 1 – Grading over the access road drainage near Pole 2/16, May 17, 2005.

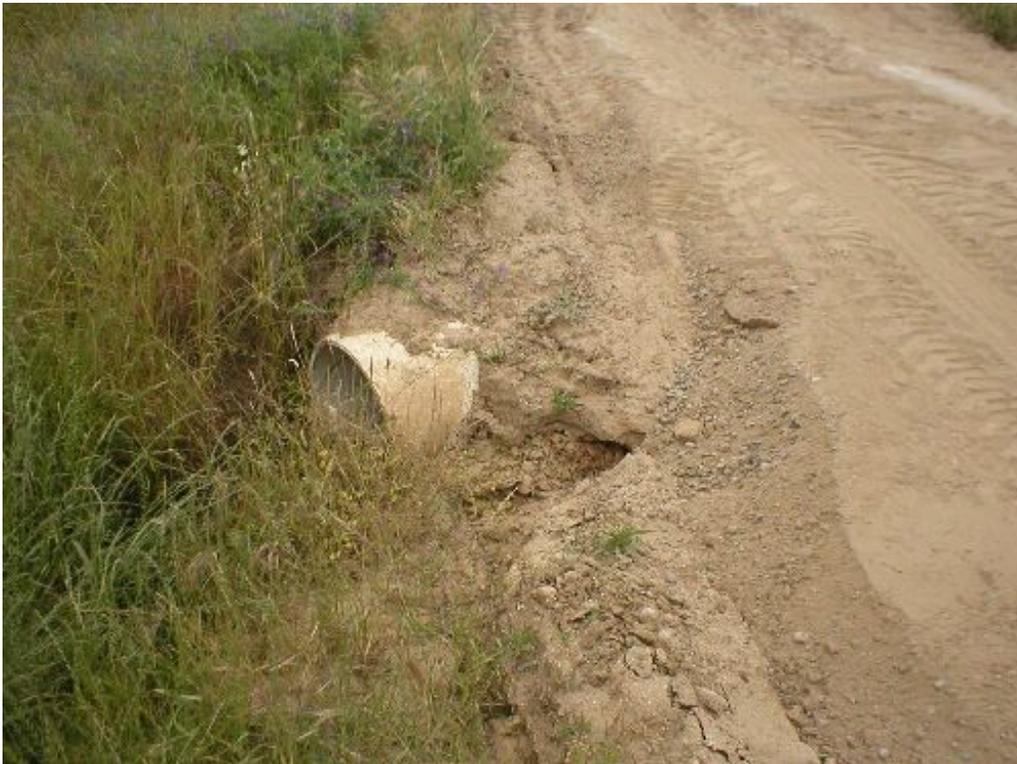
was doing and that he would correct the problem. The scraping had created lots of fine sediment and dirt that could run down into the drainage, which is a tributary to Antelope Creek; however, it did not appear that any dirt had impacted the unprotected drainage (see Figure 2). A large pile of gravel was next to the location and rain was forecast to occur over the next few days. The PG&E EI arrived on-site and told the crew Foreman that all of the non-compacted dirt had to be removed and replaced with gravel. He also informed the Foreman that erosion controls need to be installed. By 6:00 pm that day the crew had completely removed the loose dirt and replaced it with gravel. Straw wattles had been staked into the side of the drainage to protect it from erosion (see Figure 3).

Figure 2 – Fine dirt created after grading over the access road drainage near Pole 2/16, May 17, 2005.

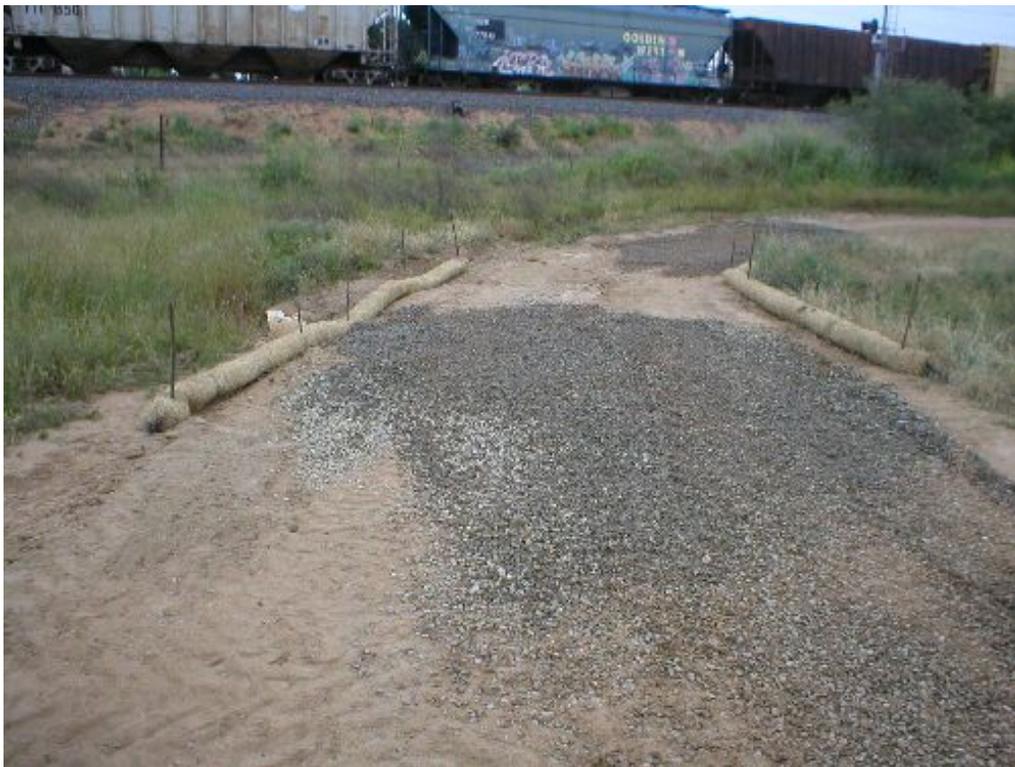
Figure 3 – Photo after the fine dirt had been removed and replaced with clean gravel over the access road drainage near Pole 2/16, May 17, 2005.

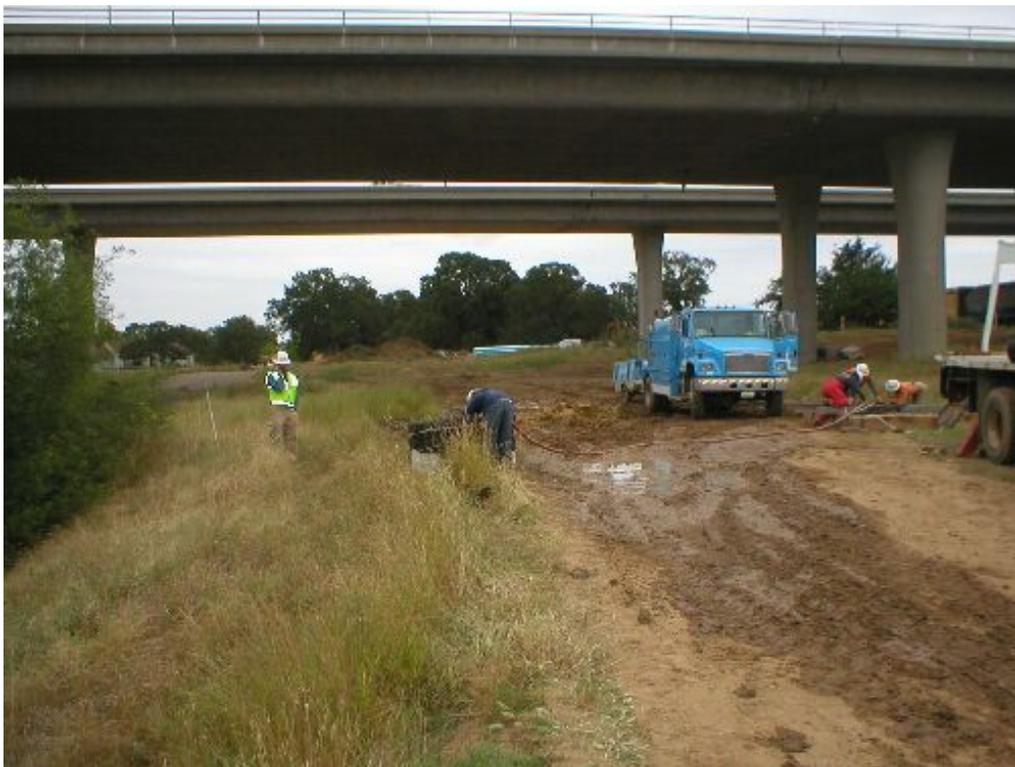
On May 17, Pole 2/15 just south of Highway 65 was toured. There exists a vernal pool area east of the location. The PG&E EI had previously installed flagging and the protective sediment fencing and hay bales as outlined in the USFWS Letter of No Effect. The PG&E EI and the PG&E crew were on-site and were dealing with groundwater intrusion in the Pole 2/15 foundation hole. The hole had filled with water and the crews were connecting a hose and pump in order to pump the water out. The CPUC EM had asked the PG&E EI if PG&E had a groundwater discharge permit or had consulted with RWQCB prior to the discharge. The PG&E EI was unable to produce a groundwater discharge permit, but pointed to a line within the storm water discharge permit which talked about "other discharges". The discharge proceeded into a filter fabric lined area which ran down into a drainage area along a building complex (see Figures 4 and 5). The CPUC EM inspected the water and it looked clear and did not have a noticeable odor; however, the CPUC EM expressed concern because the pole foundation hole lies within 50 feet of an underground Kinder Morgan Pipeline. The CPUC EM contacted the Regional Water Quality Control Board (RWQCB) Office and left an inquiry message with a RWQCB representative. Later that day the crew had created a bermed ditch on the 100-ft by 100-ft pole area and had discharged the remaining ground water into it (see Figure 6). Concrete was poured into the foundation hole and the concrete truck washed out into the ditch. The CPUC EM looked at a vegetated area to the east of the pole and found standing water (see Figure 7). The CPUC EM had asked the Foreman about the water and he had said that they had moved some of the water off the access road to the vegetated area. The water came within 12-15 feet of the edge of the sediment fence, which protects the vernal pool area; however, it appeared that flow in that direction had stopped and would not impact the pool.

Figure 4 – Dewatering groundwater from the Pole 2/15 foundation hole, May 17, 2005.

On May 17th, the CPUC EM toured the Pole 2/15 area and noticed groundwater dewatering activities into drainage alongside a building complex. The crew later created a bermed ditch for dewatering purposes.

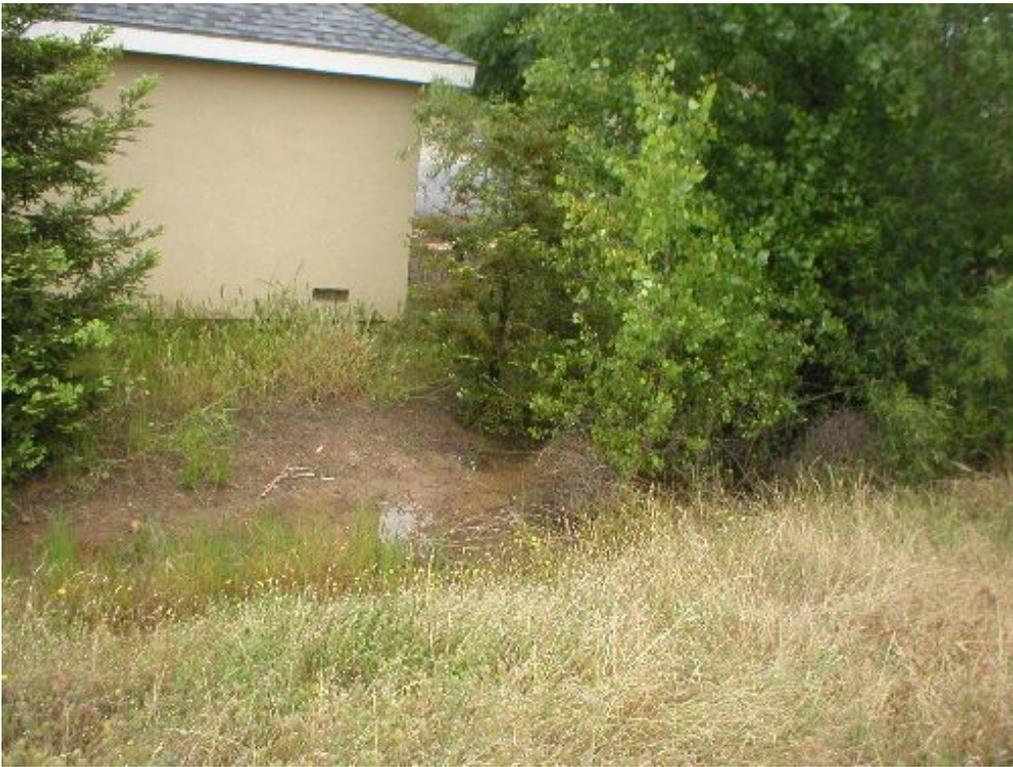
Figure 5 – Area where groundwater from the Pole 2/15 foundation hole was directed, May 17, 2005.

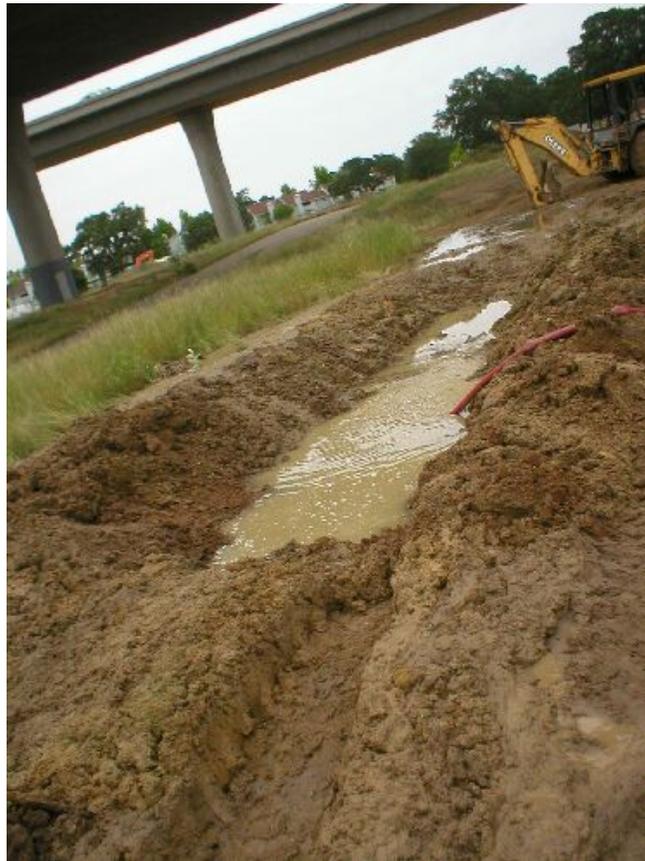
Figure 6 – Dewatering ditch created to contain groundwater from the Pole 2/15 foundation hole, May 17, 2005.

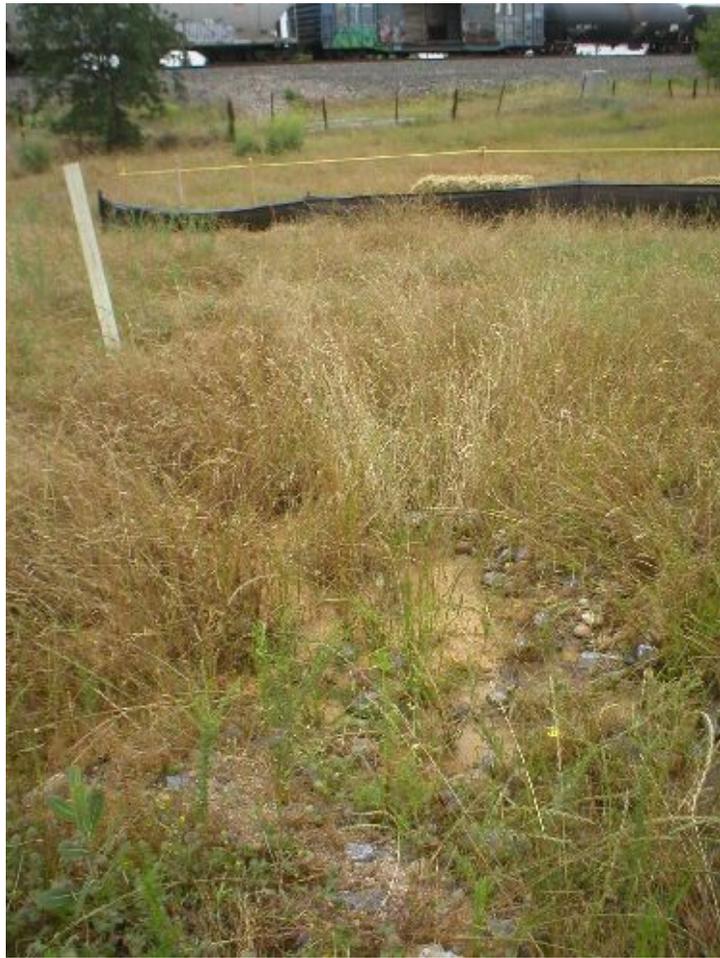
Figure 7 – Water discovered near the Pole 2/15 foundation hole, May 17, 2005.
