PROJECT MEMORANDUM PG&E ATLANTIC-DEL MAR REINFORCEMENT PROJECT

To: Jensen Uchida, CPUC
From: Vida Strong, Aspen Project Manager
Date: February 17, 2006
Subject: Weekly Report #43: February 5, 2006 – February 11, 2006
CPUC Environmental Monitor (EM): Heather Stiles

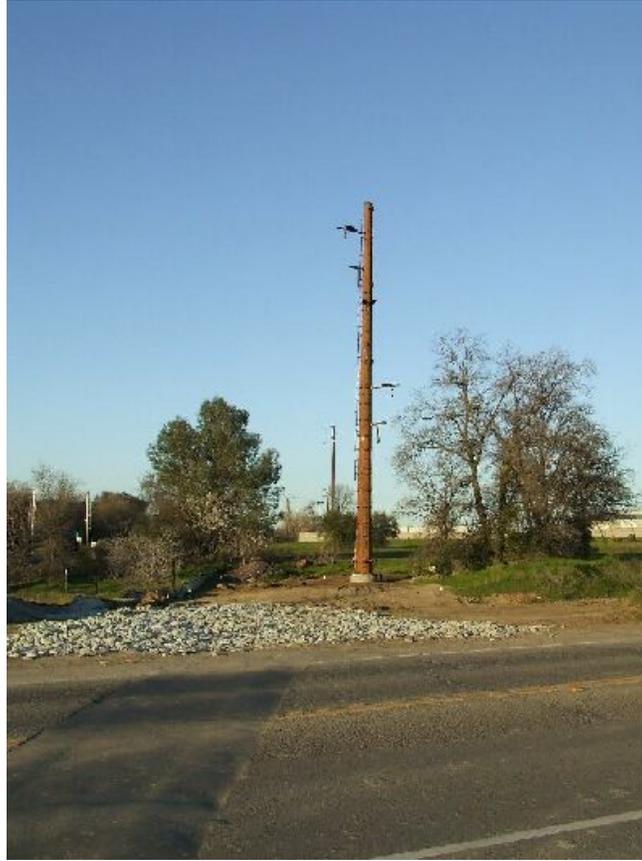
Figure 1 – Transition Pole #9 north of Midas Road, February 10, 2006.

All overhead construction including pole, foundation, and line stringing work is being done by PG&E. The only remaining pole areas where work needs to be completed are Transition Poles #9 and #10. The foundation for Transition Pole #10 was modified to accommodate the hardware design requirements and the transition pole was erected. The overhead line now connects Transition Pole #10 all the way through to Pole #24 at the Atlantic Substation. The Transition Structure #9 Pole was erected during the subject week (see Figure 1).

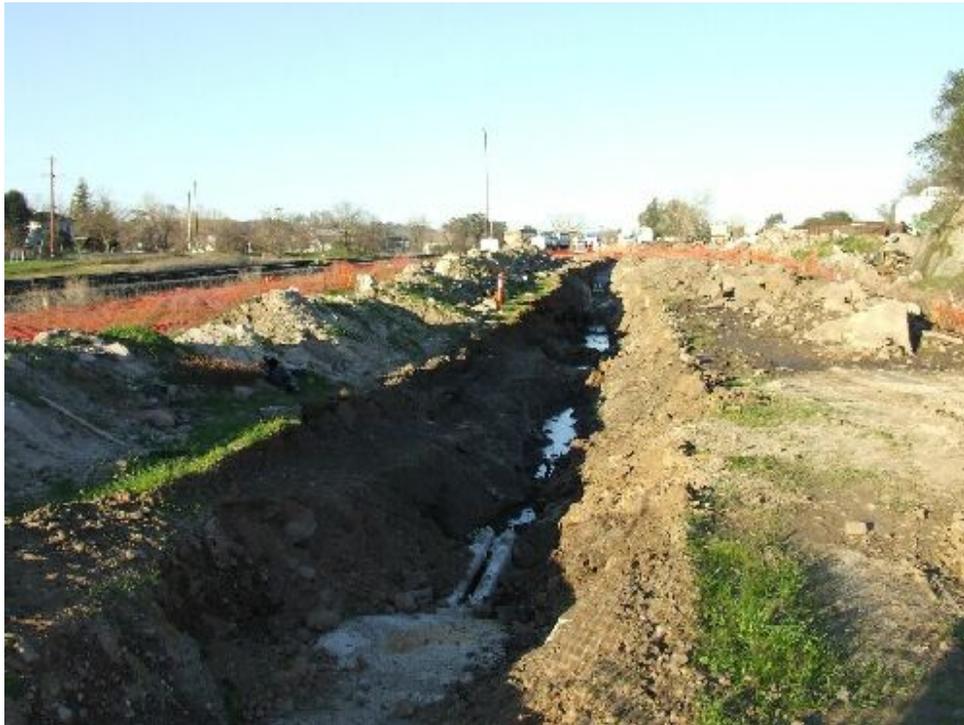
Figure 2 – Excavation north of Rocklin Road, February 10, 2006.

Zayas Construction completed the excavation of the trench line from Vault #3 through Rocklin Road. The crew hand-dug around all existing utilities throughout the street and placed steel plates over the trench at the end of each workday. Storm water continues to fill the trench. Crews have been discharging storm water through a filter bag to overland areas devoid of resources. Conduit installation has not been completed within the trench, but should be by the end of next week. Just north of Rocklin Road, during trenching crews encountered problematic soils which showed a lack of stability in terms of being able to support the underground line (see Figure 2). Wilson is currently engineering plans to deal with the soil conditions. Meanwhile construction crews have moved to other areas of the project. Orange safety fencing has been placed around the trench.
