PROJECT MEMORANDUM PG&E ATLANTIC-DEL MAR REINFORCEMENT PROJECT

To: Jensen Uchida, CPUC
From: Vida Strong, Aspen Project Manager
Date: February 24, 2006
Subject: Weekly Report #44: February 12-18, 2006
CPUC Environmental Monitor (EM): Heather Stiles and Anne Sweet Coronado

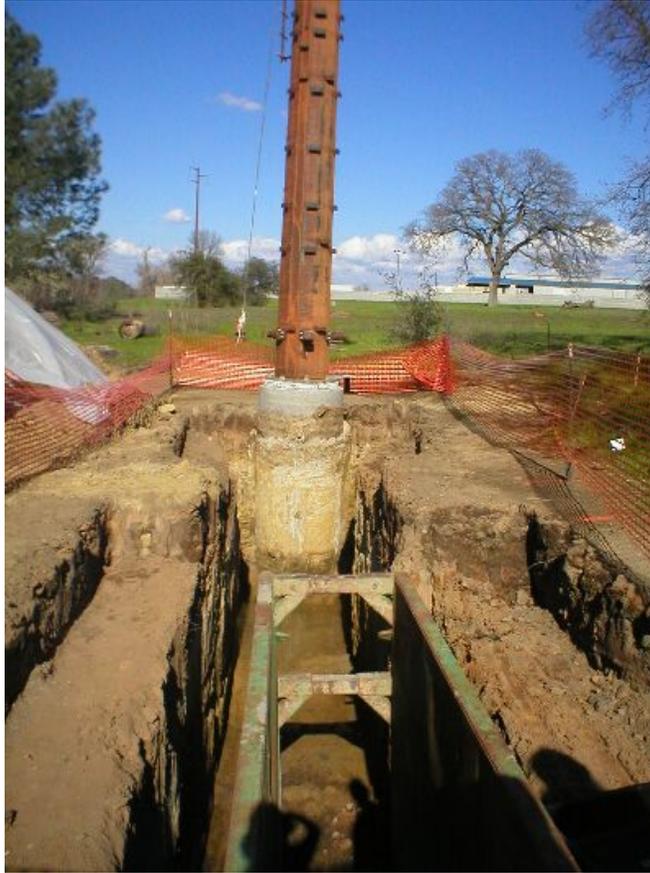
Crews have completed the trench excavation from Vault 4 to Transition Structure #9. PVC conduit installation is scheduled for next week.

Figure 1 – Tie-in to Transition Structure #9, February 16, 2006.

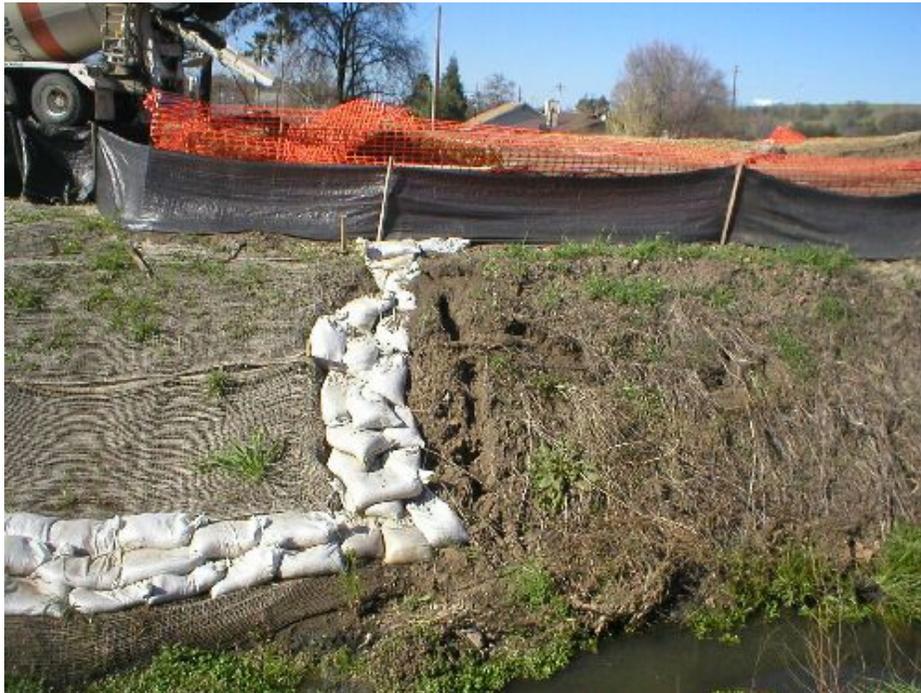
On Wednesday, February 15, Zayas commenced the trench line tie-in operations from Vault 4 to the area directly adjacent to the Drainage #30 bank. Crews used extreme caution and care excavating slowly and hand digging some portions. After the PVC conduit tie-ins, thermal concrete and later top slurry were poured one foot at a time as to not overwhelm the fragile bank (see Figures 2 and 3). No damage to the bank or drainage occurred throughout these operations. Top soil will be placed over the installation on a future date.

Figure 2 – Drainage #30 adjacent to the trenching operations, February 16, 2006.

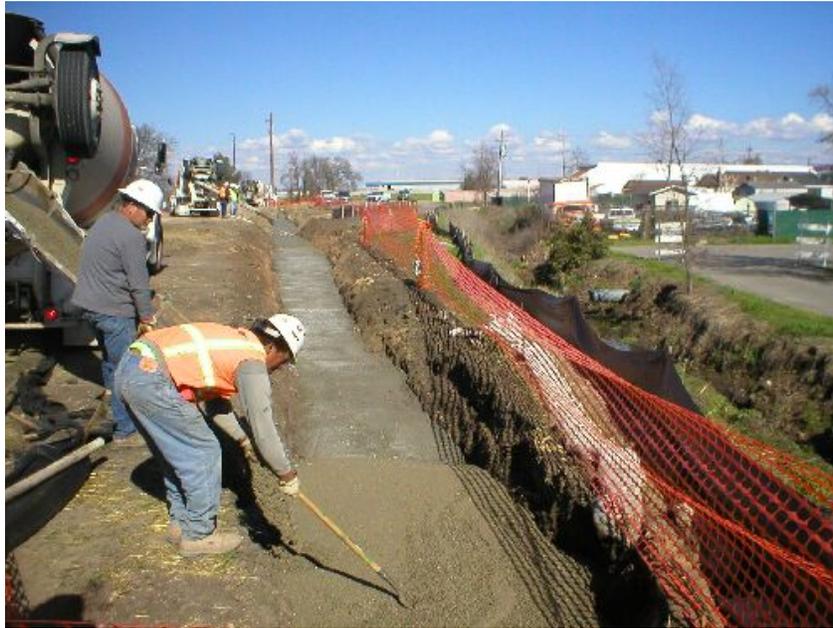
Figure 3 – Thermal concrete pour adjacent to Drainage #30, February 16, 2006.

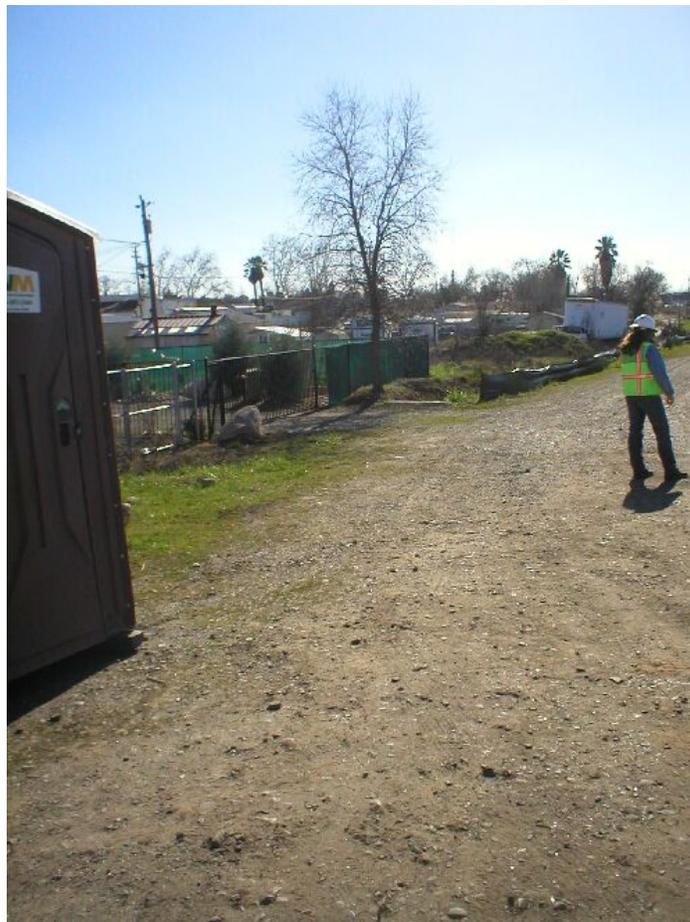
During the tour on February 16, the CPUC EM noticed that portable restroom facilities had been placed upslope and within approximately 50 feet of an inlet to Drainage #30 (see Figure 4). The PG&E EI was informed that this posed a potential spill issue. The City of Rocklin Inspector was also on-site and expressed similar concerns. The PG&E EI informed the PG&E Inspector that the facility needed to be moved or that secondary containment must be placed around the unit.

During the tour on February 16, the CPUC EM noticed that portable restroom facilities had been placed upslope and within approximately 50 feet of an inlet to Drainage #30. The PG&E EI was informed that this posed a potential spill issue. The City of Rocklin Inspector was also on-site and expressed similar concerns. The PG&E EI informed that PG&E Inspector that the facility needed to be moved or that secondary containment must be placed around the unit.

Figure 4 – Portable restroom facilities upslope of Drainage #30, February 16, 2006.
