PROJECT MEMORANDUM PG&E ATLANTIC-DEL MAR REINFORCEMENT PROJECT

To: Jensen Uchida, CPUC
From: Vida Strong, Aspen Project Manager
Date: March 24, 2006
Subject: Weekly Report #48: March 12, 2006 – March 18, 2006
CPUC Environmental Monitor (EM): Heather Stiles

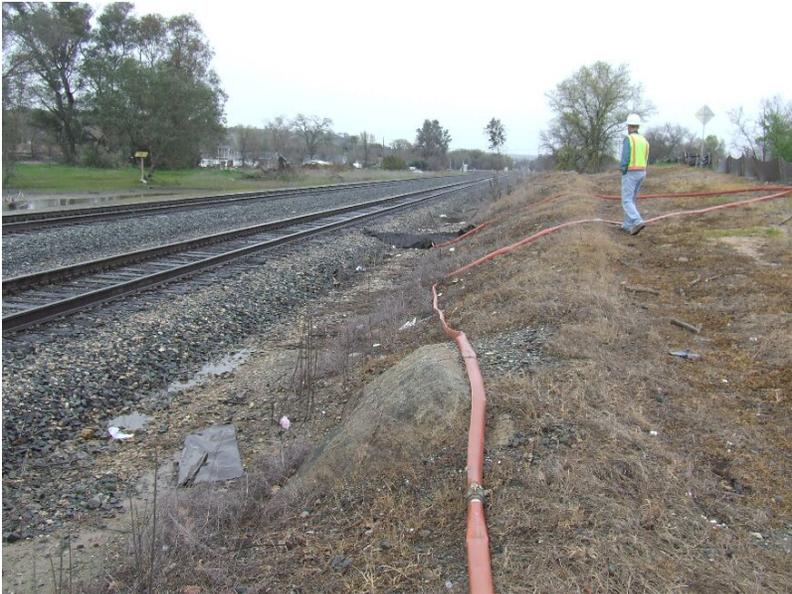
Wilson Construction continued to dewater from Vaults 1, 2, 3, and 4. As noted in previous reports, crews have left dewatering devices in place at each of the vaults to help ensure that the correct dewatering procedures are followed. At each site, hoses extend from the dewatering pumps at the vaults to a suitable area of flat, stable ground, devoid of sensitive resources (see Figure 1). A sediment bag is attached to the outlet of the hoses.

Figure 1 – Dewatering near Vault #2, March 16, 2006.

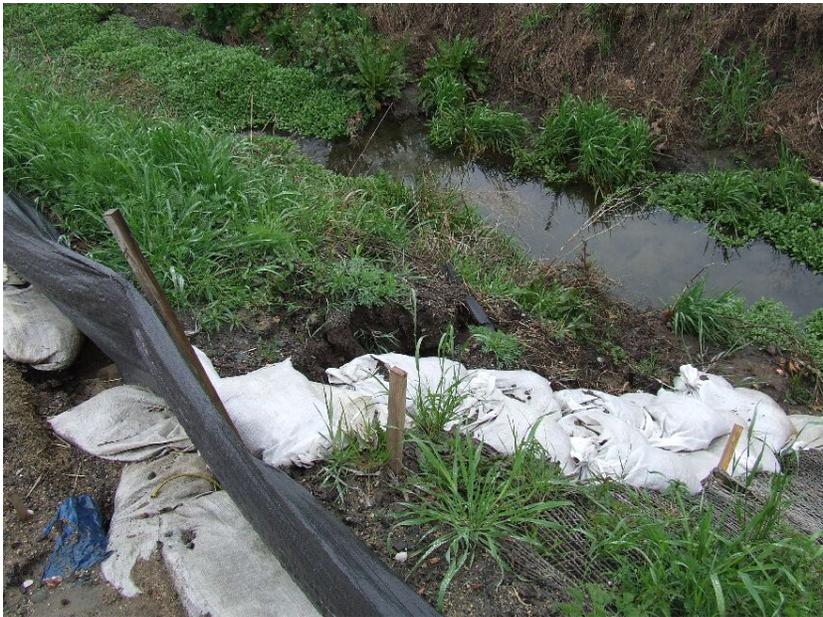
A section of silt fence at Drainage #30 was undercut by water flow during a storm event on Tuesday. This section was previously breached in December, which caused erosion on the bank of the drainage. After the initial problem, Wilson's crews had installed sandbags on the bank to prevent further erosion. This remedy had been working until Tuesday, when the water undercut the fence in nearly the same location (slope of the terrain directs water to this location). The water flow cut parallel to the original erosion and caused additional damage to the bank (see Figures 2 and 3). Wilson crews installed additional erosion control devices to repair the undercut section and attempted to direct water flow away from this location. The CPUC EM reminded the PG&E EI of the sensitive nature of Drainage # 30 and the importance of finding a solution that would prevent degradation to the resource.

Figure 2 – Bank of Drainage #30, March 16, 2006.

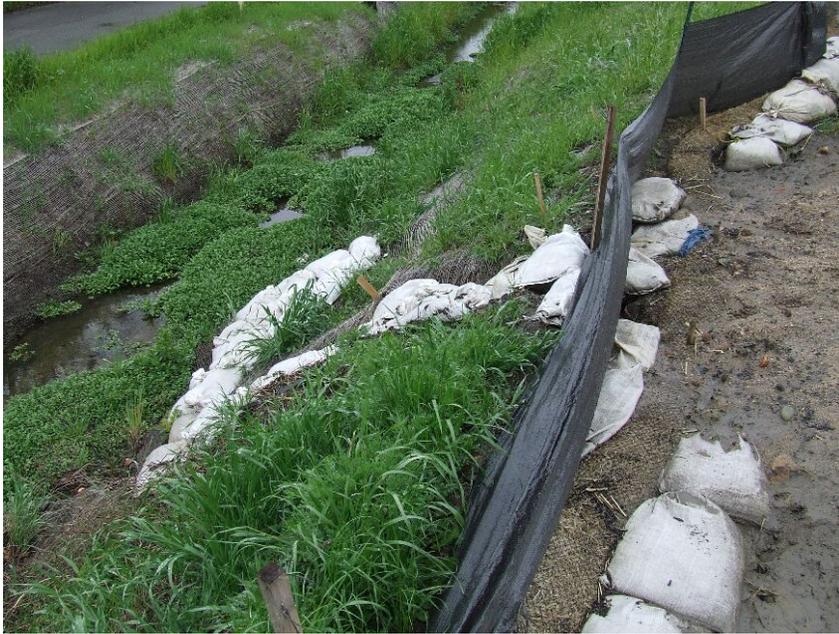
Figure 3 – Alternate view of the damage to the bank of Drainage #30, March 16, 2006.
