PROJECT MEMORANDUM PG&E ATLANTIC-DEL MAR REINFORCEMENT PROJECT

To: Jensen Uchida, CPUC
From: Vida Strong, Aspen Project Manager
Date: April 5, 2006
Subject: Weekly Report #50: March 26, 2006 – April 1, 2006
CPUC Environmental Monitor (EM): Heather Stiles

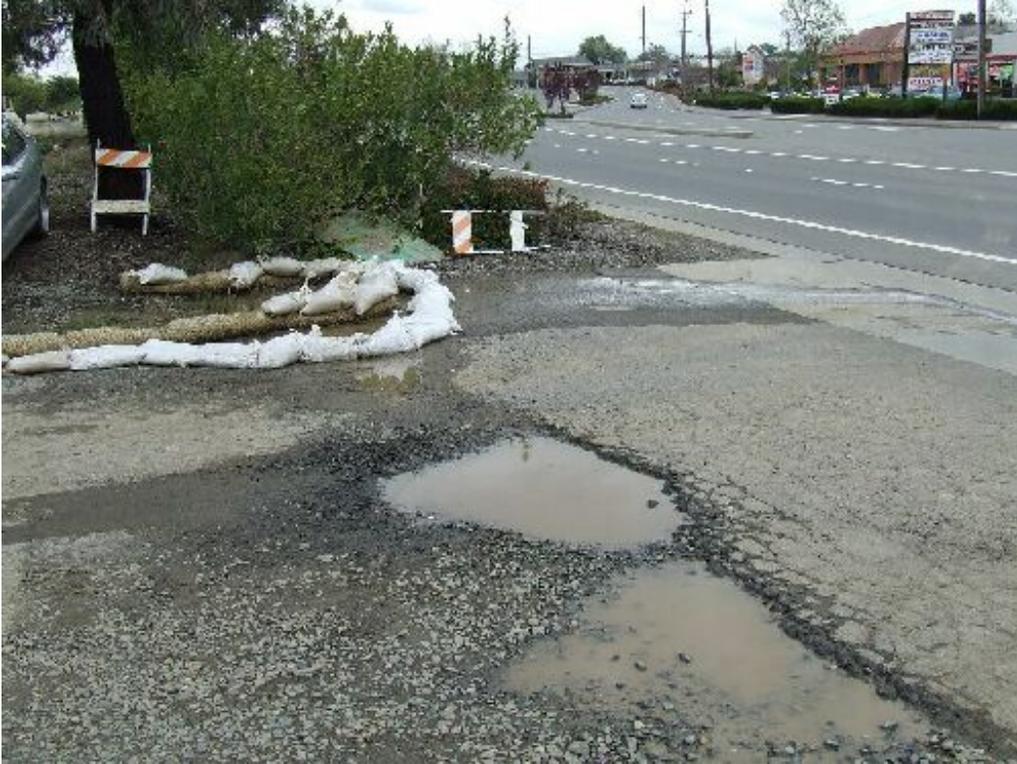
Figure 1 – Storm water runoff from the Staging yard near the tank farm, March 30, 2006.

At Vaults 1 and 4, erosion control devices are in place and properly functioning; however, storm water has carried suspended sediment into a nearby adjacent wetlands. Similarly, at the construction yard on Pacific Avenue, storm water is carrying sediment off the project area and into the City of Rocklin's storm gutters (see Figure 1). Wilson responded by installing some additional measures such as straw wattles and rock/sand bag containment barriers. Silt fence, straw wattles, and rock bags can trap a large amount of loose material; however, it is difficult to prevent suspended sediments in storm water from reaching nearby waterbodies with these devices. If the erosion persists, other measures such as containment settling basins or pumping to Baker tanks or acceptable upland sites may be necessary. Continued erosion at these locations is out of compliance with the RWQCB General Storm Water Permit and could also result in non-compliance reports from the CPUC, and/or fines and non-compliance from the RWQCB, and the City of Rocklin. During the subject week, the PG&E EI recommended to both Wilson and Zayas that straw mulch be placed over all exposed soil (most importantly at Vaults 1 and 4) to help reduce erosion during storm water runoff. In addition the PG&E EI also recommended to Zayas that a straw bale and filter fabric lined detention basin be constructed to trap more sediment laden storm water runoff entering the municipal sewers. The CPUC EM will continue to monitor these areas and report whether these recommendations have been implemented.

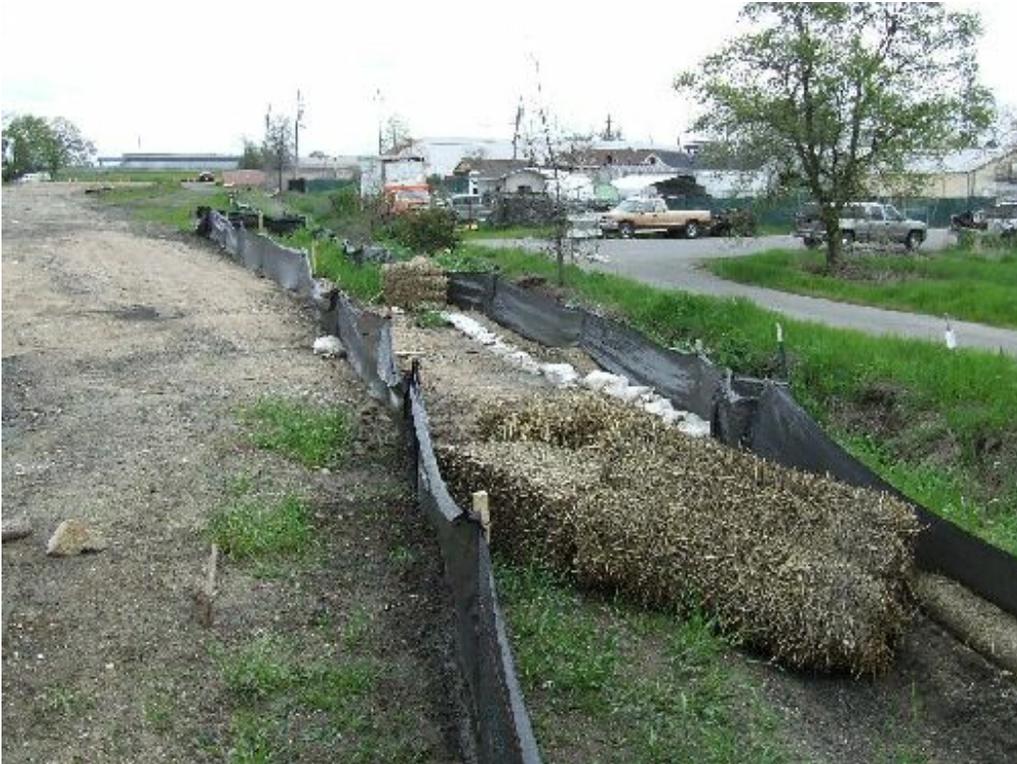
Figure 2 – Bank of Drainage #30 with newly installed erosion control features, March 30, 2006.

Previously, a section of silt fence at Drainage #30 was undercut by water flow during recent storm events. This section was previously breached in December, which caused erosion on the bank of the drainage. After the initial problem, Wilson's crews had installed sandbags on the bank to prevent further erosion. This remedy had been working; however, the water eventually undercut the fence in nearly the same location (slope of the terrain directs water to this location). The water flow cut parallel to the original erosion and caused additional damage to the bank. The CDFG was notified via email on Thursday, March 23rd. After repeated notifications by the PG&E EI as well as the CPUC EM, Wilson crews installed additional erosion control devices to repair the undercut section and to attempt to direct water flow away from this location (see Figure 2). Repairs included re-burying the undercut section of fence, placing sandbags along the area that had been undercut, and installing a new section of silt fence to direct water flow away from this location.
