**SCE VALLEY SOUTH SUBTRANSMISSION PROJECT**

**Date:** September 23, 2019  
**To:** Eric Chiang, Project Manager, CPUC  
**From:** Vida Strong, Aspen Project Manager  
**Subject:** Monitoring Report #11: September 1, 2019 to September 14, 2019

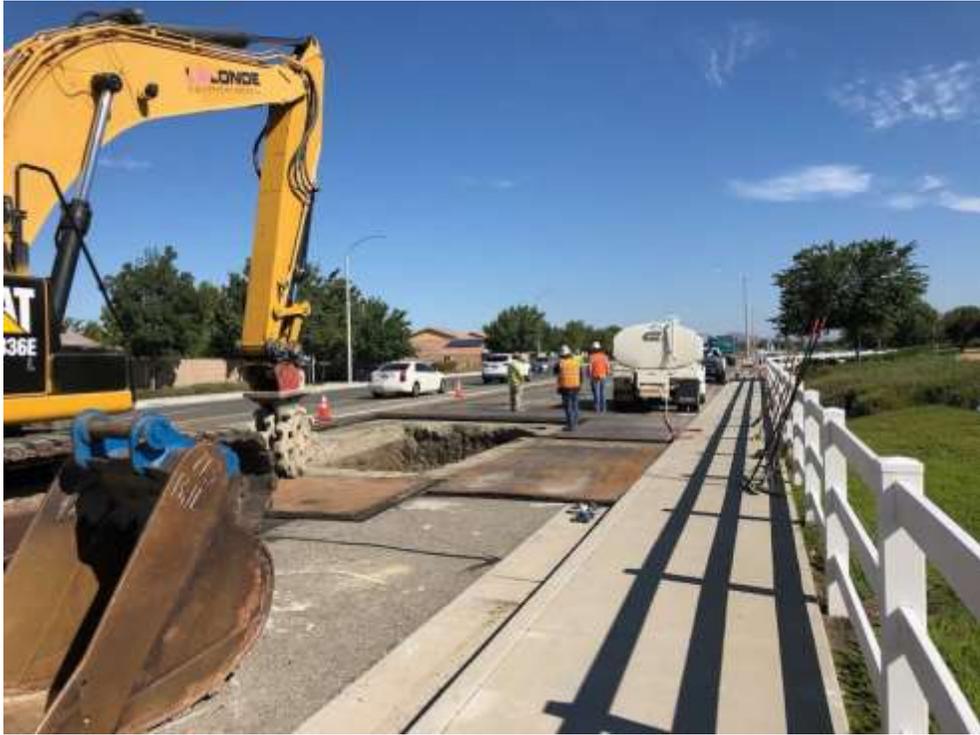
2. BMP inspections and maintenance occurred at TSP foundation locations in Segment 1.
3. Cattract excavated the duct bank trench from UNK207 to Vault 1B and trenched from Vault 3 to UNK222 for the southern underground section on Leon Road (Construction Areas UNK207 through UNK222) (see Photo 1).

Photo 1 – Vault excavation on the southern underground (September 6, 2019).

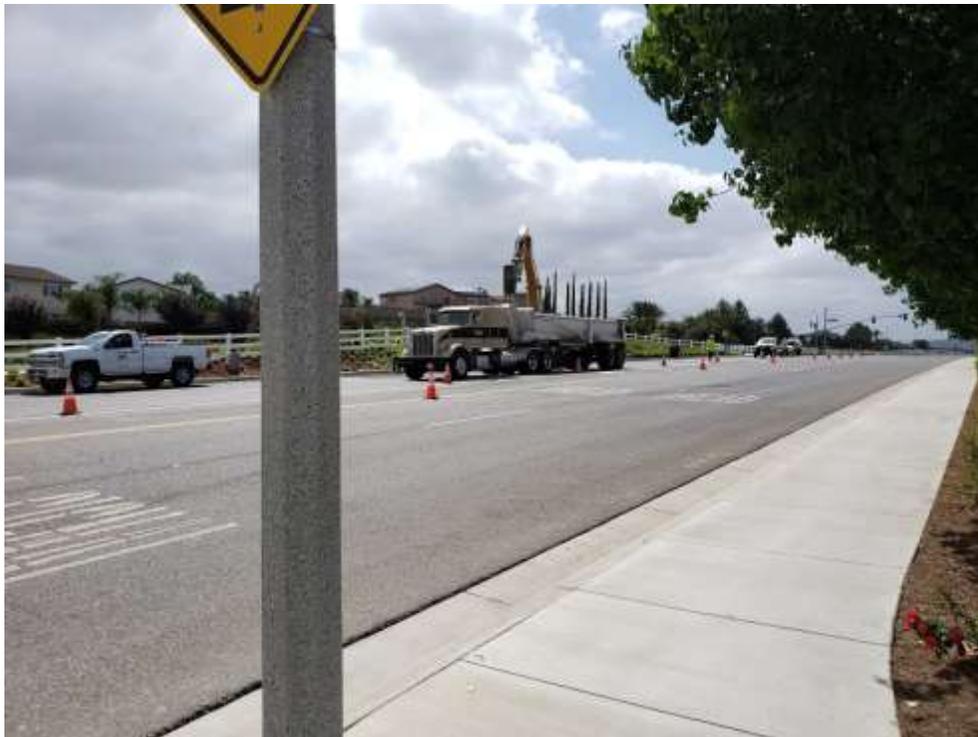
1. Biological, paleontological, and archaeological monitoring occurred during construction activities.
2. Traffic control was in place on Leon Road during excavation of vaults and trenching for the southern underground section (see Photo 2).

Photo 2 – Traffic control in place on Leon Road during underground construction activities (September 10, 2019).

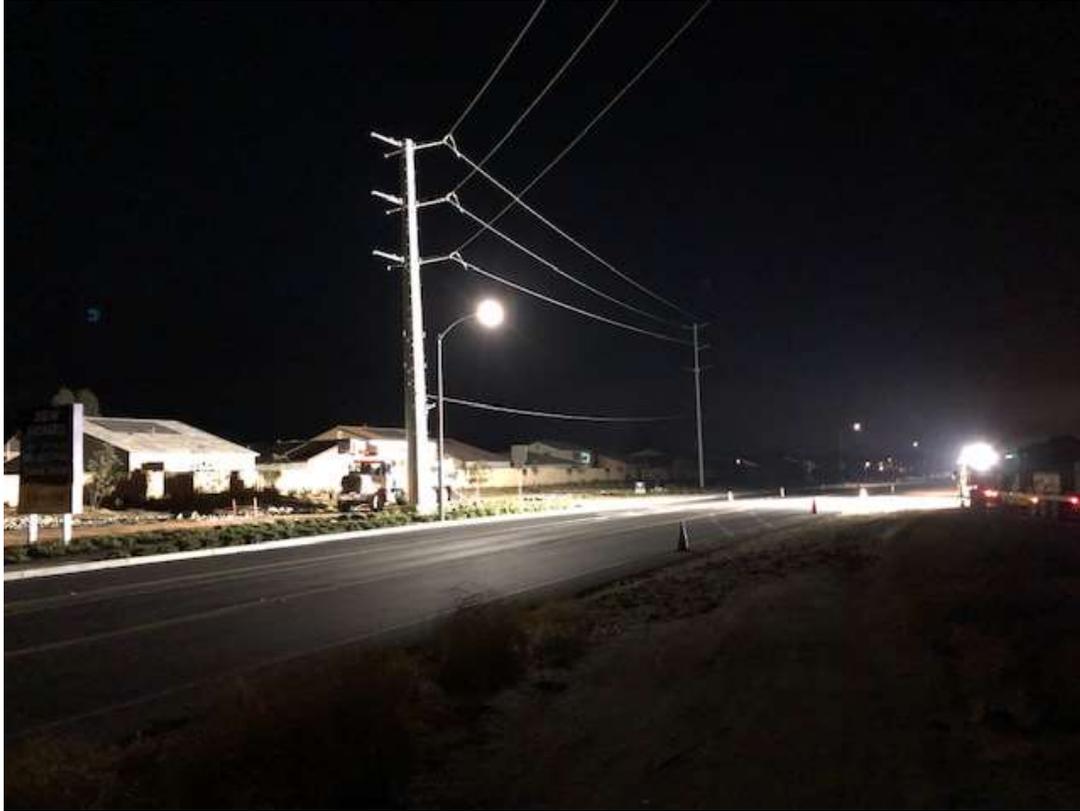
4. On June 5, the CPUC EM observed a light tower on the west side of Briggs Road with the illumination aimed in the direction of the residences located along the east side of the road during overnight construction activities from Construction Areas UNK250 to UNK01 (see Photo 3). The CPUC EM asked the crew if it was a worker or safety necessity to have the tower set up in that manner. They stated it was not and the tower was immediately turned in a position that did not result in light directly aimed at the residences. The Contractor's Environmental Manager was notified the next morning and they stated the location observed was a temporary site and light was used only to connect the grounds required for the outage.

Photo 3 – Construction night lighting directed at residences during overnight construction activities from Construction Areas UNK250 to UNK01 (September 5, 2019).
