SCE VALLEY SOUTH SUBTRANSMISSION PROJECT

Date: October 17, 2019
To: Eric Chiang, Project Manager, CPUC
From: Vida Strong, Aspen Project Manager
Subject: Monitoring Report #13: September 29, 2019 to October 12, 2019

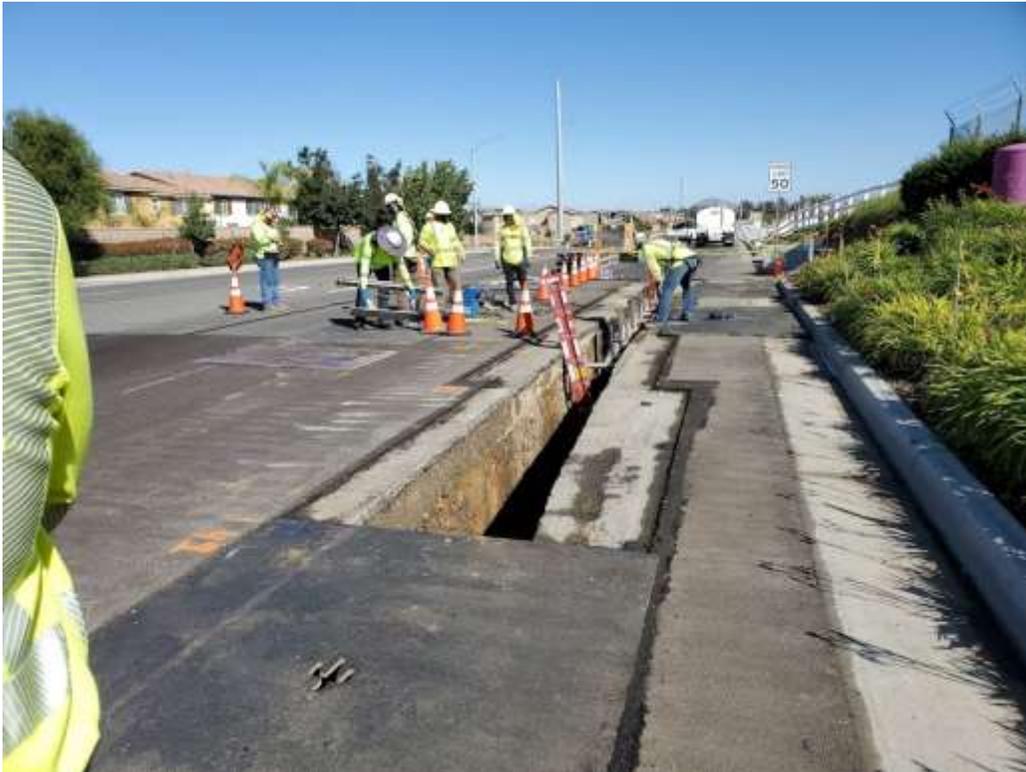
2. BMP inspections and maintenance occurred at TSP foundation locations in Segment 1.
3. Cattract installed the conduit in the duct bank trench from Construction Area UNK207 to Vault 1B (see Photo 1) and removed asphalt between Vaults 1B and 2B for the southern underground section on Leon Road (Construction Areas UNK207 through UNK222).

Photo 1 – Conduit installation on the southern underground (October 9, 2019).

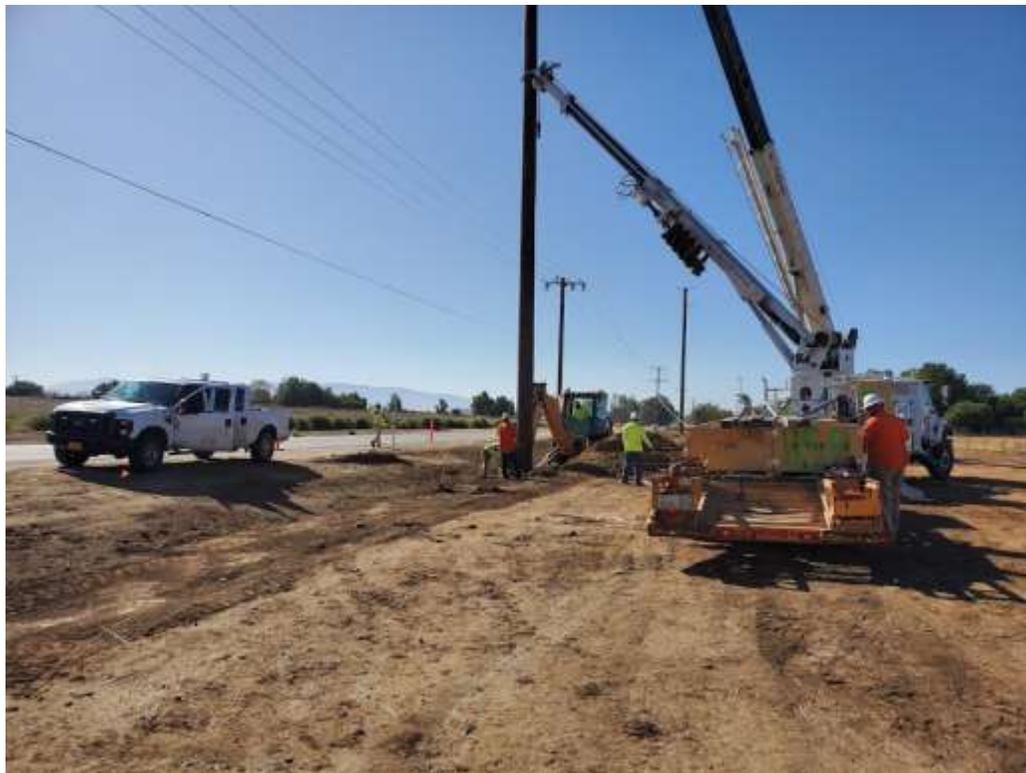
4. Construction activities on Segment 1 included: Hauling and framing poles from Construction Areas UNK140 to UNK247; setting wood poles at Construction Areas UNK156, UNK173, UNK178, UNK183, UNK189 through UNK203, and UNK226 through UNK234 (see Photo 2); assembling TSPs at Construction Areas UNK46 and UNK125; hanging distribution arms from Construction Area UNK156 to UNK234; and a tree trimming crew continued work at Construction Areas UNK177 and UNK178 removing trees and grinding stumps.

Photo 2 – Setting wood pole at Construction Area UNK183 (October 2, 2019).

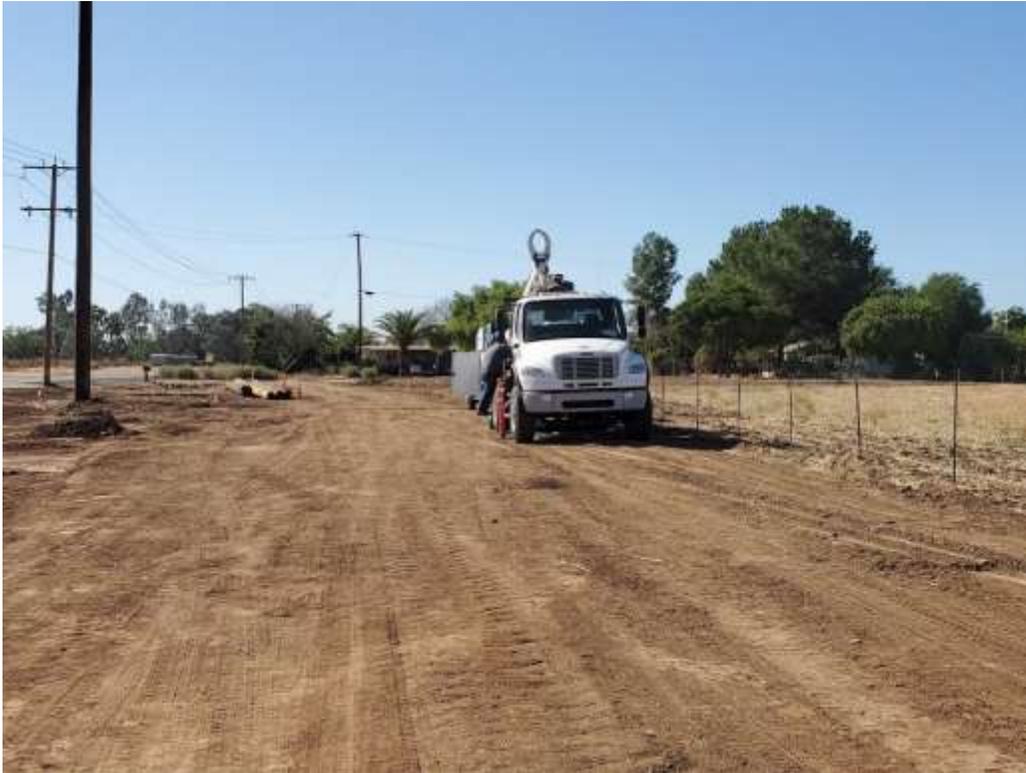
3. On October 2, the CPUC EM observed a Nesco mechanic truck parked outside of approved disturbance limits at Construction Area UNK183 (see Photo 3). The biological monitor arrived onsite about the same time and asked the mechanic to move the vehicle inside marked approved disturbance limits. The biological monitor notified the CPUC EM that the incident would be documented as a Level 1 incident and the contractor was notified of the issue.

5. There was one SCE self-reported incident and three observations documented throughout the monitoring period. The SCE self-reported incident was the Level 1 incident discussed above for the equipment mechanic truck parked outside of approved disturbance limits at Construction Area UNK183. The incident states that third party mechanics will have one single point of contact and will be escorted into the field to ensure their vehicles and equipment are staged within approved work areas. On October 1, a new cultural feature was discovered by the tribal monitor in Segment 2, within an already established ESA. The feature was documented as an observation by the archaeological monitor. The other observations included accumulated rock on shaker plates at yard entrance and non-project related trash near the Valley Substation Yard.

Photo 3 – Mechanic truck parked outside of approved disturbance limits at Construction Area UNK183 (October 2, 2019).

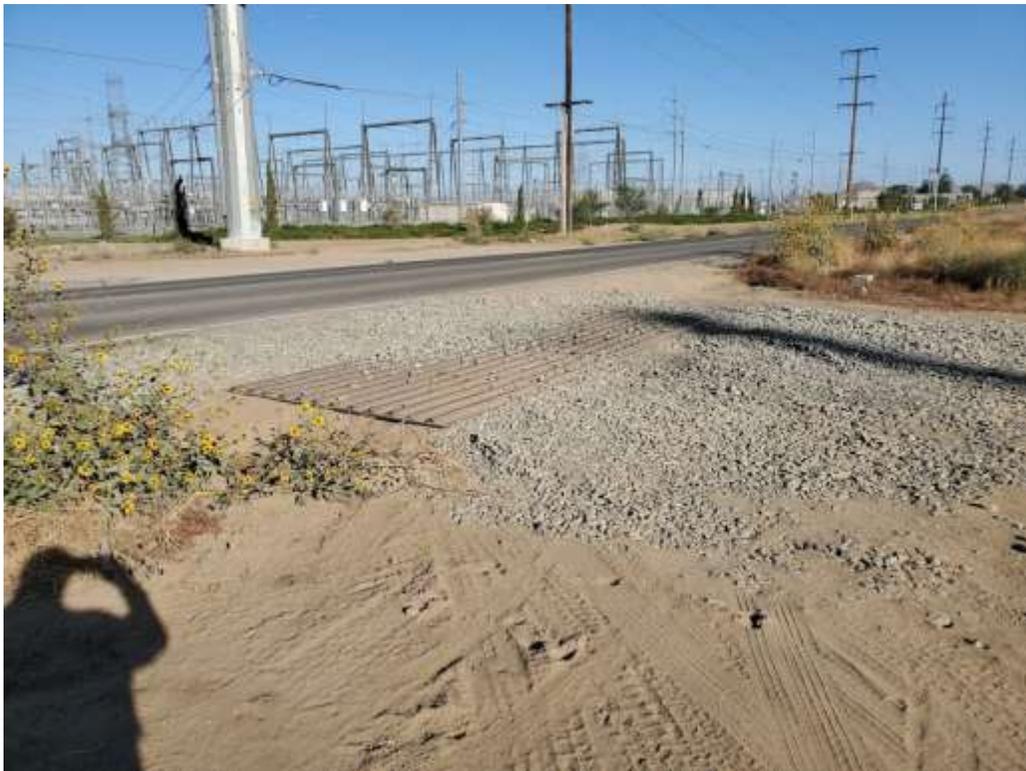
4. On October 9, the CPUC EM observed rock accumulated on shakers plates off of Menifee Road near Construction Area UNK250 (see Photo 4). The CPUC EM notified the contractor's Environmental Manager of the issue and was informed the shaker plate and rock were going to be removed the next day.

Photo 4 – Rock accumulated on shaker plates off Menifee Road near Construction Area UNK250 (October 9, 2019).
