PROJECT MEMORANDUM

ANTELOPE PARDEE PROJECT, SEGMENT 1

**Subject:** Weekly Report #7, February 24-March 1, 2008

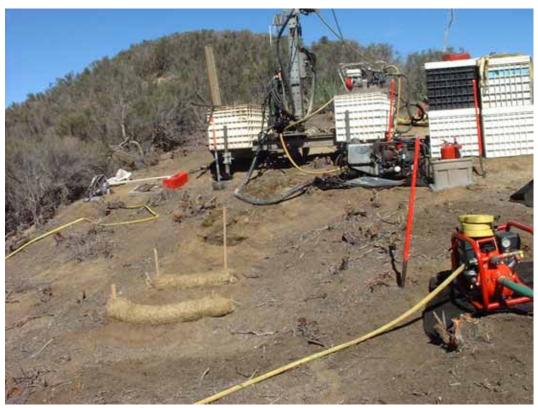
- 4. On February 28<sup>th</sup>, ANF and CPUC representatives Marian Kadota and Jenny Slaughter conducted a site inspection of the Tower 85 site, along Spunky-Edison Road (see Figure 1). The drilling operation was on hold because of an equipment problem. The Spill Kit on site was inspected and found to be complete. Fire and weed prevention measures were in place.

**Figure 1:** Drilling operations at Tower Site 85.

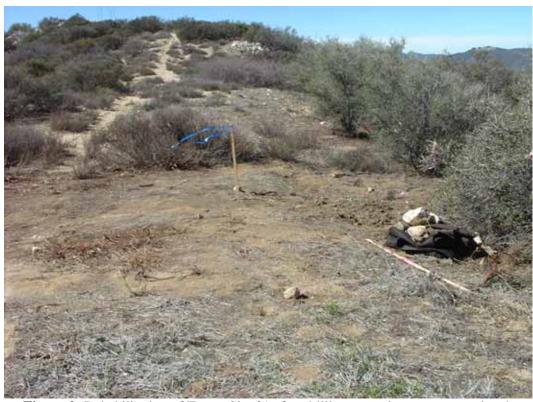
5. After completing the site inspection at Tower 85, Marian Kadota (ANF), Jenny Slaughter (CPUC), and Kimberly Toal (Burns and McDonald) conducted a site visit of Tower Sites 81 and 79. Tower 79 is a proposed tower site located down a steep ravine. This proposed tower location is undergoing further examination to determine if it falls within jurisdiction of the Army Corps of Engineers or if it is considered to be a Riparian Conservation Area as defined by the Forest Service. Tower Site 81 was noted to have been restored after the drilling operation (see Figure 2).

Figure 2: Rehabilitation of Tower Site 81 after drilling operations were completed.

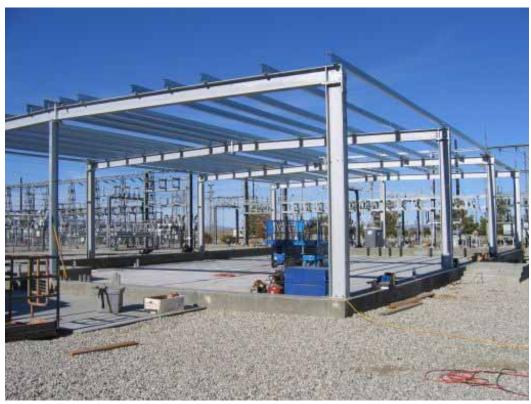
- Construction of the Mechanical Electrical Equipment Room (MEER) continued (see Figure 3). Crews
  are working on the sub-floor and walls. Excavation for the building foundation has been completed.
  The Paleontological Monitor is no longer required during construction activities because the Paleontological Plan has been approved.

**Figure 3:** Construction of the MEER building at the Antelope Substation.
