**PROJECT MEMORANDUM  
SCE TRANSMISSION PROJECTS, SEGMENTS 1 - 11**

**To:** John Boccio, Project Manager, CPUC  
**From:** Vida Strong, Aspen Project Manager  
**Date:** August 02, 2011  
**Subject:** Weekly Report 182, July 17 to July 23, 2011

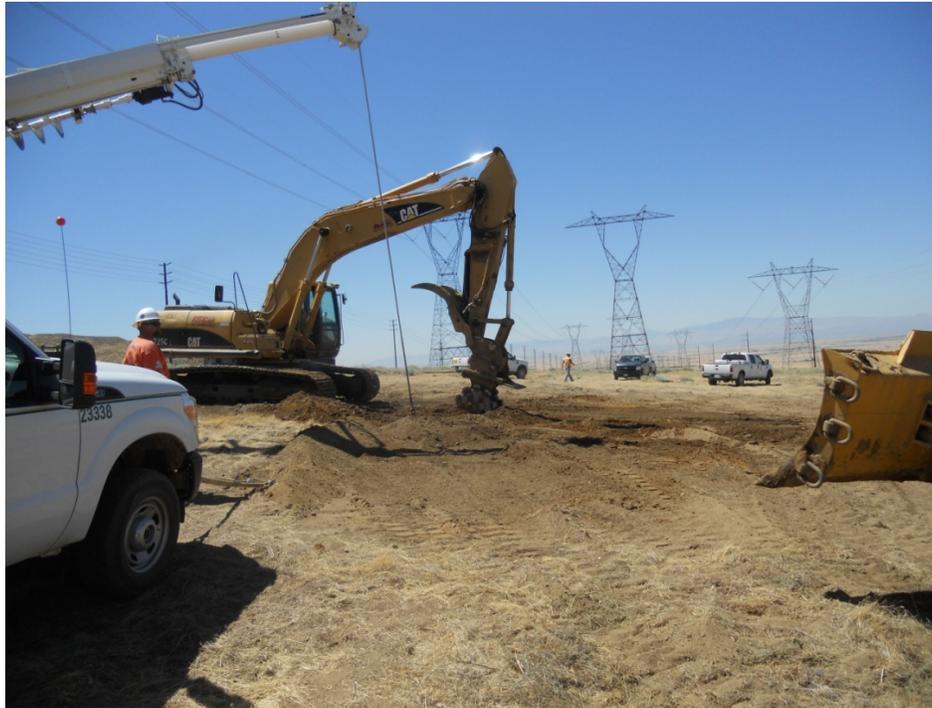
**Figure 1:** H&H Grading installed snubs in the wire set-up site between Towers 15 and 16, for upcoming wire stringing activity, Segment 4.

2. Segment 4: KV Structures (drilling contractor) continued drilling, setting rebar cages using a spider jig for stub angle placement, and concrete pouring at Towers 18 and M73-T3C. H&M steel crews continued tower assembly and erection at Towers 1, 2, 3, M74-T1X, M74-T1B, 6, and 17. H&M wire crews continued wire stringing preparation which includes guard pole sites and installing travelers on the newly erected towers. H&H Grading conducted snub installation in two wire set-up sites in preparation for wire stringing (see Figure 1).

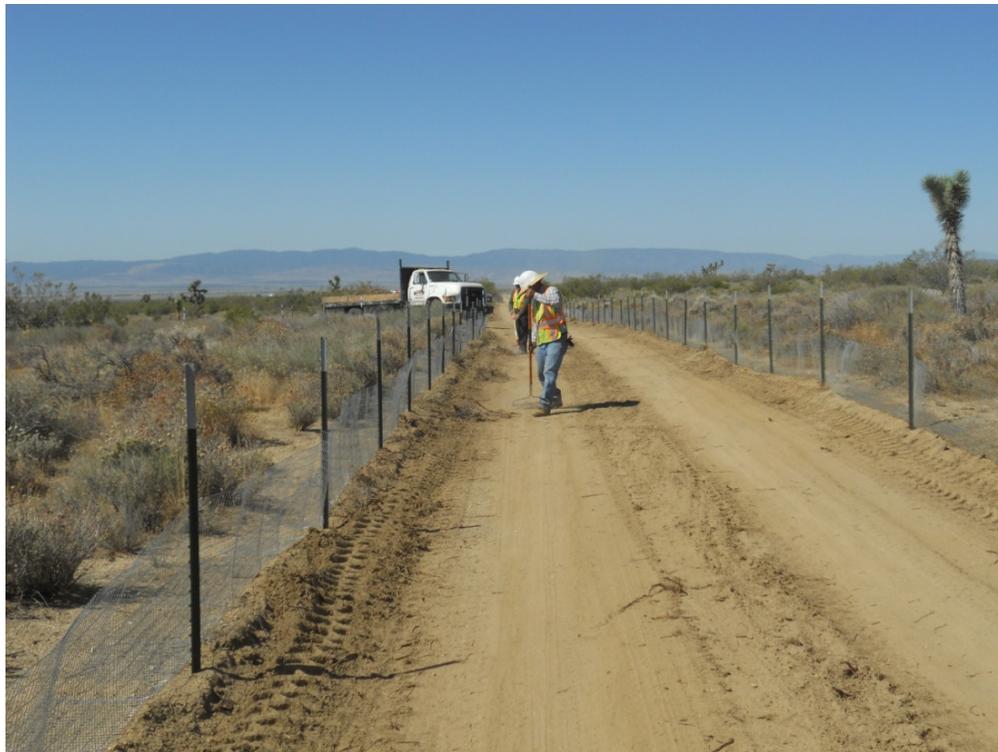
**Figure 2:** Moore Fence crew raking cut vegetation from General Petroleum Road, Segment 10.

heading northeast from Tower 62. Cut vegetation from General Petroleum Road is being removed from the road (see Figure 2).

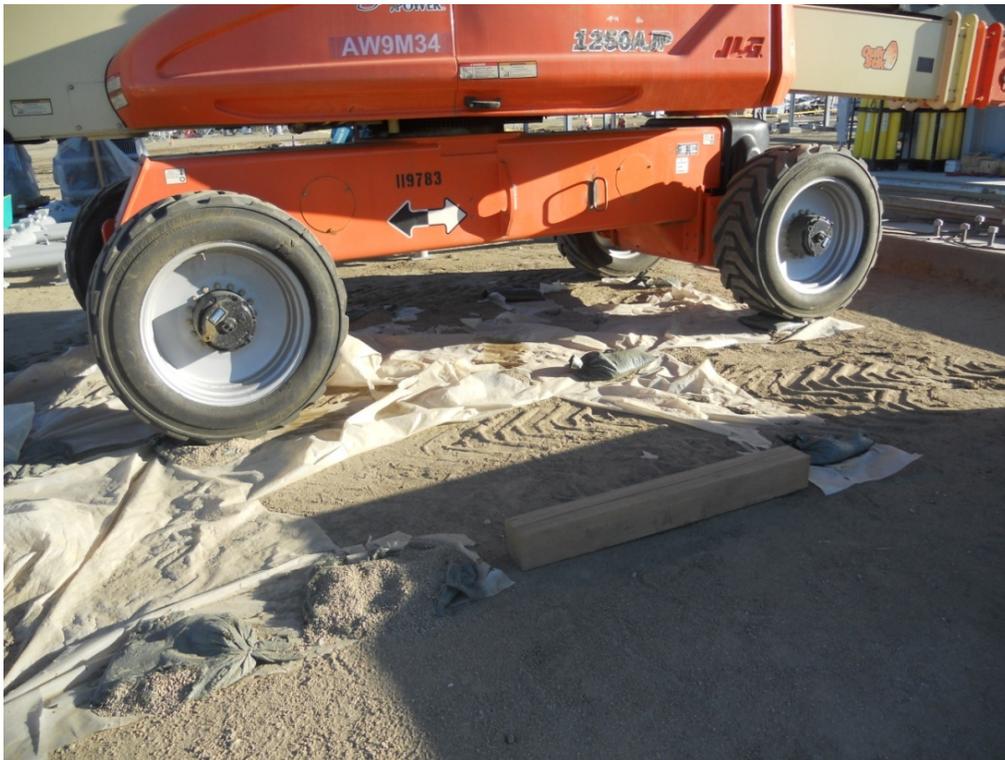
3. On July 19<sup>th</sup>, the CPUC EM accompanied the CH2M Hill Environmental Monitor on a walk through site visit of Whirlwind Substation. The monitor looked for spills, leaks, secondary containment under equipment and vehicles, open trenches, BMP's, and air quality stickers. Improper secondary containment was documented (see Figure 3).

**Figure 3:** Improper secondary containment underneath equipment in Whirlwind Substation, Segment 9.

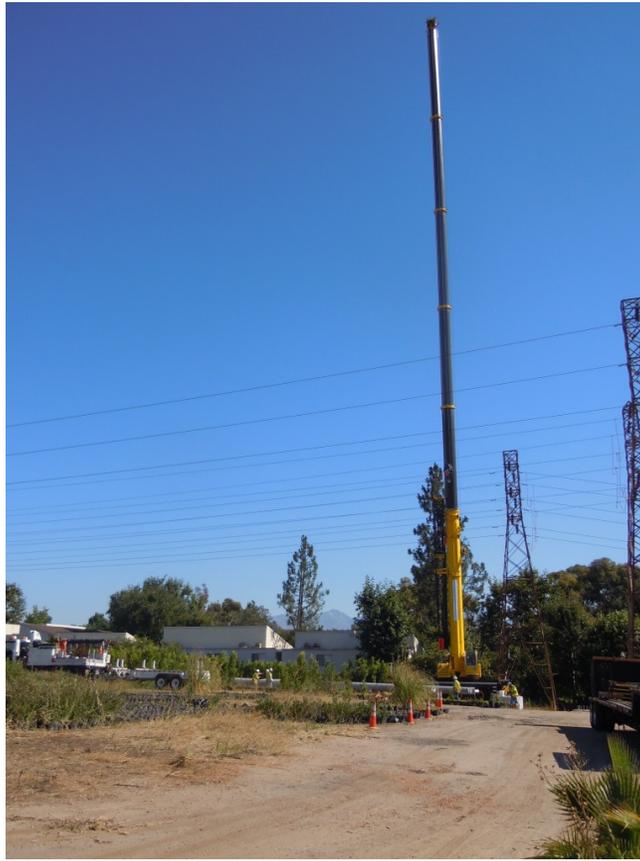
**Figure 5:** An SCE crew prepares to set a riser pole, Segment 7 66 kV.

1. Segments 7 & 8, 66 kV: During the subject period, Wilson crews continued worked on the overhead portion of the Rio Hondo-Bradbury line. Crews continued transferring 66 kV wire to poles along Arrow Highway. SCE crews continued pulling conduit on the Rio Hondo-Anita No. 2/Rio Hondo-Amador lines west and east of Interstate 605 (I-605). Additionally, SCE crews continued setting tubular steel poles (TSPs) and stringing wire on the Rio Hondo-Amador-Jose-Mesa line behind Mesa Substation (see Figure 5).

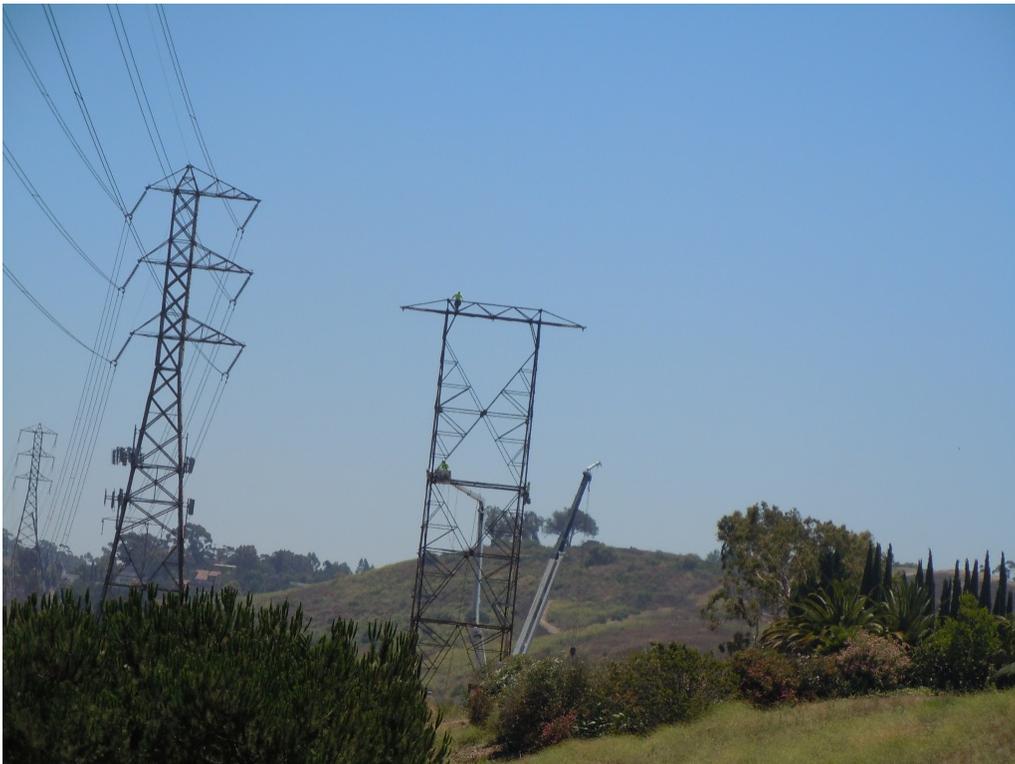
**Figure 6:** Crews disassemble a tower, Segment 8, Phase 4.

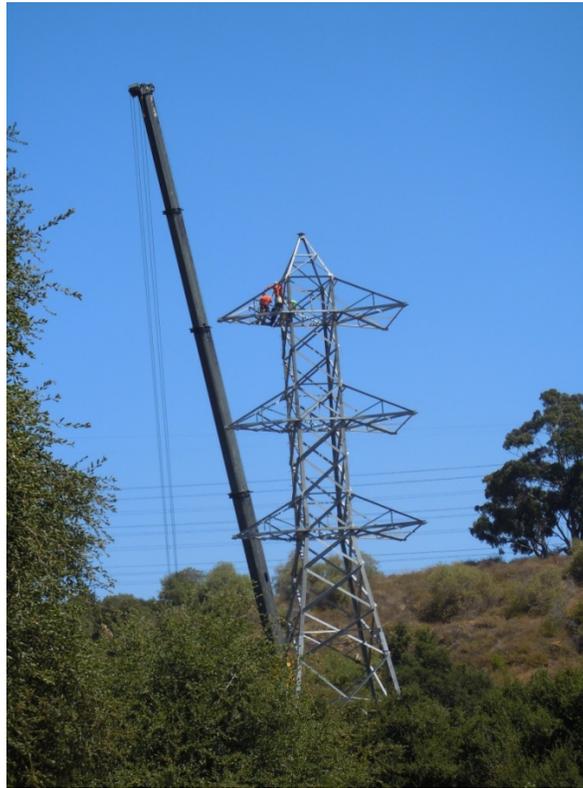
**Figure 7:** Crews build a tower within the PHLNHA, Segment 8 Phase 4.
