PROJECT MEMORANDUM
SCE WEST OF DEVERS UPGRADE PROJECT

To: John Forsythe, Project Manager, CPUC
From: Vida Strong, Aspen Project Manager
Date: January 24, 2020
Subject: Monitoring Report #95: January 13 to January 19, 2020

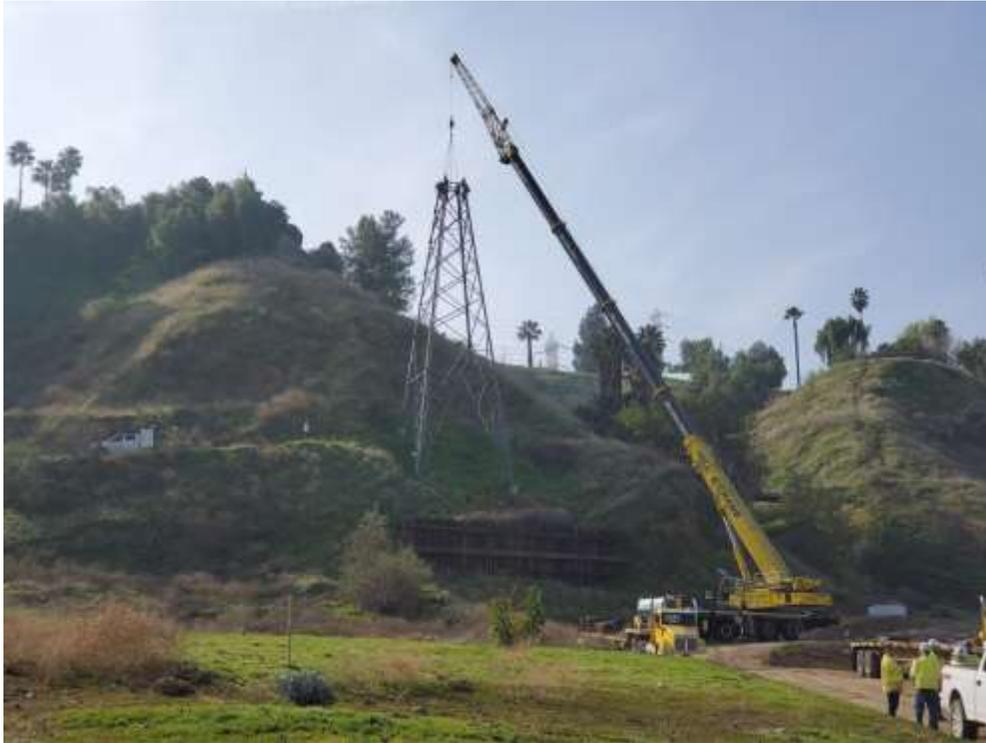
Photo 1 – Tower wreck-out at Construction Area 2N30, Segment 2 (January 14, 2020).

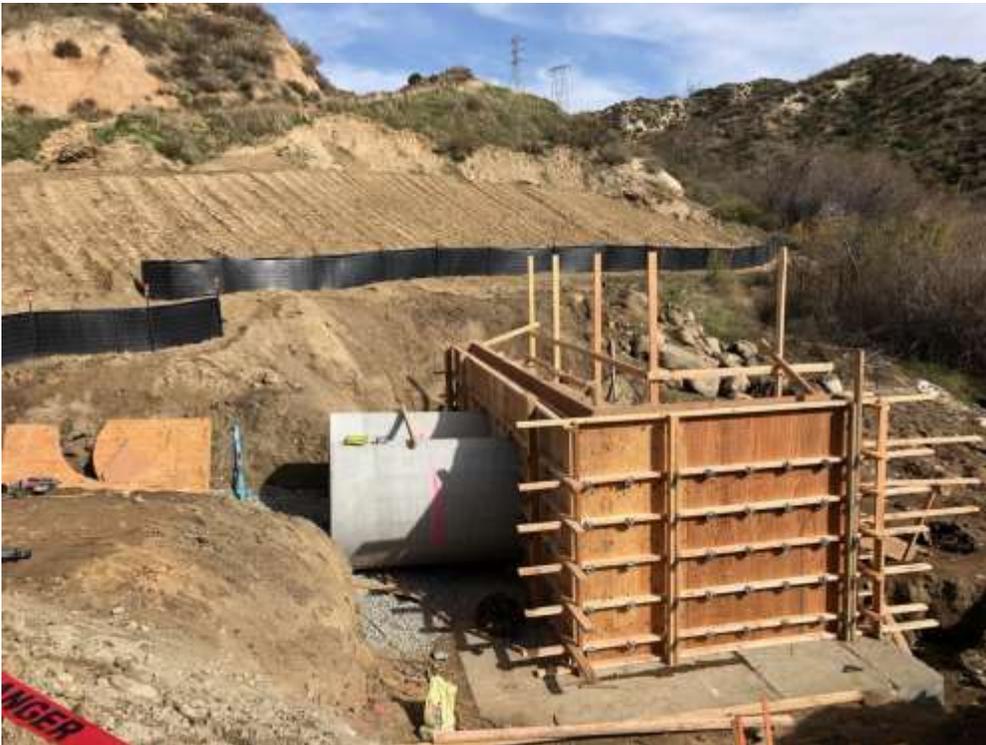
5. Work associated with Segment 4 included: Grading, pipe excavation, road crossing, and headwall build activities at Construction Area 4X04 (see Photo 2); foundation activities at Construction Areas 4X27, 4X29 through 4X32, and 4X36; and BMP maintenance at Construction Areas 4X29, 4X31 through 4X42, and 4X44 through 4X58.

Photo 2 – Pipe installation and road crossing construction at Construction Area 4X04, Segment 4 (January 17, 2020).

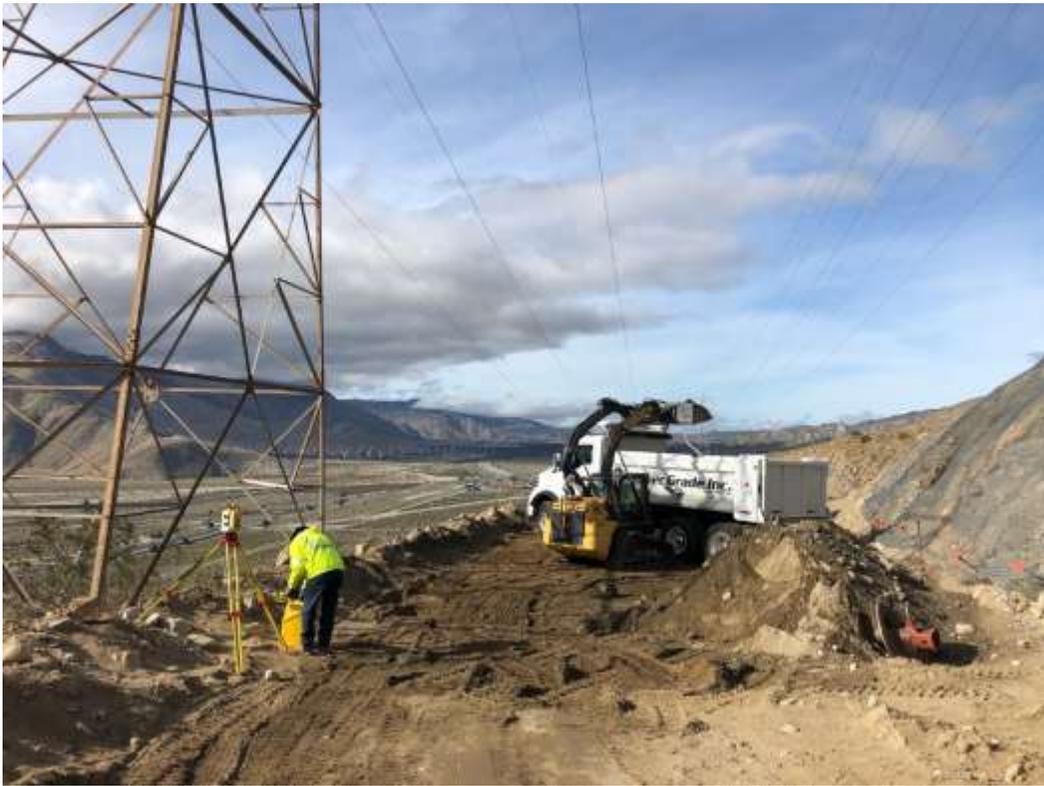
7. Work associated with Segment 6 (non-BLM lands) included: Grading, drilling, pouring slurry, fencing, and material export at Construction Area 6N30 (see Photo 3); rock and stockpile removal at Construction Area 6S28-S; OPGW wire punch-list activities at Construction Areas 6S26 through 6S38; marker ball installation between Construction Areas 6S27 and 6S28; BMP maintenance at Construction Area

Photo 3 – Grading and material export at Construction Area 6N30, Segment 6 (January 17, 2020).

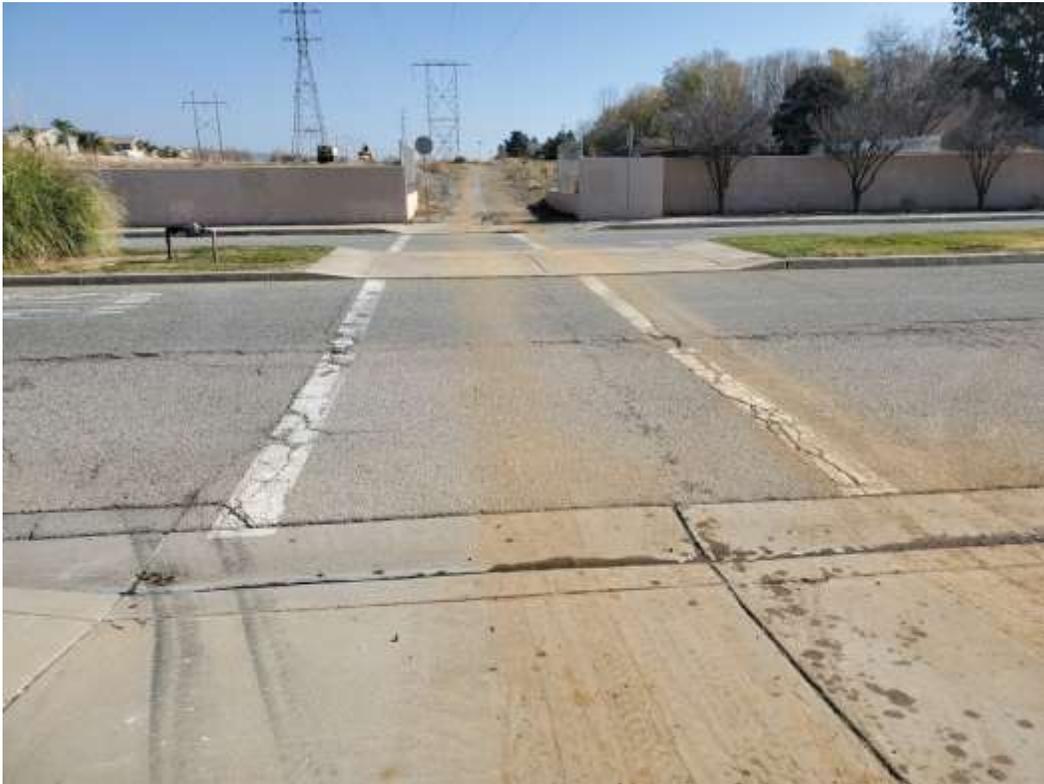
3. On January 13, the CPUC EM observed track out on a paved public road between Constructions Areas 4X29 and 4X30 that extended greater than 20 feet (see Photo 4). The CPUC EM immediately notified the Barnard Environmental Compliance Lead of the observation. The Compliance lead had crew members immediately sweep the track out and sent the CPUC EM photos of the road when it was completed.

Photo 4 – Track-out on paved public road between Construction Areas 4X29 and 4X30, Segment 4 (January 13, 2020).

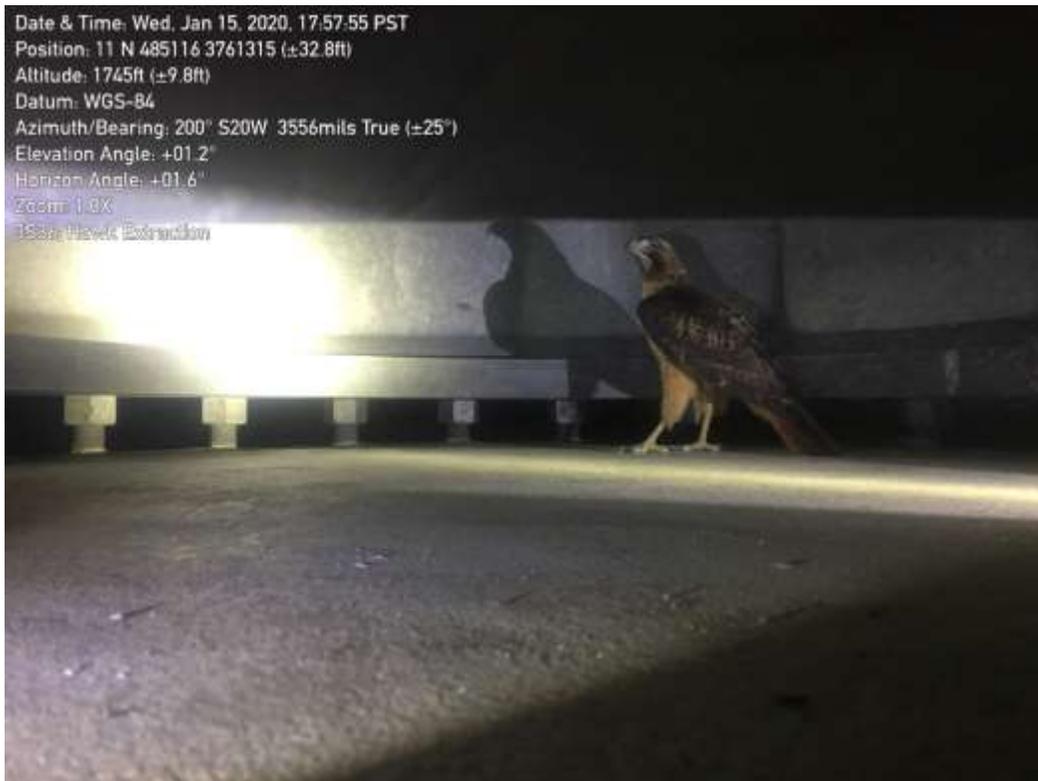
7. On January 15, one red-tailed hawk became entrapped within a TSP at Construction Area 3S36 (see Photo 5). An avian biologist observed while a crew member was lowered into the TSP to retrieve the hawk with a blanket. The hawk was released on the ground near a tall eucalyptus tree. After lifting the blanket off of the bird, the hawk took less than one minute to orient itself, and then flew straight for the tree. The avian biologist observed the hawk and its flight pattern and determined it did not have any apparent injuries and had only been entrapped for a short period of time; there were no bird droppings, pellets, feathers, or other signs within the TSP that would indicate long-term entrapment.

Photo 5 – Red-tailed hawk trapped inside a TSP at Construction Area 3S36, Segment 3 (January 15, 2020) (Photo courtesy of SCE).
