PROJECT MEMORANDUM
SCE BANDUCCI SUBSTATION PROJECT

To: Jensen Uchida, Project Manager, CPUC
From: Vida Strong, Aspen Project Manager
Date: February 23, 2018
Subject: Monitoring Report #9: January 28 to February 17, 2018

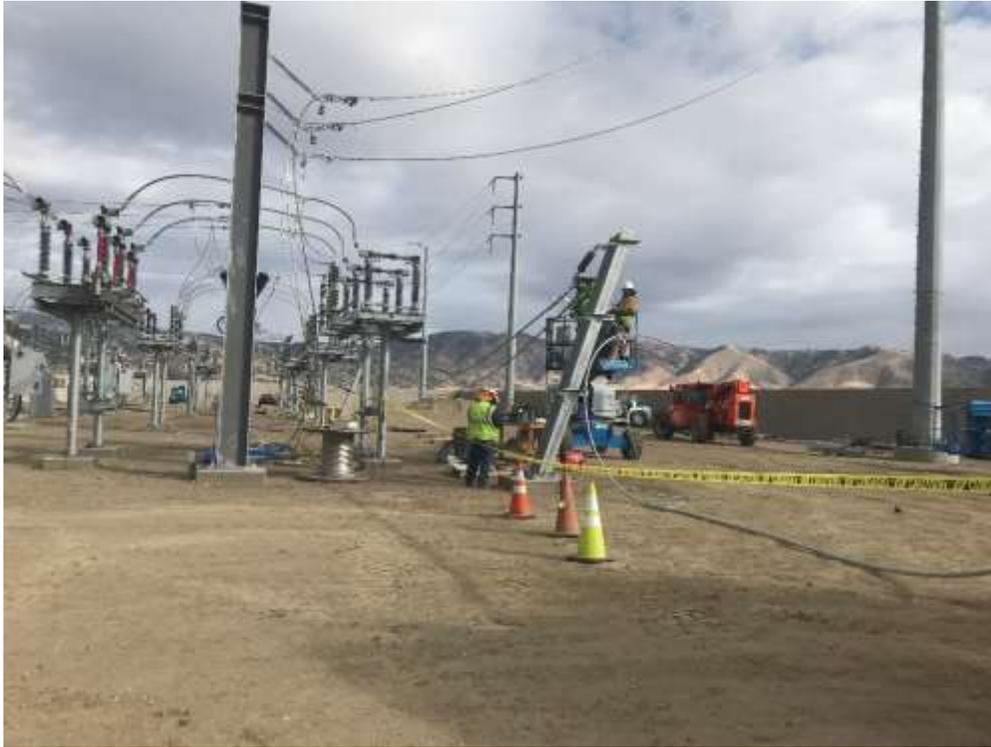
Figure 1 – Henkels and McCoy crew installing jumpers on the 66 kV rack.

2. Bus placement into the 12-kV rack took place and jumpers were installed for the 66-kV rack (see Figure 1).
3. Control wiring was installed and tested in the MEER building.
4. Erosion control BMPs were inspected and maintained at the Banducci Substation site.
5. Construction crews are trucking in non-potable water for dust control and compaction from an approved hydrant located near Highline Road.

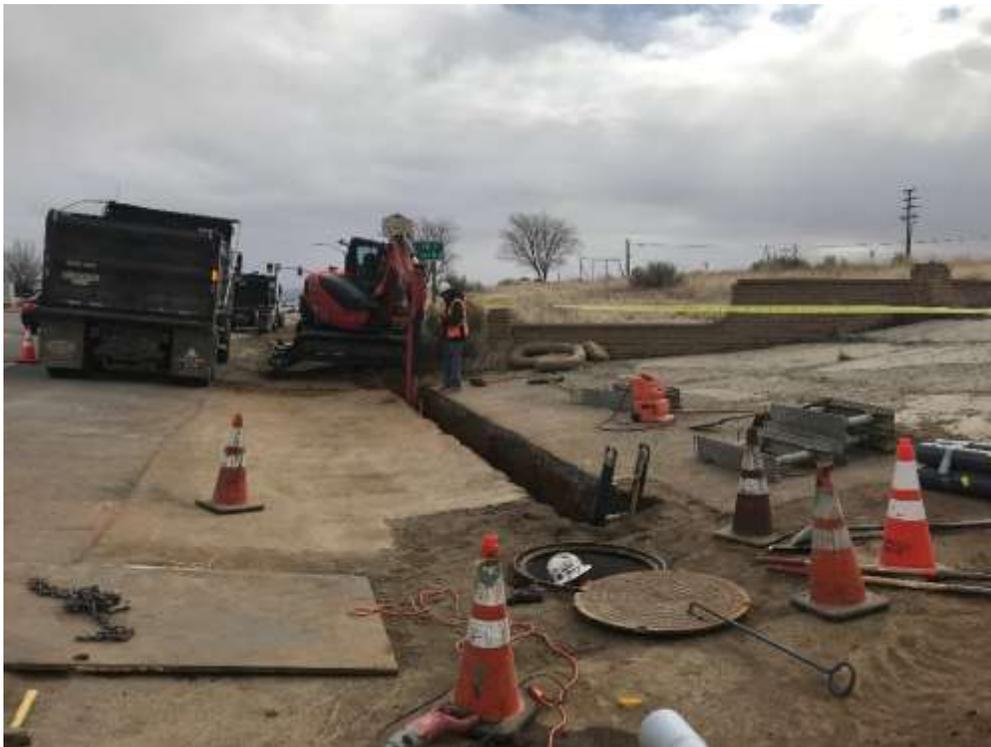
Figure 2 – Telecom underground crews trenching to tie in with overhead sections installed along Highway 202 and Woodford Tehachapi Road.

8. H&M crews began work on Routes 1 and 2 of the Telecommunication work on September 27, 2017.
9. H&M crews completed fiber installation along Highway 202.
10. Trenching and conduit installation took place along Highway 202 and Woodford Tehachapi Road (see Figure 2).

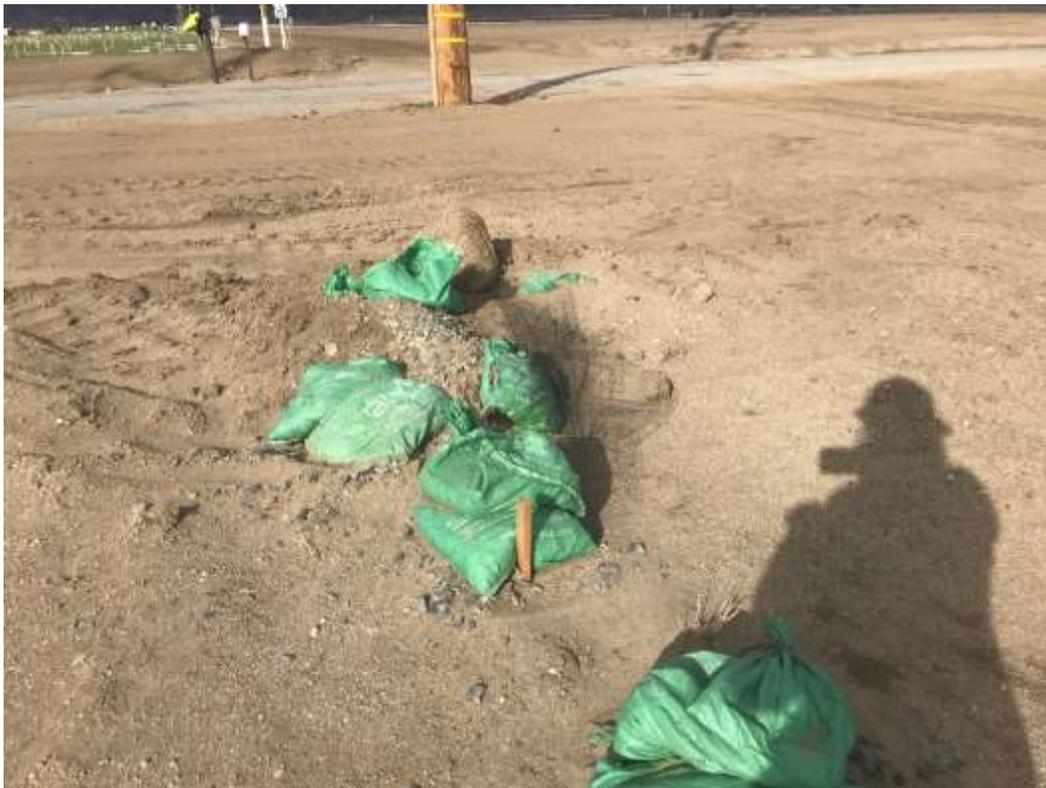
2. On February 13, the CPUC EM noted that sections of bird netting used to cover conduit was left on the ground unsecured. On February 14, two sections of bird netting were found caught in the perimeter sand bag berm surrounding the Substation (see Figure 3). The CPUC EM documented this as a Level B compliance incident, because of the threat to wildlife (entrapment) and also for microtrash (see Table 2).

Figure 3 – Bird netting used to cover ends of conduit was left unsecured and became caught in perimeter sandbag berm causing a microtrash and wildlife entrapment concern documented by the CPUC EM on February 14.
