PROJECT MEMORANDUM SCE DPV 2 TRANSMISSION PROJECT

To: Billie Blanchard, Project Manager, CPUC
From: Vida Strong, Aspen Project Manager
Date: August 11, 2011
Subject: Weekly Report 03, August 1 to August 7, 2011

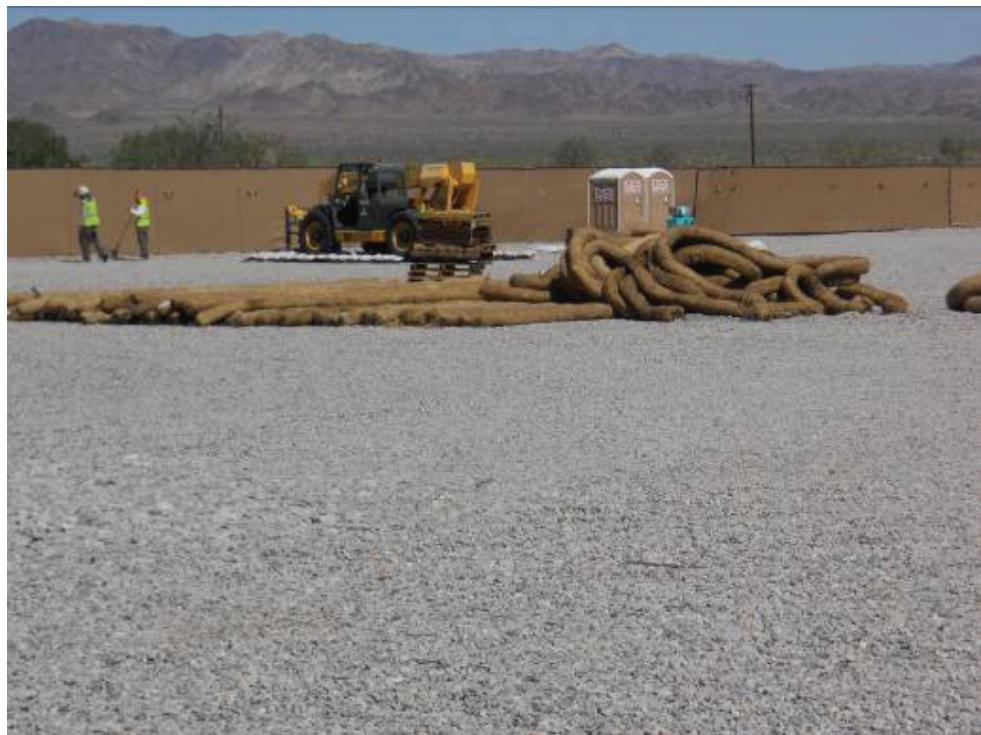
1. Throughout the week, DC1 was used primarily for equipment storage and parking. Minor activities at this yard included repairs to a broken hinge on the entrance gate and privacy screens, removal of Best Management Practices (BMP) straw wattles, and leveling of $\frac{3}{4}$ " gravel in areas from which wattles had been removed. When water trucks were not available, gravel was leveled using hand shovels to prevent fugitive dust (see Figure 1).

Figure 1: Activities at DC1 included storage of equipment, removal of straw wattles, and localized leveling of gravel.

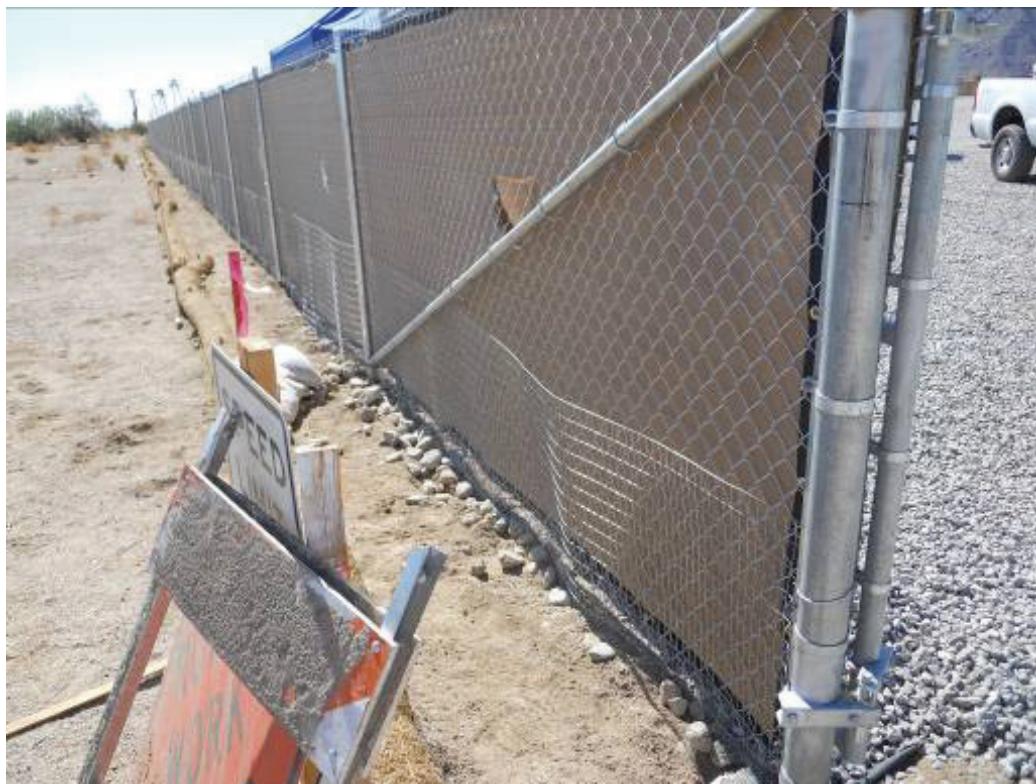
2. Construction activities continued at DC2 and included grading, placement of geofabric and gravel, installation of exclusionary and project boundary fencing, and implementation of BMPs (see Figure 2).

Figure 2: Exclusionary and project boundary fencing has been installed at DC2.

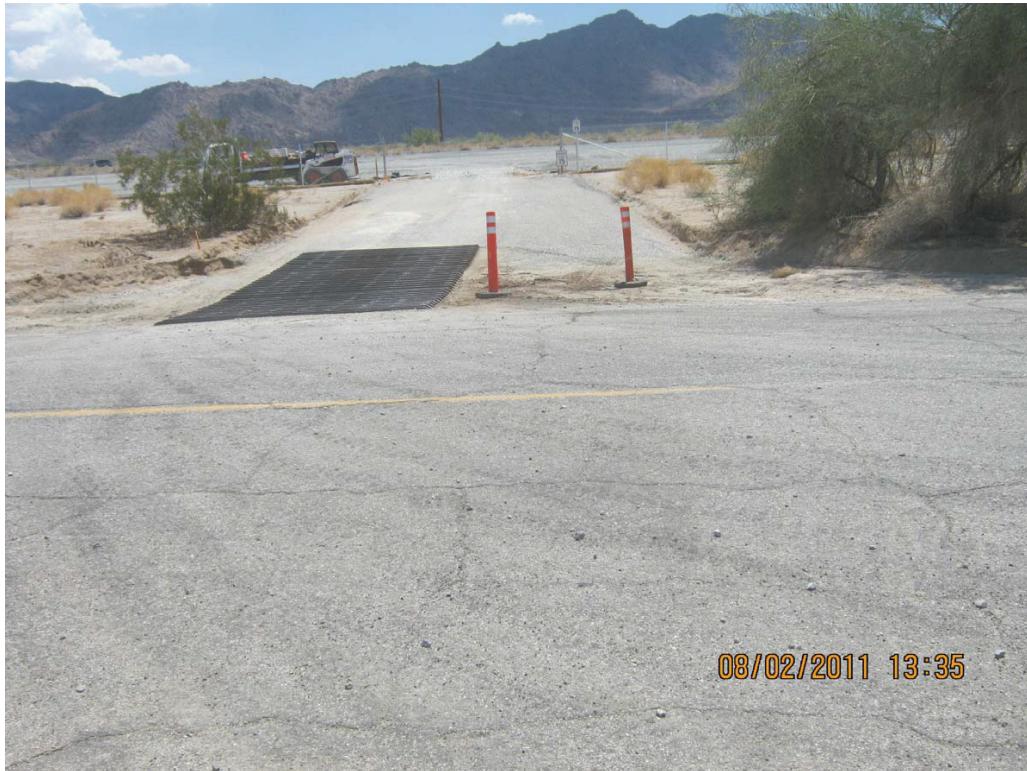
1. The SCE Environmental Compliance Monitor (ECM) noted visible material being tracked out onto roadway without sweepers at DC2 on August 2 (Level 1) (see Figure 3). SCE Representative was informed and sweepers were onsite within one hour.
2. On August 3, the SCE ECM identified a 613C scraper that was improperly parked overnight at DC2 (see Figure 4). The machine was only partially parked above plastic sheeting while the rear of the machine (where the fuel tank is located) was not parked above plastic sheeting. The ECM informed the contractor and geofabric was then placed underneath. However, the geofabric is a porous material that would be ineffective in the event of a leak. This event is not in compliance with the approved SWPPP for DC2, which states, "Place all equipment or vehicles, which are to be fueled, maintained and stored in a designated area fitted with appropriate BMPs."

Figure 3: Trackout observed at DC2 (note gravel in foreground).

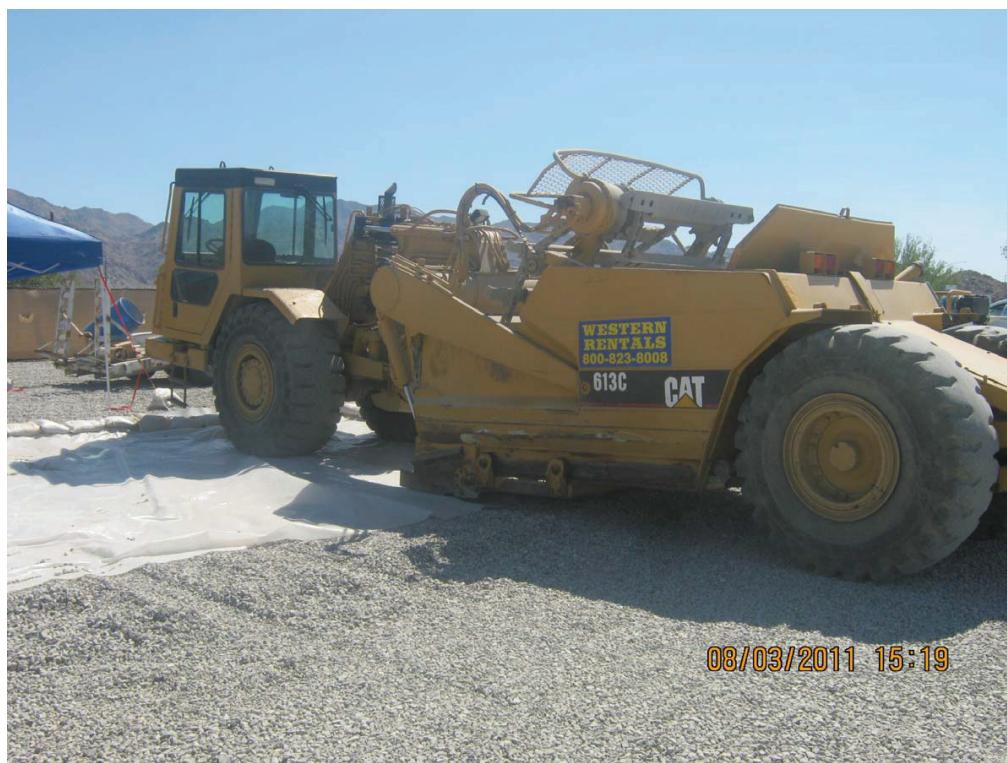
Figure 4: Equipment improperly parked at DC2 with only partial coverage of plastic sheeting underneath.
