PROJECT MEMORANDUM SCE DPV2 TRANSMISSION PROJECT

Subject: Weekly Report 14, October 17 to October 23, 2011

This report provides a summary of the construction and compliance activities associated with the SCE DPV2 Transmission and Red Bluff Substation Projects.

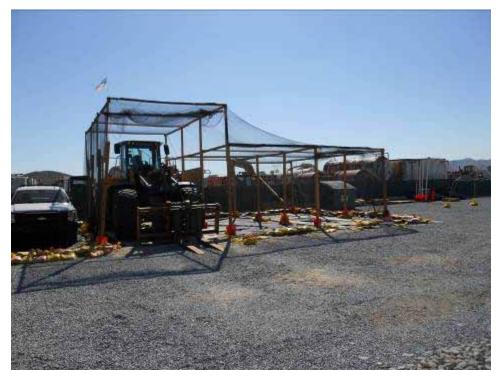
Figure 1: Bird netting and BMPs effectively installed at Menifee Construction Yard.

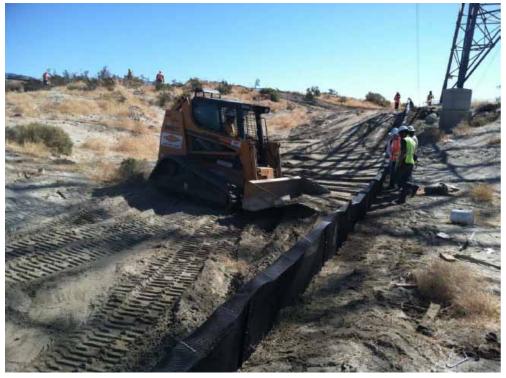
1. During the subject period, exclusionary fencing activities were completed at several locations, including Towers #2201 through #2208, #2211, and #2013. These activities included trenching and installation of fencing (see Figure 2).

Figure 2: Backfilling of trench at Tower #2013 during exclusionary fencing activities.

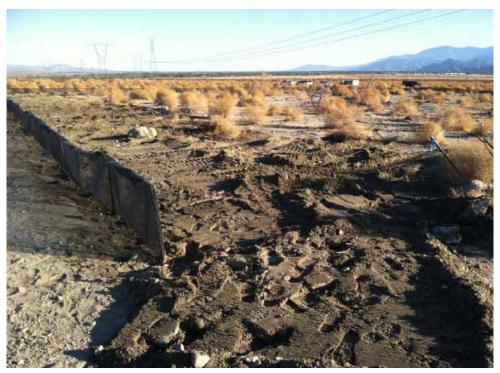
- 3. Secondary containment was reported where appropriate, such as at portable toilet locations.
- 4. No open trenches remained onsite at the end of each workday, including along areas that were only partially completed (see Figure 3).

Figure 3: View southeast along partially completed fencing at Tower #2204. No open trenches were left overnight.

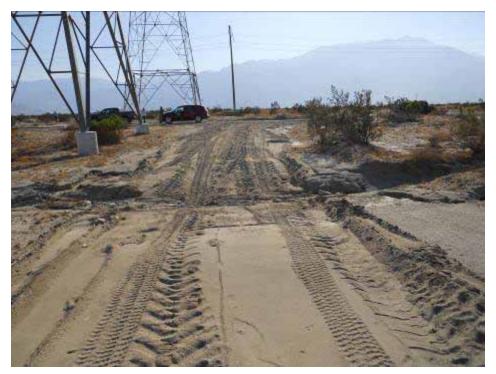
- 5. SCE General Monitor(s) reported that all materials and equipment were picked up and taken offsite for overnight storage.
- 6. On October 19, the CPUC EM reinvestigated the potential jurisdictional drainage at Tower #2101 with Ty Garrison (SCE Biologist). During this investigation, the CPUC EM noted that heavy equipment had been recently driven across the drainage as fresh tracks were observed (see Figure 4). The CPUC EM called SCE to inquire about this incident and it was confirmed that an SCE Operation & Maintenance crew had been in the area earlier that day.

Figure 4: View south along stub road and across potential jurisdictional drainage at Tower #2101. Note fresh equipment tracks crossing drainage that were later confirmed to be the result of O&M crew in the area.

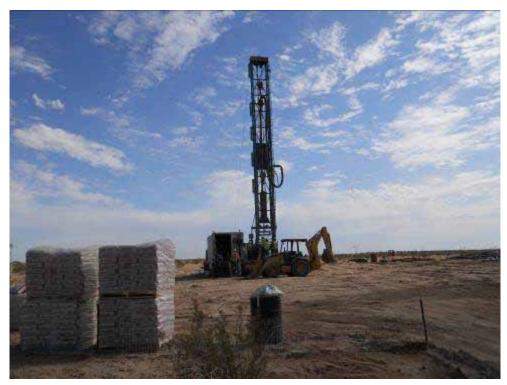
1. Major activities occurring at the Red Bluff Substation during the subject period included the well site preparation, drill rig erection, the drilling of a 50-foot pilot shaft, installation of well conductor casing, and road maintenance and improvement (see Figure 5).

Figure 5: Erection of drill rig at CRS.

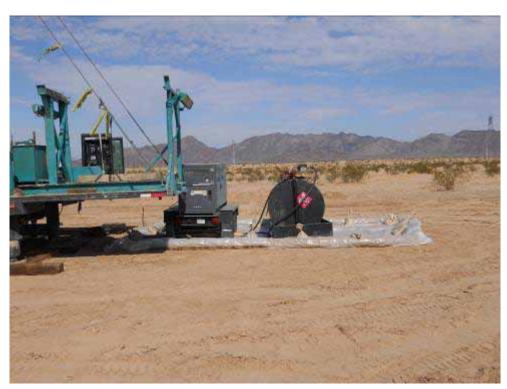
- 2. On October 18, a backhoe and trash pump were observed to be too dirty to enter the site. The SCE General Monitor refused entry and the equipment was removed from the area for cleaning.
- 3. All personnel entering the work area, including delivery drivers, were WEAP trained.
- 4. Clearance surveys for desert tortoise were initiated on October 17 within the fenced portion of the substation site.
- 5. SCE Biological Monitors conducted daily clearance sweeps of work areas and surveyed access routes while vehicles and equipment were mobilizing.
- 6. General BMPs, including secondary containment and dust suppression were inspected and confirmed to be adequate by the CPUC EMs during the subject period (see Figure 6).

Figure 6: Secondary containment confirmed by CPUC EM at CRS. Note plastic sheeting and sandbag containment of generator and fuel tank.

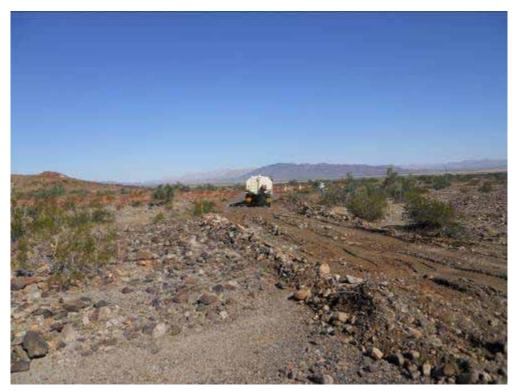
- 2. Rough grading for the eastern substation access road was initiated on October 19 (see Figure 7). A D6-Dozer was used to clear rocks and vegetation within the previously staked boundaries between the existing gas line road and the incised eastern channel just outside the eastern fence line. An access road within the fenced boundaries of the substation site was also roughly graded, starting from the southwest corner and following the southern fence line to the eastern corner. On October 20, a grader was used to smooth the newly constructed road.

Figure 7: Rough grading of eastern access road and dust suppression occurring at Red Bluff Substation site.
