PROJECT MEMORANDUM SCE DPV2 TRANSMISSION PROJECT

To: Billie Blanchard, Project Manager, CPUC
From: Vida Strong, Aspen Project Manager
Date: July 6, 2012
Subject: Weekly Report 47, June 04 to June 10, 2012

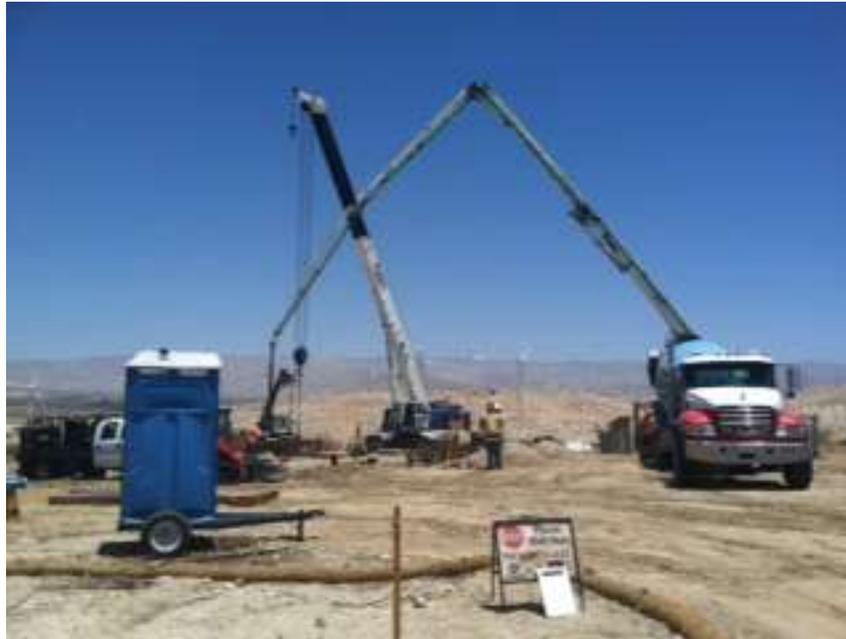
Figure 1. Foundation concrete pouring at Tower 2107

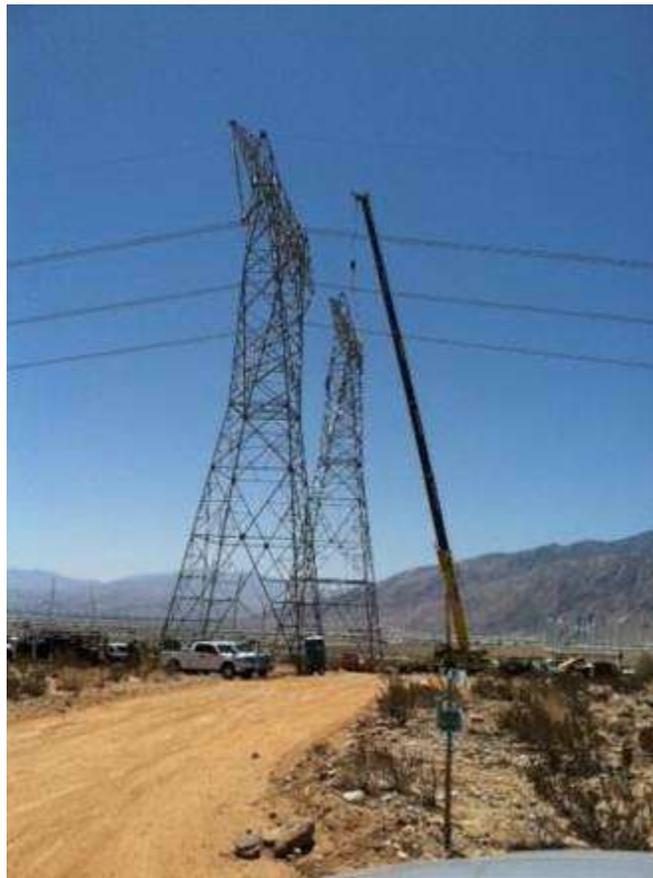
Figure 2. Tower assembly at Tower 1004.

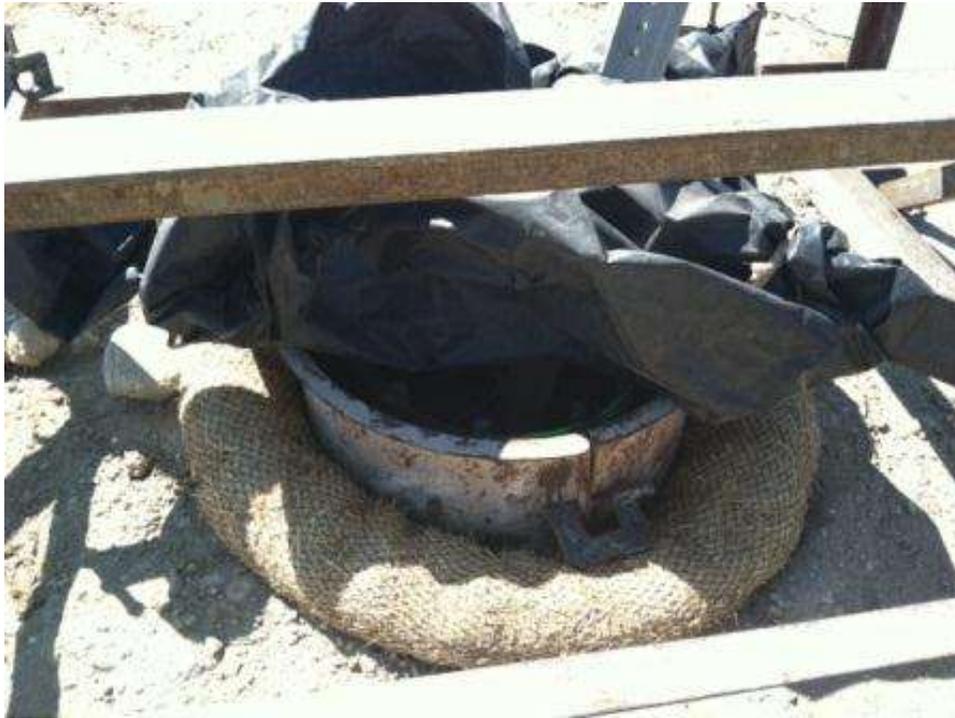
- On June 5, CPUC EM observed inadequate covering of two foundation excavations at Tower 1006. The holes were previously covered with plastic, but high winds blew the plastic off, exposing the hole to wildlife that could fall in (see Figure 3). The CPUC EM notified the SCE EC. Follow-up action was a crew was dispatched to recover the exposed holes. The CPUC EM was notified by the SCE EC when this action was completed and that the crew had been informed to take extra care in covering holes in high wind areas.

Figure 3. Inadequate covering of open excavation at Tower 1006.

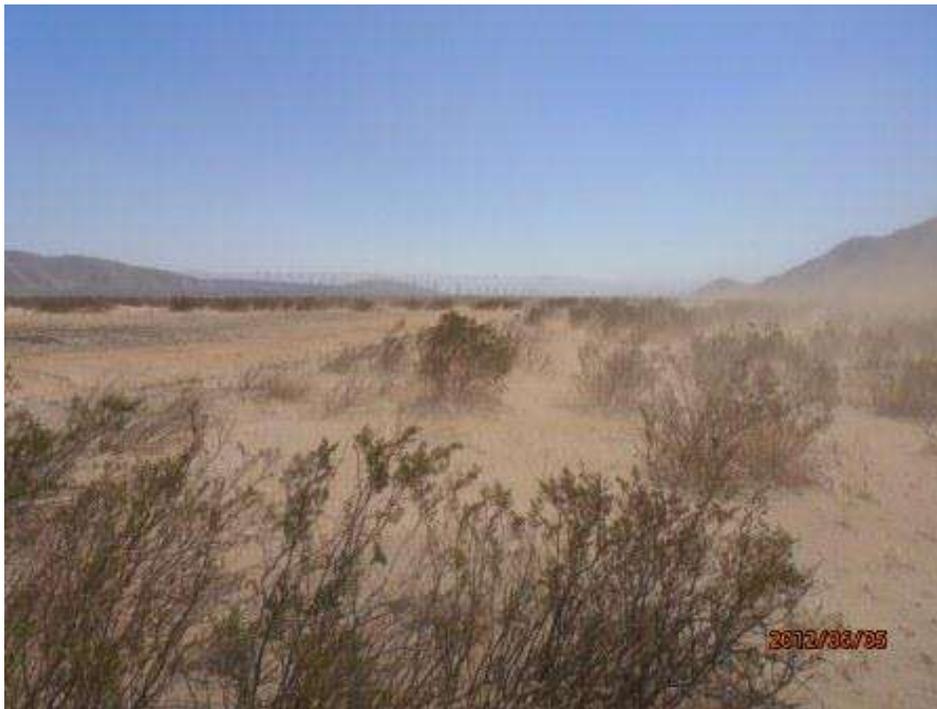
- On June 5, an SCE General Monitor observed clouds of fugitive dust exiting the H1X Landing Zone in excess of 100 feet in height (see Figure 4). The fugitive dust clouds that originated onsite began within 20 minutes of two water trucks watering the entire site.

Figure 4. Fugitive dust leaving Landing Zone H1X (photo courtesy of FRED).

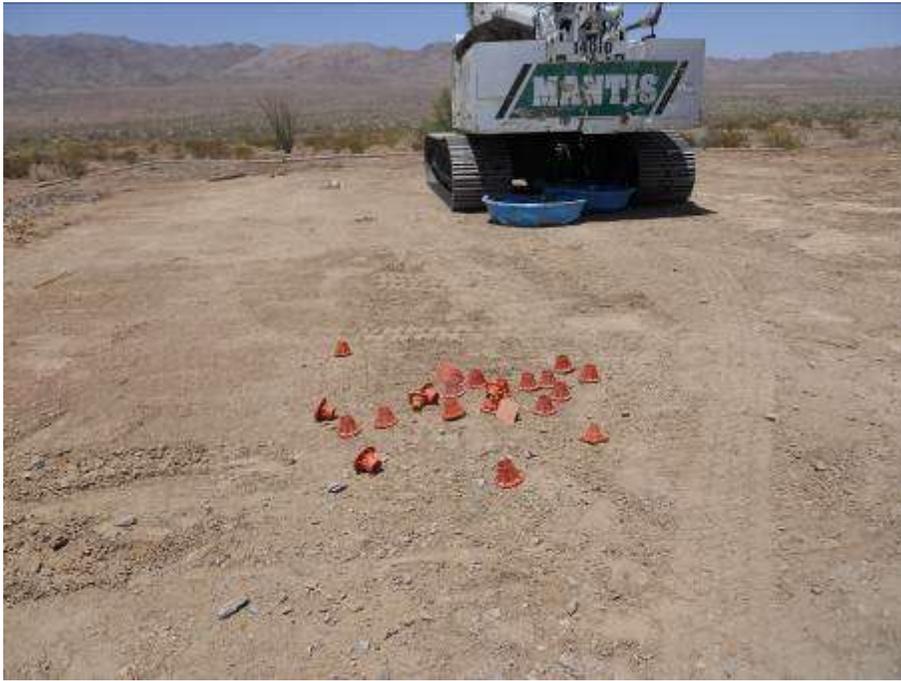
- During a spot check on June 8, the CPUC EM observed several t-post caps left in a pile within the disturbance limits at Tower 2344 after crews had already left the site (see Figure 5). The SCE General Monitor was contacted and he informed the contractor. The caps were removed the same day.

Figure 5. Several t-post caps left at Tower 2344.

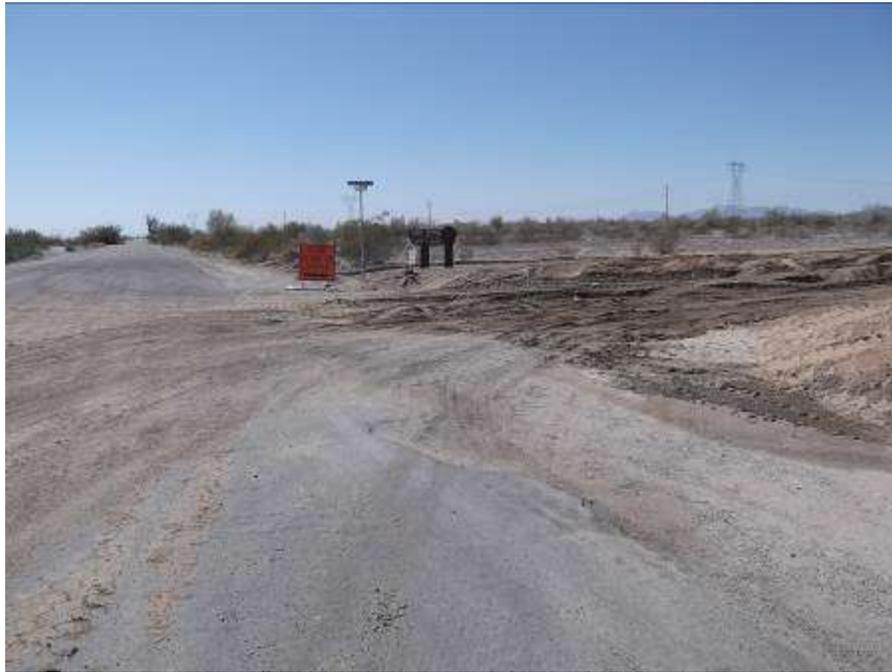
- The CPUC EM observed excessive track-out at the intersection of Chuckwalla Road and Corn Springs Road on June 5 (see Figure 7) near the Series Capacitor site. The SCE General Monitor was notified and a sweeper was used the same day to clean up.

Figure 7. Excessive track-out identified at intersection of Chuckwalla and Corn Springs Roads.

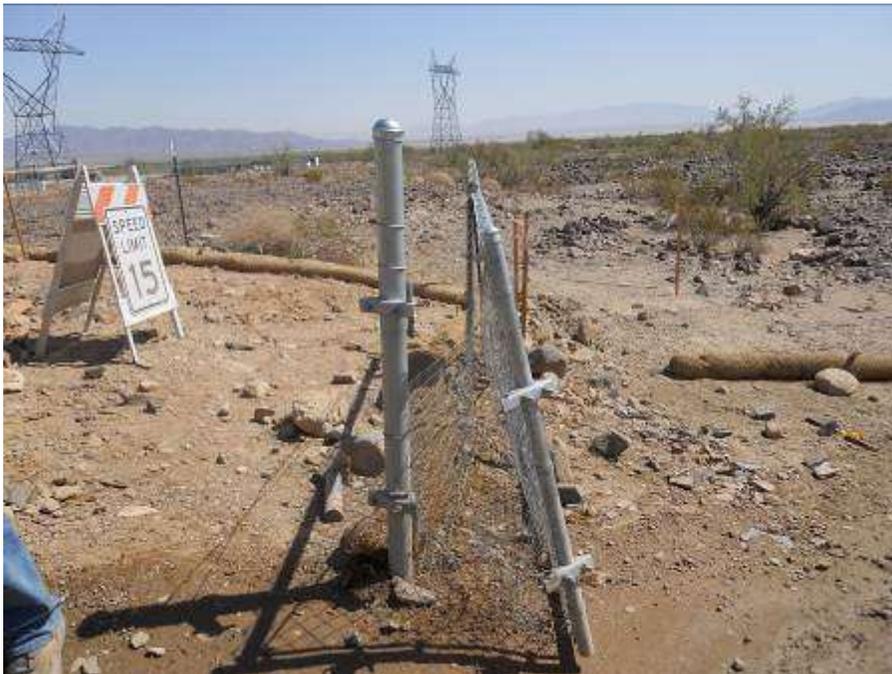
- The eastern entrance gate to the Red Bluff Substation was damaged on June 7 and could not be properly closed as a result (see Figure 8). Due to the substation location within desert tortoise habitat, a SCE Biological Monitor was staged at the location of the damaged fence continuously until repairs were conducted early the following week.

Figure 8. Damaged gate at the eastern entrance to Red Bluff Substation. SCE Biological Monitors were staged at this location until repairs were performed.

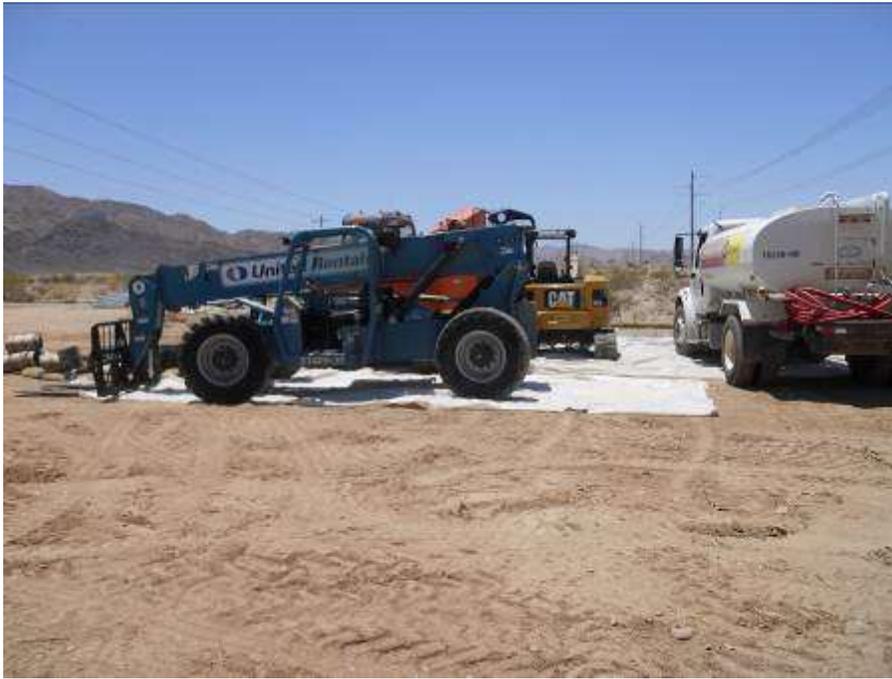
- The CPUC EM and SCE SWPPP Coordinator identified inadequate secondary containment at the Series Capacitor equipment parking area on June 8 (see Figure 9). The SCE General Monitor was notified and the issue was resolved by the contractor the same day.

Figure 9. Inadequate secondary containment at the equipment parking area for the Series Capacitor site.

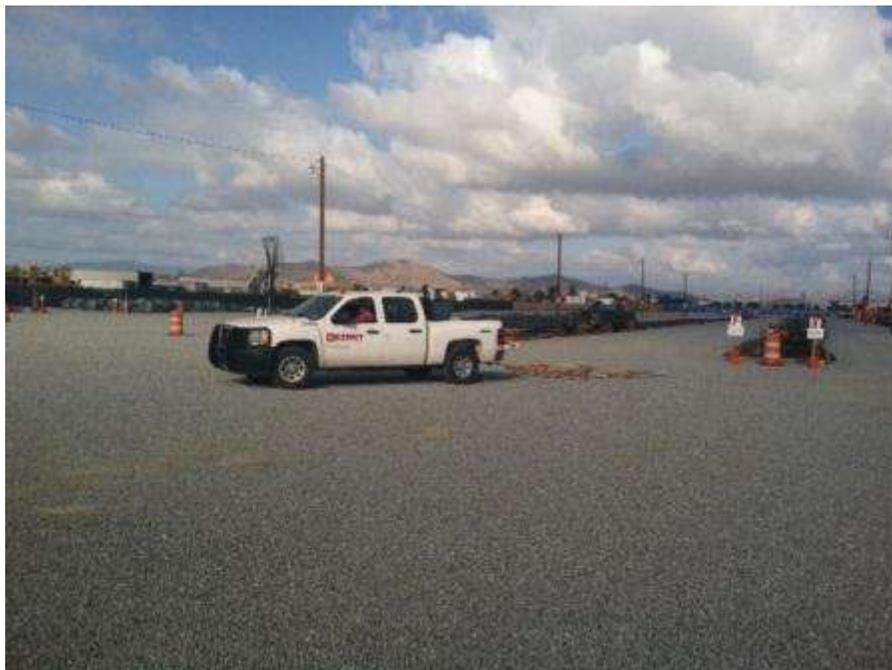
Menifee Yard (Contractor Show-Up Yard) – No construction activities were conducted during the subject period. Activities are limited to minor maintenance, implementation of BMPs, temporary storage of construction equipment and materials, and worker vehicle parking. Gravel in the yard is currently being dragged each day to prevent nesting bird activity in the yard (see Figure 10).

Figure 10. Contractor vehicle dragging a piece of fencing to comb gravel within the Meniffee Yard.
