PROJECT MEMORANDUM SCE DPV2 TRANSMISSION PROJECT

To: Billie Blanchard, Project Manager, CPUC
From: Vida Strong, Aspen Project Manager
Date: August 6, 2012
Subject: Weekly Report 50, June 25 to July 1, 2012

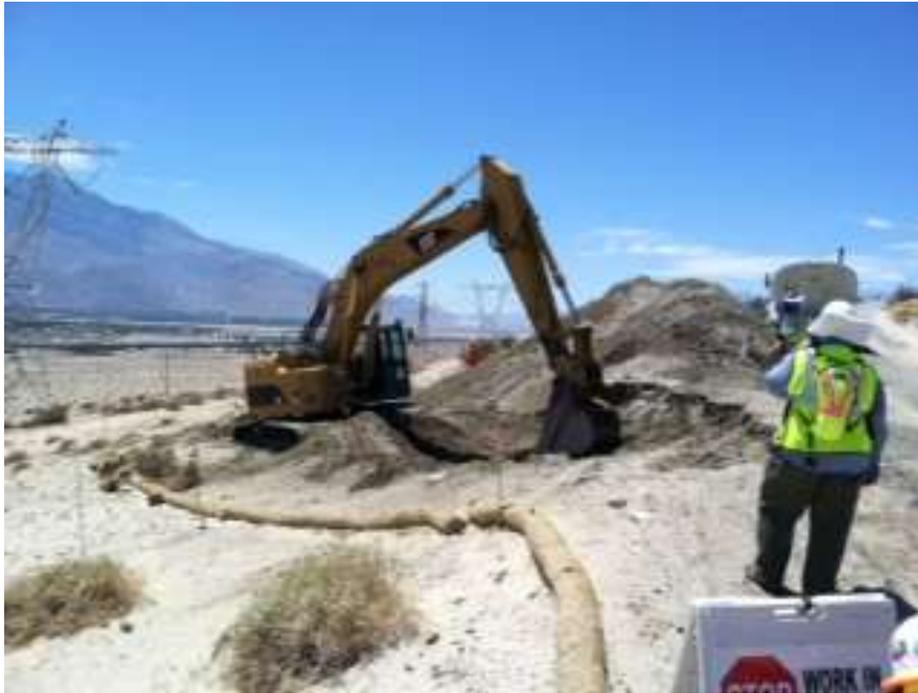
Figure 1. Excavating and grading activities for the spur road into Tower 2117.

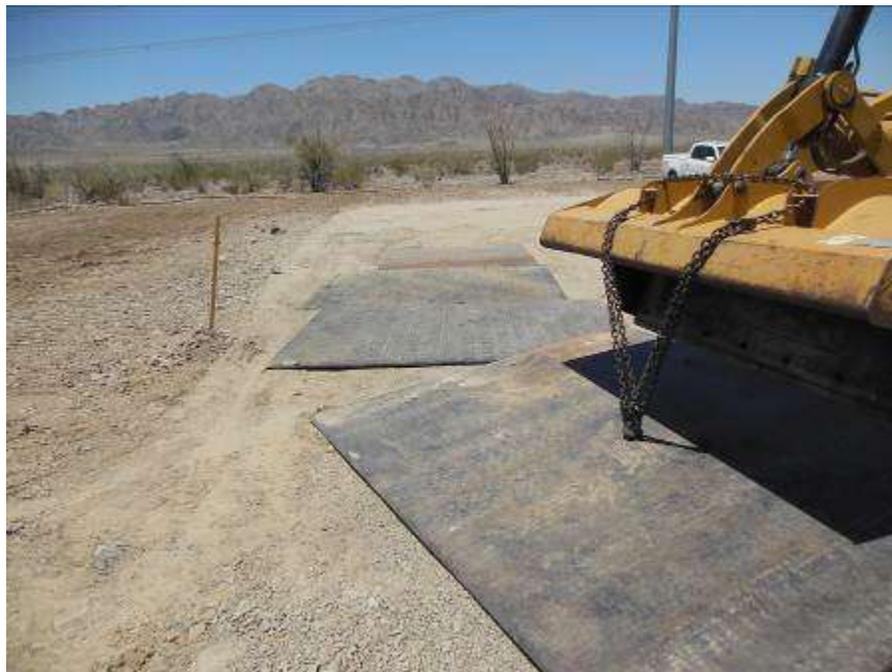
- Shaker plates, trench plates, and/or rock base were installed along necessary spur roads and the right-of-way (ROW) access road at various locations between Dillon and Frontage Roads, and along Gasline and Chuckwalla Roads (see Figure 2).

Figure 2. Installation of trench plates along the spur road to Tower 2415.

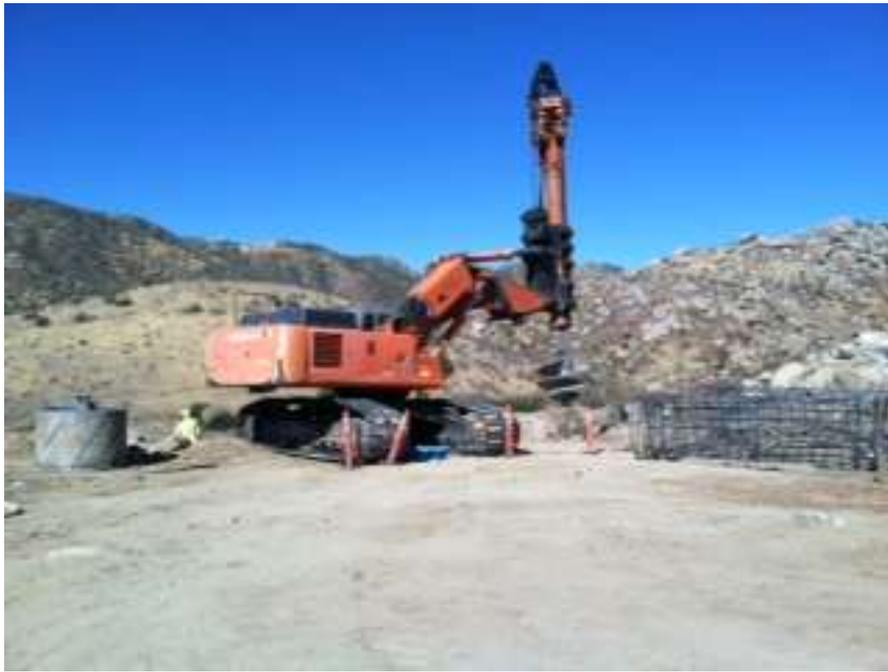
Figure 3. Foundation drilling activities at Tower 1071.

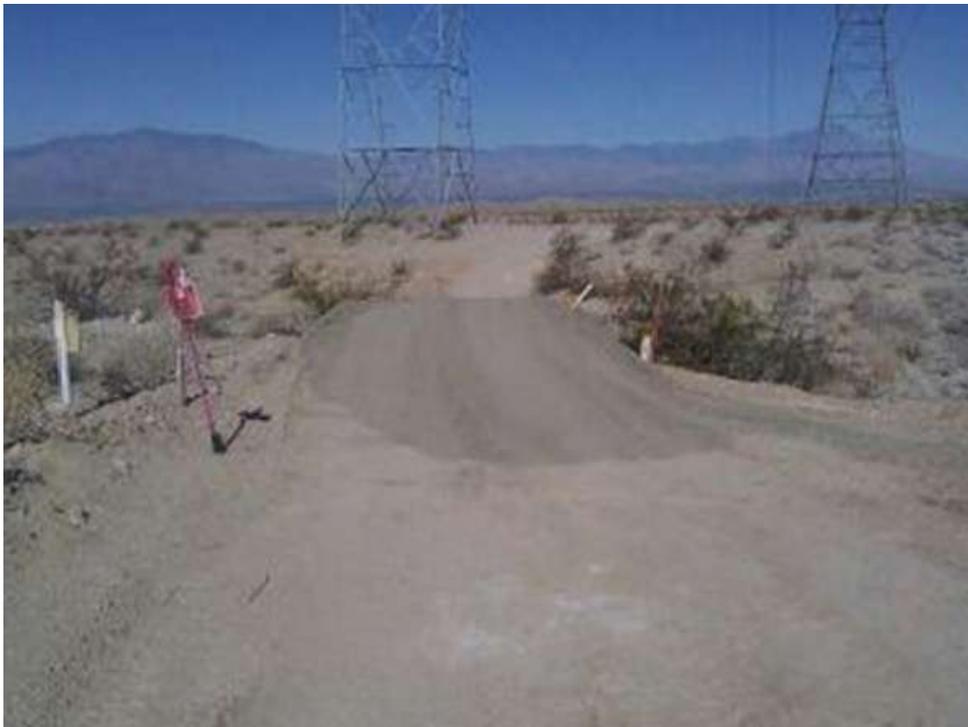
- On June 25, the CPUC EM identified an unapproved road near Tower 2303 where gravel road base had been installed (see Figure 4). The CPUC EM immediately notified the CPUC Lead EM and the SCE Environmental Coordinator (EC) was contacted. Consequently, the CPUC issued Non-Compliance Report (NCR) #4 on July 2, which included conditions to coordinate with the landowner to find a resolution for the road base removal.

Figure 4. Gravel road base installed along an unapproved road near Tower 2303.

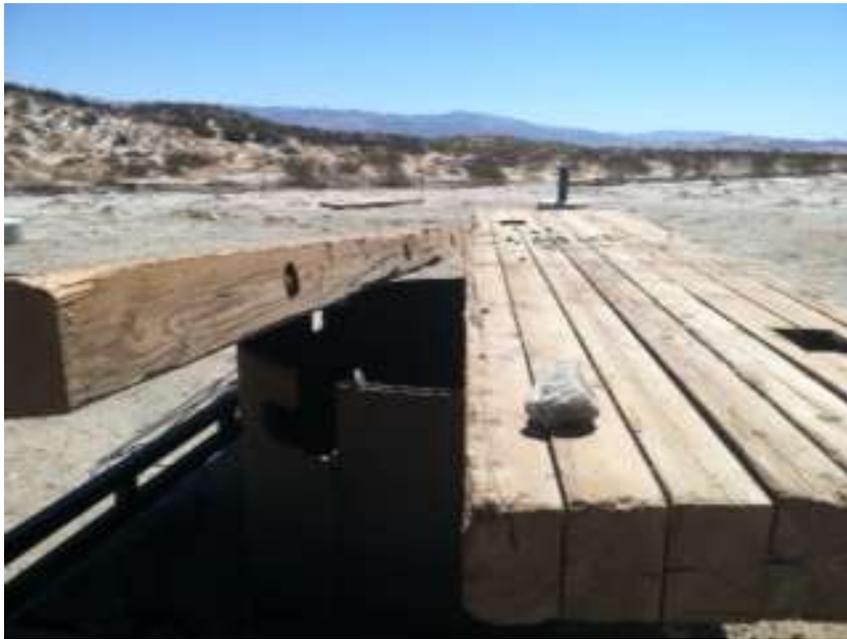
- During the subject period, inadequately covered foundation excavations were observed at Towers 1073, 2015 (see Figure 5), 2204, 2205, and 2443.
 - Upon inspecting Tower 2443 later the same day of the observation, Biologist Monitors reported that the conditions had not changed and unidentified wildlife were detected at the bottom of one of the foundation holes. The following morning, two live traps were lowered into the hole and a little pocket mouse (*Perognathus longimembris*) and unidentified rodent were successfully rescued.

Figure 5. Inadequately covered foundation excavation at Tower 2015.

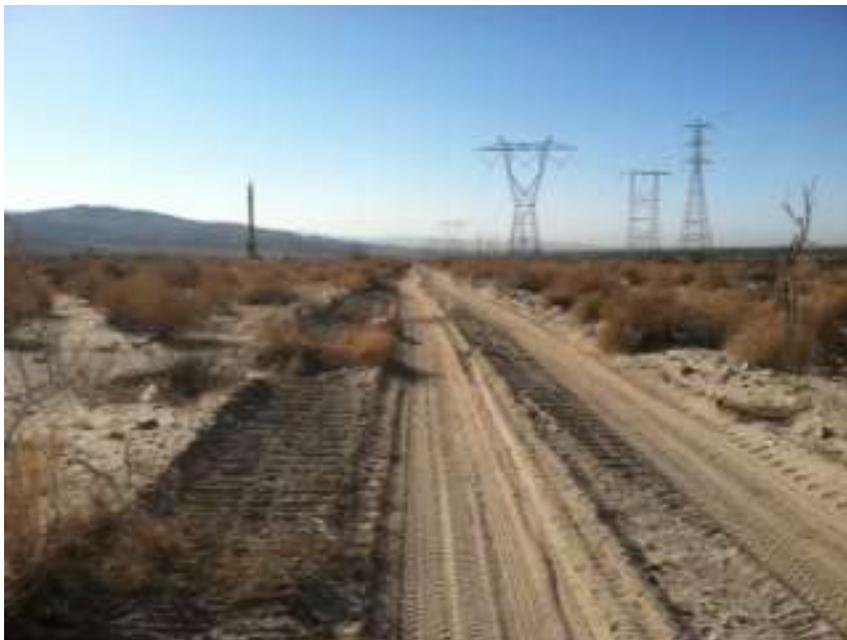
Figure 6. Impacts outside of the approved access road width between Towers 2204 and 2205 within the Coachella Valley Preserve.

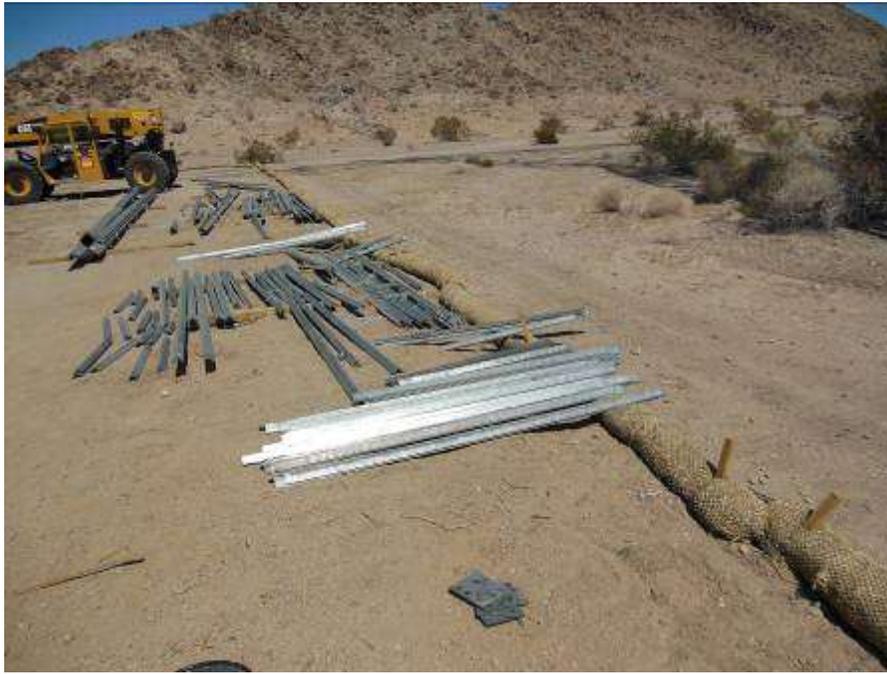
- On June 28, the CPUC EM notified the SCE General Monitor of concerns associated with tower hardware placed on top of straw wattle BMPs at Tower 2409 (see Figure 7). The SCE General Monitor contacted the SWPPP Coordinator who confirmed that the hardware should not be staged in a manner that could damage BMPs. The SCE General Monitor notified the contractor and the hardware was relocated to another area within the disturbance limits.

Figure 7. Tower hardware placed across BMPs at Tower 2409.

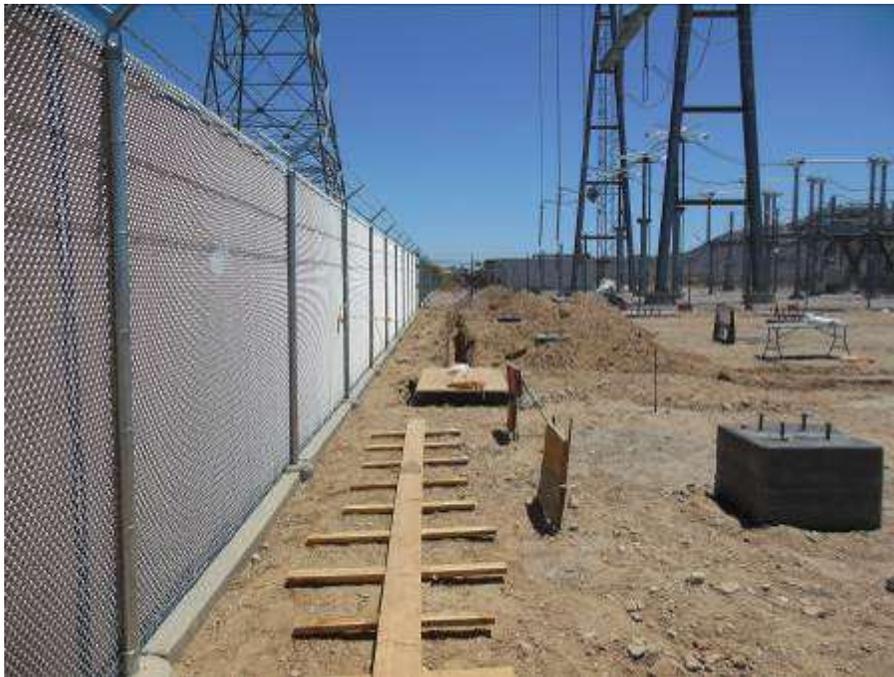
2. CRS Telecomm Line (BLM and Private Lands) – No major activities were conducted along the CRS telecomm line during the subject period.
3. Series Capacitor (BLM Lands) – Activities associated with the expansion of the existing Series Capacitor site included site grading, ground wire trenching, and foundation construction (see Figure 8).

Figure 8. Trenching for ground wire installation at the Series Capacitor site.

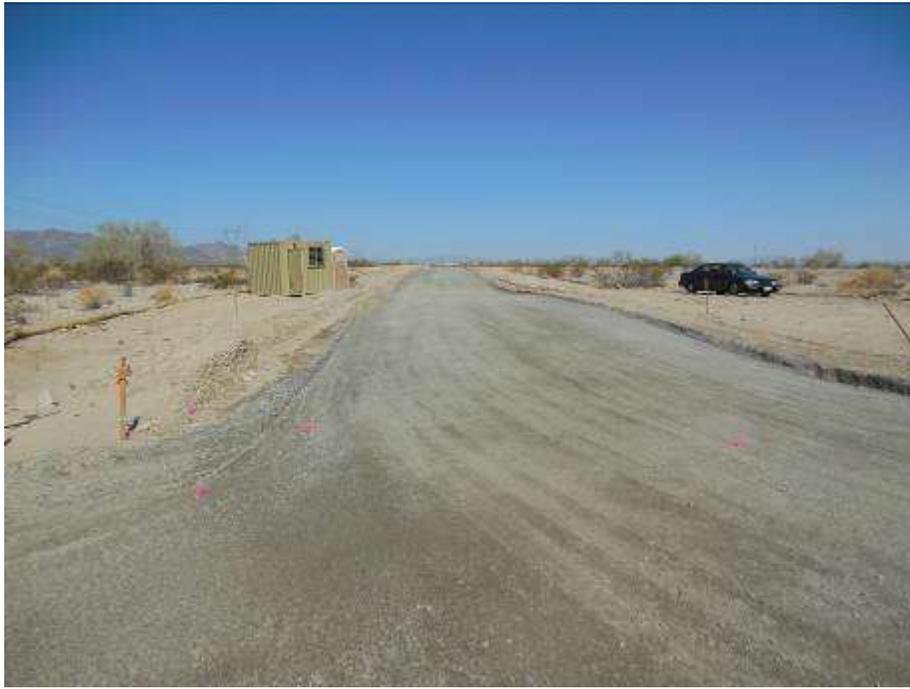
4. Red Bluff Substation (BLM Lands) – Activities that were conducted at the Red Bluff site included ongoing grading of cut and fill areas, installation of drainage structures, and rock crushing of native fill. Well development, involving pumping of the well, continued throughout the subject period. Activities that were conducted along the primary access road between Corn Springs Road and the substation eastern access road included grading, installation of gravel road base, and culvert and drainage improvements (see Figure 9). BMP installation and maintenance continued, as required.

Figure 9. View west along Red Bluff access road where gravel road base has been installed.

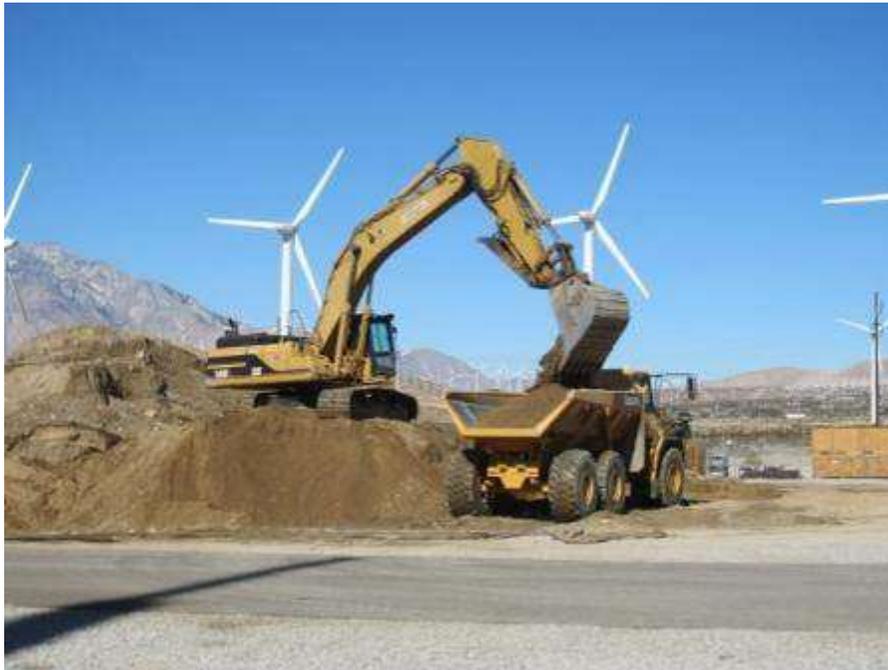
5. Devers Substation – Soil that had been stockpiled within the existing substation was moved by a dump truck and a skip loader into the expansion area and graded and compacted (see Figure 10). Concrete was also removed from areas within the existing substation to accommodate a new road that will be built.

Figure 10. Stockpiled soil being transported from within the existing Devers Substation to the expansion area.
