PROJECT MEMORANDUM SCE DPV2 TRANSMISSION PROJECT

To: Billie Blanchard, Project Manager, CPUC
From: Vida Strong, Aspen Project Manager
Date: August 13, 2012
Subject: Weekly Report 51, July 2 to July 8, 2012

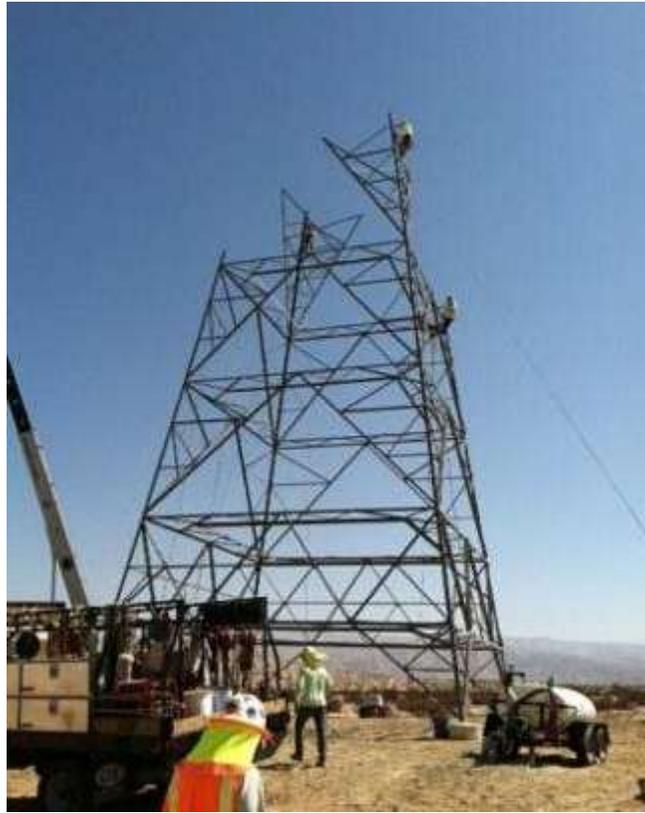
Figure 1. Tower assembly at Tower 2104.

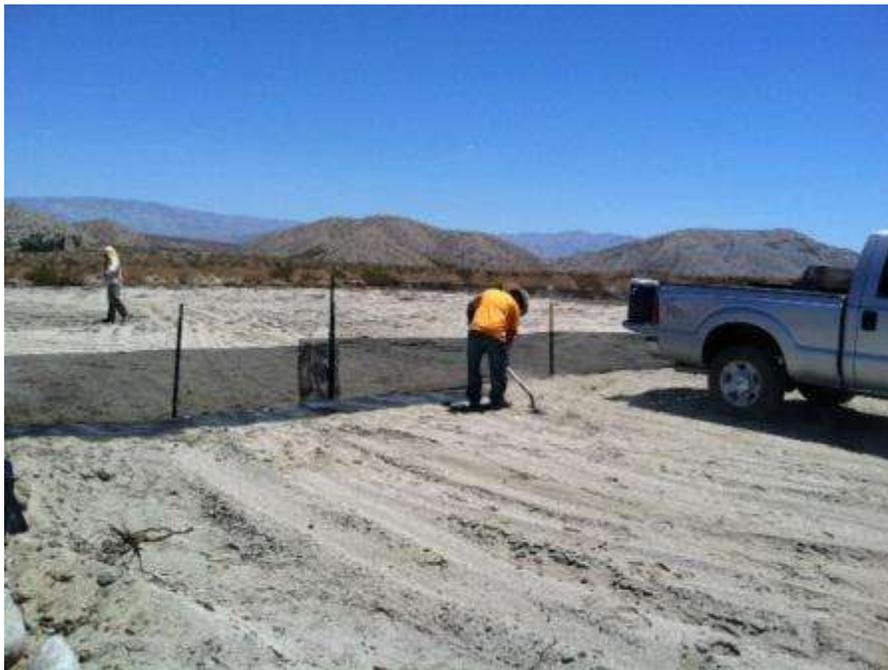
- Shaker plates, trench plates, and/or rock base were installed at various locations between Dillon and Frontage Roads, and along Gasline Road.
- Exclusion fencing for tower sites in Coachella Valley Fringe-toed Lizard habitat was repaired at Towers 2201, 2202, 2204, 2205, 2206, 2207, 2208, 2209, and 2210 (see Figure 2).

Figure 2. Coachella Valley fringe-toed lizard exclusion fencing repair at Tower 2104.

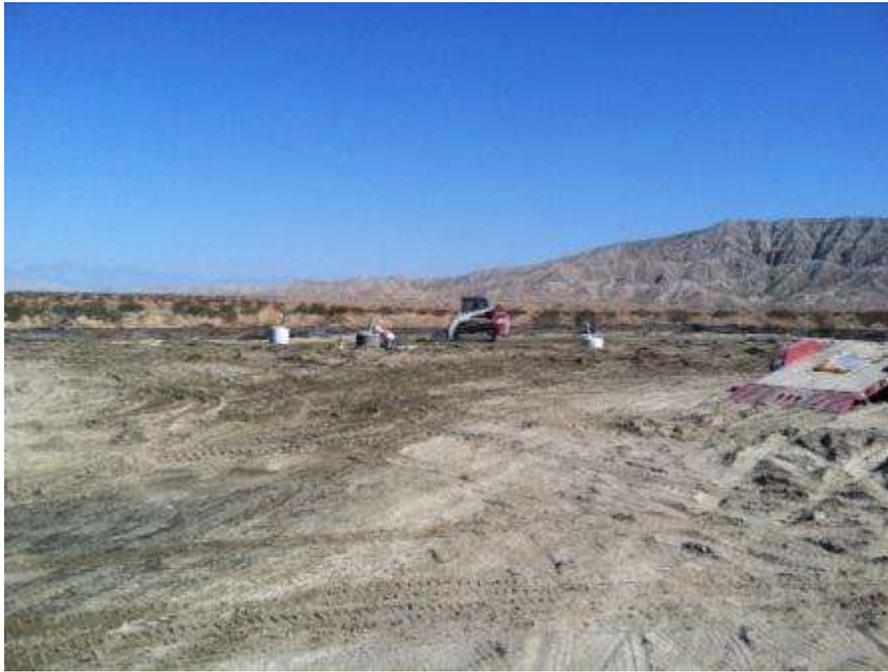
Figure 3. Grading for the spur road and crane pad at Tower 1003.

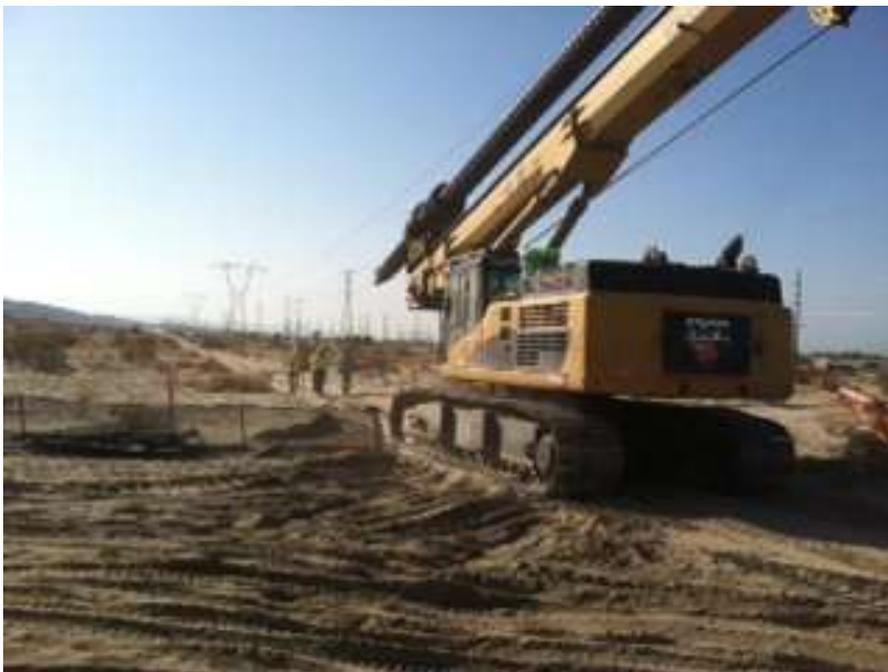
Figure 4. Drill rig being moved from Tower 2209 to Tower 2212 using both construction and biological monitor spotters to prevent off road impacts.

- On July 2, the CPUC issued NCR #5 for impacts outside of the approved road width between Towers 2204 and 2205 within the Coachella Valley Preserve. As a preventative measure SCE implemented the use of spotters to accompany drill rigs along the right-of-way (ROW) to ensure equipment stayed within the approved road limits. On July 3, CPUC EMs observed a drill rig being moved from Tower 2209 to Tower 2212 with the use of both construction spotters and Biological Monitors (see Figure 4). SCE's response to NCR#5 included an environmental stand-down scheduled for July 14, enhanced construction readiness by personnel evaluating road widths in upcoming construction areas, and enhanced WEAP training.

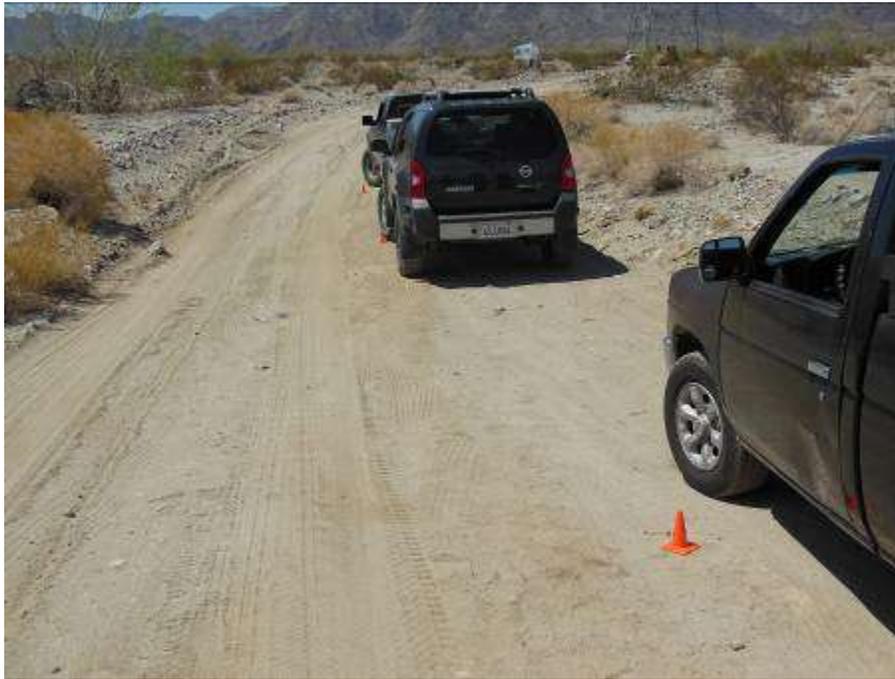
- On July 5, the CPUC EM observed small orange cones located underneath all vehicles associated with the vegetation clearing crew at Tower 2536 (see Figure 5). The orange cones are being used as a reminder to inspect underneath vehicles for wildlife prior to moving.

Figure 5. Orange cones placed near vehicles to remind personnel to inspect underneath for wildlife.

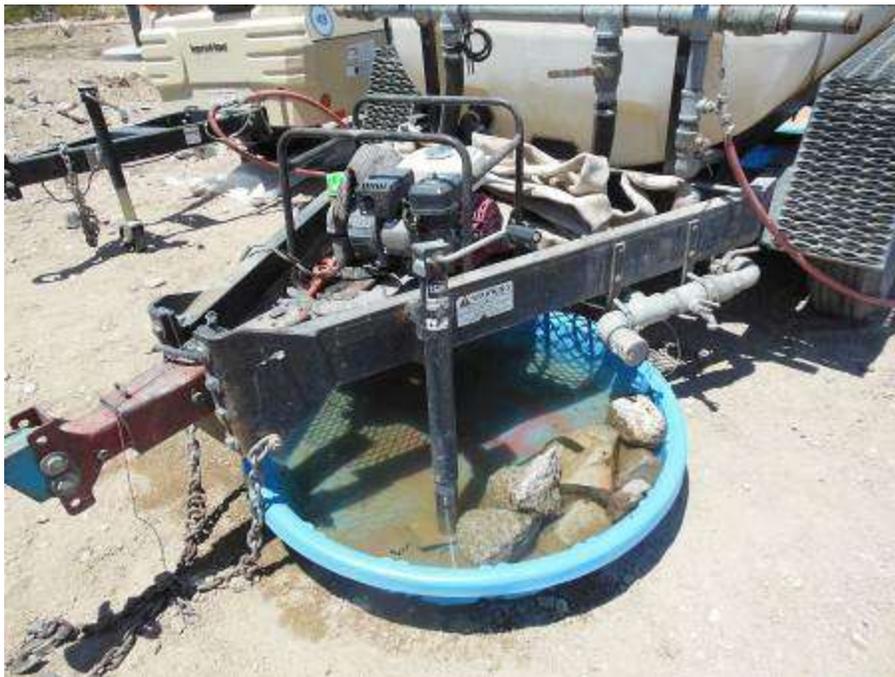
- On July 5, the CPUC EM observed that a kiddie pool being used for secondary containment underneath a water buffalo was filled with water at Tower 2526 (see Figure 6). The CPUC EM notified the onsite SCE Biological Monitor. The SCE Biological Monitor informed the CPUC EM that the water was observed in the pool during the morning sweep, indicating that the water was left in the pool overnight. The contractor identified that the water was leaking from the water buffalo only when the machine was operating. As a resolution, the water in the kiddie pool was spread within the disturbance limits as necessary to avoid filling the pool and leaving any standing water.

Figure 6. Kiddie pool observed filled with water at Tower 2526.

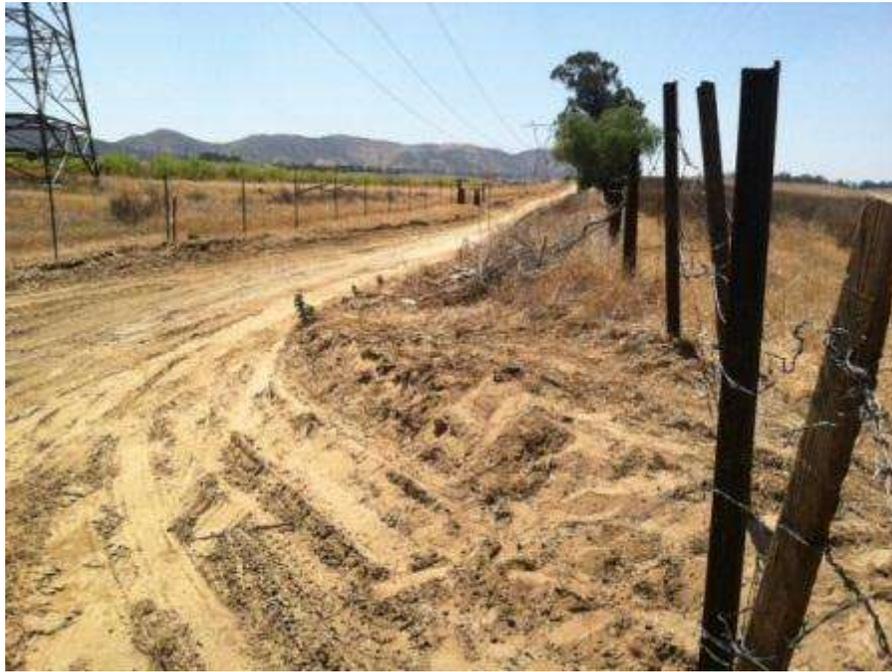
- On July 6, the CPUC EM was informed that a contractor delivery truck went outside of the approved access road at Tower 1083. Upon arriving at the site, the CPUC EM found tracks well over the berm of the road where two posts of the gate were removed to allow the truck access to the site (see Figure 7). Upon approaching the Monitor at Tower 1083 the Monitor was unaware that an incident had occurred. The CPUC LEM notified the SCE Environmental Coordinator (EC) of the incident immediately. NCR #6 was issued on July 6. This was the second NCR issued for impacts outside of the approved road limits during the same subject time period. To date, SCE has only recorded this incident as an observation.

Figure 7. Impacts outside of the approved road width at the entrance to Tower 1083.

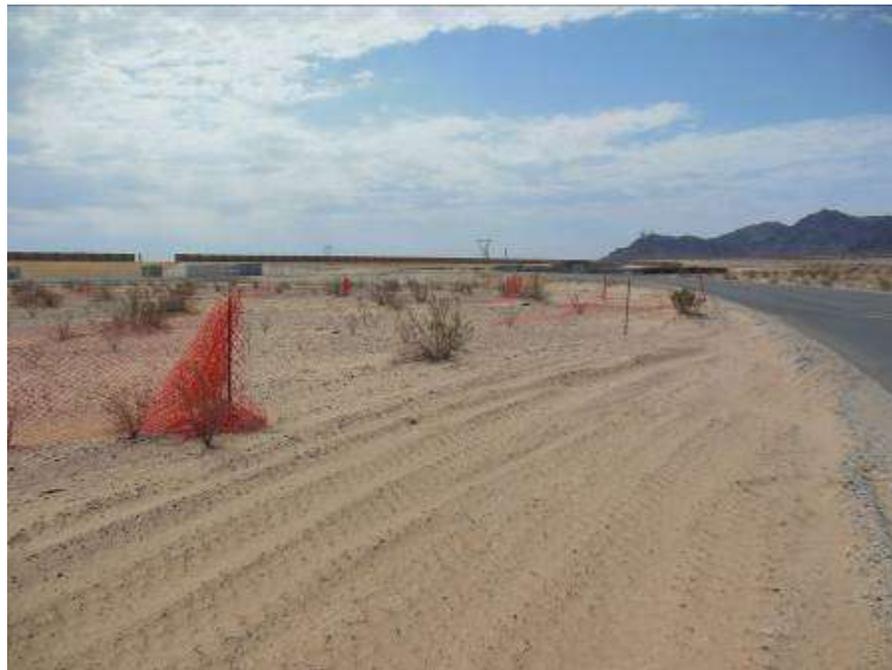
- On July 3, the CPUC EM observed several Environmentally Sensitive Area (ESA) locations adjacent to the CRS access road with damaged exclusionary fencing (see Figure 8). The CPUC EM notified the SCE EC. The SCE EC relayed the concern to the construction site representative and the fencing was repaired.

Figure 8. Damaged ESA fencing along CRS access road.

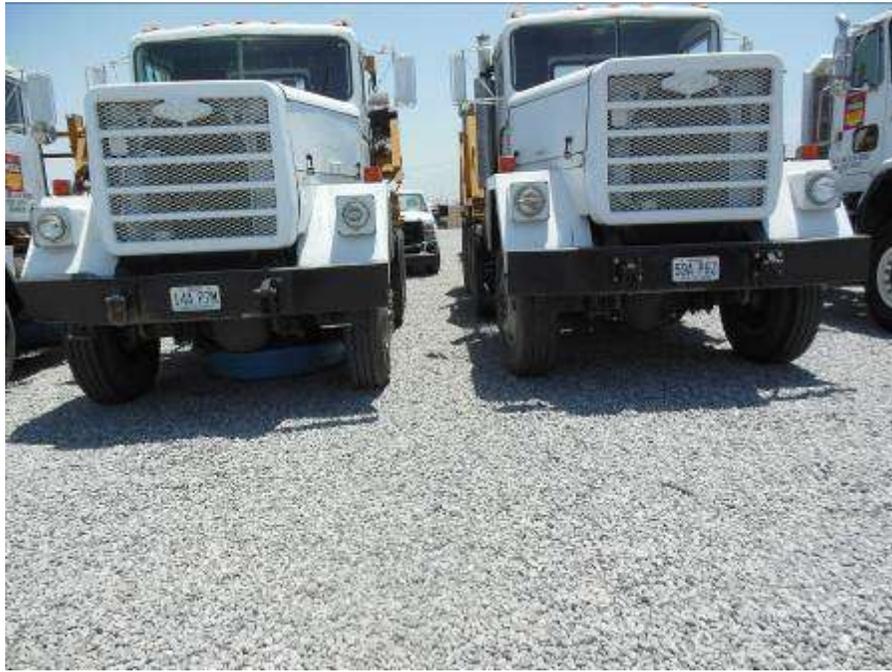
- On July 3, the CPUC EM identified several concerns at the PAR Desert Center 2 and Indio 2 Yards. These included inadequate secondary containment and improper covering of trash receptacles (see Figure 9). The CPUC EM notified the SCE General Monitor who observed and reported the same concerns. Consequently, PAR has informed SCE and the CPUC that personnel would be hired to specifically monitor construction yards to ensure that proper implementation of project mitigation measures and SWPPP conditions are met. At the time that this weekly report was prepared, the CPUC has not yet received information that fully details the implementation of these monitors.

Figure 9. Trucks parked at Indio 2 Construction Yard. Note lack of secondary containment under truck on left of photo.

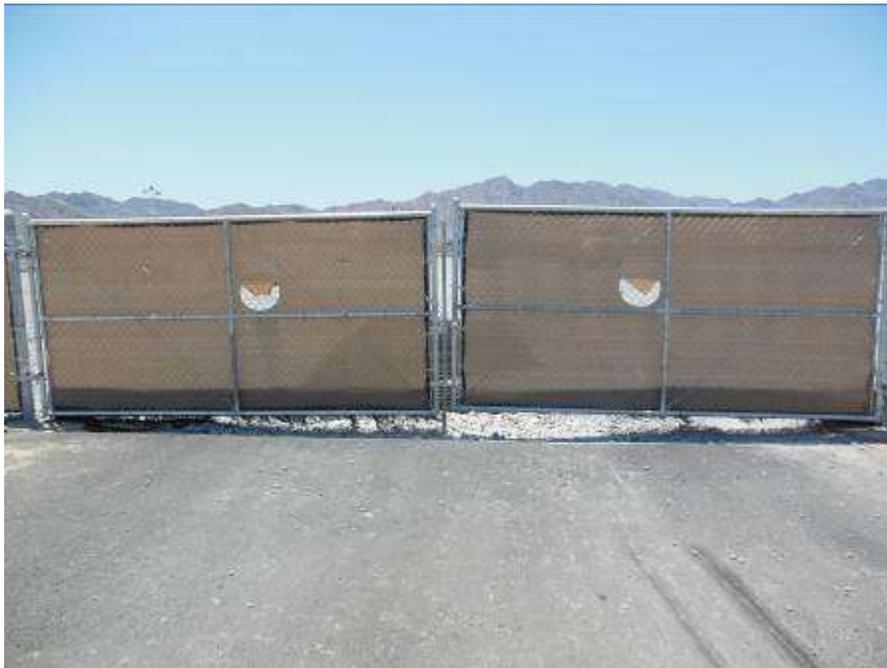
- On July 3, the CPUC EM observed damaged desert tortoise exclusionary fencing on the entrance gate to the PAR Desert Center 2 yard, resulting in a substantial gap that could allow tortoises to enter (see Figure 10). The CPUC EM notified the SCE Subject Matter Expert and the fencing was repaired.

Figure 10. Substantial gap underneath entrance gate at PAR Desert Center 2 Construction Yard.
