PROJECT MEMORANDUM SCE DPV2 TRANSMISSION PROJECT

To: Billie Blanchard, Project Manager, CPUC
From: Vida Strong, Aspen Project Manager
Date: August 29, 2012
Subject: Weekly Report 55, July 30 to August 5, 2012

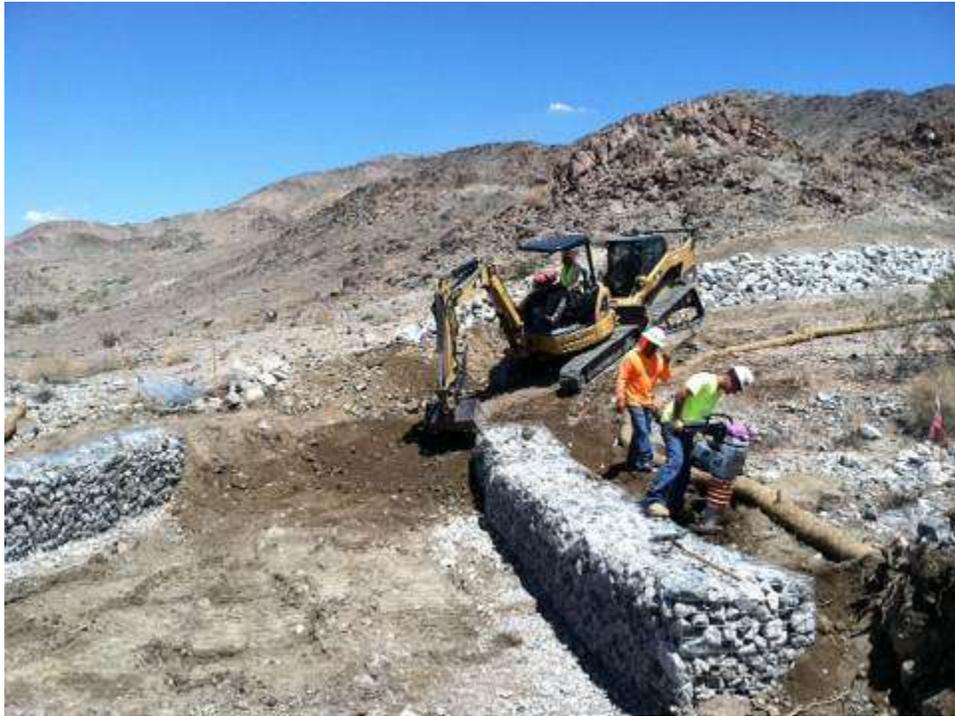
Figure 1. Wet crossing installation at Tower 2325.

- Spur road and crane pad grading occurred at Towers 2123, 2224, 2225, 2244, 2245, 2246, 2247, 2304, 2321, 2325, 2344, 2345, 2346, 2347, 2349, and HLZs H4 and H1E (see Figure 1).

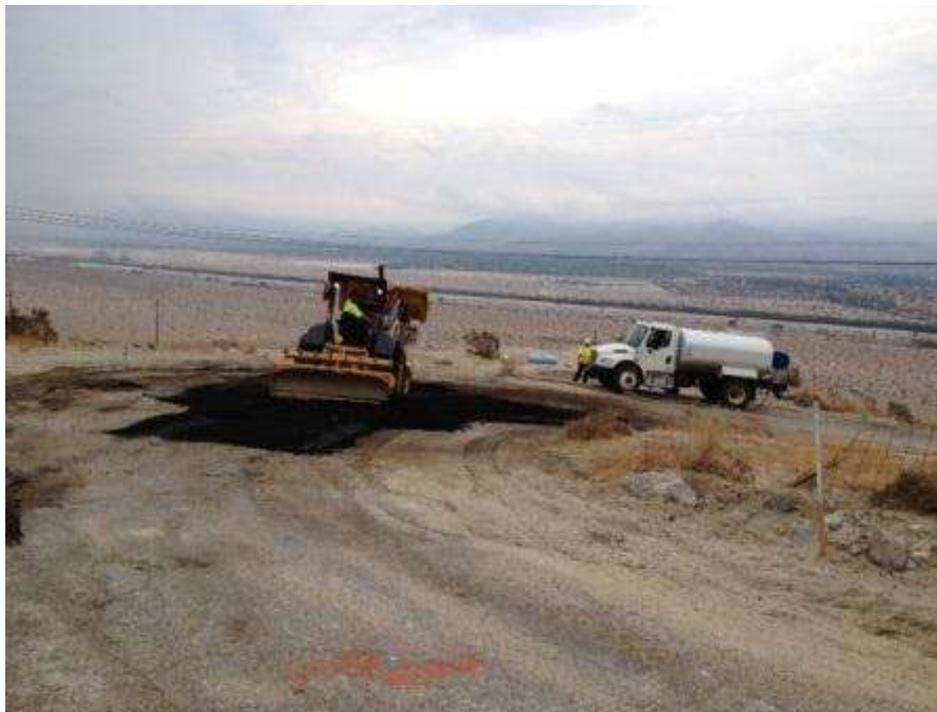
Figure 2. Asphalt repair on the access road to Tower 2117. (Photo Courtesy of FRED)

- Access road repair occurred near Tower 2117, between 2264 and 2302, between 2239 to 2248, and between 2317 to 2327 (see Figure 2).
- Tower foundation drilling activities occurred at Towers 2248, 2250, 2253, 2254, 2255, 2256, 2257, 2258, 2259, 2262, 2266, 2268, 2456, 2458, 2500, and 2501 (see Figure 3).

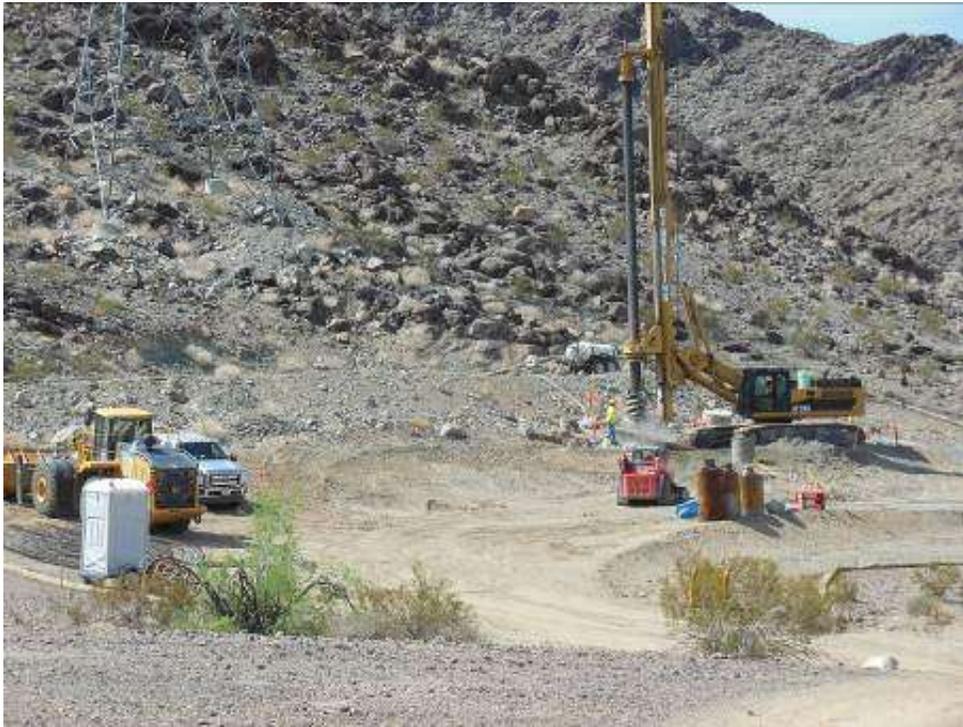
Figure 3. Drilling activities at Tower 2456.

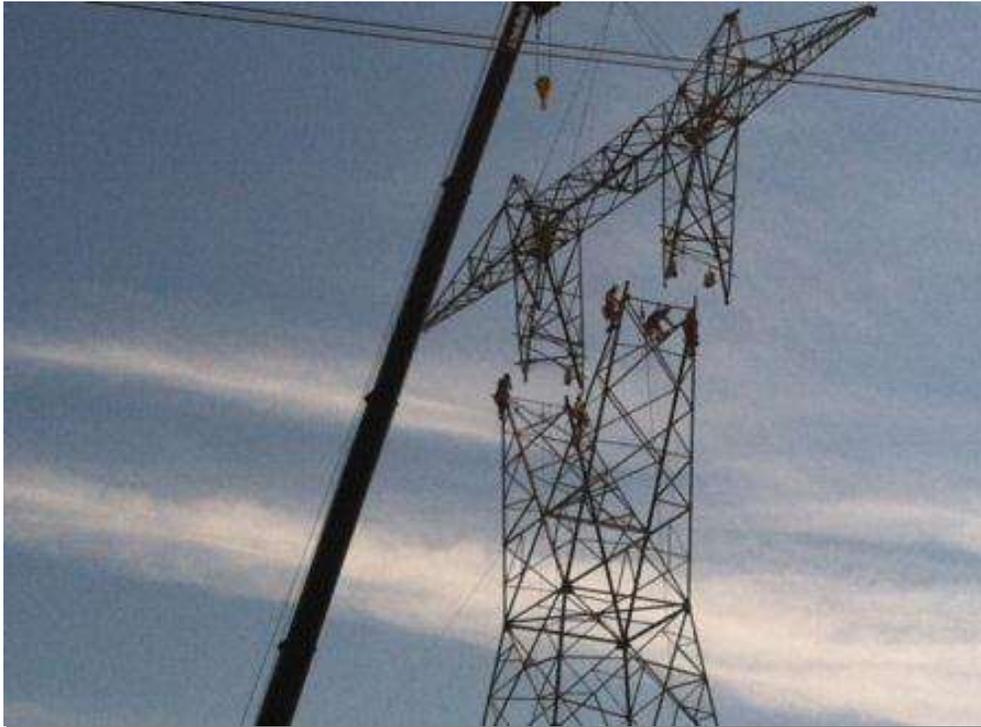
Figure 4. Tower Bridge erection at Tower 2127.

- Tower assembly and/or steel deliveries occurred at Towers 2122, 2123, 2124, 2125, 2126, 2127, 2128, 2129, 2131, 2132, 2133, 2134, 2209, 2210, 2211, 2212, 2213, 2315, 2317, 2333, 2334, 2335, 2402, 2403, 2405, 2406, 2408, 2409, 2410, 2411, 2427, 2429, 2437, 2438, 2445, 2512, 2513, 2514, 2515, 2518, 2543, RB2-3E, and RB2-5E (see Figure 4).

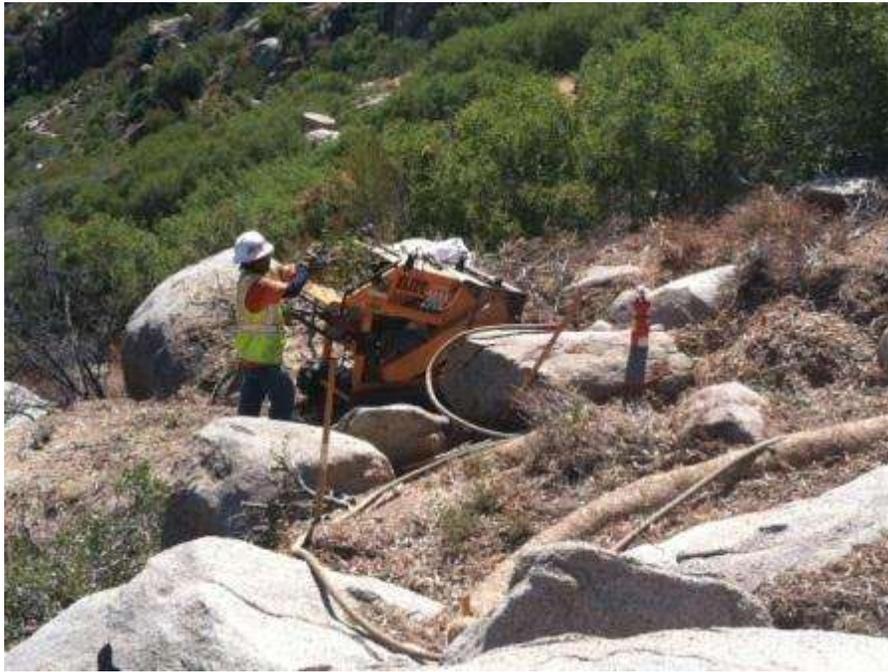
Figure 5. Vegetation clearing at Tower 1044.

- The installation of BMPs occurred at Tower 1045.
- Vegetation clearing occurred at Towers 1044 and 1045 (see Figure 5).

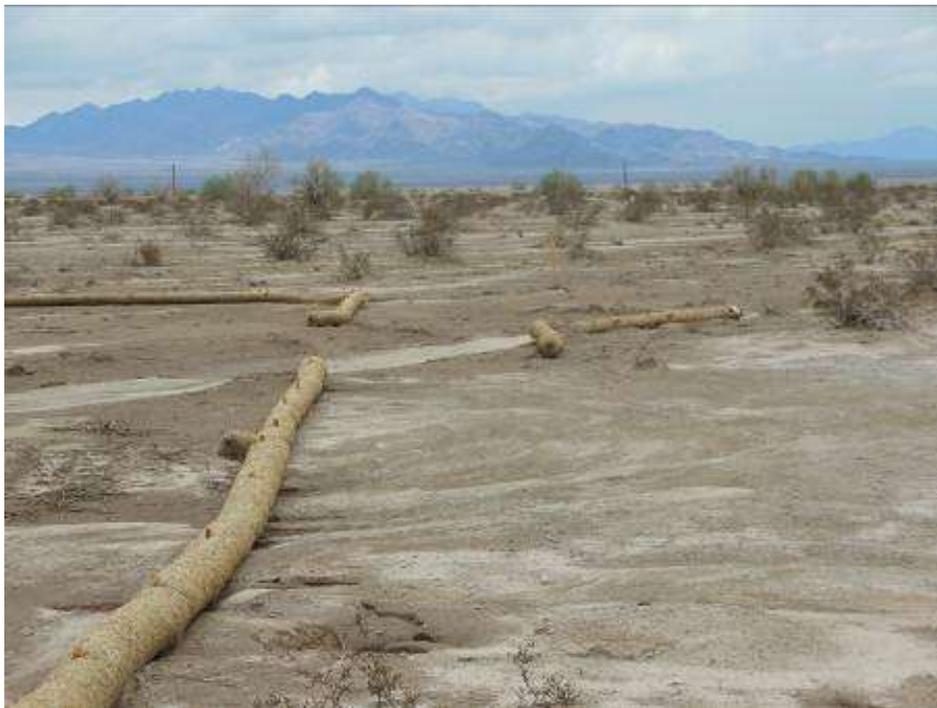
- As a result of a significant monsoonal storm that occurred on July 31, BMPs located at several tower disturbance areas were damaged (see Figure 6). PAR Electric dispatched maintenance crews throughout the subject period to remediate damages where required.

Figure 6. Storm damage to BMPs at Tower 2608.

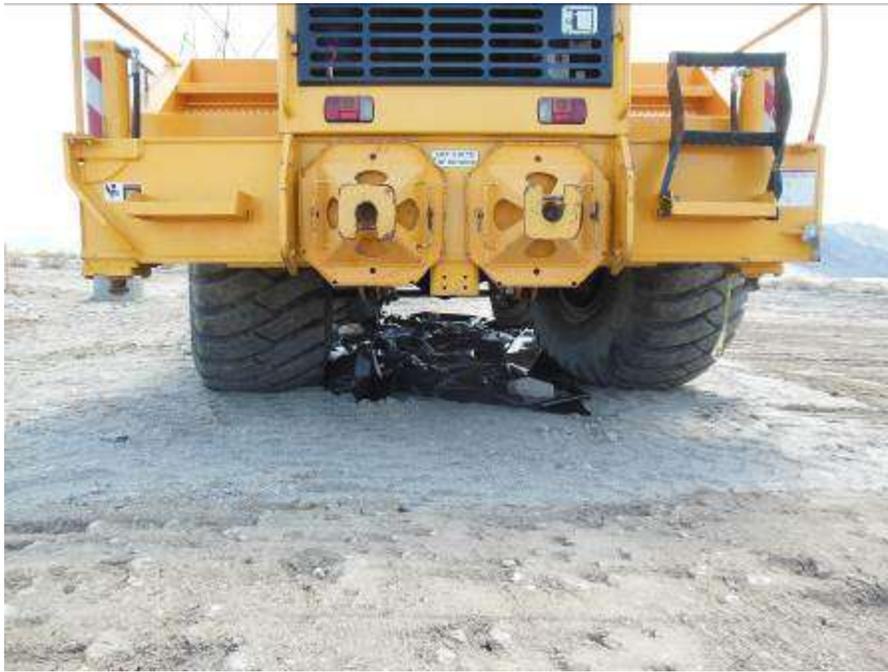
- There were four reported incidents associated with working without a Biological Monitor present during the subject period.
- There were five reported incidents by the CPUC EM and FRED associated with improper implementation of SWPPP conditions, including inadequate/damaged secondary containment during the subject time period (see Figure 7).

Figure 7. Plastic sheeting used for inadequate secondary containment at Tower RB2-3E.

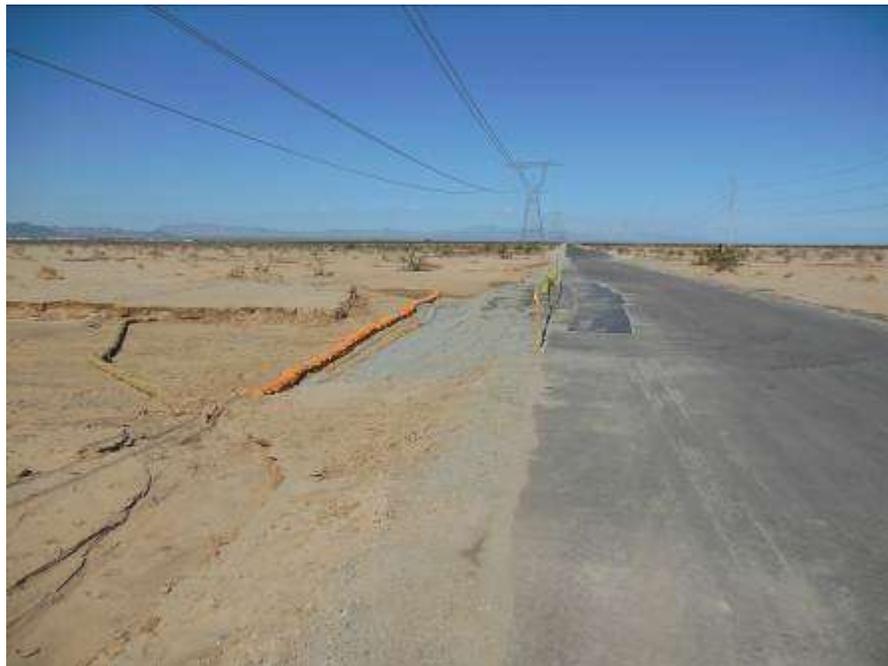
1. Colorado River Substation (CRS) (BLM Lands) – Activities associated with the development of the CRS site included the closeout of wall panel installation and jute netting of slopes. Package 2 construction activities, including foundation development, were initiated. Due to storm damage that occurred during the subject period, maintenance and repair activities were conducted along the CRS access road (see Figure 8).

Figure 8. Storm repairs were conducted along the CRS access road.

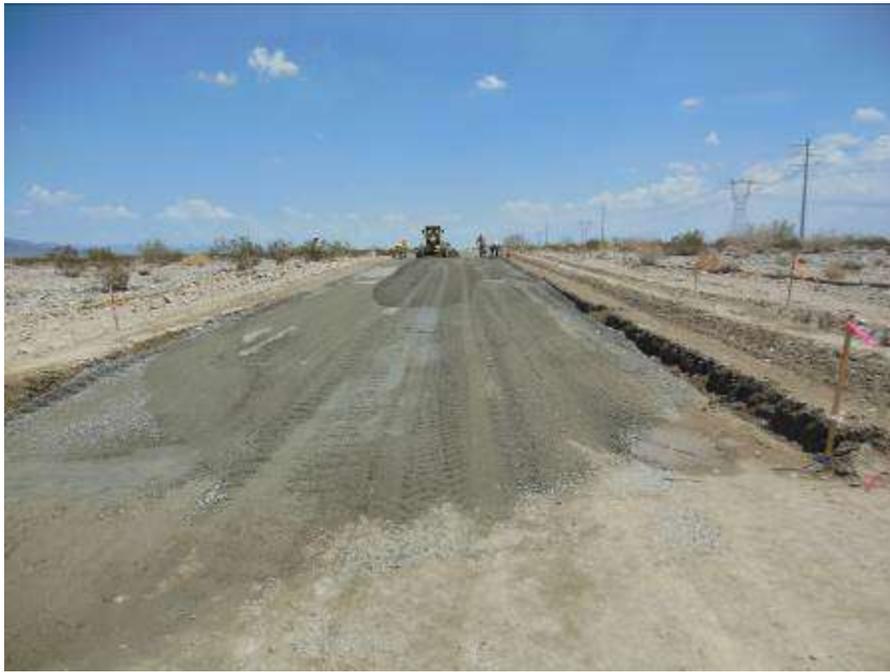
Figure 9. Road base installation continued along the Red Bluff access road.

4. Red Bluff Substation (BLM Lands) – Activities that were conducted at the Red Bluff site included ongoing grading of cut and fill areas, installation of drainage structures, rock crushing of native fill, and erection of the perimeter wall. Well development, involving pumping of the well, continued throughout the subject period. Activities that were conducted along the primary access road between Corn Springs Road and the substation eastern entrance included grading, installation of gravel road base, and culvert and drainage improvements (see Figure 9). Mobilization activities associated with the Package 2 construction phase continued. BMP installation and maintenance continued, as required.
