**PROJECT MEMORANDUM  
SCE DPV2 TRANSMISSION PROJECT**

**To:** Billie Blanchard, Project Manager, CPUC  
**From:** Vida Strong, Aspen Project Manager  
**Date:** April 11, 2013  
**Subject:** Weekly Report 87, March 11 to March 17, 2013

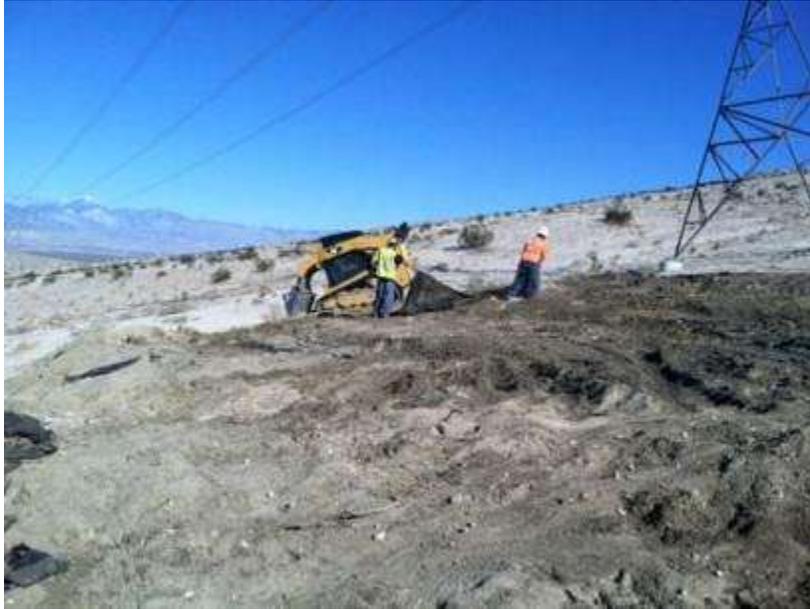
Figure 1. Site stabilization activities at Tower 2116.

- Site stabilization activities, including BMP removal, recontouring, and desert pavement/topsoil replacement were conducted at Towers 2112 through 2128, 2349, 2350, 2351, 2352, 2353, 2354, 2355, 2356, 2400, 2401, 2405, 2406, 2407, 2408, and 2432, Guard Structures GS26A and GS26B, Fiber Optic Site 61, Splice Site 34, 36, and 64, Wire Site 45, 47, and 49, and Helicopter Landing Zone (HLZ) H4 (see Figure 1).

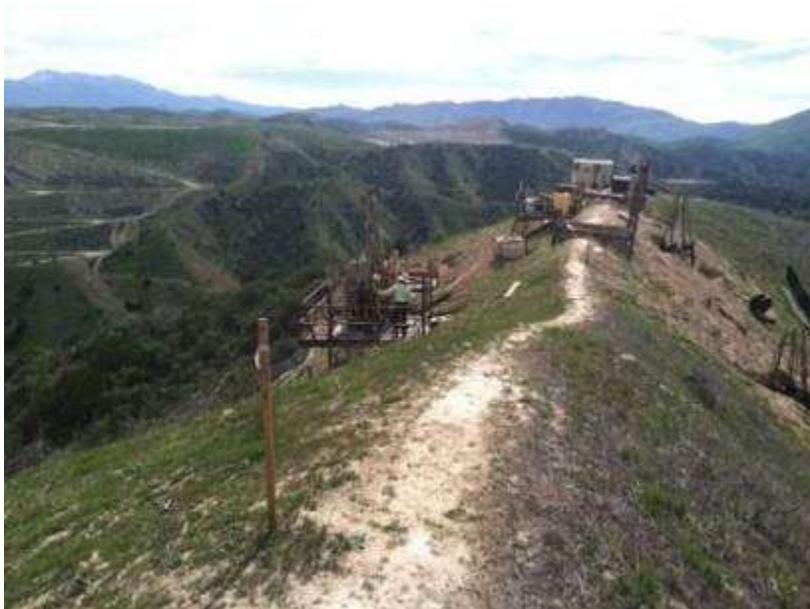
Figure 2. Micropile drilling at Tower 1108.

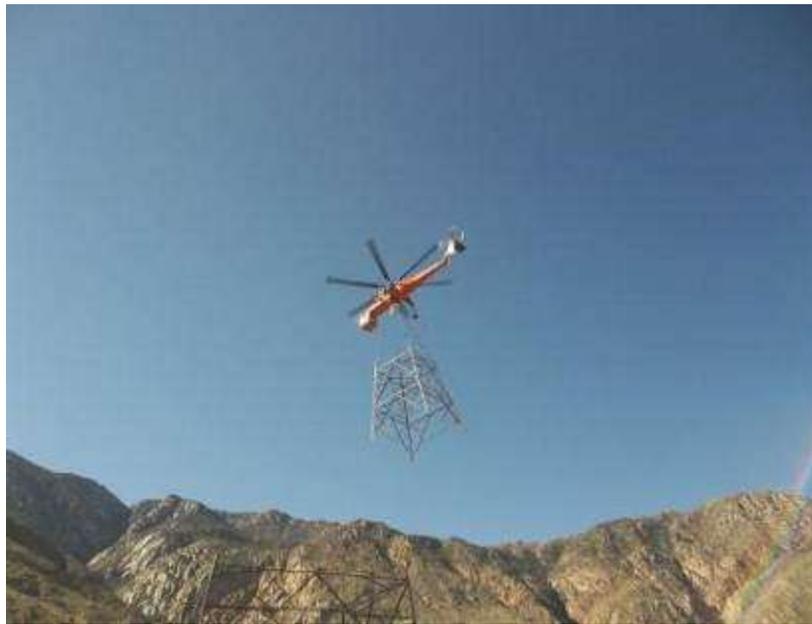
Figure 3. Skycrane lifting a tower section out of HLZ H2. (Photo courtesy SCE).

- On March 12, onsite observation identified fugitive dust emissions being generated due to air crane activity at HLZ H2. The source of fugitive dust emissions appeared to be from the stub road located west of HLZ H2, since the stub road was not adequately watered prior to air crane activity.

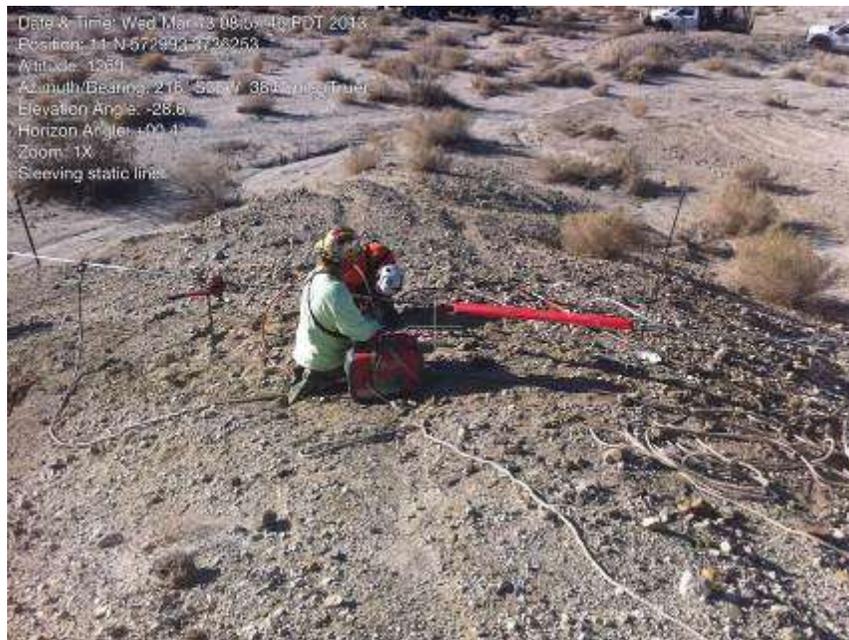
- On March 13, the OPGW crew conducted sleeving of static wire between Towers 2230 and 2230AX outside of the approved work area. Often the static wire on reels is not long enough for the entire pull length and it is necessary to join the ends. This was done by hydraulically compressing a metal sleeve onto the two ends of the static wire by using a small press that is driven by a small generator. Two crew members operated the generator and press, and two other crew members held the static wire close to the ground. The crew walked to the site and carried the equipment by hand. Vehicles remained on the approved access road. The SCE Biological Monitor was informed that the sleeving activity was planned and advised the General Foreman that it would result in a Level 1 incident report. The Biological Monitor also conducted a survey of the sleeving site before the crew arrived and found no sensitive species. A post-construction survey was also conducted and no habitat impact was noted other than footprints and soil disturbance. The site is located in the sparsely vegetated southern base of the Indio Hills (see Figure 4).

Figure 4. OPGW crew conducted sleeving of the static wire outside the approved disturbance areas between Towers 2230 and 2230AX. (Photo courtesy of FRED)

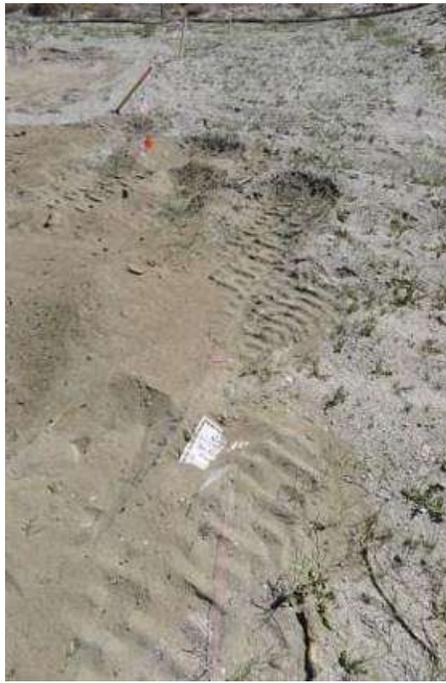
- On March 14, a Coachella Valley milk vetch (CVMV) Monitor visited Tower 1028 and observed that a clearly marked Environmentally Sensitive Area (ESA) for CVMV was run over during a grading operation on the site (see Figure 5). The Biological Monitor had last visited the site at 2:45pm the previous day. Between these two times, it was discovered a foundation close-out crew had graded around the tower and piled up soil around the tower legs. In the process, the CVMV ESA was run into and partially graded. The area within the ESA that was graded contained a bent pin flag which had marked a CVMV plant the day before. No trace of the plant could be found upon inspection. SCE reported this incident to the resource agencies on March 15. To date, SCE has not provided the CPUC or the resource agencies their intended remedial actions.

Figure 5. CVMV ESA impact at Tower 1028.

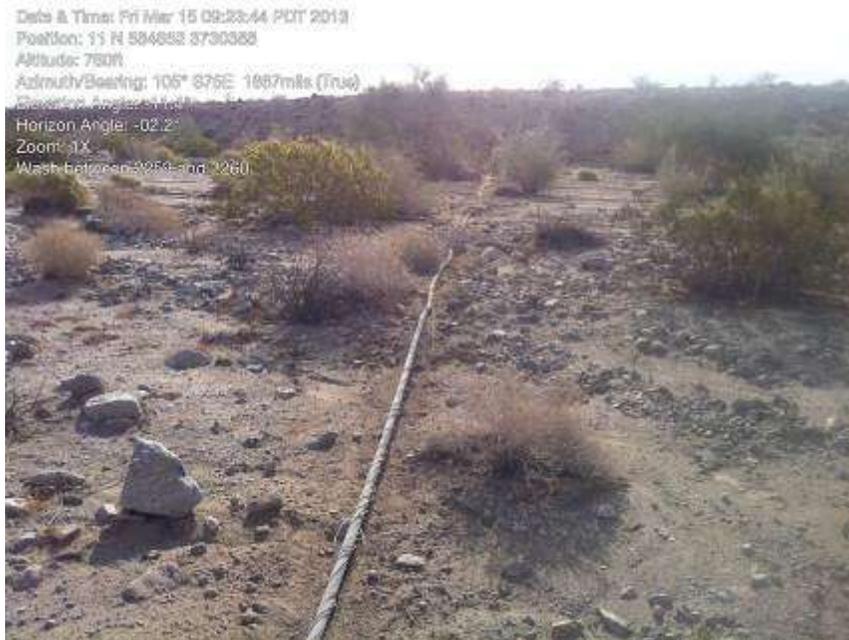
- On March 15, at approximately 0835, equipment failure at Wire Site 31/Pull Site 32 (between Towers 2259 and 2260) caused one of two B-phase conductor wires to break free, injuring one lineman, and coming into contact with the ground. After the SCE Biological Monitors conducted a clearance sweep of the immediate area, ground crews took action by mobilizing one bulldozer on an existing off-road trail (selected by the Biologists to minimize impacts) located in a large wash immediately west of the wire/pull site. Crews were able to temporarily secure the wire, but advised all on-site personnel to avoid the area until further action could be taken on Monday, March 18<sup>th</sup> (see Figure 6 and 7).

Figure 6. Equipment failure at Wire Site 31/Pull Site 32 (between Towers 2259 and 2260) caused one of the conductor wires to break free coming into contact with the ground. (Photo courtesy of FRED).

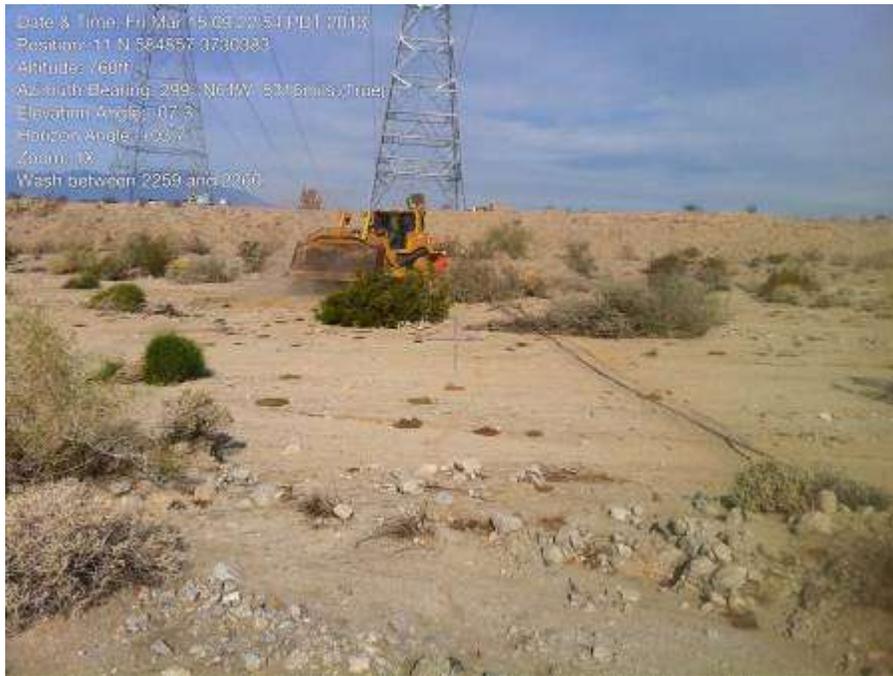
Figure 7. After the conductor fell to the ground, it was decided to mobilize one bulldozer on an existing off-road trail (selected by the SCE Biologists to minimize impacts) located in a large wash immediately west of the wire/pull site. Crews were able to temporarily secure the wire. (Photo courtesy of FRED).

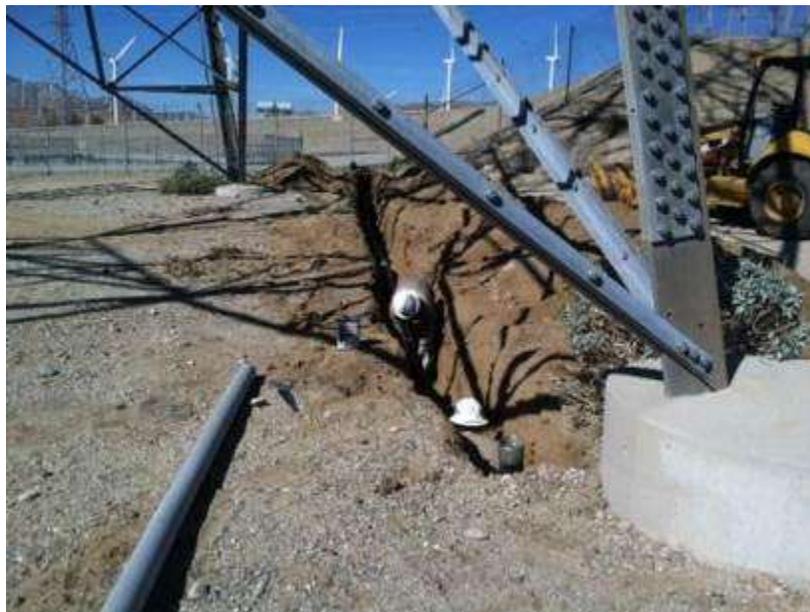
Figure 8. Telecommunications conduit trench work from the Devers Substation to Tower 1000X.

7. Mirage Substation Loop-ins (Private Lands) – No construction activities occurred during the subject time period.
8. Devers Substation (Private Lands) – Activities that were conducted for the Devers Substation expansion and upgrades included work associated with the extension of the 500 kV switchrack 2 positions, MEER building electrical improvements, and telecommunications conduit run trenching and installation to connect to the Tower 1000X (see Figure 8).
