## **PROJECT MEMORANDUM**

### **PG&E JEFFERSON-MARTIN 230KV TRANSMISSION PROJECT**

**To:** Billie Blanchard, CPUC  
**From:** Vida Strong, Aspen Project Manager  
**Date:** March 2, 2005  
**Subject:** Weekly Report #6: February 20, 2005 – February 26, 2005  
**CPUC Environmental Monitor (EM):** Jody Fessler

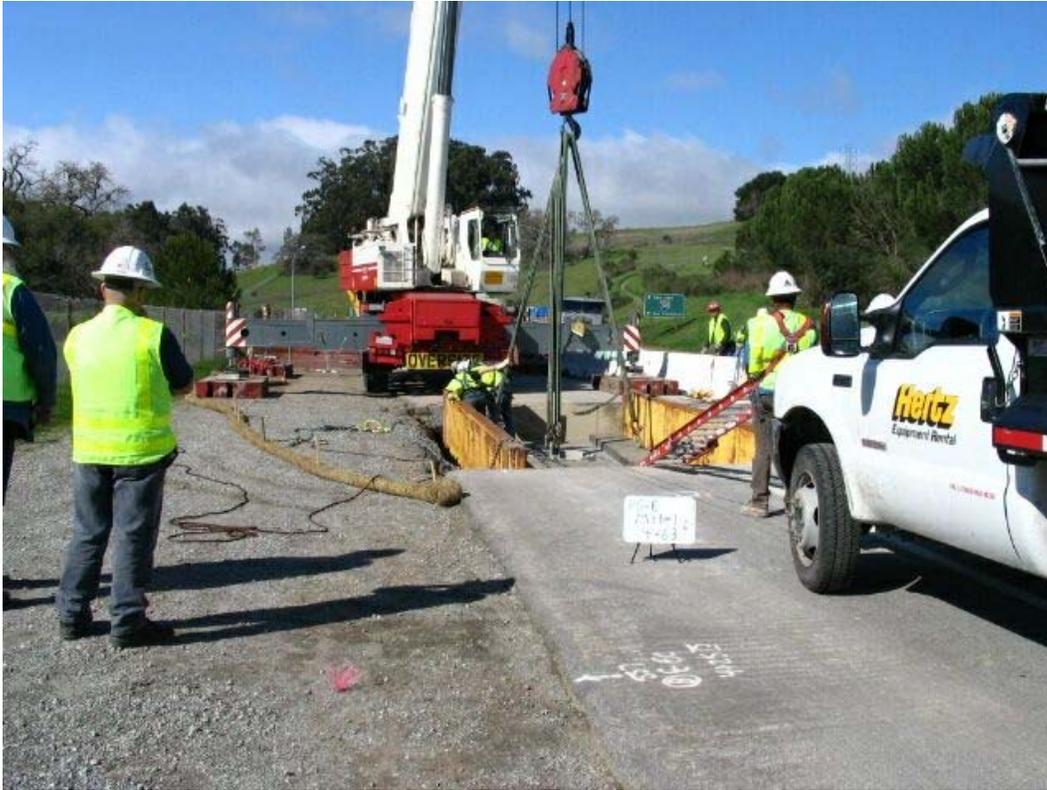
**Figure 1** – Manhole #1 setting vault in pit with crane on Cañada Road, Segment 1, February 23, 2005

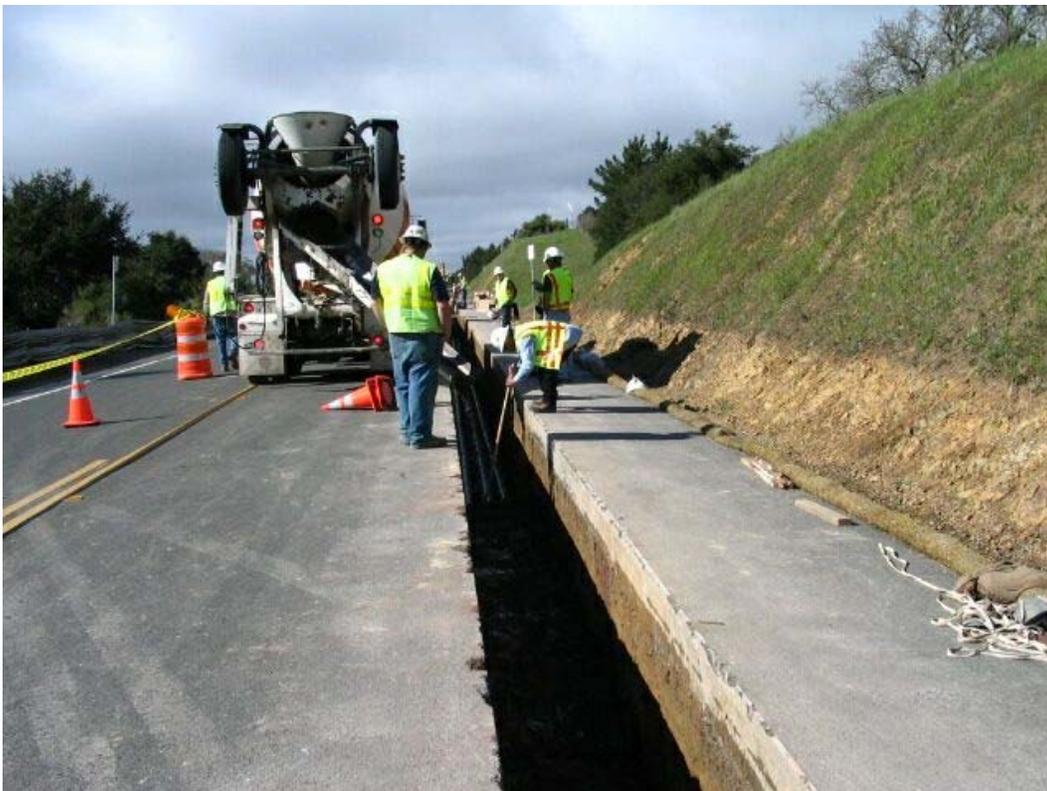
2. On Tuesday, trenching activities began between Station #112+15 to #118+05 on Cañada Road adjacent to the Filoli Estate (see Figure 2). Excavation of the trench went smoother and quicker this week. Crews were excavating the asphalt, then excavating the soil, shoring the trench, installing conduit, and pouring thermal cement slurry as they moved north. Crews paved over the trenched area on Friday and finished in the afternoon.

**Figure 2** – Excavated trench on Cañada Road, Segment 1, February 23, 2005

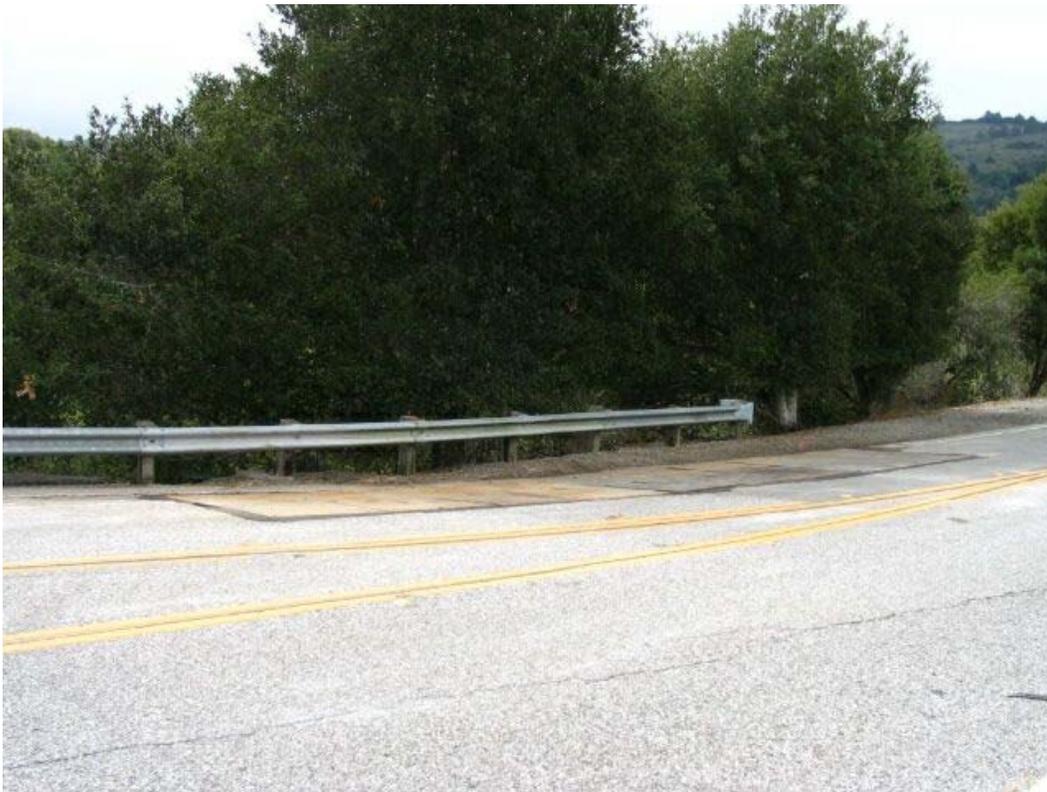
3. Construction in the Caltrans right-of-way on Cañada Road at the Highway 92 W exit off Highway 280 began early Tuesday morning (see Figure 3). Work hours at that location are from 9 PM to 6 AM. Early Wednesday morning, 41 feet of trench was opened and plated with recessed trench plates for daytime traffic. Construction was slow along this segment partly because of the narrow curved road as well as a new crew. On Friday morning at 12:15 AM, a traffic accident occurred between a public vehicle and a piece of construction equipment. No one was hurt during the accident and CHP was called to write up a report.

**Figure 3** – Trench plated recessed into pavement in Caltrans ROW on Skyline, Segment 1, February 23, 2005

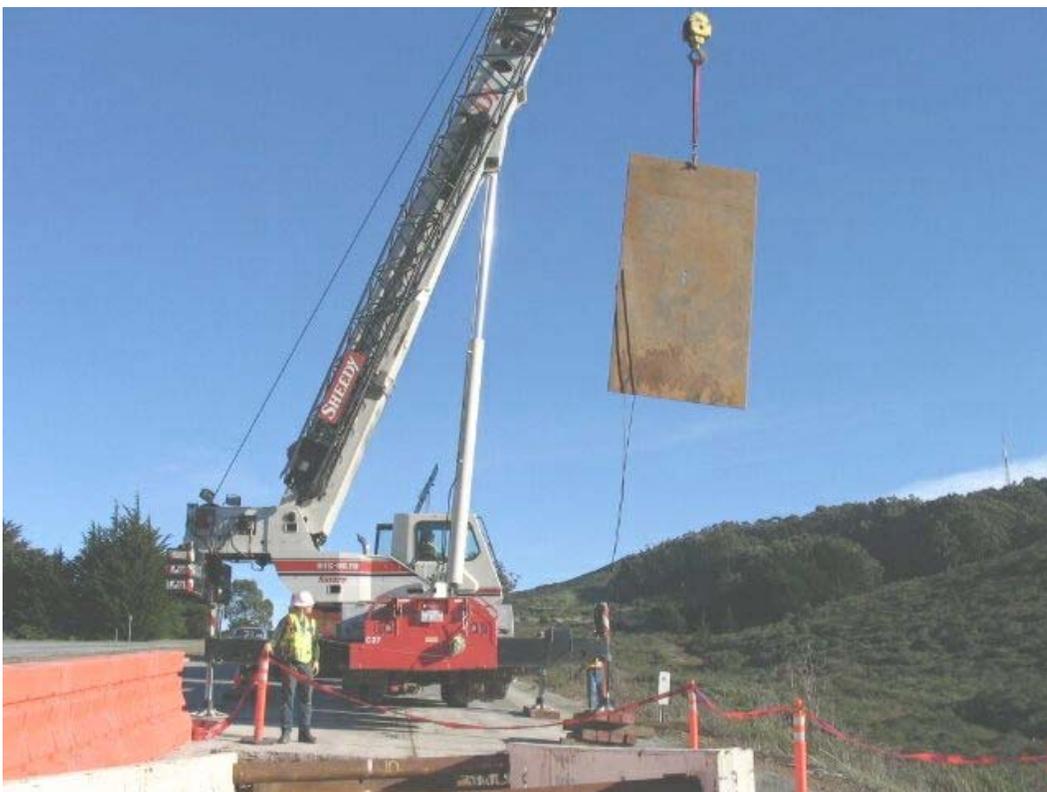
1. Excavation of Manhole #69 vault pit began February 22 along Guadalupe Canyon Parkway on San Bruno Mountain (see Figure 4). Crews finished excavating the manhole to about 14 feet and shored the pit. The vault was installed on Thursday. Cement slurry was poured on Friday and final paving was completed on Saturday.

**Figure 4** – Shoring Manhole #69 on Guadalupe Canyon Parkway, Segment 5, February 22, 2005

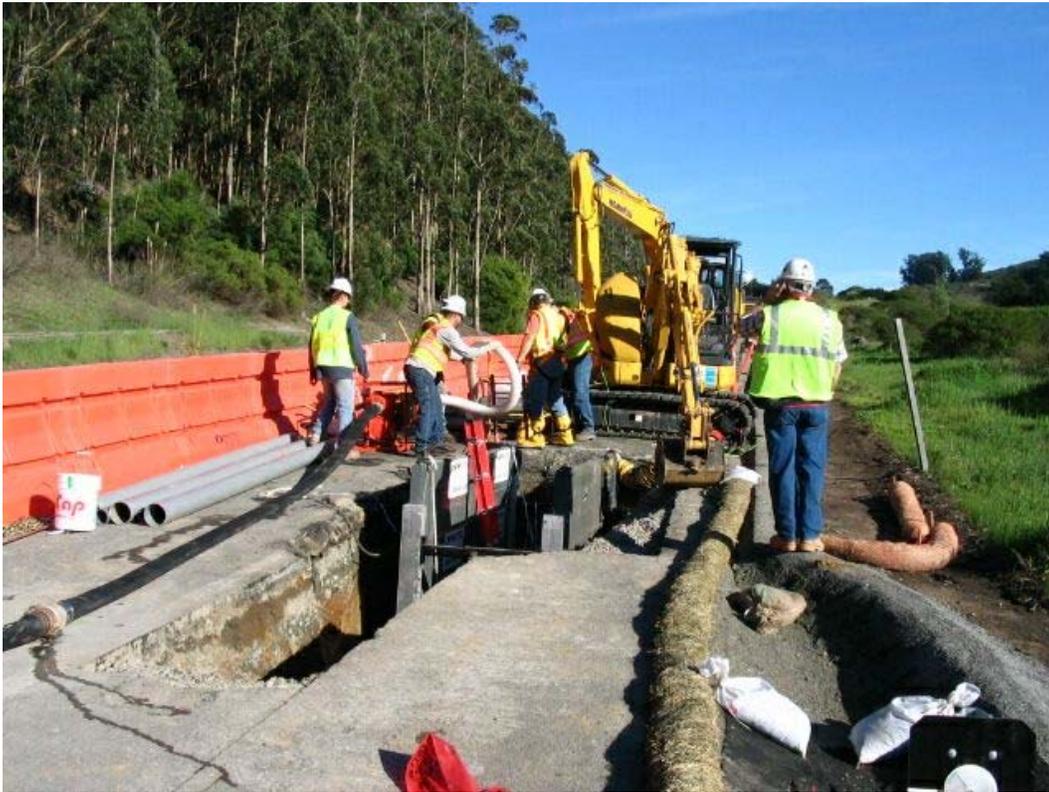
2. Excavation of approximately 50 feet east of Manhole #68 (Station #1271+45) began on Tuesday for the installation of conduit (see Figure 5). Crews were having problems with the trenching activities and did not get any conduit installed. They backfilled the trench and paved it over on Saturday.

**Figure 5** – Crews trenching east of Manhole #68, Segment 5,  
February 25, 2005
