PROJECT MEMORANDUM SDG&E – MIGUEL-MISSION 230 KV #2 PROJECT

Subject: Weekly Report #37: April 10 – April 16, 2005.

FANITA JUNCTION TO MIGUEL 138/69 KV ACTIVITIES, NTP #1 AND #2

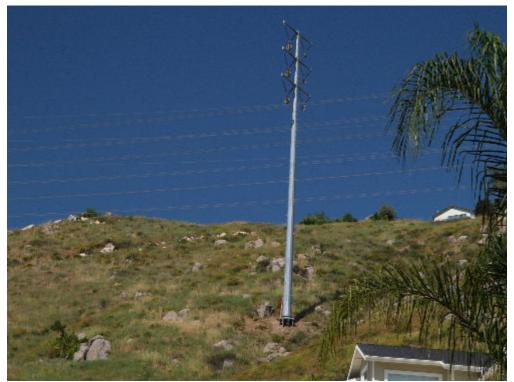
Figure 1 – A heavy-lift helicopter was used to set the steel pole sections at Pole Site 493.

- 1. A heavy-lift helicopter was used to set the steel poles at Pole Sites 493 and 522 on Wednesday of the subject week. The operation proceeded very smoothly and was completed by noon. These are the steel poles where the foundations were completed using the micro-pile method due to the steep side-slope (see Figure 1). The CPUC EM has not been advised of any complaints from the public on the use of a helicopter at the sites.

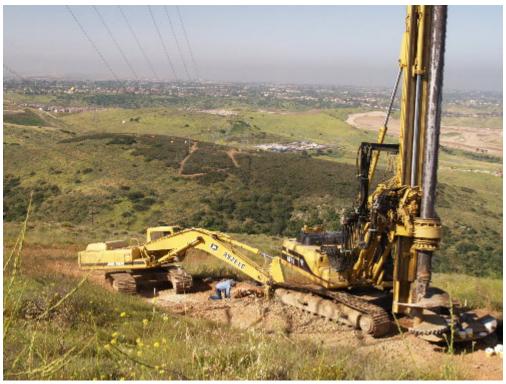
Figure 2 – The Woodward drilling crew worked at Pole Site 30 to complete the final 138 kV foundation excavation on the project.

- 2. The Woodward crew continued drilling and using the hydraulic hammer on the hard rock at Pole Site 30 during the subject week (see Figure 2). The crew used a rock-hammer to assist in breaking up the rock ledges at the edges of the excavation in between drilling (see Figure 3). The excavation was to depth and crew was close to final width at the time of the site visit. This foundation is the final 138 kV excavation and the drilling contractors have started to demobilize from the project. A section of chain-link fence used to cover the open excavation was observed on the habitat adjacent to the pad. Construction equipment and materials needs to remain within the disturbed area.

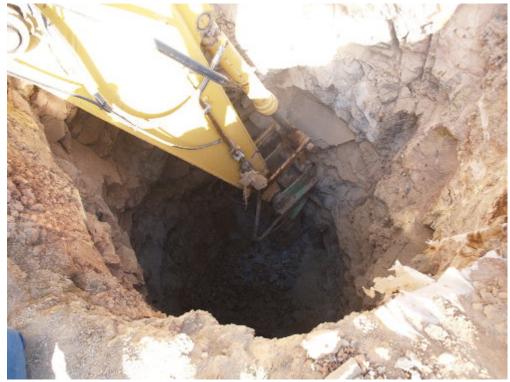
Figure 3 – The Woodward drilling crew at Pole Site 30 used a hydraulic hammer to break off the rock shelves on the sides of the excavation.

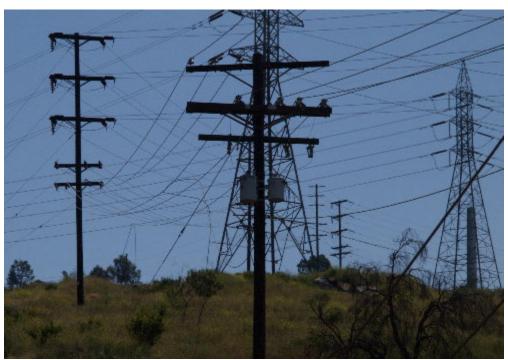
Figure 4 – A mobile crane struck a live 12 kV service line on the access road above the Los Coches Substation.

- 1. A Wilson crew worked on the hill directly above the Los Coches substation installing a steel pole during the site visit. The first crew set the lower section of the steel pole, but hit a live 12 kV service line with the mobile crane on the way down the hill (see Figure 4). Work was suspended until a SDG&E Transmission operations crew reviewed the damage and investigated the incident. No injuries or environmental damage occurred as a result of the accident. Work resumed in the early afternoon and a larger crane was moved up the hill to set the upper sections of the steel poles. A small bulldozer was used to assist the truck carrying the pole section up the steel slope (see Figure 5).

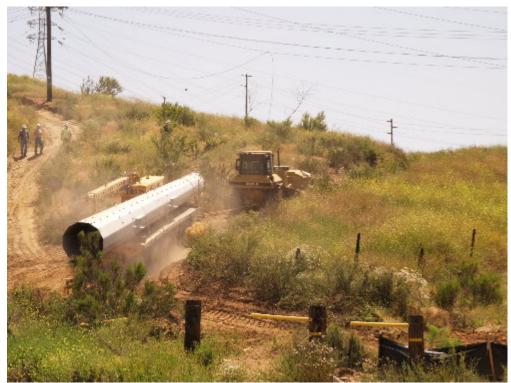
Figure 5 – Wilson moved the upper section of the steel pole up to the crane pad above Los Coches Substation.
