3 December 2009

**Subject: Addendum No. 3 to Sunrise Powerlink Phase I ESA  
September Route Modifications  
San Diego and Imperial Counties, California**

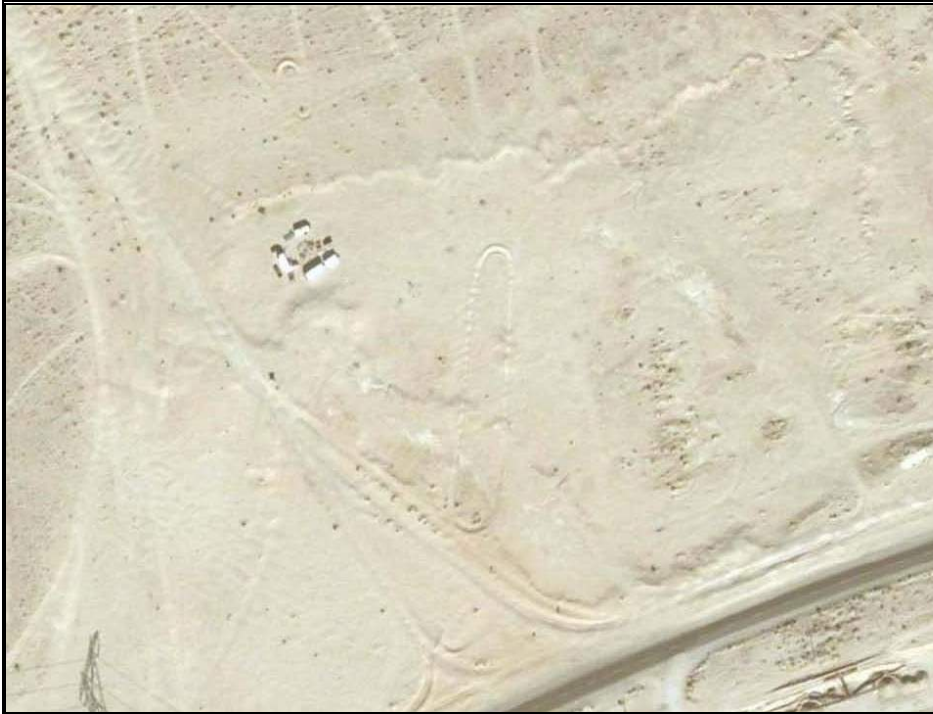
### PHOTOGRAPH 1:

View: Aerial photograph of Geosyntec Site ID No. 2A.

Photo shows undeveloped desert land with Recreational Vehicles and evidence of Off Highway Vehicle (OHV) use.

Geosyntec Site I	2A
Mile Post:	MP 11
Sempre Segmen	2
EDR Map ID	
EDR Focus Map	
EDR Listing ID:	
Site Name:	Evan Hewes Highway Site/Proposed Fly Yard
Site Address:	None
APN:	034-360-25 & 033-230-08
REC:	None
Comments:	The site appears to be undeveloped desert land used by off-road recreators. If SDG&E intends to utilize the site for storage of vehicles, transformers, or other potential hazardous materials, Geosyntec recommends an onsite reconnaissance to further evaluate the potential for pre-existing impacts.

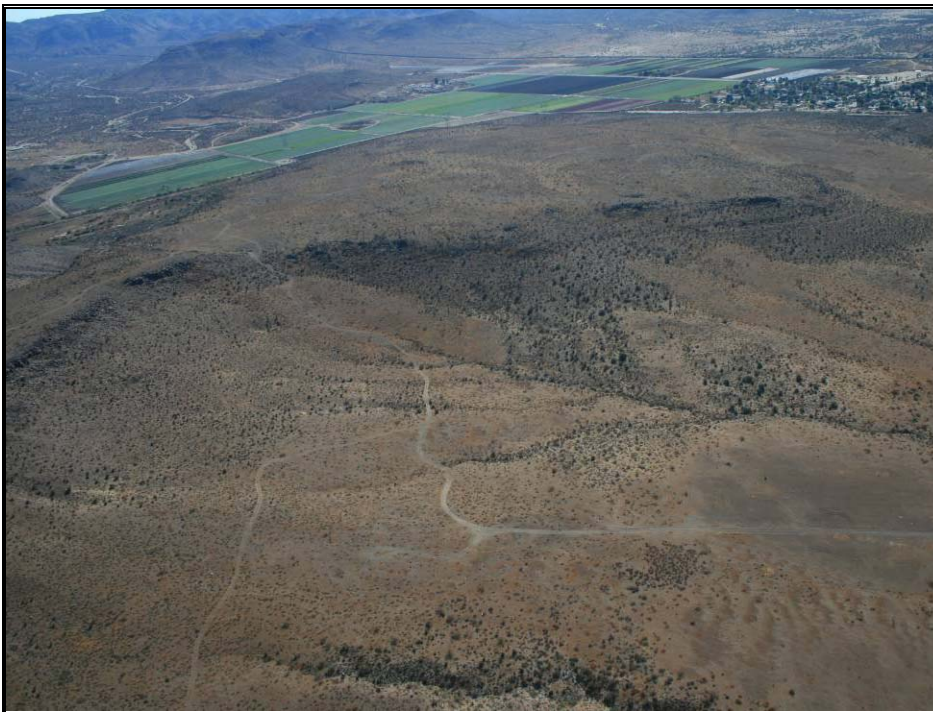
### PHOTOGRAPH 2:

View: Aerial photograph of Geosyntec Site ID No. 16A looking southeast.

Geosyntec Site I	16A
Mile Post:	MP 35
Sempra Segmen	5
EDR Map ID	
EDR Focus Map	
EDR Listing ID:	
Site Name:	The Nature Conservancy Property/Proposed Fly Yard
Site Address:	None
APN:	66002003
REC:	None
Comments:	Aerial reconnaissance indicated unpaved access roads at the site. During a follow-up ground reconnaissance, access was not available and view from public right-of-way was not possible. If SDG&E intends to utilize the site for storage of vehicles, transformers, or other potential hazardous materials, Geosyntec recommends an onsite reconnaissance to further evaluate the potential for pre-existing impacts.

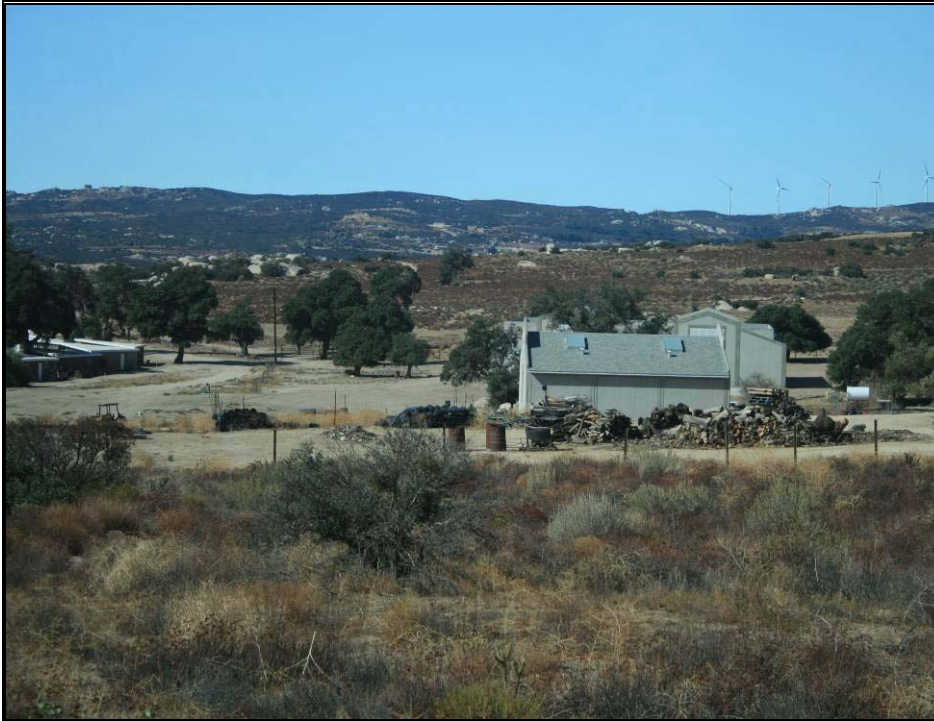
### PHOTOGRAPH 3:

View: Photograph of Geosyntec Site ID No. 23A looking west from McCain Valley Road.

Photo shows a maintenance area and several structures at the proposed Base II Field Office site.

The site was previously identified during the initial Sunrise Phase I ESA due to a landing strip at the site. However, the proposed footprint as part of the September Route has been shifted to include several structures and parking areas. Due to access limitations at the time of the ground reconnaissance, onsite reconnaissance was not performed. During ground reconnaissance from public right-of-way, stockpiled woody debris and rusty 55-gallon drums were observed near the property's eastern boundary. Additionally, the September Route revision proposes to shift the transmission line approximately 400 feet west in the vicinity of the Rough Acres property. Although the drums may present a source of adverse environmental conditions, proposed tower locations appear to be sufficiently distant from the area to not affect construction. However, Geosyntec recommends an onsite reconnaissance to further evaluate the potential for pre-existing impacts.

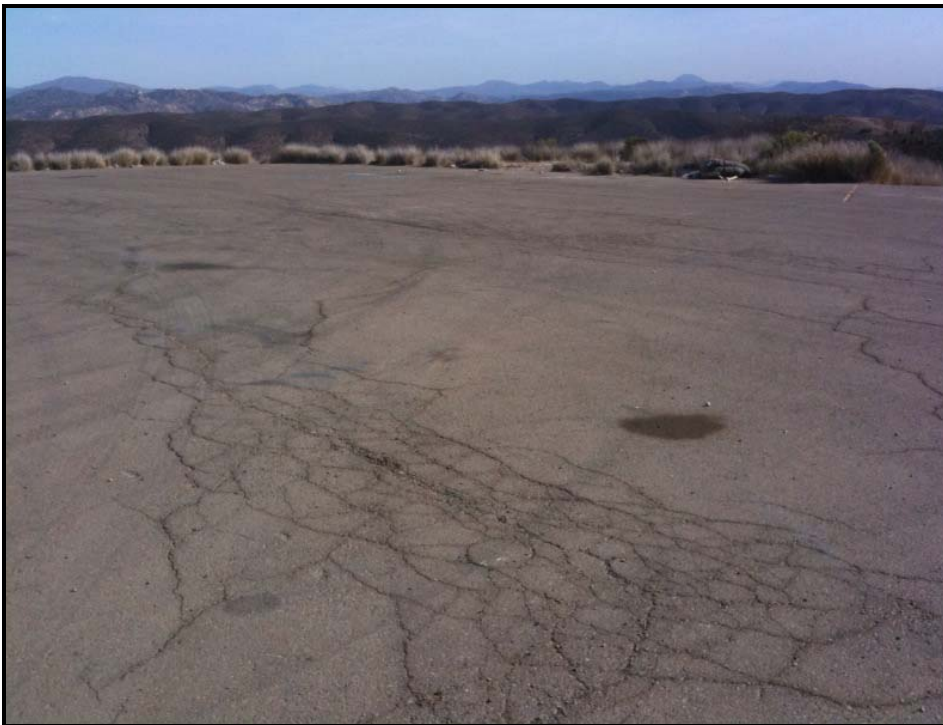
### PHOTOGRAPH 6:

- Sycamore Canyon Site (Geosyntec Site ID No. 175A) - Surface staining on weathered pavement was observed during ground reconnaissance.

Photo shows minor surface staining on the weathered asphalt ground surface.

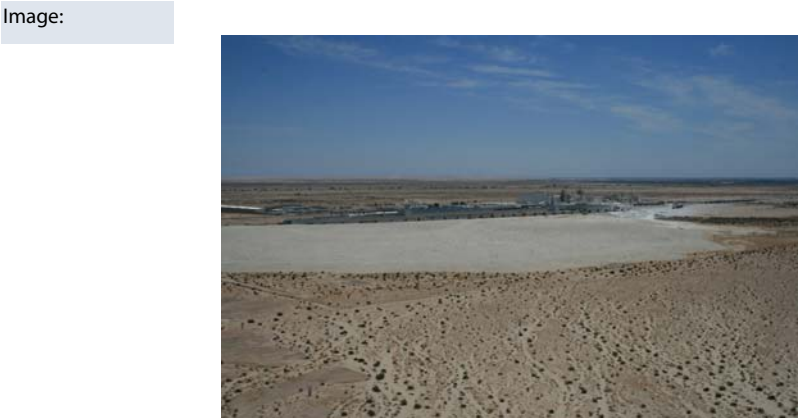
Geosyntec Site ID	2
Mile Post:	MP 10
Sempra Segment:	2
EDR Map ID	-
EDR Focus Map	-
EDR Listing ID:	-
Site Name:	US Gypsum Co. Factory
Site Address:	3810 W. Highway 80, Plaster City, CA 92243
APN:	03436091
REC:	SREC
Comments:	Nearby gypsum factory may use hazardous materials. Disturbed soil extends into Action Area 1/4-mile buffer area. Based on historical aerials, the area of observed disturbed soil may be a former gypsum waste pile area. However, no proposed tower locations are plotted in the area of disturbed soil. Based on the identified information and the proximity of the site to the Action Area and proposed tower locations, the potential for the site to adversely affect construction appears low.

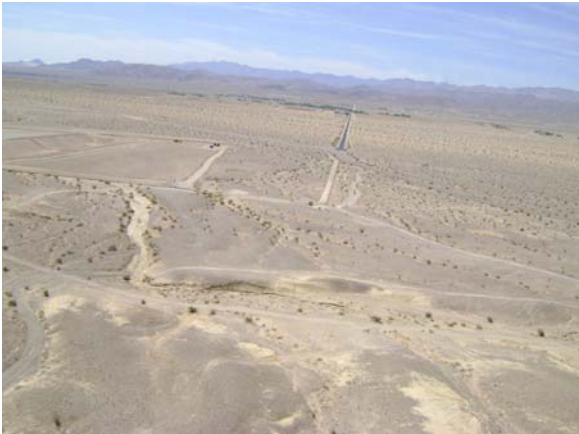
Geosyntec Site ID	3
Mile Post:	MP 18
Sempra Segment:	2
EDR Map ID	71
EDR Focus Map	32
EDR Listing ID:	S102360220, S105964516
Site Name:	Ocotillo Solid Waste Site and Transfer Station
Site Address:	Shell Canyon, 3 Miles Northwest of Ocotillo
APN:	03322023
REC:	SREC
Comments:	Solid waste disposal site for C&DD and mixed municipal waste, closed in 2004. No significant impacts to groundwater reported. Limited volume transfer operation for C&DD and mixed municipal waste also located at this site. Based on the proximity to the site, the potential for impacts from the landfill to adversely affect construction appears low.

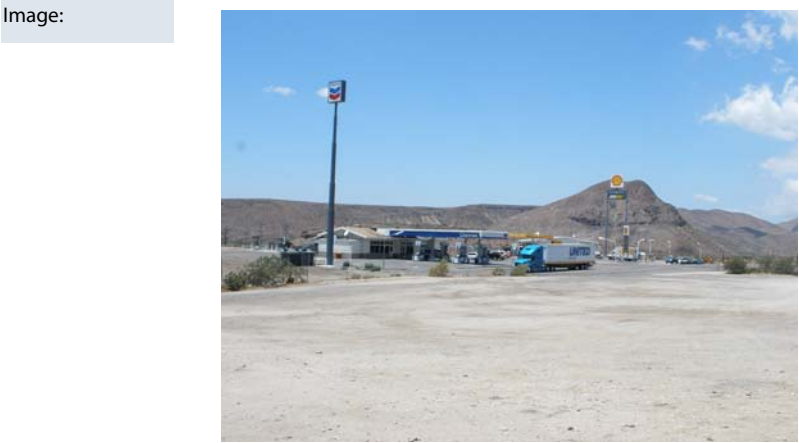
Geosyntec Site ID	10
Mile Post:	MP 33
Sempra Segment:	5
EDR Map ID	87
EDR Focus Map	76
EDR Listing ID:	S104745640, S106060318, U003789082
Site Name:	Woodward Shell/Jacumba Shell
Site Address:	1494 Carrizo Gorge Road, Jacumba, CA
APN:	66101028
REC:	HREC
Comments:	Case closed: LUST affecting aquifer with cleanup completed as of 1999. Nine USTs listed: 6 unleaded gasoline, one diesel, and two of unknown contents. Based on the proximity to the Action Area and the nature of the site, the potential for the site to adversely affect construction appears low.

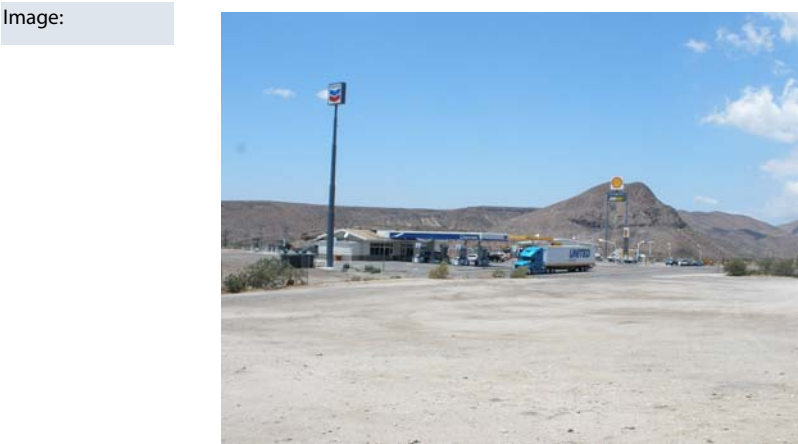
Geosyntec Site ID	10
Mile Post:	MP 33
Sempra Segment:	5
EDR Map ID	87
EDR Focus Map	76
EDR Listing ID:	S104745640, S106060318, U003789082
Site Name:	Woodward Shell/Jacumba Shell
Site Address:	1494 Carrizo Gorge Road, Jacumba, CA
APN:	66101028
REC:	HREC
Comments:	Case closed: LUST affecting aquifer with cleanup completed as of 1999. Nine USTs listed: 6 unleaded gasoline, one diesel, and two of unknown contents. Based on the proximity to the Action Area and the nature of the site, the potential for the site to adversely affect construction appears low.

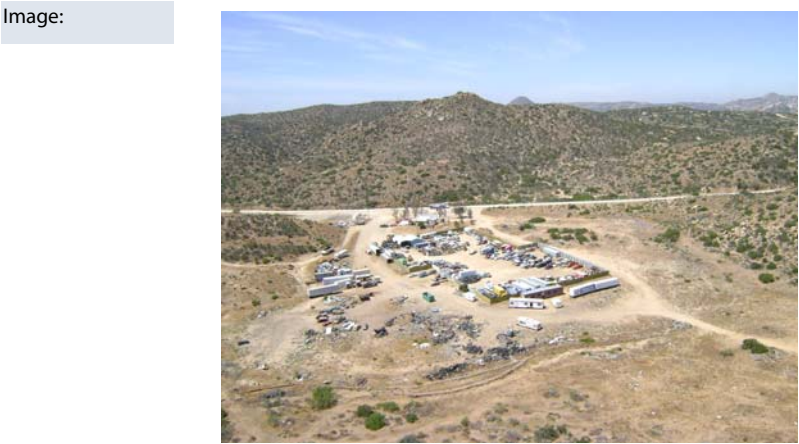
Geosyntec Site ID	19
Mile Post:	MP 40
Sempre Segment:	6
EDR Map ID	82
EDR Focus Map	59-74
EDR Listing ID:	S109427960
Site Name:	Kenan Advantage Group, Inc.
Site Address:	2170 McCain Valley Road, Boulevard, CA 91905
APN:	61303028
REC:	None
Comments:	No violations reported for disposal of organic solids and unspecified organic liquid mixture. Based on the proximity to the Action Area and the nature of the site, the potential for the site to adversely affect construction appears low.

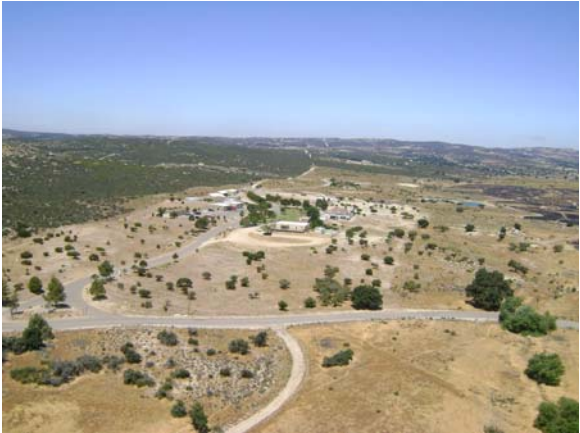
Geosyntec Site ID	22
Mile Post:	MP 41
Sempra Segment:	6
EDR Map ID	79
EDR Focus Map	59
EDR Listing ID:	1001217488, S103646867, S103866564, 1007739453
Site Name:	McCain Valley Conservation Camp/State of CA Department of F
Site Address:	2550 McCain Valley Road, Boulevard, CA 91905
APN:	61110006
REC:	REC
Comments:	Site assessment underway for LUST with potential aquifer impacts and case open as of 1999. One diesel 2,200-gal AST. Two USTs at site: one 550-gal leaded and one 1000-gal "other." RCRA-SQG handling PCE with notices of violation. Monitoring wells are located west of the corridor and groundwater reportedly flows to the north. Domestic sewage treatment facility is rated as a moderate threat to water quality and complexity category B. Groundwater depth is reportedly approximately 15 feet below ground surface. Due to the reported depth to groundwater and the distance from the nearest proposed access road and tower location (approximately 1/2-mile) , the potential for the site to adversely affect construction appears low.

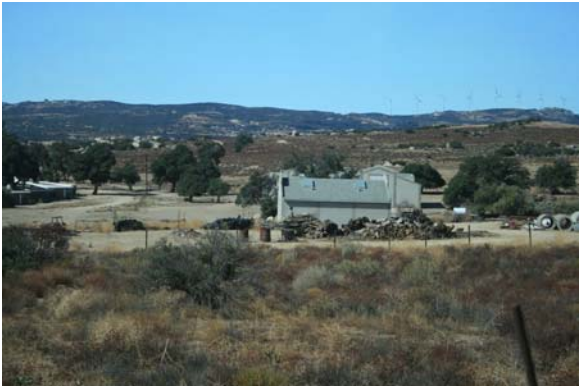
Geosyntec Site ID	24
Mile Post:	MP 49
Sempra Segment:	6
EDR Map ID	-
EDR Focus Map	-
EDR Listing ID:	-
Site Name:	Disturbed soil
Site Address:	Unknown
APN:	52823011
REC:	None
Comments:	Yard appears to be contain disturbed soil and suspicious berms. However, a plat map viewed on the BLM webpage indicated that the area is used as a fire break, which would not likely present a material threat to the environment. Therefore, the potential for the site to adversely affect construction appears low.

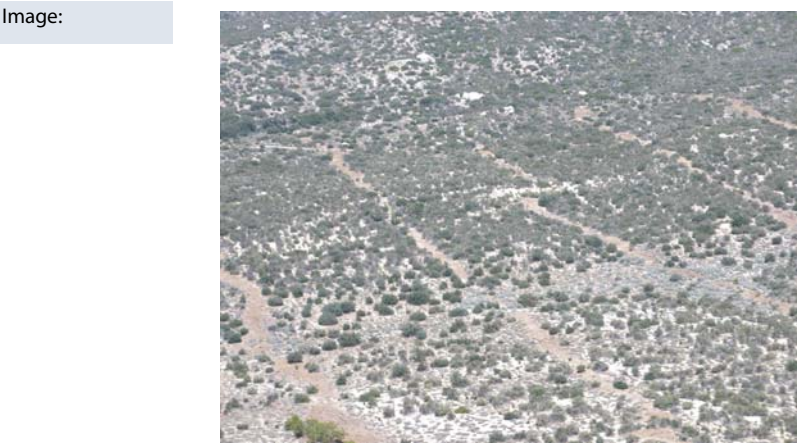
Geosyntec Site ID	25
Mile Post:	MP 49
Sempre Segment:	6
EDR Map ID	0
EDR Focus Map	28-29-41-42
EDR Listing ID:	CIND100573
Site Name:	Manzanita Indian Reservation
Site Address:	Unknown
APN:	52823019
REC:	None
Comments:	Indian Reservation Area. No issues identified. Therefore, it appears that the potential for the site to adversely affect construction is low.

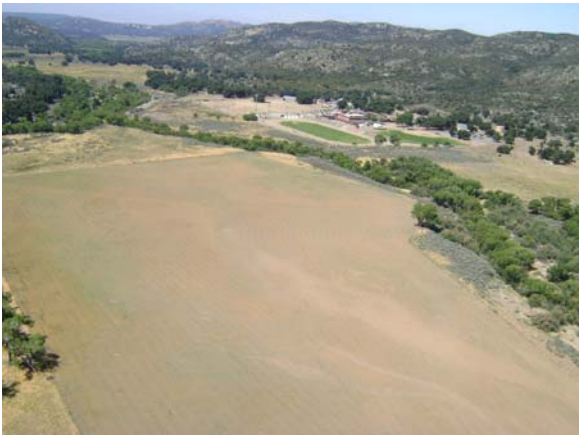
Geosyntec Site ID	34
Mile Post:	MP 61
Sempra Segment:	7
EDR Map ID	-
EDR Focus Map	-
EDR Listing ID:	-
Site Name:	Agricultural field
Site Address:	Unknown
APN:	52711005
REC:	SREC
Comments:	<p>Yard appears to be graded land adjacent to a stream on the west. Reviewed historic aerials from 1980, 2005, and 2008 do not positively indicate that the land has been historically cultivated. However, the land appears to be currently maintained free of native vegetation. Although no farming equipment was observed near the site, it may have been applied with pesticides or herbicides. Currently, Geosyntec is awaiting a response from the local Building Department regarding information about the site. However, the San Diego Assessors Office lists the property use as "field crops." Therefore, it appears that soil testing per the CPUC Mitigation Measures may be required. Furthermore, it appears that the potential for the site to adversely affect construction is low to medium.</p>

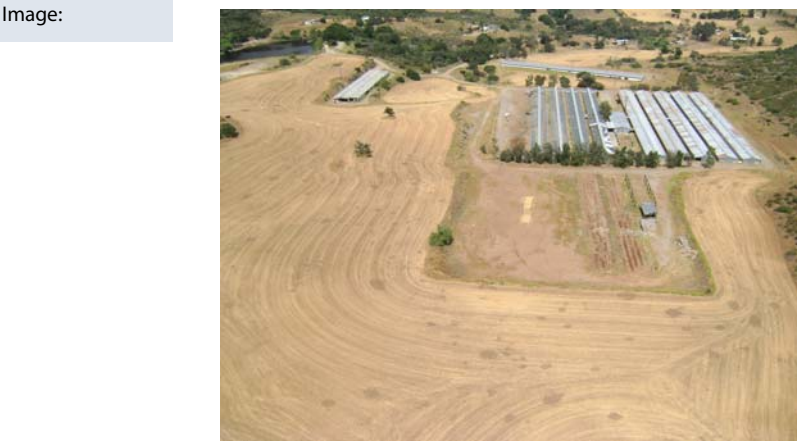
Geosyntec Site ID	48
Mile Post:	MP 86
Sempra Segment:	12
EDR Map ID	72
EDR Focus Map	23
EDR Listing ID:	S104761233
Site Name:	Woodcrest Egg Ranch
Site Address:	20676 Japatul Road, Alpine, CA 91901
APN:	52401002
REC:	None
Comments:	No incidents reported. Agricultural field may have had applications of pesticides or herbicides. However, construction is not proposed in this area. Furthermore, it appears that the potential for the site to adversely affect construction is low.

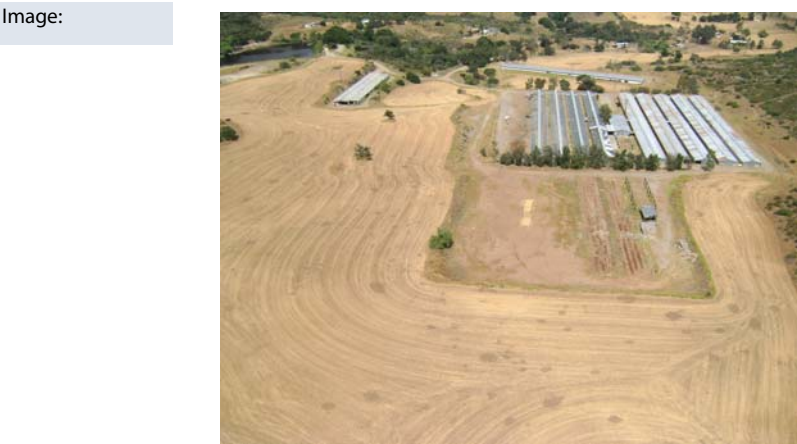
Geosyntec Site ID	49
Mile Post:	MP 87
Sempra Segment:	12
EDR Map ID	70
EDR Focus Map	23
EDR Listing ID:	S106070098
Site Name:	Cramer Egg Ranch
Site Address:	19737 High Glen Road, Alpine CA 91901
APN:	52313009
REC:	None
Comments:	No incidents reported. Agricultural field may have had applications of pesticides or herbicides. However, construction is not proposed in this area. Furthermore, it appears that the potential for the site to adversely affect construction is low.

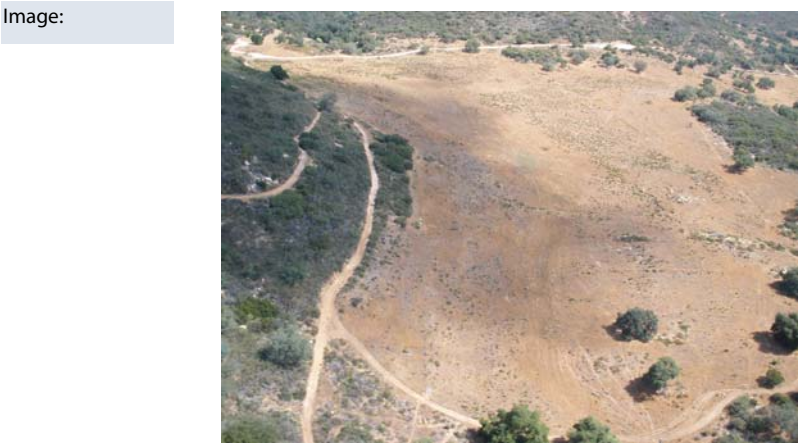
Geosyntec Site ID	54
Mile Post:	MP 90
Sempra Segment:	12
EDR Map ID	-
EDR Focus Map	-
EDR Listing ID:	-
Site Name:	Agricultural field
Site Address:	Unknown
APN:	52304008
REC:	None
Comments:	Yard appears to be a former pasture land. Reviewed historical aerals from 1953, 1980, 2005, and 2008 do not indicate that the land has been historically cultivated. It does not appear that soil testing per the CPUC Mitigation Measures would be required. Furthermore, it appears that the potential for the site to adversely affect construction is low.

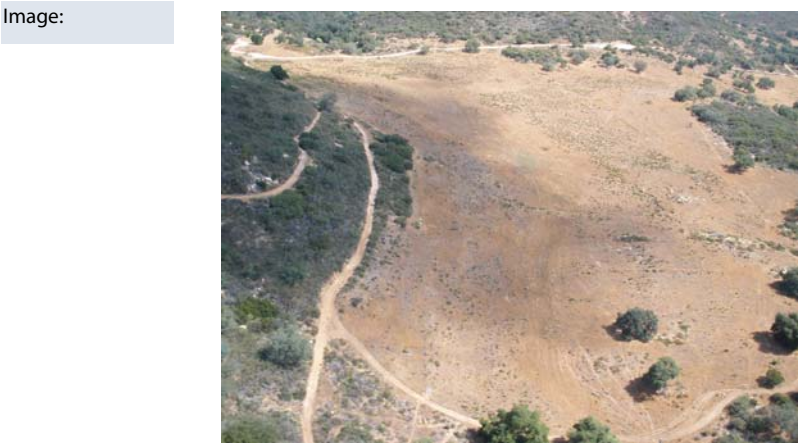
Geosyntec Site I	54A
Mile Post:	MP 89
Sempra Segmen	12
EDR Map ID	
EDR Focus Map	
EDR Listing ID:	
Site Name:	Lightner Property/Proposed Suncrest Substation
Site Address:	None
APN:	52303014
REC:	None
Comments:	<p>During the aerial reconnaissance an area near an existing unpaved access road was observed with grey discoloration near a possible groundwater well. The site is not visible from public right-of-way and property access was not available at the time of the ground reconnaissance. Therefore, the identification of a groundwater well at the site has not been "ground truthed." It is recommended that access be permitted and an onsite reconnaissance be performed to positively identify or refute the existence of a groundwater well at the site.</p>

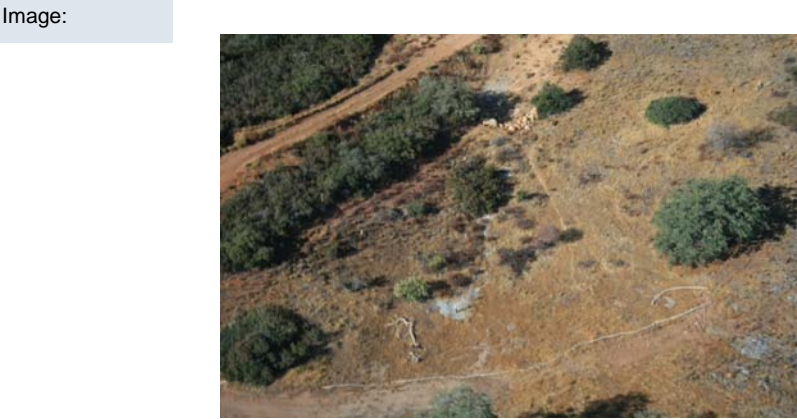
Geosyntec Site I	54A
Mile Post:	MP 89
Sempra Segmen	12
EDR Map ID	
EDR Focus Map	
EDR Listing ID:	
Site Name:	Lightner Property/Proposed Suncrest Substation
Site Address:	None
APN:	52303014
REC:	None
Comments:	<p>During the aerial reconnaissance an area near an existing unpaved access road was observed with grey discoloration near a possible groundwater well. The site is not visible from public right-of-way and property access was not available at the time of the ground reconnaissance. Therefore, the identification of a groundwater well at the site has not been "ground truthed." It is recommended that access be permitted and an onsite reconnaissance be performed to positively identify or refute the existence of a groundwater well at the site.</p>

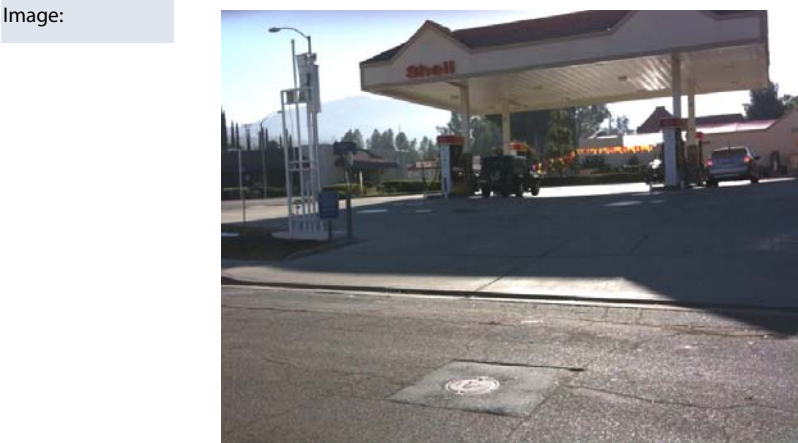
Geosyntec Site ID	79
Mile Post:	MP 96
Sempra Segment:	15
EDR Map ID	53
EDR Focus Map	17
EDR Listing ID:	S101669472, S102863950, S104746248, S106063921, S106071002, U001570888, S104576207
Site Name:	Alpine Country Station/ Texaco/Mobil/Progressive Auto Center
Site Address:	2232 Alpine Boulevard, Alpine, CA 91901
APN:	40326219
REC:	REC
Comments:	Gasoline release found during tank closure in 1999, groundwater affected. LUST cleanup site with remediation in progress, case open as of 2002. Ten USTs listed: 4 regular unleaded, 2 premium unleaded, 2 diesel, and 2 of unknown content. Currently under investigation and suspected of impacting upgradient supply wells. No violations reported for the disposal of unspecified oil-containing waste and organic liquid mixture. According to the DEH, delineation has not been achieved, and pump and treat remediation began in 2006. Based on the nature and proximity of the site to the Action Area, the potential for the LUST site to adversely affect construction appears medium to high. It is recommended that excavation near this site be monitored for impacted soils and a contingency plan be in place to properly handle and dispose impacted soils if encountered.

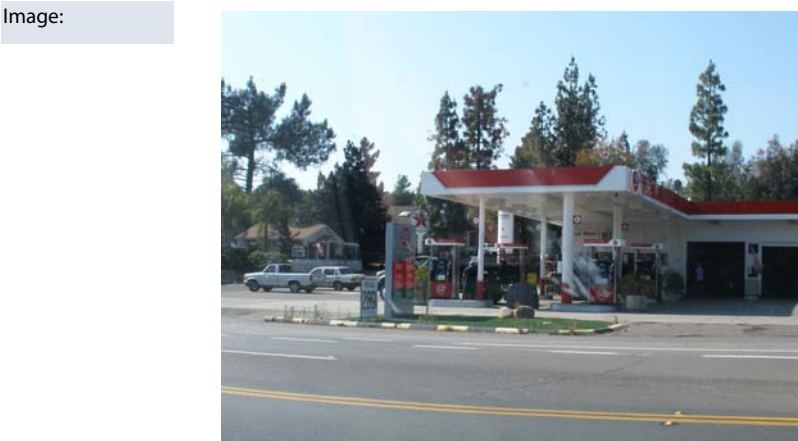
Geosyntec Site ID	80
Mile Post:	MP 96
Sempre Segment:	15
EDR Map ID	53
EDR Focus Map	17
EDR Listing ID:	1008241721, S105939938
Site Name:	Texaco Alpine
Site Address:	2227 Alpine Boulevard, Alpine, CA 91901
APN:	40327144
REC:	None
Comments:	Air emissions reported without violations. Appears to be related to nearby Texaco (2232 Alpine Blvd.) pump and treat remediation system. Refer to Geosyntec Site ID No. 79.

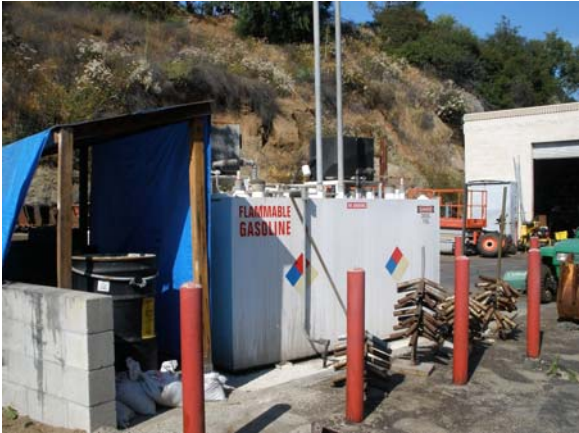
Image:

Geosyntec Site ID	88
Mile Post:	MP 96
Sempra Segment:	15
EDR Map ID	51
EDR Focus Map	17
EDR Listing ID:	S106065334, S104580582
Site Name:	Alpine Equipment Rentals, Inc.
Site Address:	2110 Alpine Boulevard, Alpine, CA 91901
APN:	40325019
REC:	SREC
Comments:	No violations reported for disposal of motor/hydraulic oil, gasoline, diesel, acetylene, propane, oxygen, waste oil, oily absorbent, sump sludge, and used oil filters. No USTs reported. During ground reconnaissance, an AST was observed with poor housekeeping and stained ground surface topographically upgradient of Alpine Boulevard. Due to the proximity to the proposed trench, petroleum impacted soil may be encountered during excavation. Therefore, it appears that the potential for the site to adversely affect construction is low to medium. It is recommended that excavation near this site be monitored for impacted soils and a contingency plan be in place to properly handle and dispose impacted soils if encountered.

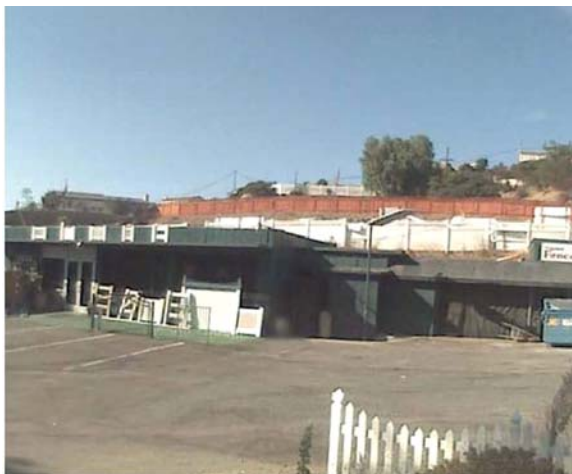
Image:

Geosyntec Site ID	90
Mile Post:	MP 96
Sempra Segment:	15
EDR Map ID	51
EDR Focus Map	17
EDR Listing ID:	S103949615, S106060308, U001570886
Site Name:	Alpine Auto Center/Discount Batteries Etc.
Site Address:	2042 Alpine Boulevard, Alpine, CA 91901
APN:	40325028
REC:	SREC
Comments:	Four USTs installed at site: 6,200-gal of unleaded gasoline, 6,200-gal of regular, 6,200-gal of premium, and one for waste oil (size not reported). No violations reported for disposal of unspecified oil-containing waste. The site generally appeared well maintained in good condition. Based on the nature of the site and close proximity to the Action Area, the potential for the site to adversely affect construction appears low to medium. It is recommended that excavation near this site be monitored for impacted soils and a contingency plan be in place to properly handle and dispose impacted soils if encountered.

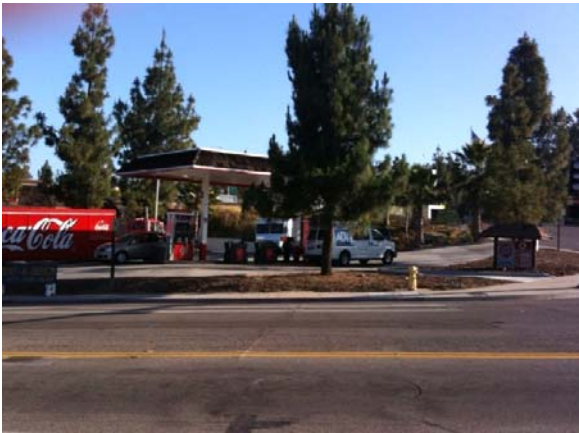
Image:

Geosyntec Site ID	103
Mile Post:	MP 97
Sempra Segment:	15
EDR Map ID	44
EDR Focus Map	17
EDR Listing ID:	S109285352, 1008200922, S104750590, U003939176, S108210978, S103634987
Site Name:	Conoco Phillips/Circle K #8581/Kayo Oil Co.
Site Address:	1666 Alpine Boulevard, Alpine, CA 91901
APN:	40339019
REC:	REC
Comments:	Assessment and interim remedial action in progress: drinking water aquifer affected, began 1/4/08. No violations reported for permitted air emissions of hydrocarbons. A letter dated 1 October 2008 from the SD DEH approved a workplan to install 4 groundwater monitoring wells at the site to assess the unauthorized leak. Three USTs reported: two 10,000-gal unleaded gasoline, one 10,000-gal leaded gasoline. No violations reported for disposal of organic residue and solids. Due to the proximity to the proposed trench location, it appears likely that contaminated soil and/or groundwater may be encountered during excavation; therefore, it appears that the potential for the site to adversely affect construction is medium to high. It is recommended that excavation near this site be monitored for impacted soils and a contingency plan be in place to properly handle and dispose impacted soils if encountered.

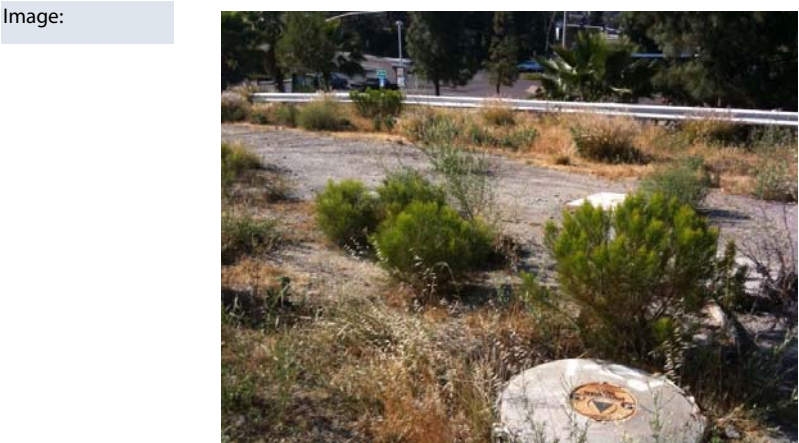
Geosyntec Site ID	104
Mile Post:	MP 97
Sempra Segment:	15
EDR Map ID	50
EDR Focus Map	17
EDR Listing ID:	S104494684, U001570893, 1000256361
Site Name:	Alpine Shell Service Station/Sterling Thomas
Site Address:	1340 Tavern Road, Alpine, CA 91901
APN:	40339011
REC:	REC
Comments:	Site assessment underway as of 2000. RCRA-SQG (historically LQG) with no violations found. Nine USTs reported: 3 regular unleaded, 2 premium unleaded, 1 midgrade unleaded, 1 leaded, and 1 with unknown contents. Facility has been demolished, however remediation is ongoing. One groundwater monitoring well in Alpine Blvd. reportedly contained 3ppb MTBE during a 2008 monitoring event. Active remediation is reportedly ongoing. Groundwater appears to be approximately 15 feet bgs in the vicinity of Alpine Boulevard. Two wells are apparently located on both sides of Alpine Boulevard. Due to the proximity to the proposed trench location, it appears likely that groundwater monitoring wells, contaminated soil, and/or groundwater may be encountered during excavation; therefore, it appears that the potential for the site to adversely affect construction is medium to high. It is recommended that excavation near this site be monitored for impacted soils and a contingency plan be in place to properly handle and dispose impacted soils if encountered.

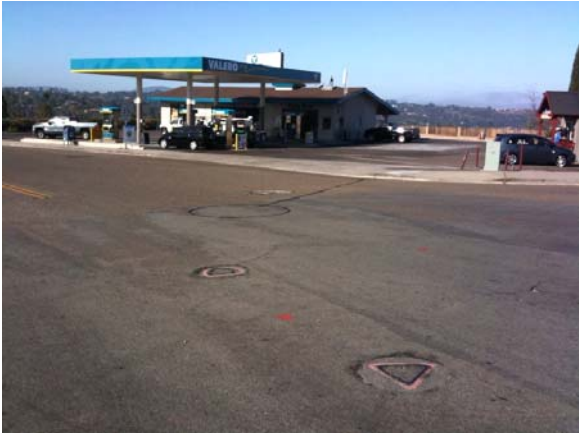
Image:

Geosyntec Site ID	110
Mile Post:	MP 97
Sempra Segment:	15
EDR Map ID	41
EDR Focus Map	17
EDR Listing ID:	S106072526
Site Name:	Tavern Road Texaco/Daniel Smith Trust
Site Address:	1140 Tavern Road, Alpine, CA 91901
APN:	40338045
REC:	REC
Comments:	Site assessment underway: diesel release reported 10/19/04. Two cases closed: one release of waste-oil to soil closed 11/4/96; and one release of diesel closed 11/20/08. Nine USTs listed for the site: 6 unleaded gasoline, 1 waste-oil, and 2 diesel. One AST 1,550-gal AST reported onsite. Reportedly, groundwater is greater than 30 feet below ground surface and flows southwest, away from the nearby Action Area. Additionally, the site is topographically downgradient of the nearby Action Area; therefore, it is unlikely that impacted soil or groundwater as a result of the site will be encountered during the proposed construction activities in the nearby Action Area. Therefore, the potential for the site to adversely affect construction appears low.

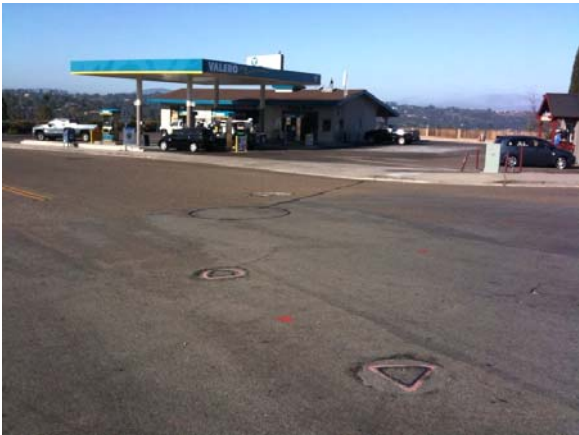
Image:

Geosyntec Site ID	110
Mile Post:	MP 97
Sempra Segment:	15
EDR Map ID	41
EDR Focus Map	17
EDR Listing ID:	S106072526
Site Name:	Tavern Road Texaco/Daniel Smith Trust
Site Address:	1140 Tavern Road, Alpine, CA 91901
APN:	40338045
REC:	REC
Comments:	Site assessment underway: diesel release reported 10/19/04. Two cases closed: one release of waste-oil to soil closed 11/4/96; and one release of diesel closed 11/20/08. Nine USTs listed for the site: 6 unleaded gasoline, 1 waste-oil, and 2 diesel. One AST 1,550-gal AST reported onsite. Reportedly, groundwater is greater than 30 feet below ground surface and flows southwest, away from the nearby Action Area. Additionally, the site is topographically downgradient of the nearby Action Area; therefore, it is unlikely that impacted soil or groundwater as a result of the site will be encountered during the proposed construction activities in the nearby Action Area. Therefore, the potential for the site to adversely affect construction appears low.

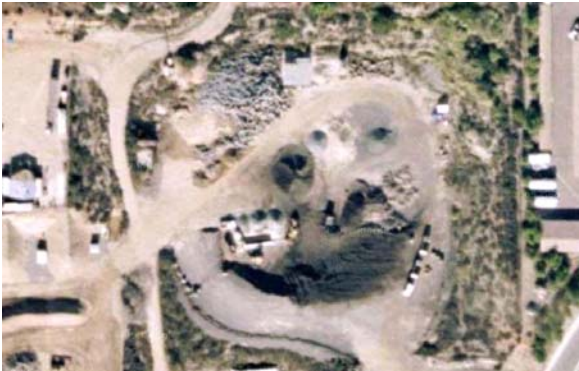
Geosyntec Site ID	111
Mile Post:	MP 97
Sempra Segment:	15
EDR Map ID	41
EDR Focus Map	17
EDR Listing ID:	U003789905
Site Name:	Impac Ready Mix
Site Address:	1117 Tavern Road, Alpine, CA 91901
APN:	40338056
REC:	REC
Comments:	Two USTs reported: one 25,000-gal unleaded gasoline, one 20,000-gal motor vehicle fuel. No incidents reported. Discolored soil was observed in recent aerial photographs which may indicate impacted soil at the site. However, due to access limitations, the nature of the dark soil was not evaluated. Currently, Geosyntec is awaiting a response from the local Building Department regarding files related to the site. Therefore, the potential for the site to adversely affect construction appears medium to high. It is recommended that an onsite reconnaissance be performed to further evaluate the potential to affect construction.

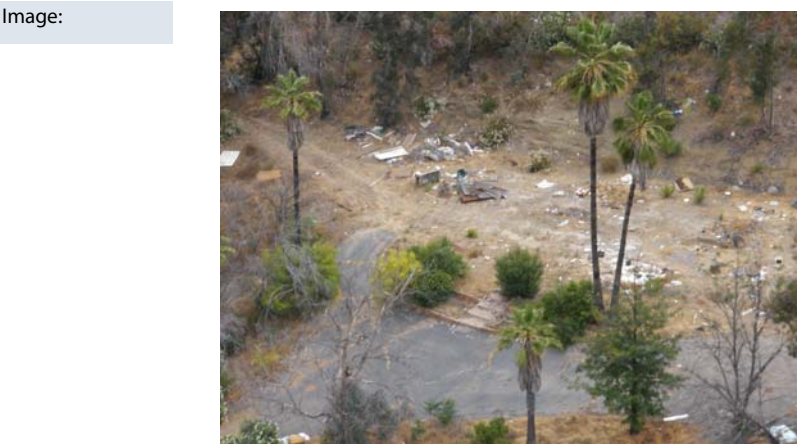
Geosyntec Site ID	122
Mile Post:	MP 98
Sempra Segment:	15
EDR Map ID	-
EDR Focus Map	-
EDR Listing ID:	-
Site Name:	Burned Residential Structure
Site Address:	Unknown
APN:	40222038
REC:	SREC
Comments:	A group of former homes appear to have been burned. Residual hazardous materials are often associated with burned structures. However, surficial impacts are unlikely to have impacted the subsurface below the paved Alpine Boulevard. Therefore, based on the nature of the site and proximity to the Action Area, the potential for the site to adversely affect construction appears low.

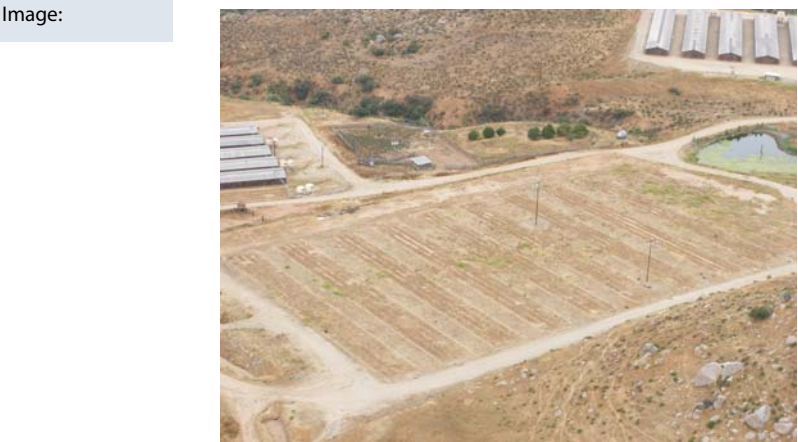
Geosyntec Site ID	131
Mile Post:	MP 100
Sempra Segment:	16
EDR Map ID	-
EDR Focus Map	-
EDR Listing ID:	-
Site Name:	Agricultural field
Site Address:	Unknown
APN:	40214120
REC:	None
Comments:	Yard appears to be a current or former pasture land and egg farm with a nearby pond. Although the land was cleared sometime between 1964 and 1968, evidence of active cultivation was not identified. Therefore, it does not appear that soil testing per the CPUC Mitigation Measures would be required.

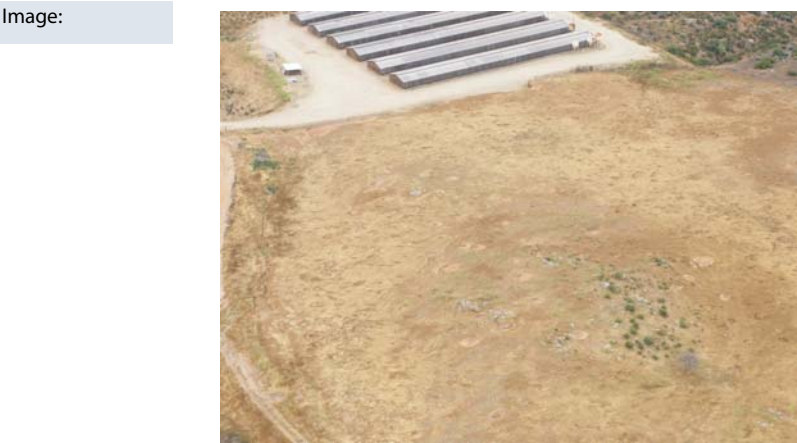
Geosyntec Site ID	132
Mile Post:	MP 101
Sempre Segment:	16
EDR Map ID	0
EDR Focus Map	14
EDR Listing ID:	CIND100561
Site Name:	Capitan Grande Indian Reservation
Site Address:	Unknown
APN:	40204004
REC:	None
Comments:	Indian Reservation Area. No issues identified. Therefore, it appears that the potential for the site to adversely affect construction is low.

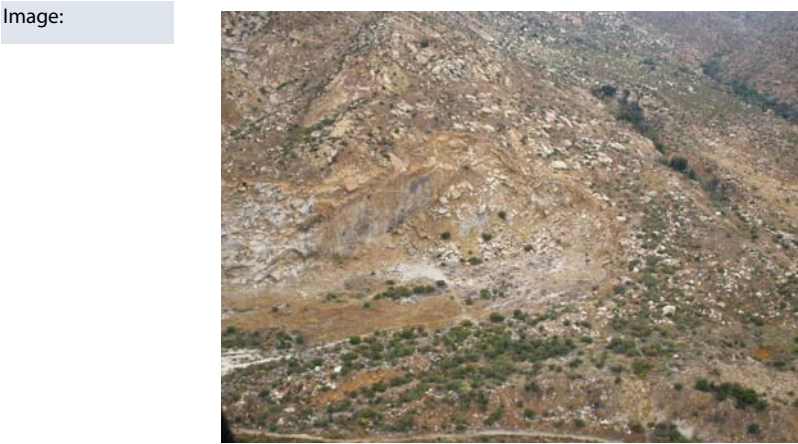
Geosyntec Site ID	136
Mile Post:	MP 103
Sempra Segment:	16
EDR Map ID	-
EDR Focus Map	-
EDR Listing ID:	-
Site Name:	Agricultural field
Site Address:	Unknown
APN:	39006008
REC:	SREC
Comments:	Disturbed soil may be a former agricultural field. Pesticides or herbicides may have been applied to the site. Site was cleared prior to 1953. A 1971 historic aerial indicates the site may have been tilled. Therefore, testing of soil for pesticides/herbicides per CPUC Mitigation Measures in the area proposed for the access road may be necessary.

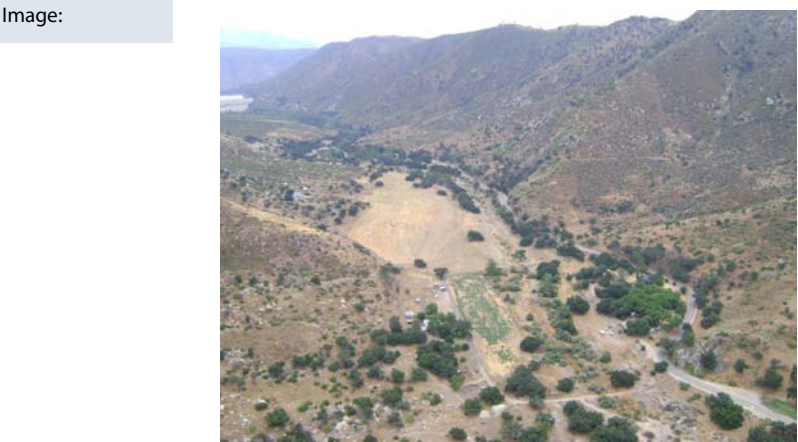
Geosyntec Site ID	137
Mile Post:	MP 104
Sempre Segment:	16
EDR Map ID	-
EDR Focus Map	-
EDR Listing ID:	-
Site Name:	Agricultural field
Site Address:	Unknown
APN:	39006002
REC:	SREC
Comments:	<p>Proposed location of an access road appears to adjoin formerly farmed land. The site was apparently developed as a farm prior to 1953. Based on the reviewed aerials from 1953, 1964, 1968, 1971, 1981, 1989, 2003, 2005, and 2008 it does not appear that the access road cut through formerly farmed land; however, due to the proximity of the access road to the formerly cultivated lands, the potential exists for residual pesticide/herbicide impacts. Therefore, it does appear that soil testing per the CPUC Mitigation Measures would be required, and the potential to adversely affect construction is low-medium.</p>

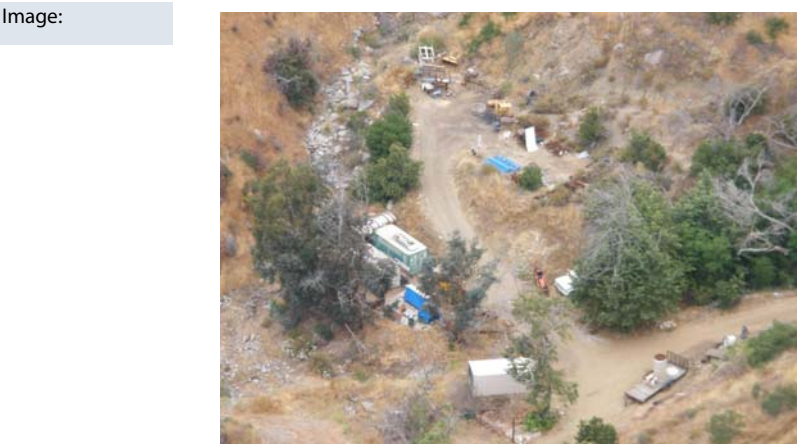
Geosyntec Site ID	138
Mile Post:	MP 105
Sempra Segment:	16
EDR Map ID	-
EDR Focus Map	-
EDR Listing ID:	-
Site Name:	Storage area with AST
Site Address:	Unknown
APN:	39001008
REC:	SREC
Comments:	Various heavy equipment and an abandoned damaged AST were observed. However, due to the proximity of proposed nearby towers located on the ridgeline, the potential for the AST site to adversely affect construction appears unlikely.

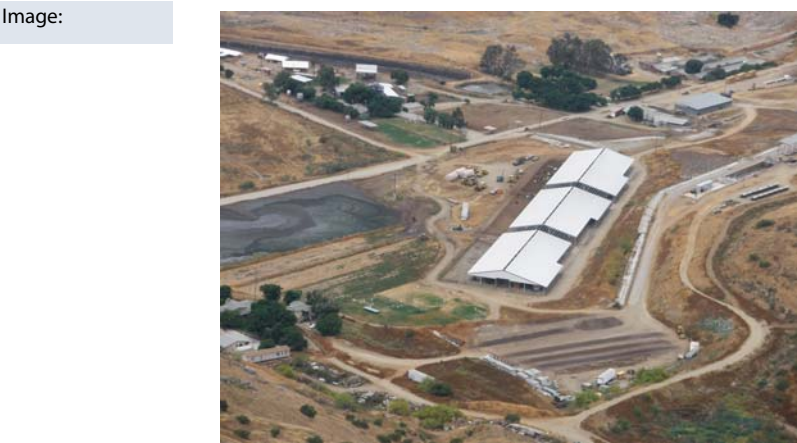
Geosyntec Site ID	142
Mile Post:	MP 106
Sempra Segment:	17
EDR Map ID	25
EDR Focus Map	12
EDR Listing ID:	S104761324
Site Name:	Van Ommering Dairy
Site Address:	15010 Willow Road, Lakeside, CA 92040
APN:	39004047
REC:	SREC
Comments:	No violations reported for use of oxygen, acetylene, iodine, phosphoric acid, gasoline, and diesel. Dairies are often associated with methane, sewage, and wastewater impacts. However, based on the nature of the site and proximity to the Action Area, the potential for the site to adversely affect construction appears low.

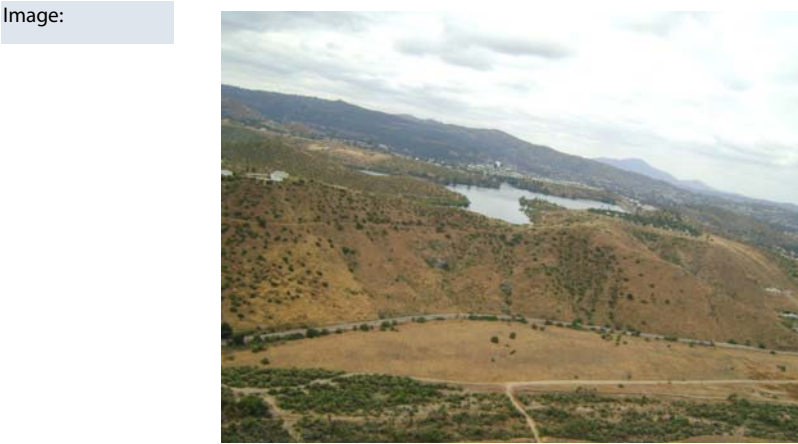
Geosyntec Site ID	144
Mile Post:	MP 107
Sempra Segment:	17
EDR Map ID	-
EDR Focus Map	-
EDR Listing ID:	-
Site Name:	Agricultural field
Site Address:	Unknown
APN:	39106101
REC:	SREC
Comments:	Yard appears to be a current or former agricultural field. Pesticides or herbicides may have been applied to the site. The site was cleared between 1964 and 1968 and row crops were noted in a 2003 aerial photo. Site may be required to be tested for pesticides and herbicides in accordance with the CPUC Mitigation Measures. Furthermore, it appears that the potential for the site to adversely affect construction is low to medium.

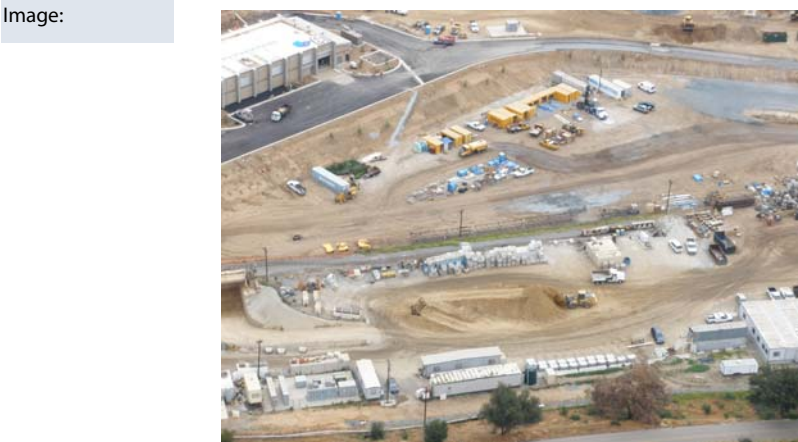
Geosyntec Site ID	151
Mile Post:	MP 110
Sempra Segment:	17
EDR Map ID	17
EDR Focus Map	11
EDR Listing ID:	S109279428, S109428007, S109457267
Site Name:	Kiewit Pacific Co./San Vicinte Pipeline
Site Address:	12393 Moreno Avenue, Lakeside, CA 92040
APN:	32912103
REC:	SREC
Comments:	One 12,110-gal diesel AST onsite. No violations reported for disposal of 3.15 tons of organic solids or stormwater construction permit. Due to the nature of the proposed nearby tower locations on the topographically upgradient ridgeline, the potential for the site to adversely affect construction appears low.

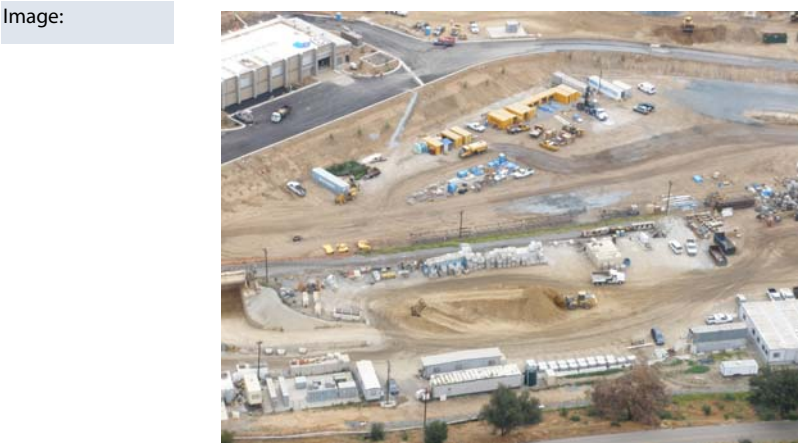
Geosyntec Site ID	151
Mile Post:	MP 110
Sempra Segment:	17
EDR Map ID	17
EDR Focus Map	11
EDR Listing ID:	S109279428, S109428007, S109457267
Site Name:	Kiewit Pacific Co./San Vicinte Pipeline
Site Address:	12393 Moreno Avenue, Lakeside, CA 92040
APN:	32912103
REC:	SREC
Comments:	One 12,110-gal diesel AST onsite. No violations reported for disposal of 3.15 tons of organic solids or stormwater construction permit. Due to the nature of the proposed nearby tower locations on the topographically upgradient ridgeline, the potential for the site to adversely affect construction appears low.

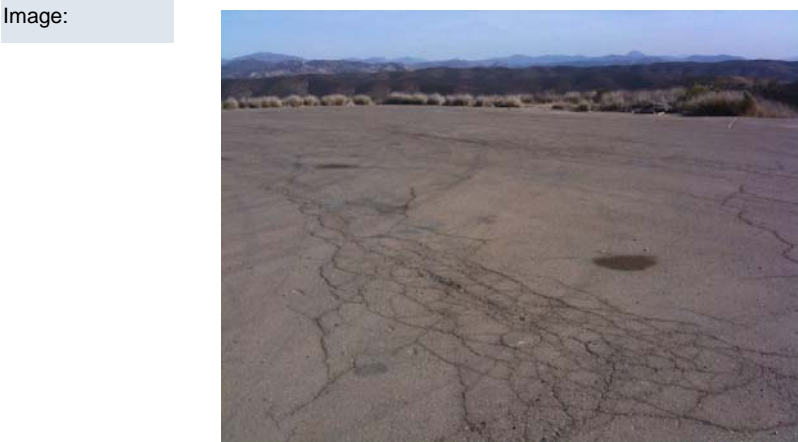
Geosyntec Site I	175A
Mile Post:	MP 114
Sempra Segmen	18
EDR Map ID	
EDR Focus Map	
EDR Listing ID:	
Site Name:	Sycamore Canyon Site - General Dynamics/Proposed Fly Y
Site Address:	None
APN:	32505016
REC:	HREC
Comments:	<p>The site was previously identified during the initial Sunrise Phase I ESA; however, no construction was proposed near potential contaminant sources. However, the September Route proposes to utilize a portion of the former General Dynamics site as a fly and staging yard. Ground reconnaissance from public ROW identified the site as an existing asphalt-paved parking lot with minor surface staining and weathered surface. No visible indications of recognized environmental conditions were identified. Based on a review of available aerial photographs, the site was undeveloped except for unpaved access roads in 1964, and graded and paved as a parking lot with one small structure onsite by 1968, and a second structure added by 1989. By 2003, the structures were removed and site conditions were similar to present. Based on available reports, a portion of the General Dynamics site (Area K) was under investigation for perchlorate impacts to soil and groundwater. However, a No Further Action letter from the RWQCB indicated that identified concentrations were below regulatory thresholds and approved development of that portion of the site for residential use. A request for files has been submitted to the RWQCB; however, at the time of this report no response has been received. If files are found which represent a material threat to the environment near the site, then an addendum will be prepared.</p>

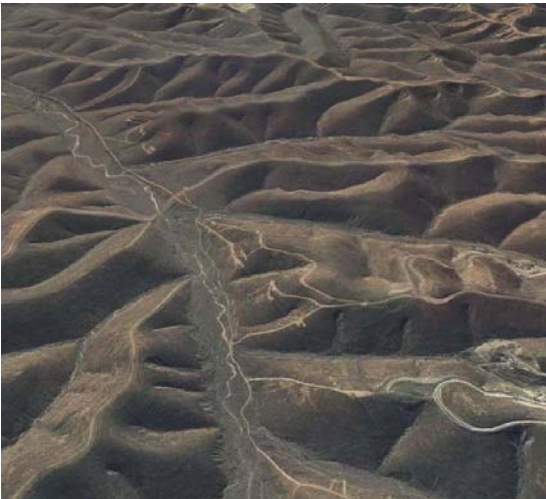
Image:

Geosyntec Site ID	176
Mile Post:	MP 118.1
Sempra Segment:	18
EDR Map ID	0
EDR Focus Map	4-5-9-10
EDR Listing ID:	CUSA145303
Site Name:	El Centro Naval Air Facility/MCAS Miramar/Former Camp Elliot
Site Address:	Unknown
APN:	37401101
REC:	None
Comments:	Appears to refer to existing Marine Corps Air Station (MCAS) Miramar and/or former Camp Elliot. No incidents were reported; however, similar sites are often associated with unexploded ordinances. An existing transmission line is present south of the Action Area (closer to the MCAS Miramar), and issues related to the construction of the existing line with respect to MCAS Miramar was not reported to Geosyntec. Furthermore, no physical evidence of a material threat was identified. Based on the identified information, it appears that the site may present a low to medium potential to adversely affect construction. It is recommended that construction personnel are notified and trained on safety procedures for working in areas with a potential to contain unexploded ordinances.
