HABITAT MITIGATION AND MONITORING PLAN

SUNRISE POWERLINK

CORPS FILE NUMBER 2007-00704-SAS

JULY 8, 2010

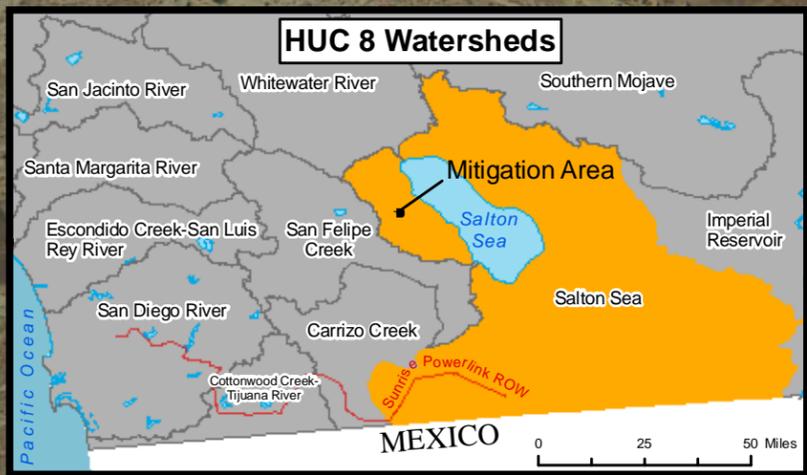
Figure 5. Mitigation Activities at the Desert Cahuilla Property

Mitigation acreage within the Desert Cahuilla property is listed in Table 8 below. Mitigation activities planned for the Desert Cahuilla property are shown in Figure 5, and described further in the text below.

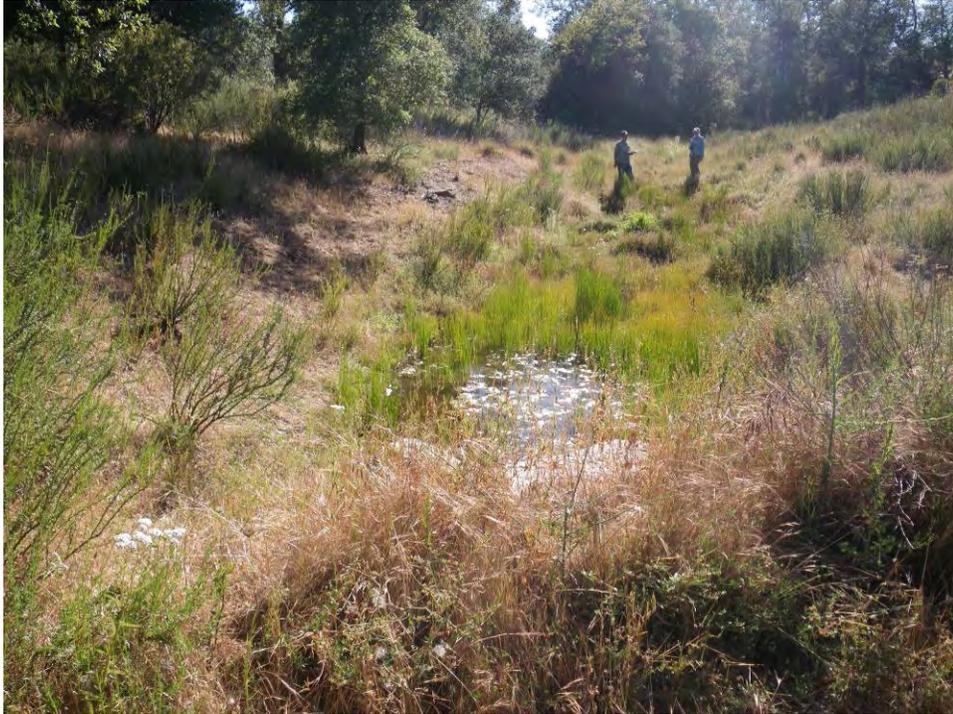
Figure C-3. At Site 1 looking upstream from the road crossing at a wetland impoundment.

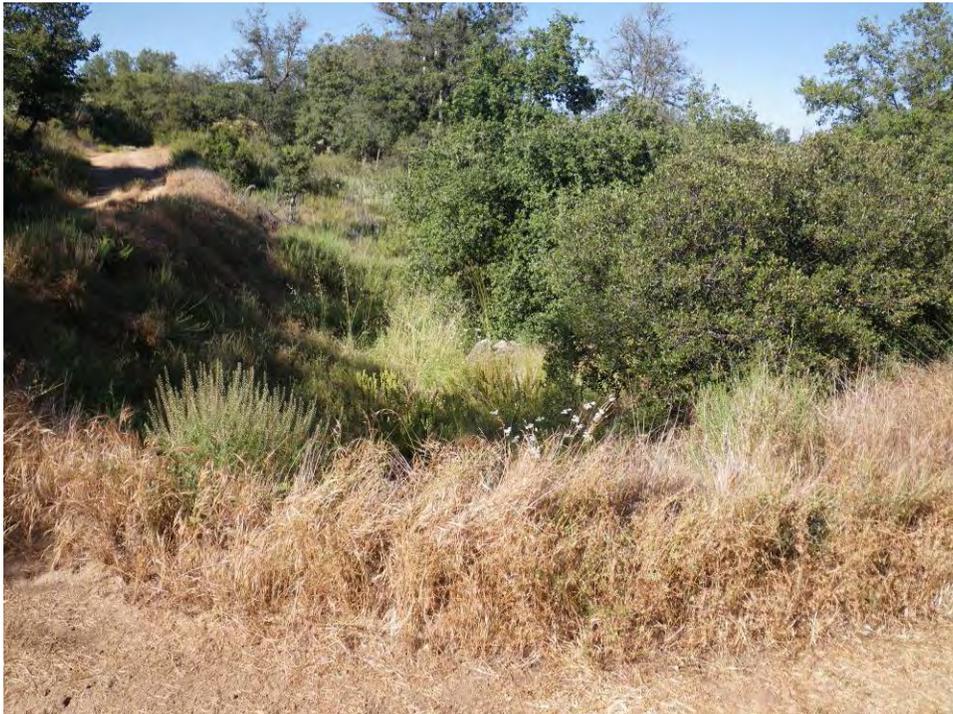
Figure C-4. At Site 1 looking downstream from the road crossing at the downstream reach of the intermittent stream channel.

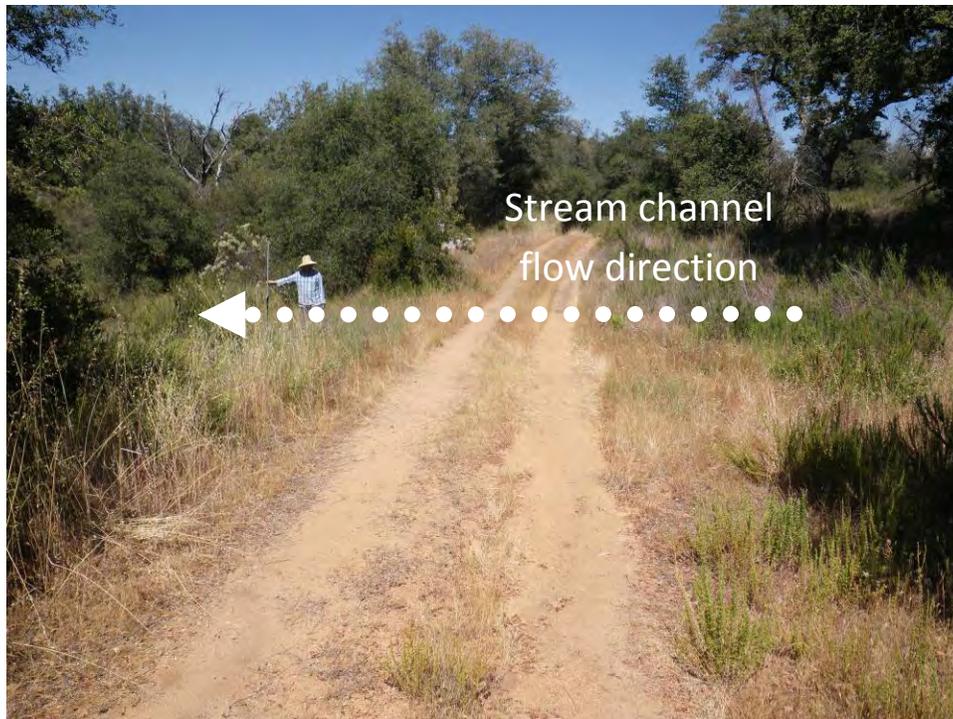
Figure C-7. At Site 8 looking east along existing road at the crossing of the western-most ephemeral stream (flow is right to left). Note that there is minimal impoundment on the upstream side of the crossing (right side of photo) and minimal channel drop on the downstream side (left side of image).

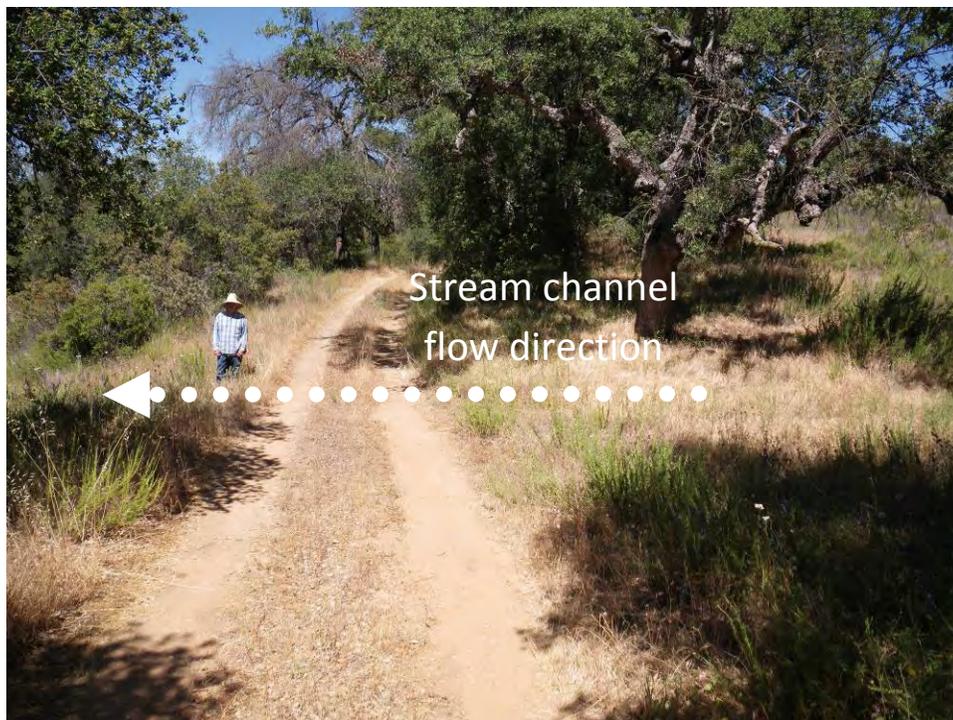
Figure C-8. At Site 8 looking east along existing road at the crossing of the middle ephemeral stream (flow is right to left); similar morphology as the western-most stream crossing (see Figure 9).

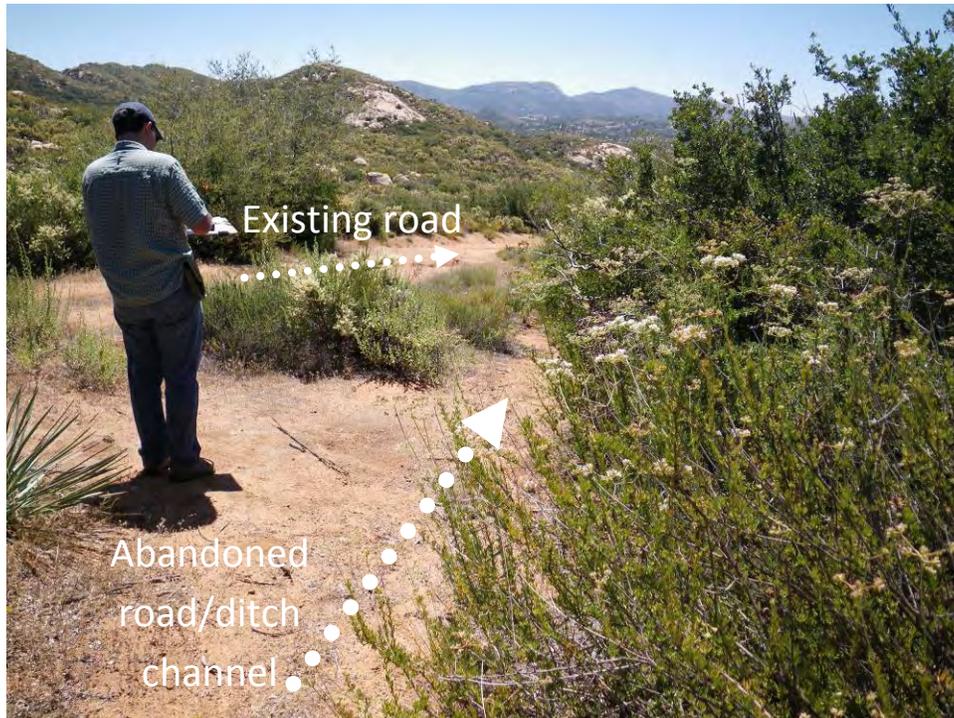
Figure C-11. At Site 1 looking downstream along abandoned road/ditch channel towards its confluence with the existing roadway. At the road, this channel continues along an inboard ditch.

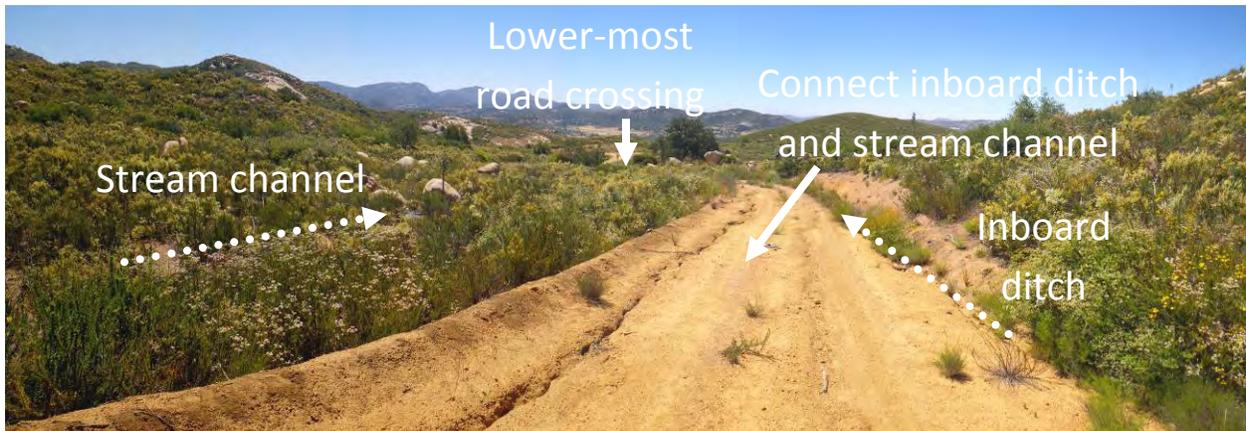
Figure C-12. At Site 1 looking down-gradient along the roadway with the stream channel running parallel to the left and an inboard ditch running on the right. The inboard ditch connects the abandoned road/ditch channel upstream to the ditch channel downstream.

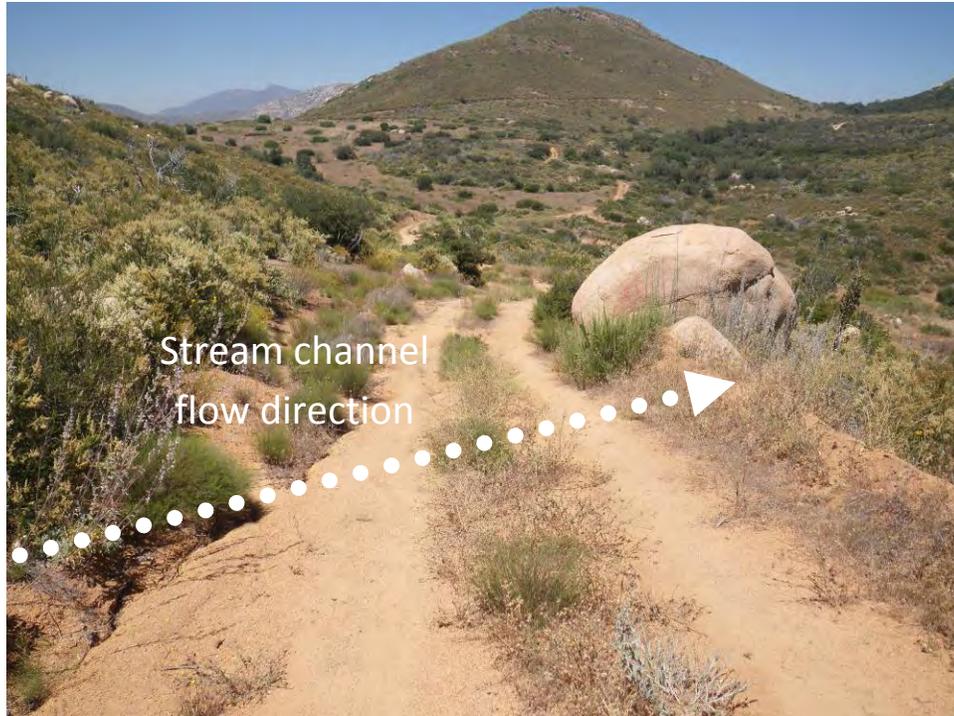
Figure C-18. View of existing road crossing (southwestern stream channel) at Site 2. Removal of road will re-connect the upstream and downstream reaches of this ephemeral stream channel.

The project will remove several abandoned roads that currently cross and adversely impact existing stream channels. The removal of the roads will ensure that unauthorized use of the roads by automobiles will not have future adverse effect at the stream crossings. The goal of this activity is to restore the original upland topography and stream geometry, and create conditions that favor revegetation of these areas with chaparral scrub vegetation. In general, the roads were created by cutting the uphill slope and filling the downhill slope to create a level cross slope. The topography will be restored by removing the down hill fill and filling the uphill cut. After the road way has been graded, approximately 2-4 feet of salvaged topsoil (from the substation footprint and other impact areas) with a native seed bank will be placed over all disturbed areas. In addition, disturbed areas will be direct seeded with chaparral scrub species. Finally, erosion control measure will be applied to all disturbed areas that result in bare soil.

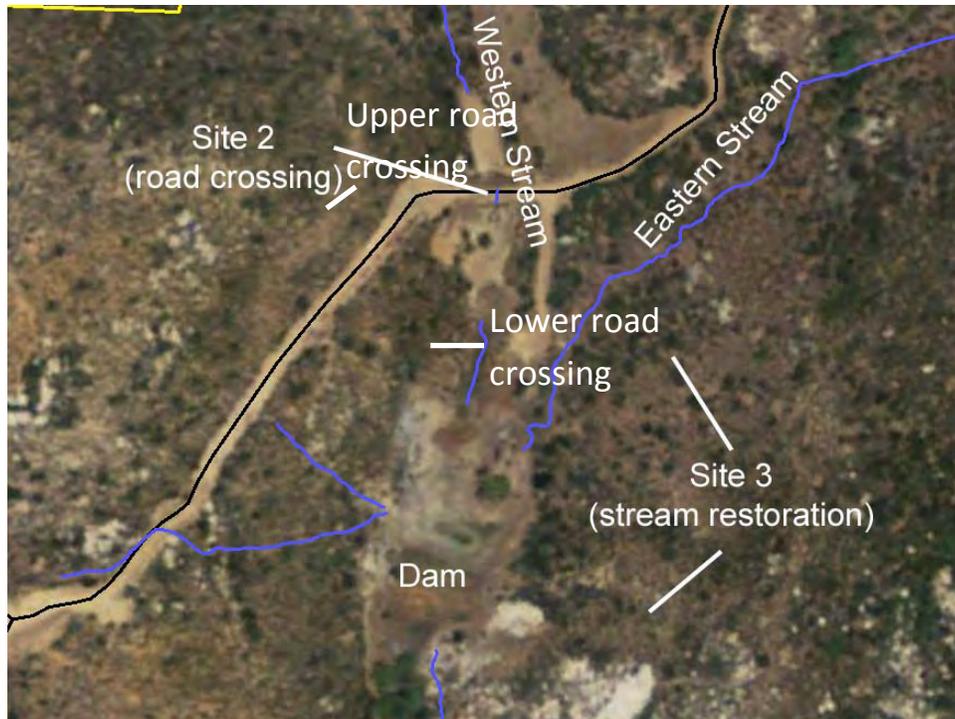
Figure C-23. View of the large reservoir, dam, road crossing, and northwestern and northeastern stream channels at Sites 2 and 3 (aerial photograph taken 25 May 2009, source: Google Earth, accessed 2010). Present day road alignment shown in black and streams shown in blue.

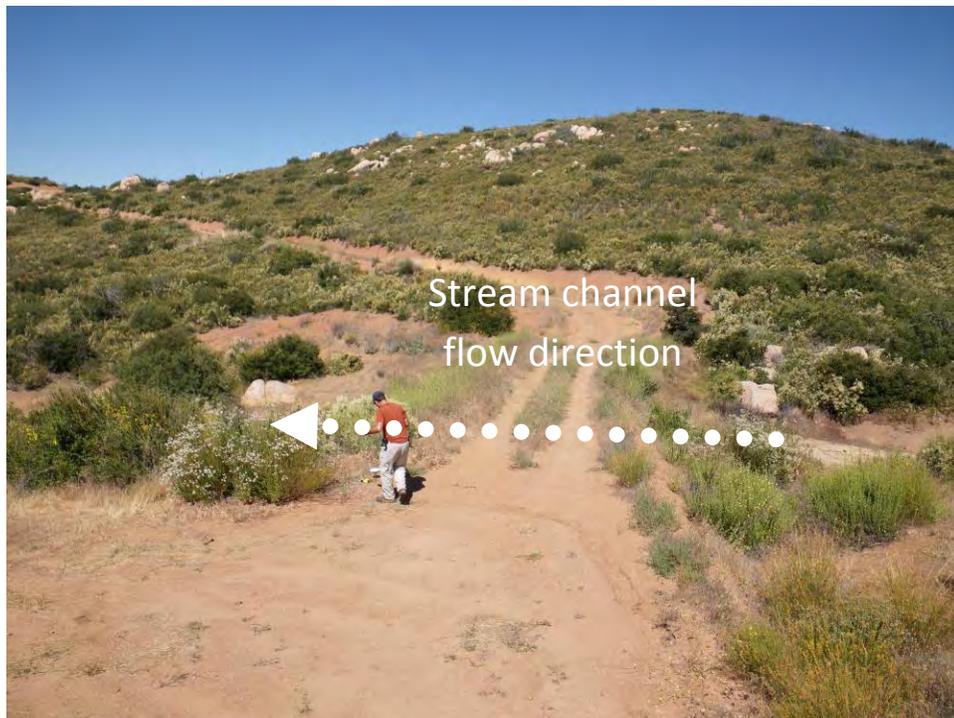
Figure C-26. View of road crossing over the northwestern stream channel with dry ponds (NW Ponds A and B) on the upstream and downstream sides at Site 2.

The other berms and ponds that will be removed are NW Pond and Berm B, NE Pond and Berm B, and NE Pond and Berm C as these are more frequently dry and do not afford any suitable wetland habitat. The channel and valley bottom cross-section geometries and longitudinal gradients will be restored to a more natural configuration as much as possible to avoid inducing erosion and/or sedimentation processes that could negatively impact the stream's post-restoration morphologic, hydrologic, and ecologic conditions. The NW Pond and Berm C and NE Pond and Berm A would remain intact as they do afford suitable wetland habitat.
