Restoration Plan for Special Status Plants*

Prepared for San Diego Gas & Electric Company by:

FINAL

January 3, 2011
November 29, 2010

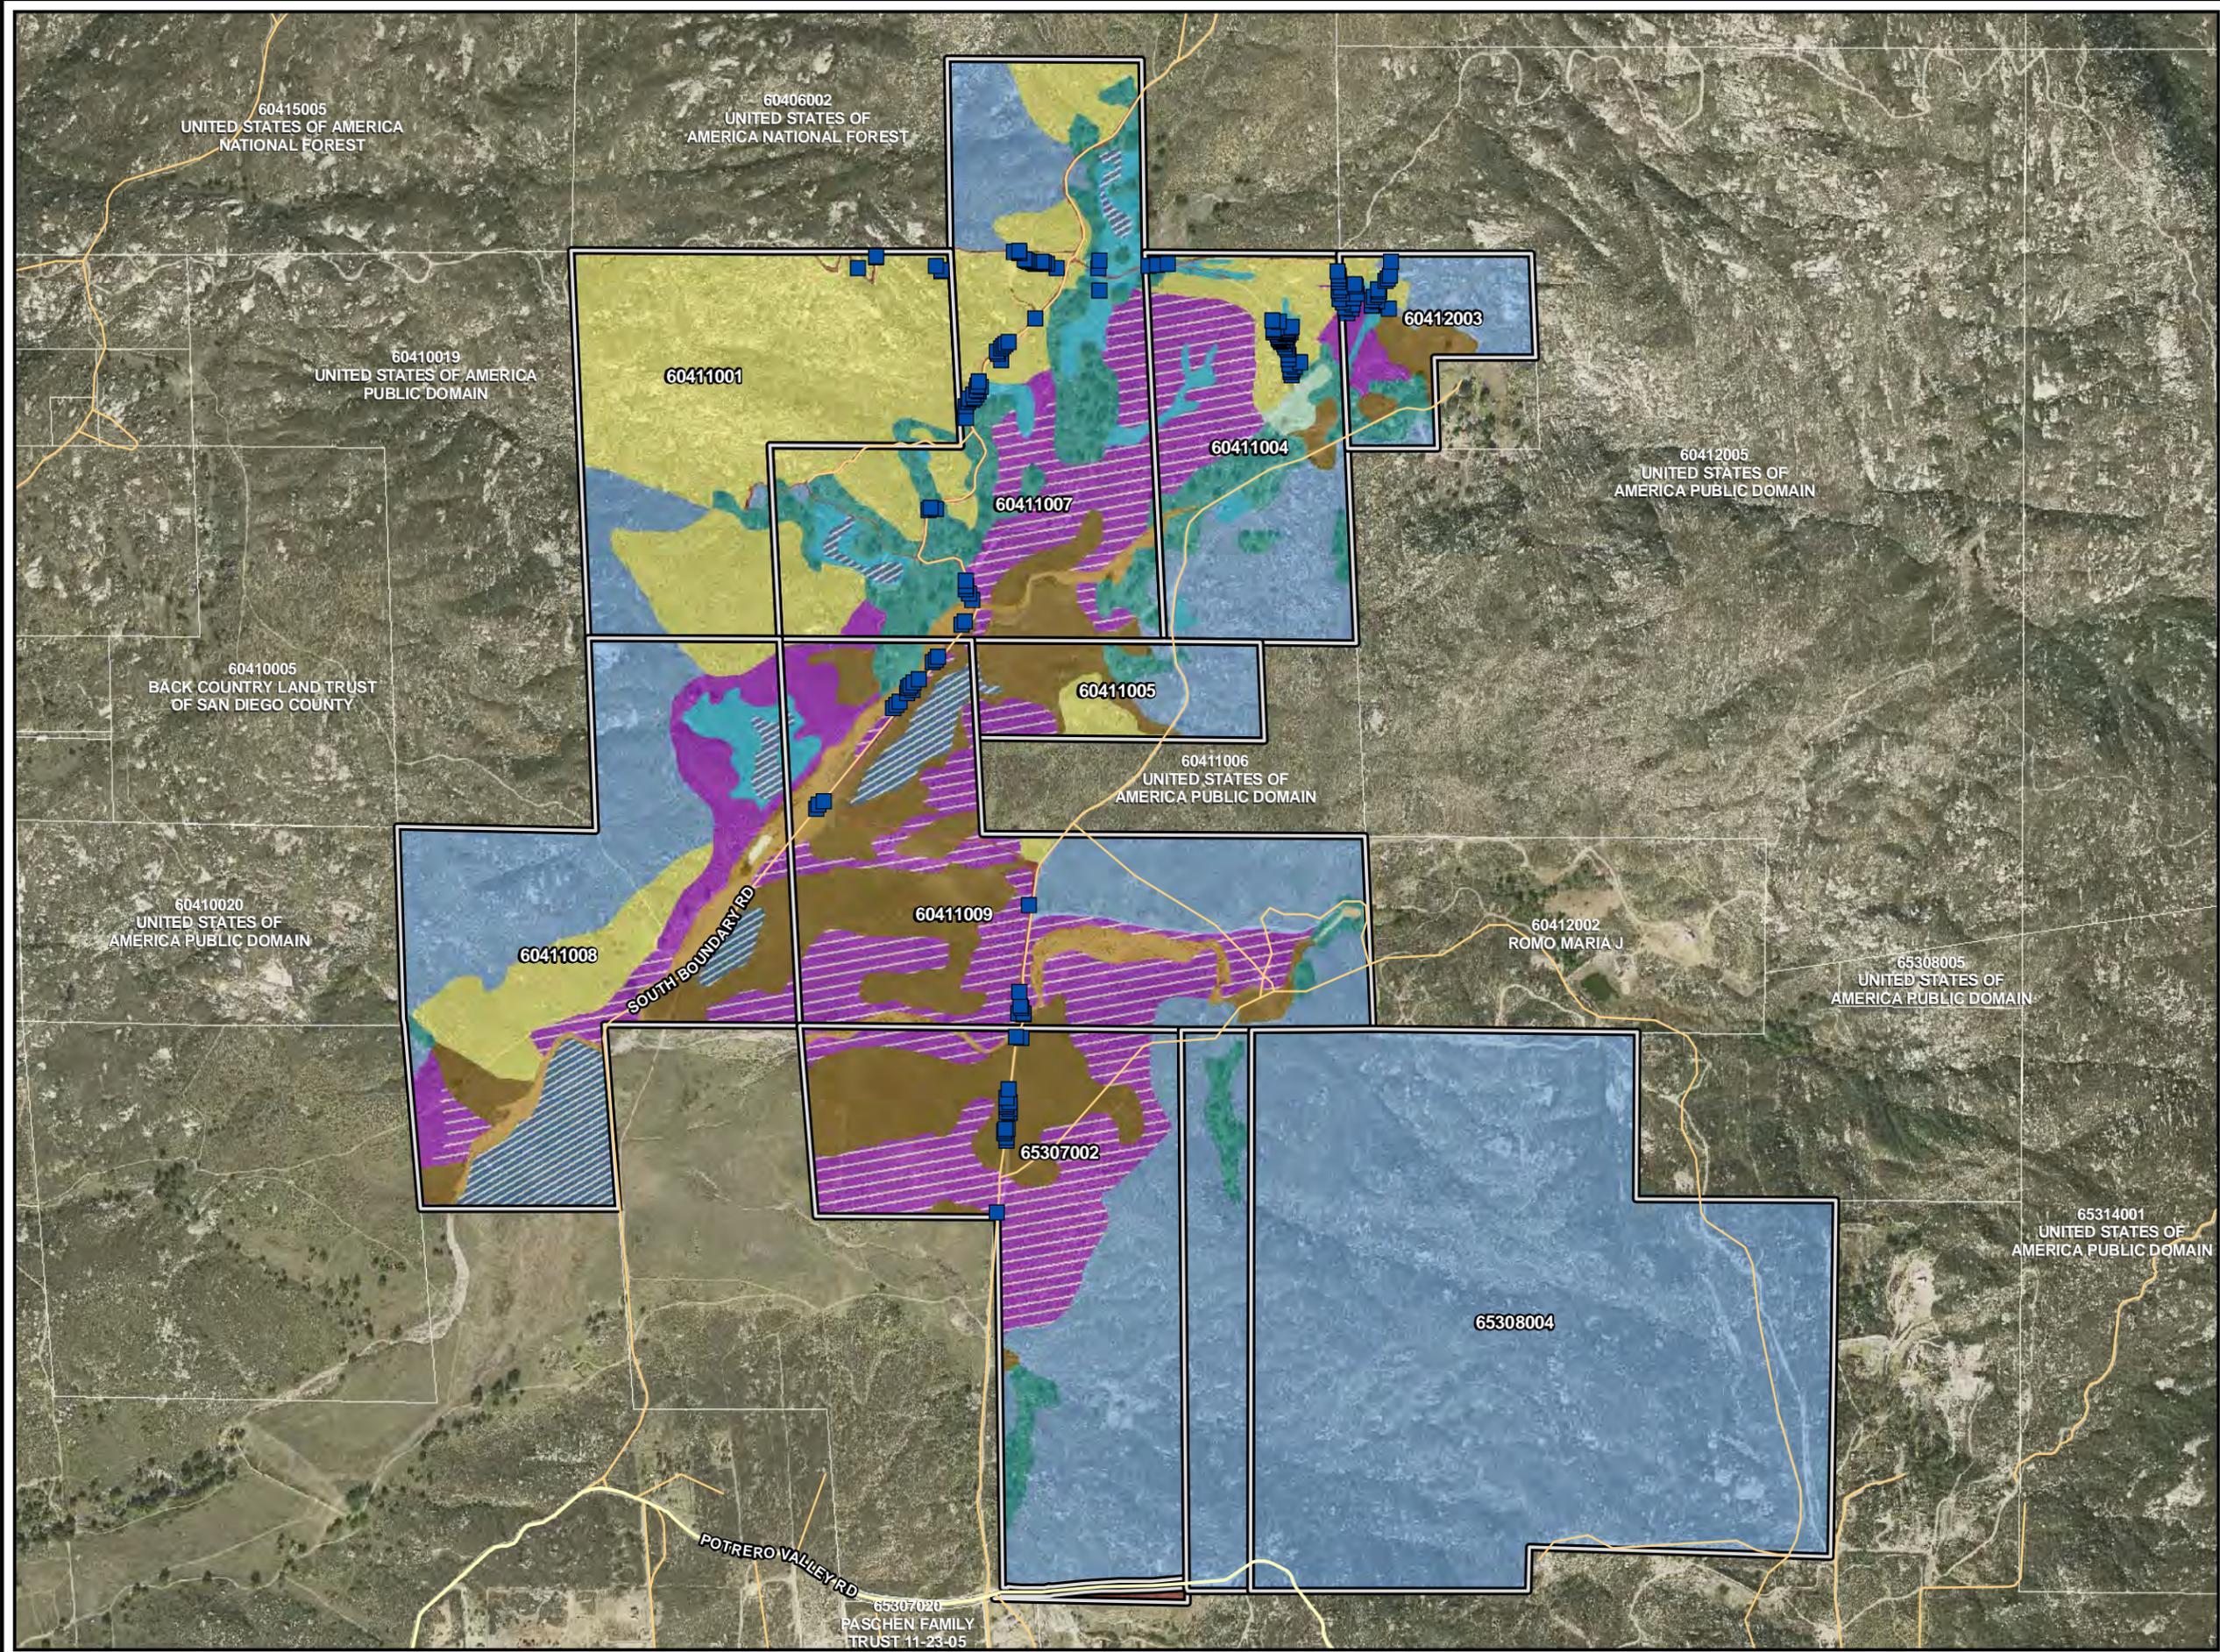
**Tecate Tarplant
Long Potrero
Mitigation Site
Figure 4**

- Mitigation Property Boundary
- Tecate tarplant *Deinandra floribunda*
- Vegetation Communities**
 - Coast Live Oak Woodland (CLOW)
 - Mule Fat Scrub (MFS)
 - Southern Coast Live Oak Riparian Forest (SCLORF)
 - Flat-topped Buckwheat Scrub (FTBS)
 - Flat-topped Buckwheat Scrub - Disturbed (FTBS-D)
 - Emergent Wetland (EM)
 - Non-vegetated Channel (NVC)
 - Vernal Marsh (VM)
 - Southern Mixed Chaparral (SMC)
 - Northern Mixed Chaparral (NMC)
 - Chamise Chaparral (CC)
 - Non-native Grassland (NNG)
 - Disturbed Habitat (DH)
 - Developed (DEV)
