APPENDIX E
LOCAL AGENCY RECORDS

DEFENSE ENVIRONMENTAL RESTORATION PROGRAM
FORMERLY USED DEFENSE SITES
FINDINGS AND DETERMINATION OF ELIGIBILITY

SITE ASSESSMENT REPORT, SITE CONCEPTUAL MODEL AND CORRECTIVE ACTION PLAN

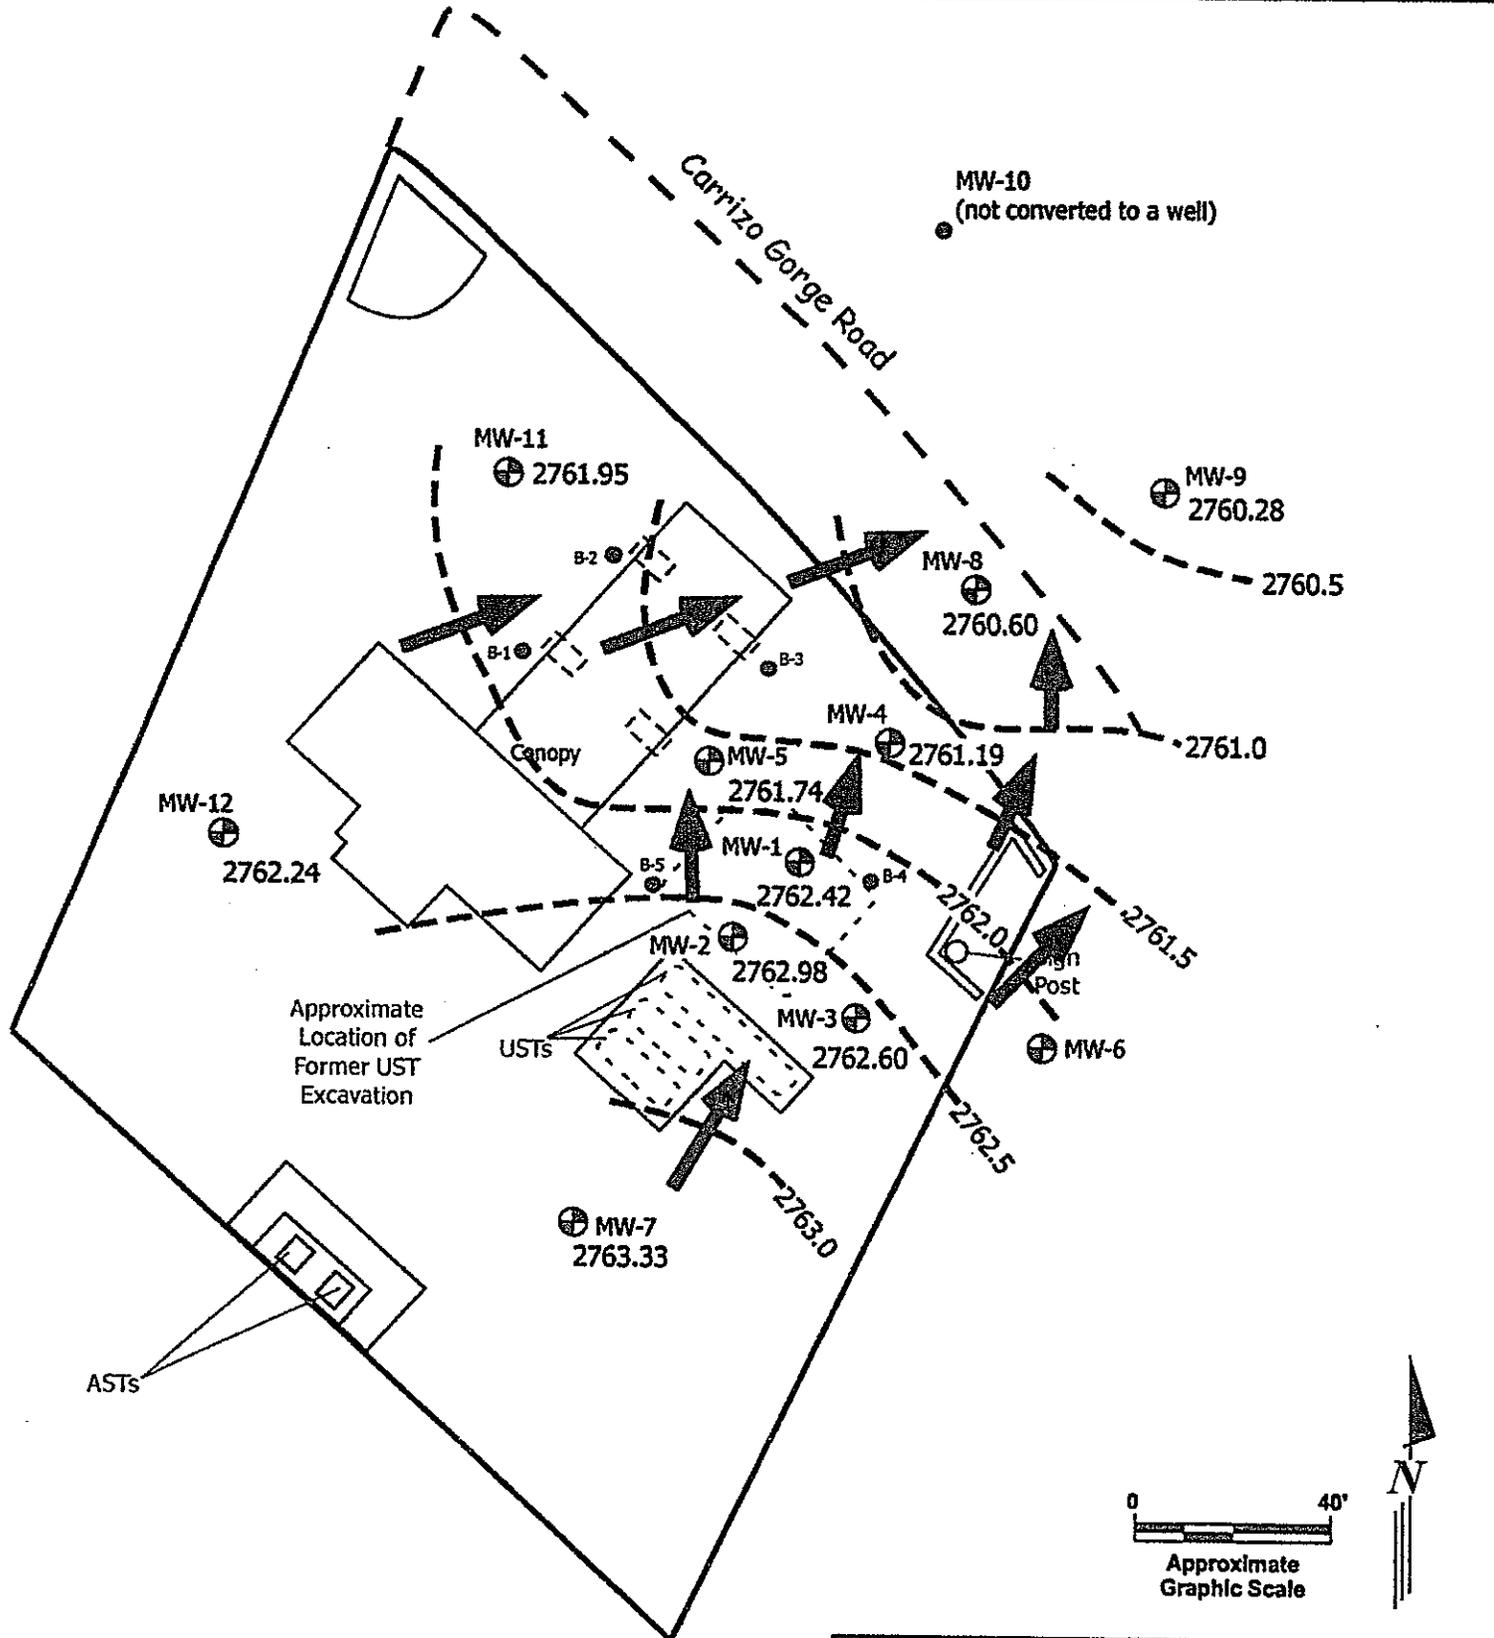
DATE May 2005	J.N. 9195-03	Fig. 4
DWG BY: PTF	SCALE: 1" = 40'

Interpreted groundwater flow direction

Jacumba Texaco
 1451 Carrizo Gorge Rd., Jacumba, CA

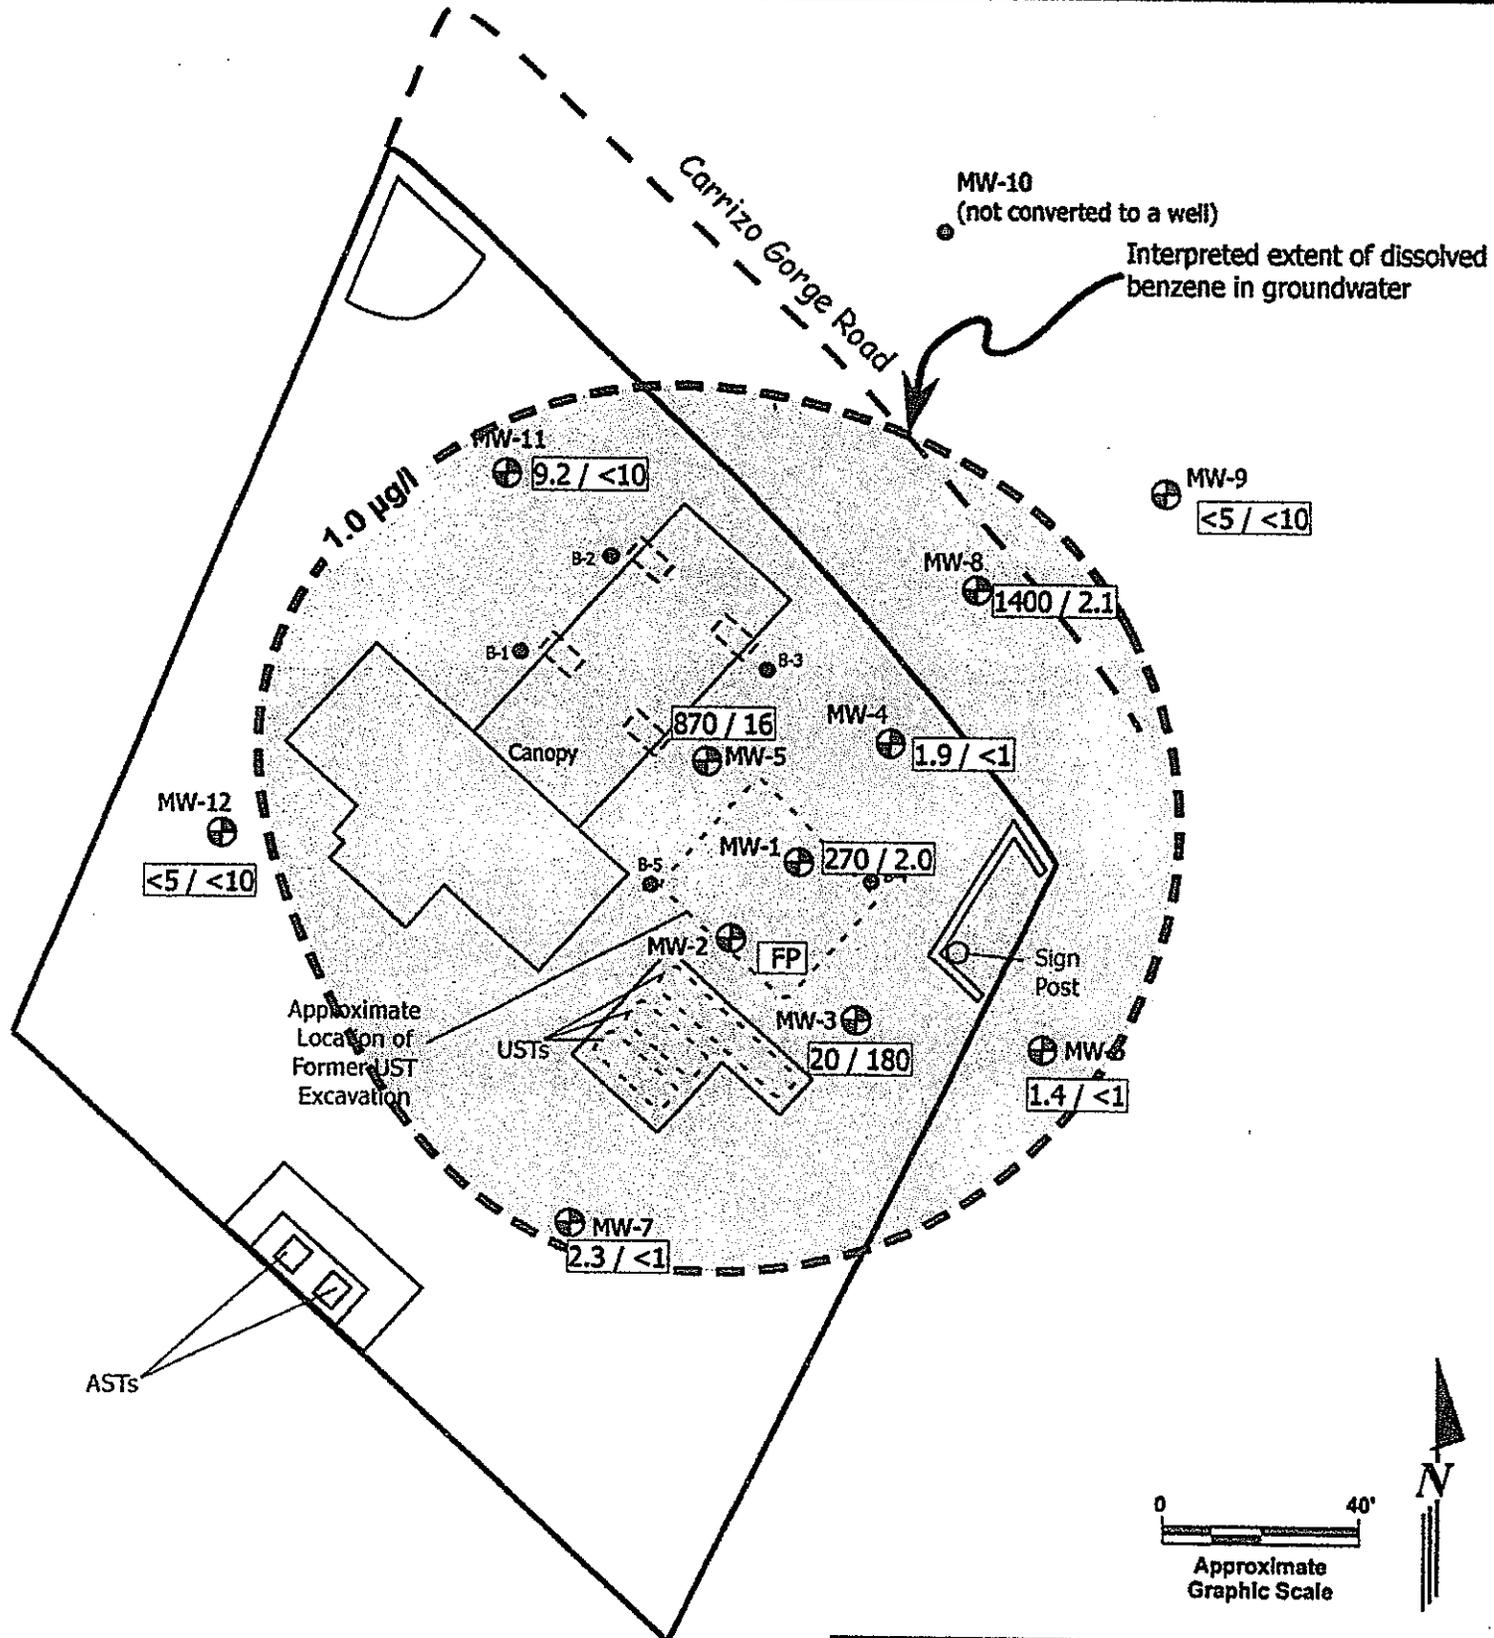
DATE May 2005	J.N. 9195-03	Fig. 5
DWGBY: PTF	SCALE: 1" = 40'

LEGEND	
MW-12 ⊕ 1400 / 2.1	Approximate location of groundwater monitoring well. Indicates reported benzene and MTBE concentrations in units of micrograms per liter.
FP	Free product in well

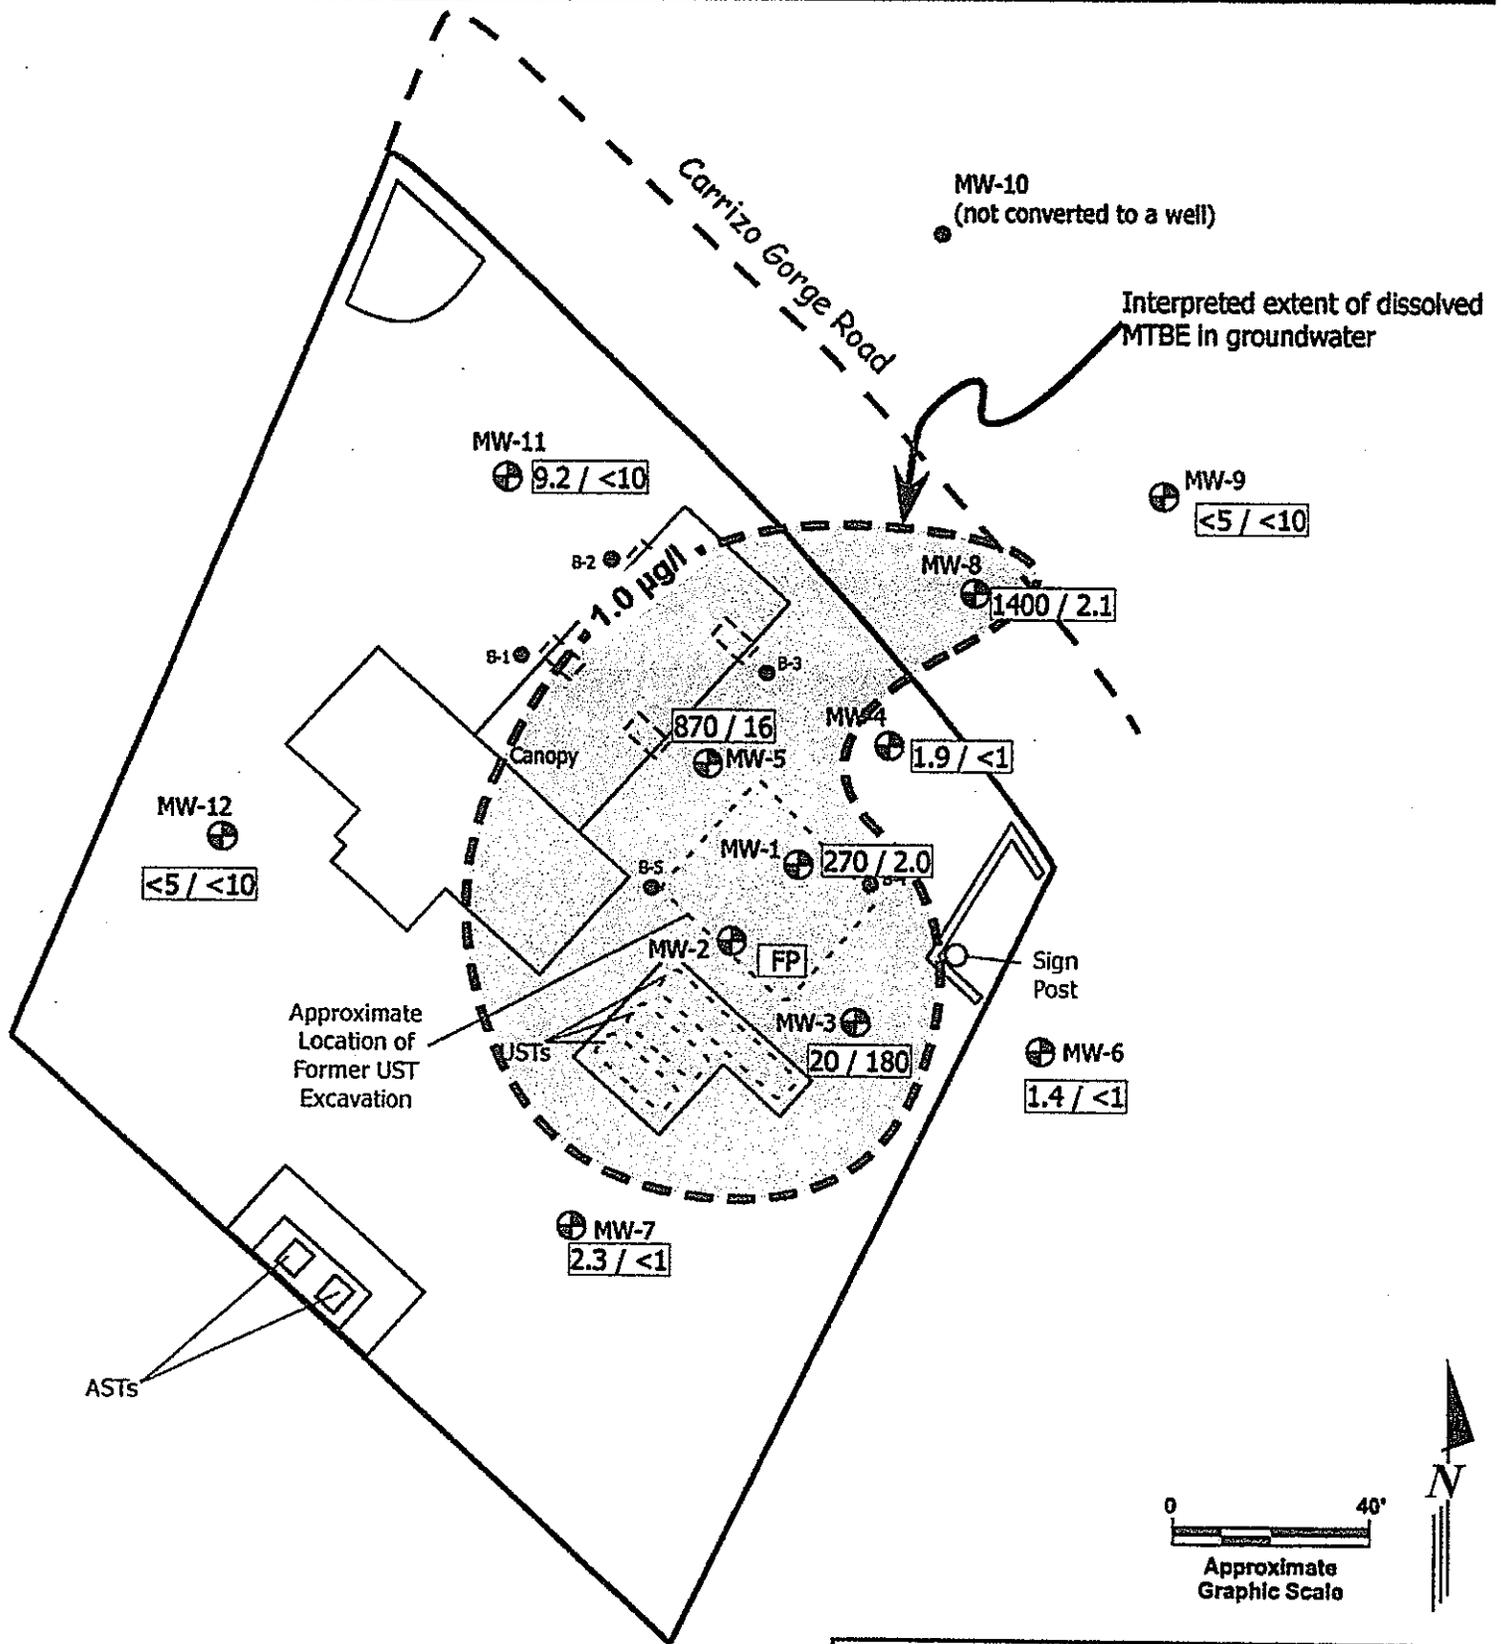
PETRA GEOTECHNICAL, INC. 12225 WORLD TRADE DRIVE, SUITE P SAN DIEGO, CALIFORNIA 92128 PHONE: (858) 485-5530		
SAN DIEGO	MURIETTA	LOS ANGELES COSTA MESA
MTBE PLUME MAP		
Jacumba Texaco 1451 Carrizo Gorge Rd., Jacumba, CA		
DATE May 2005	J.N. 9195-03	Fig. 6
DWG BY: PTF	SCALE: 1" = 40'

LEGEND	
MW-12	Approximate location of groundwater monitoring well.
⊕	Indicates reported benzene and MTBE concentrations in units of micrograms per liter.
1400 / 2.1	
FP	Free product in well

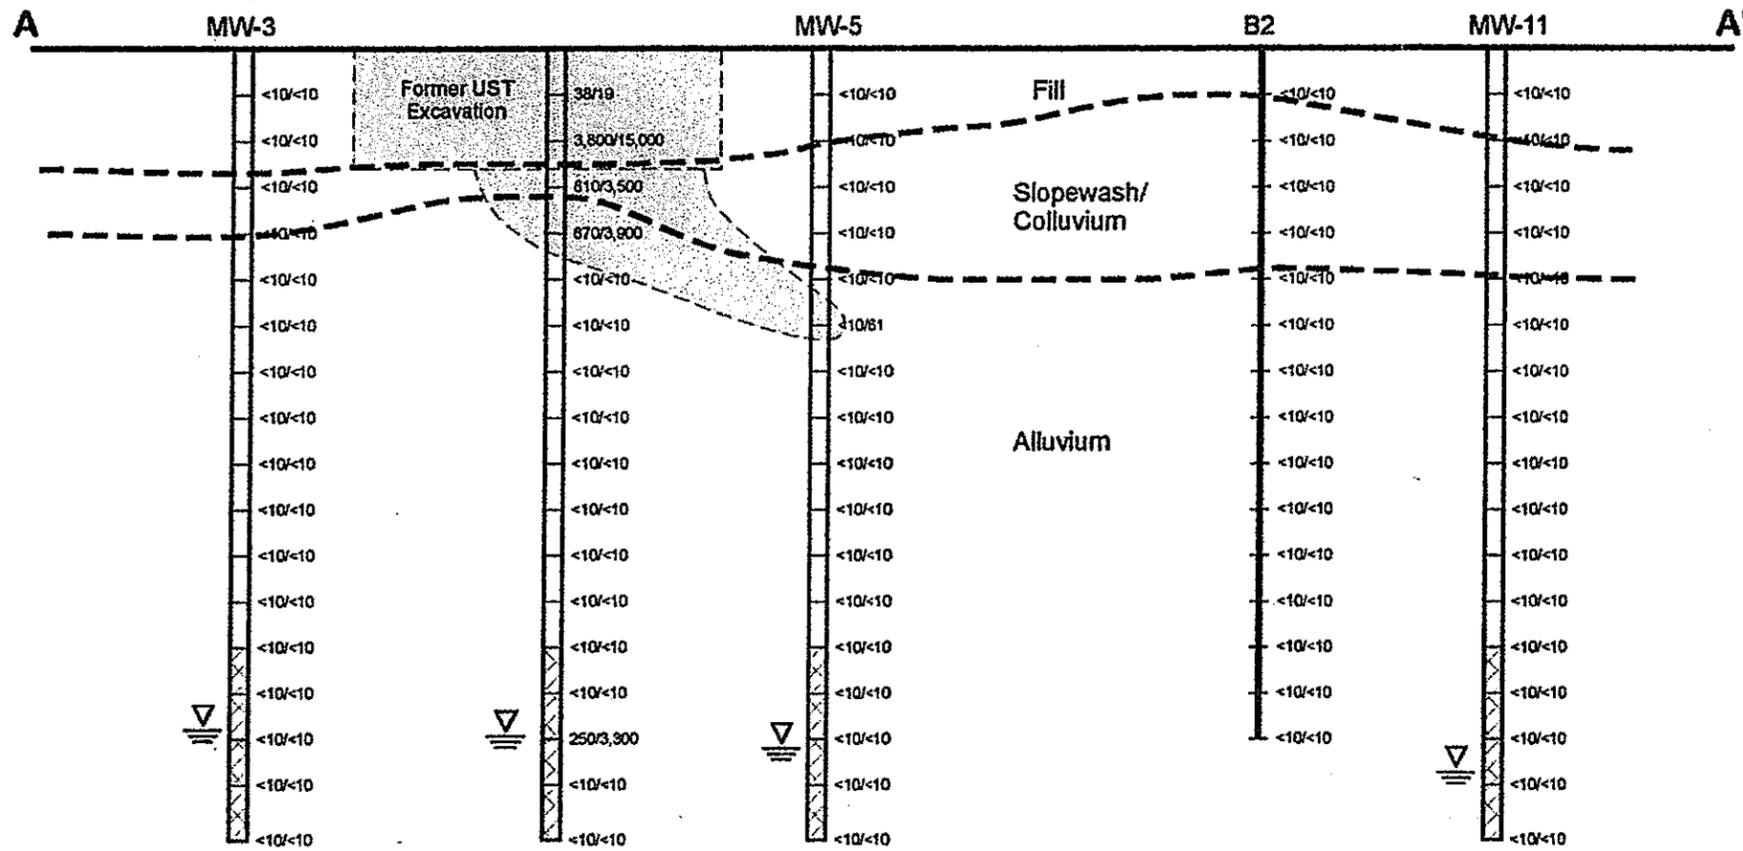
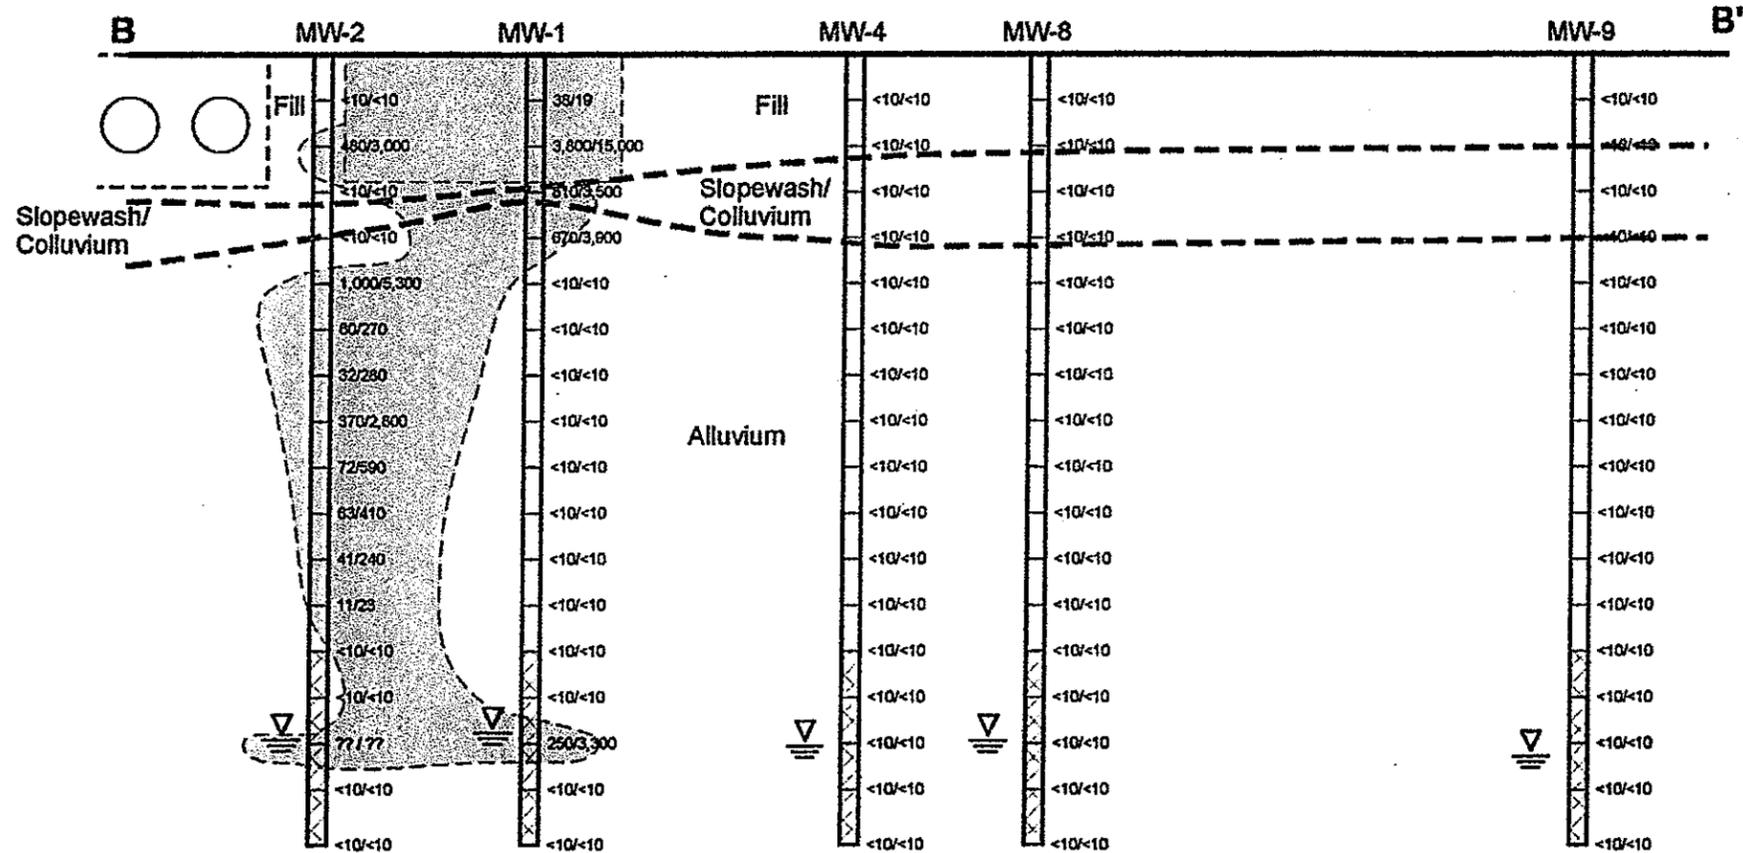
Fig. 3

- Geologic Contact
- Fill**
Yellowish-brown to dark olive gray silty to poorly-graded sand with clay
- Slopewash/Colluvium**
Light brown to olive gray silty to poorly-graded sand with clay, quartz pebbles
- Alluvium**
Varies from reddish brown to light yellowish brown to light gray, silty to clayey sand with gravel and pebble layers
- Well - indicates sample depth and TPHd/TPHg concentrations in mg/kg
- Well screen interval
- Approximate limits of petroleum hydrocarbon-bearing soil

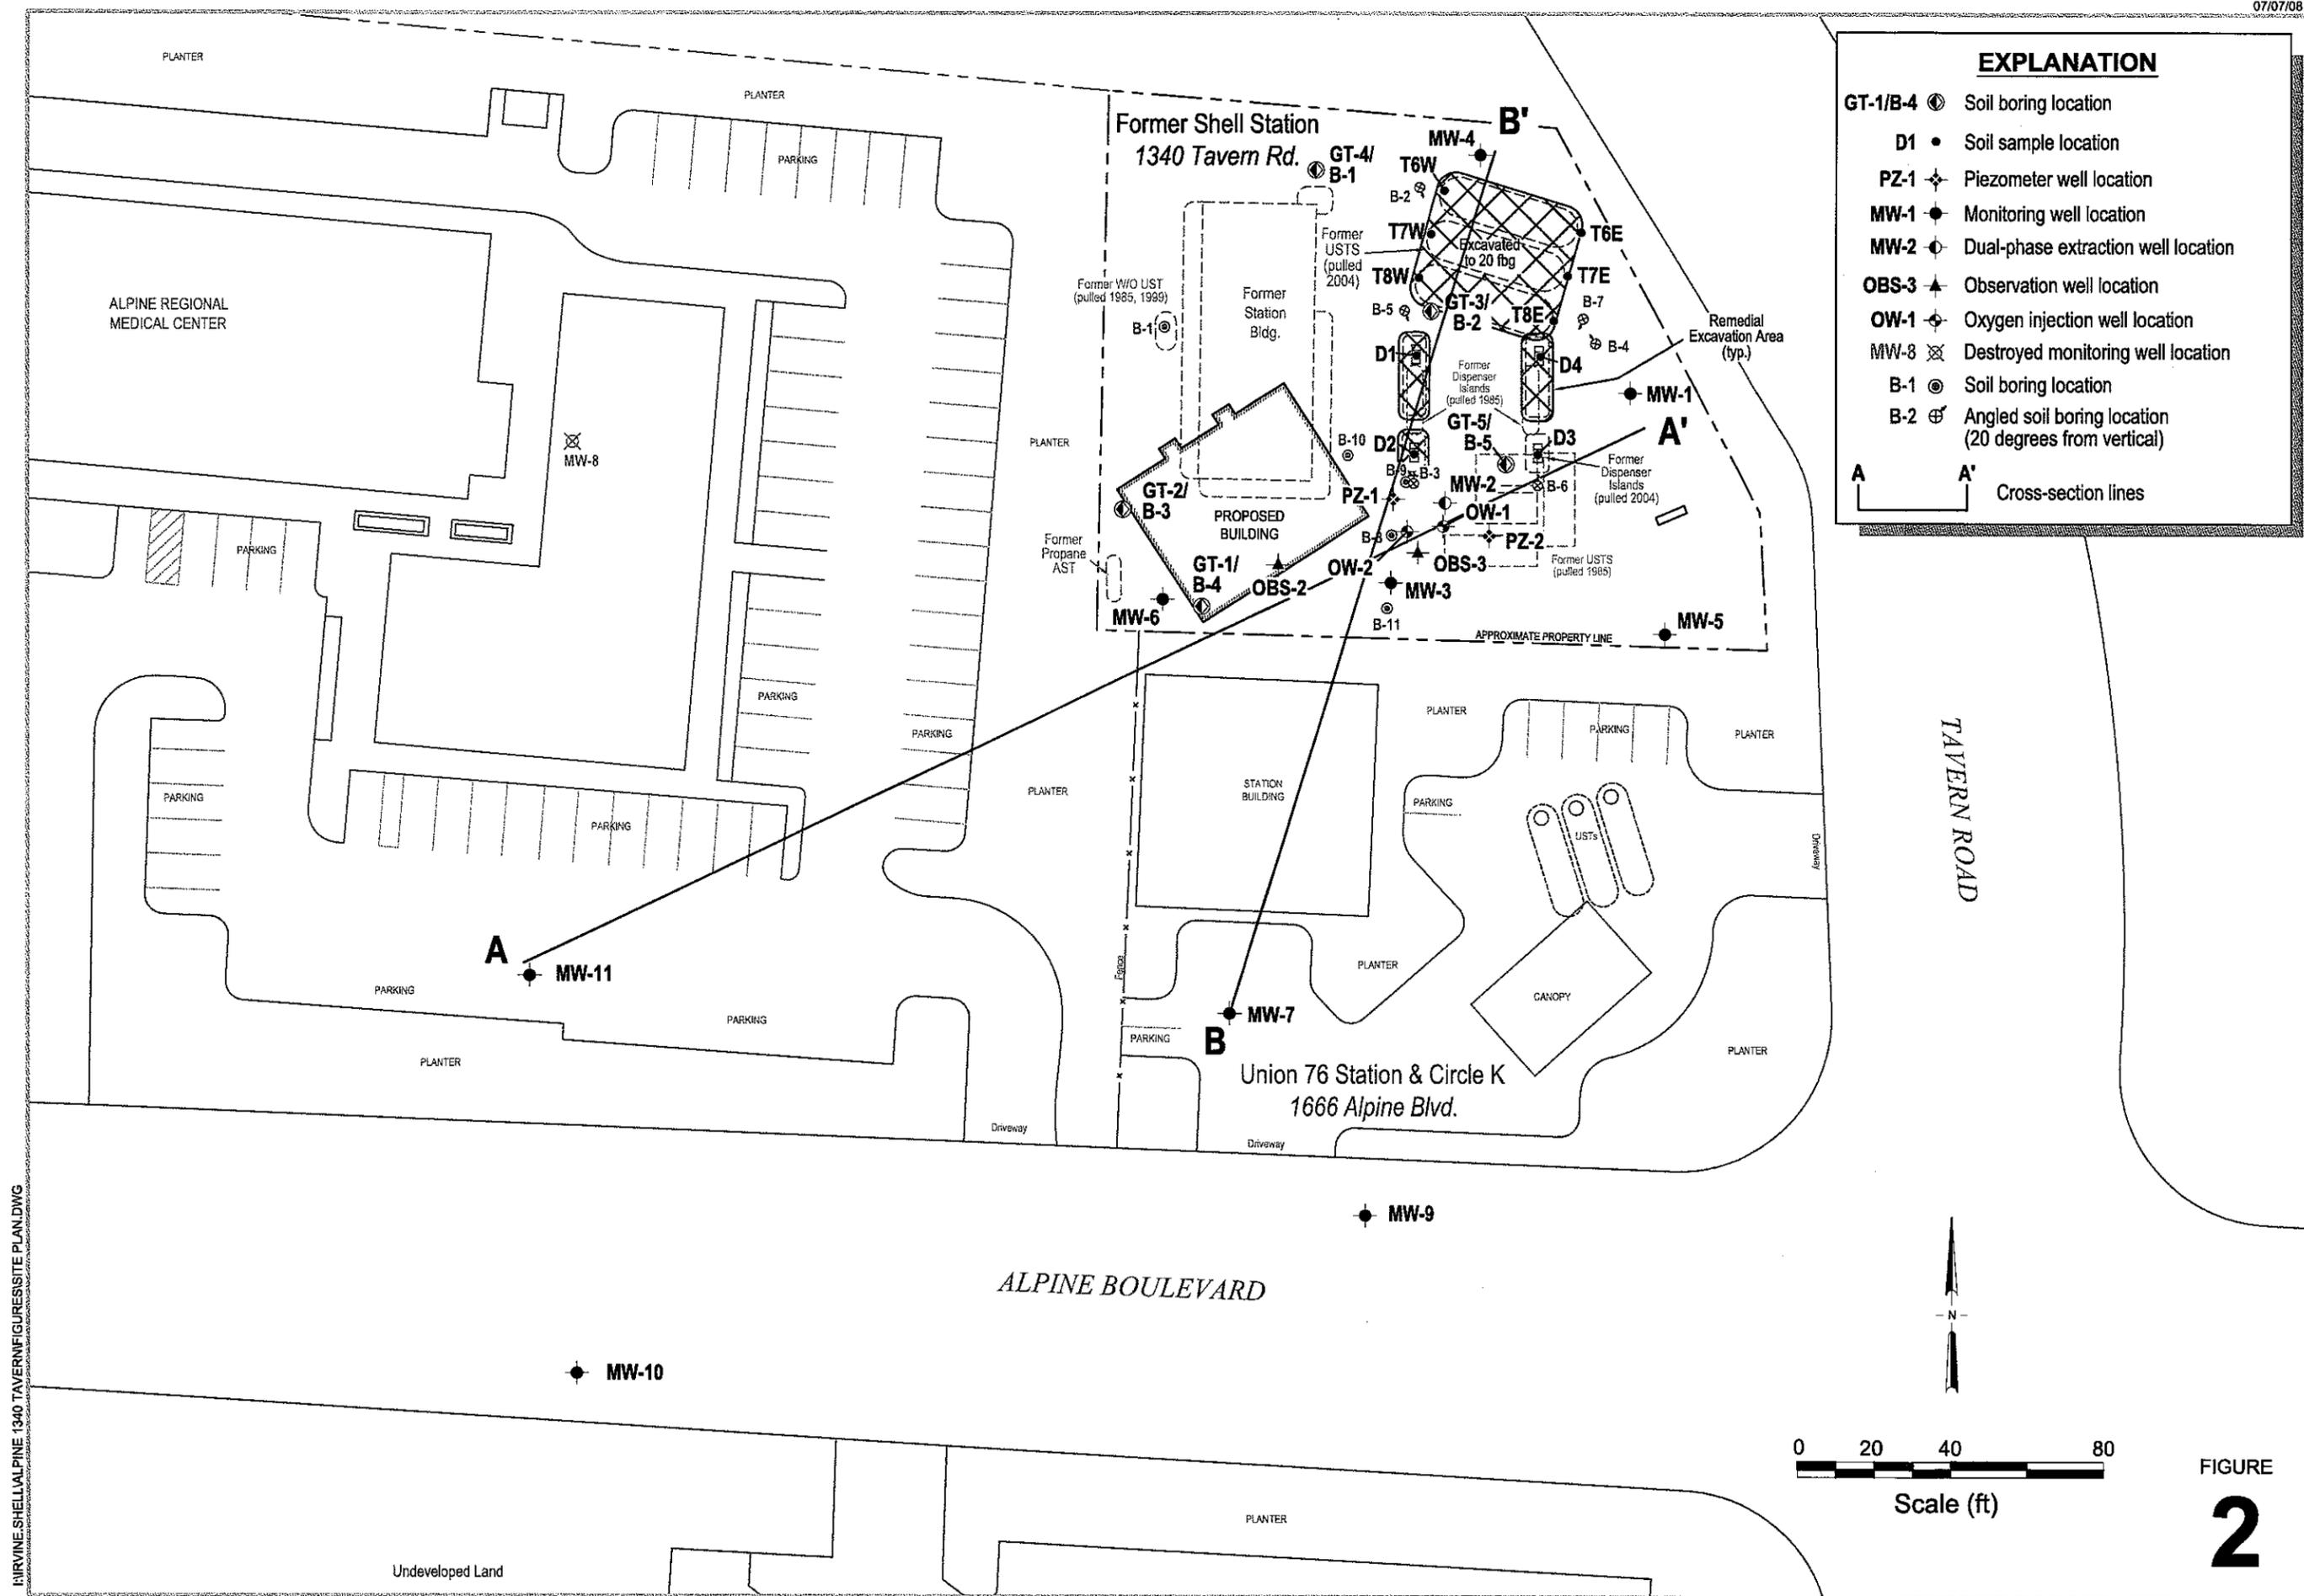
FIGURE
2

EXPLANATION	
GT-1/B-4	Soil boring location
D1	Soil sample location
PZ-1	Piezometer well location
MW-1	Monitoring well location
MW-2	Dual-phase extraction well location
OBS-3	Observation well location
OW-1	Oxygen injection well location
MW-8	Destroyed monitoring well location
B-1	Soil boring location
B-2	Angled soil boring location (20 degrees from vertical)
A-A'	Cross-section lines

Former Shell Service Station
 1340 Tavern Road
 Alpine, California

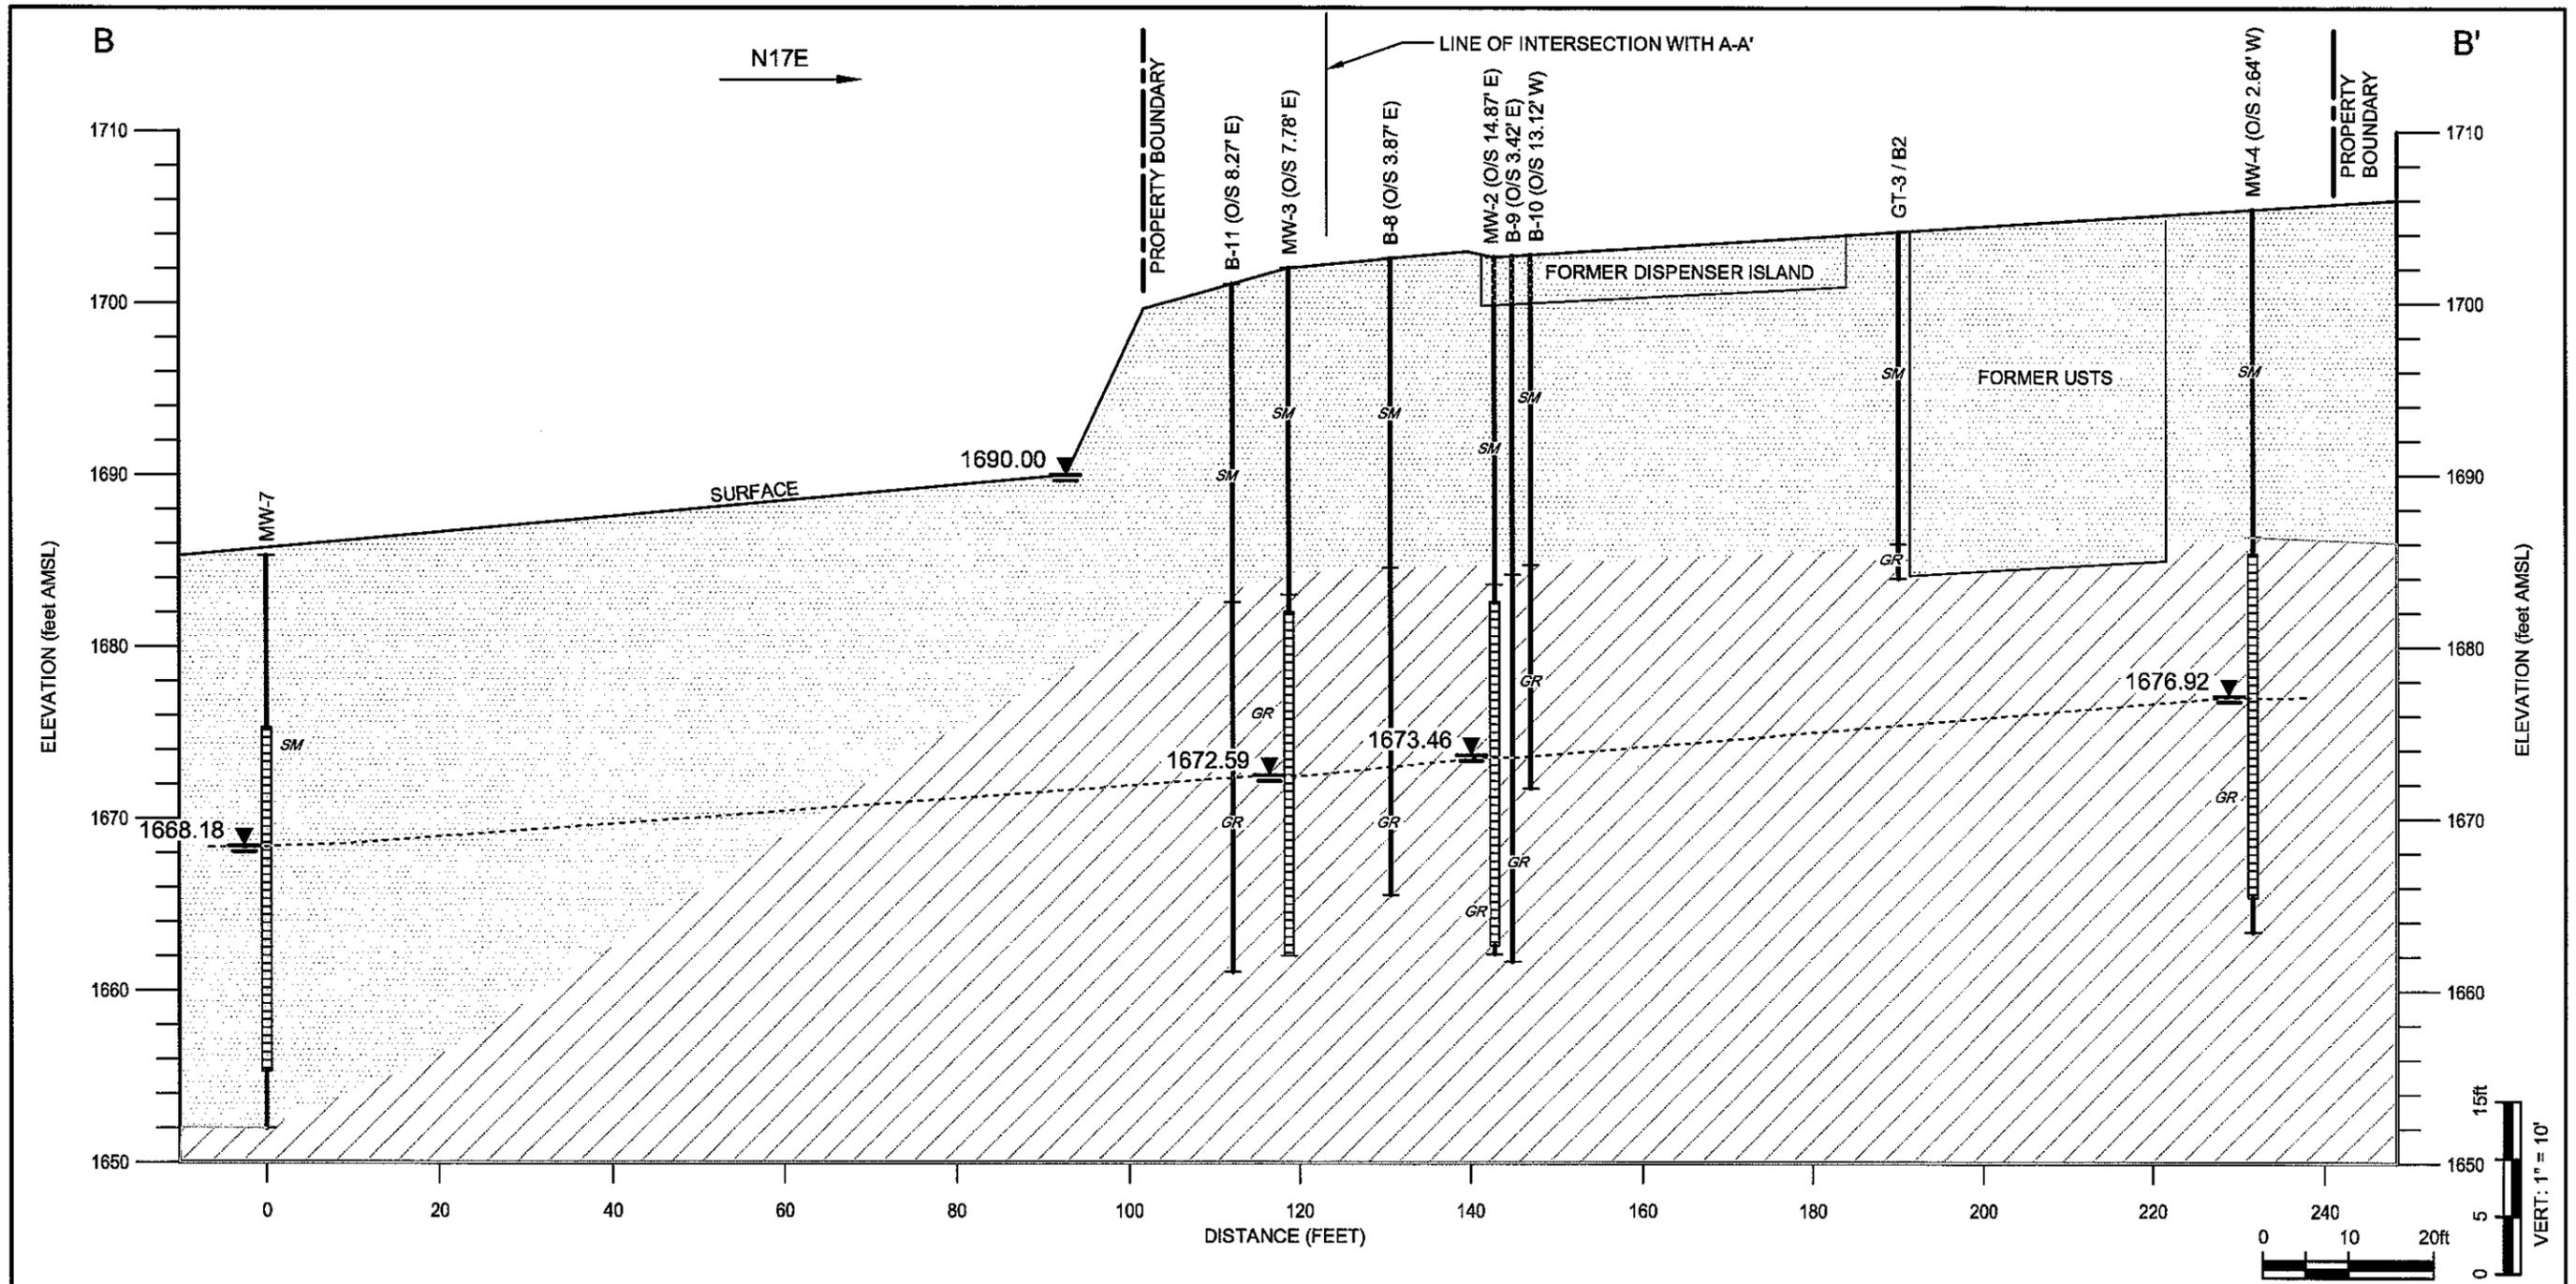
- MW-7 — WELL DESIGNATION
- GROUND SURFACE
- OBSERVATION WELL INSTALLATION
- STRATIGRAPHIC BOUNDARY
- SP — TYPICAL SOIL CLASSIFICATION
- SCREENED INTERVAL
- BOTTOM OF BORING
- GROUNDWATER ELEVATION (feet AMSL)

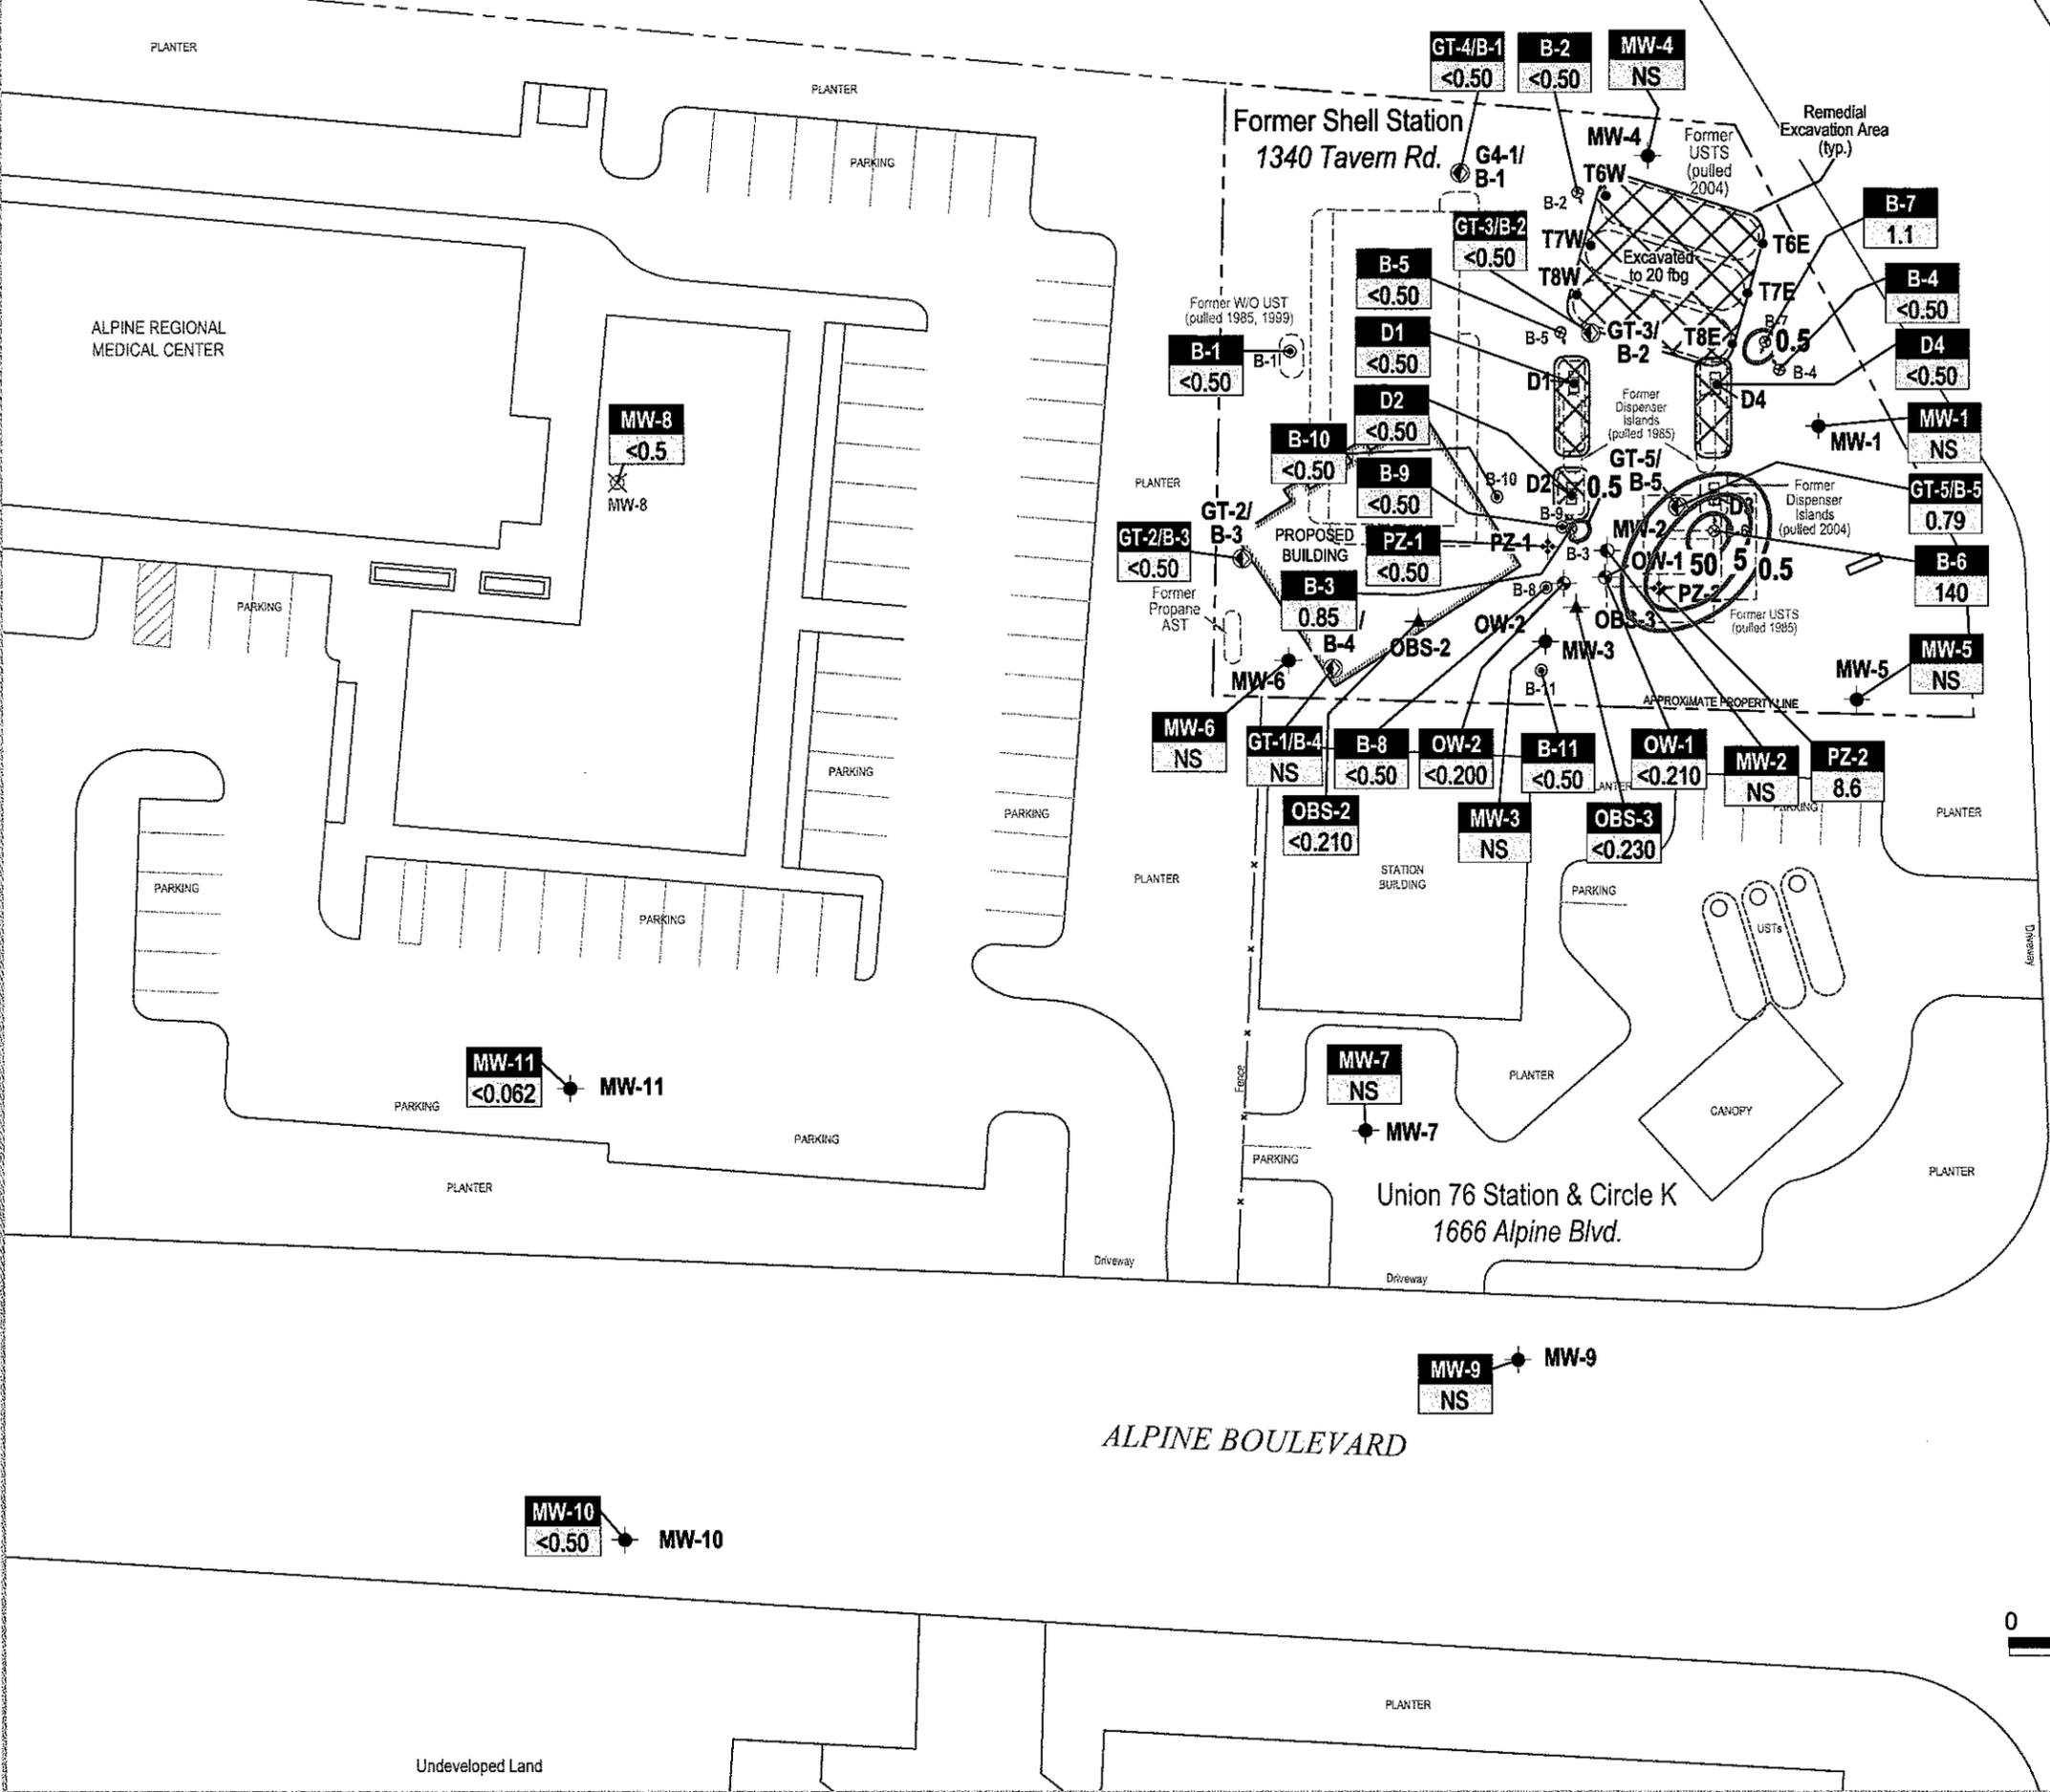
FIGURE 6

- GT-1/B-4 ● Soil boring location
- D1 ● Soil sample location
- PZ-1 ◆ Piezometer well location
- MW-1 ● Monitoring well location
- MW-2 ◆ Dual-phase extraction well location
- OBS-3 ▲ Observation well location
- OW-1 ◆ Oxygen injection well location
- MW-8 ✕ Destroyed monitoring well location
- B-1 ● Soil boring location
- B-2 ◆ Angled soil boring location (20 degrees from vertical)
- 5 TPHg isoconcentration contour, in milligrams per kilogram (mg/kg)
- Well Well designation
- TPHg TPHg concentrations are in mg/kg

TPHg in Soil
Isoconcentration Map
8 - 11 Feet Below Grade
