APPENDIX E
LOCAL AGENCY RECORDS

DEFENSE ENVIRONMENTAL RESTORATION PROGRAM
FORMERLY USED DEFENSE SITES
FINDINGS AND DETERMINATION OF ELIGIBILITY

SITE ASSESSMENT REPORT, SITE CONCEPTUAL MODEL AND CORRECTIVE ACTION PLAN

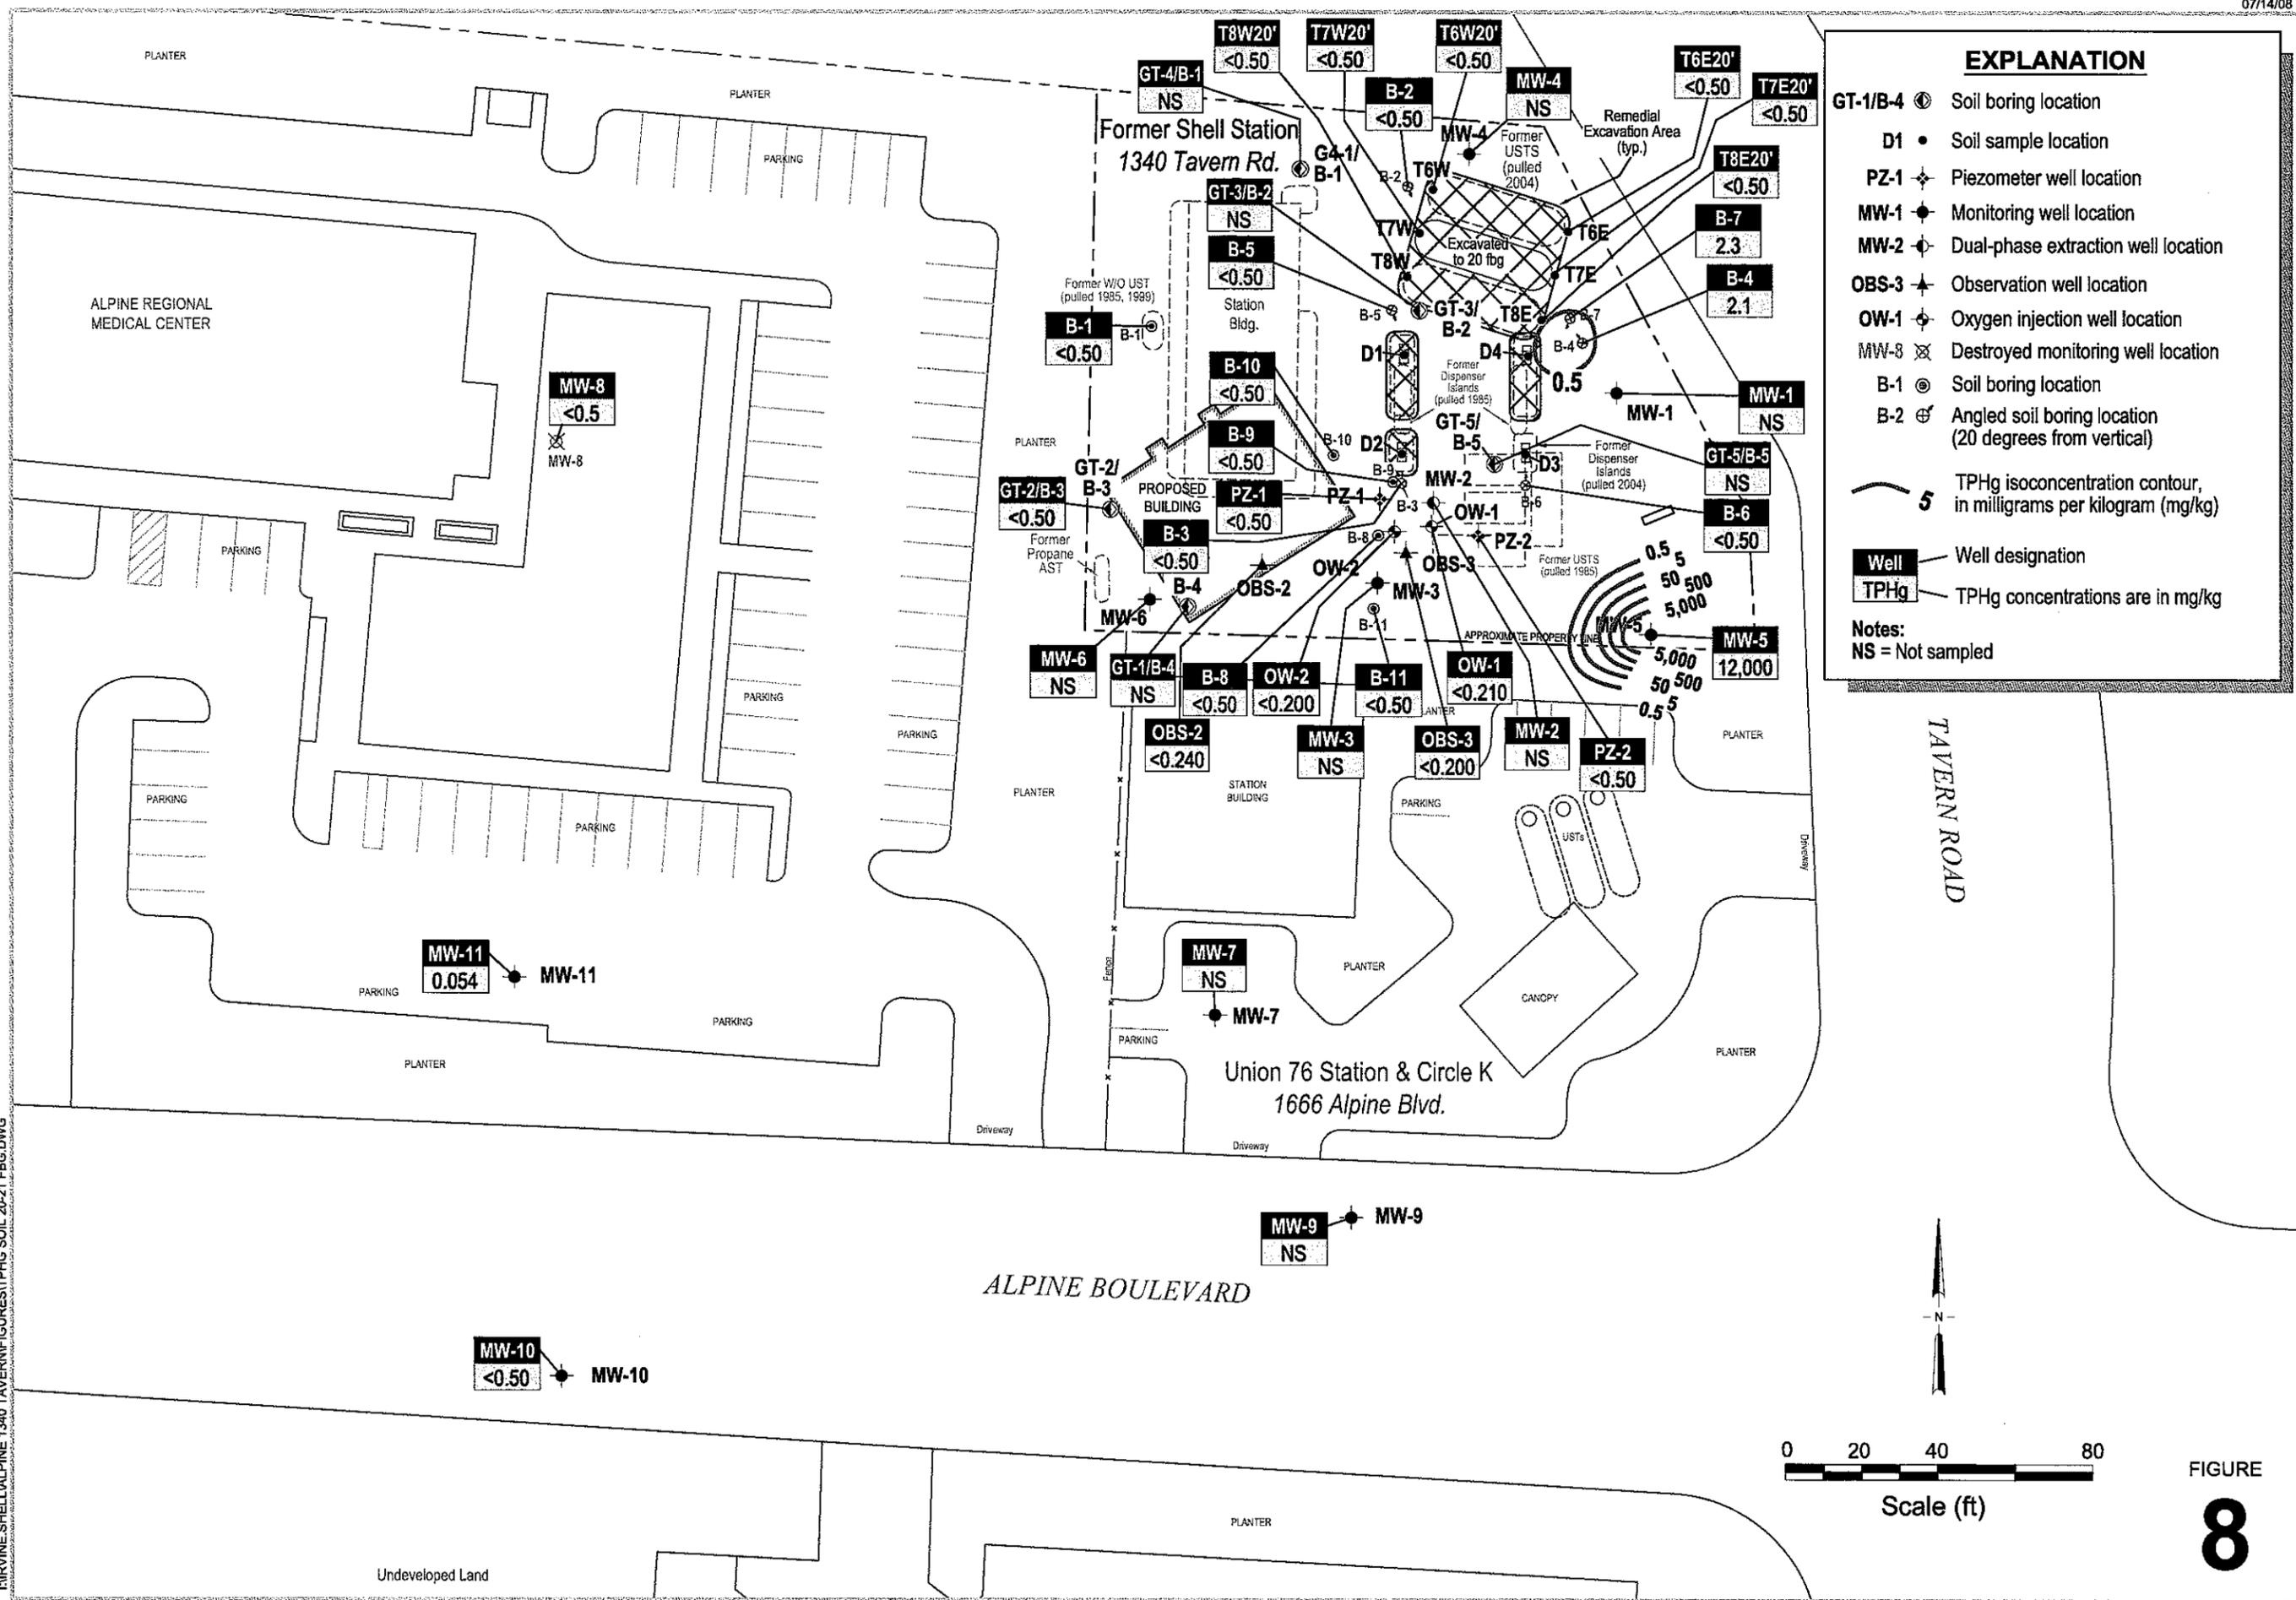
FIGURE
8

- GT-1/B-4 Soil boring location
- D1 Soil sample location
- PZ-1 Piezometer well location
- MW-1 Monitoring well location
- MW-2 Dual-phase extraction well location
- OBS-3 Observation well location
- OW-1 Oxygen injection well location
- MW-8 Destroyed monitoring well location
- B-1 Soil boring location
- B-2 Angled soil boring location (20 degrees from vertical)
- 5 TPHg isoconcentration contour, in milligrams per kilogram (mg/kg)
- Well** Well designation
- TPHg** TPHg concentrations are in mg/kg

TPHg in Soil
 Isoconcentration Map

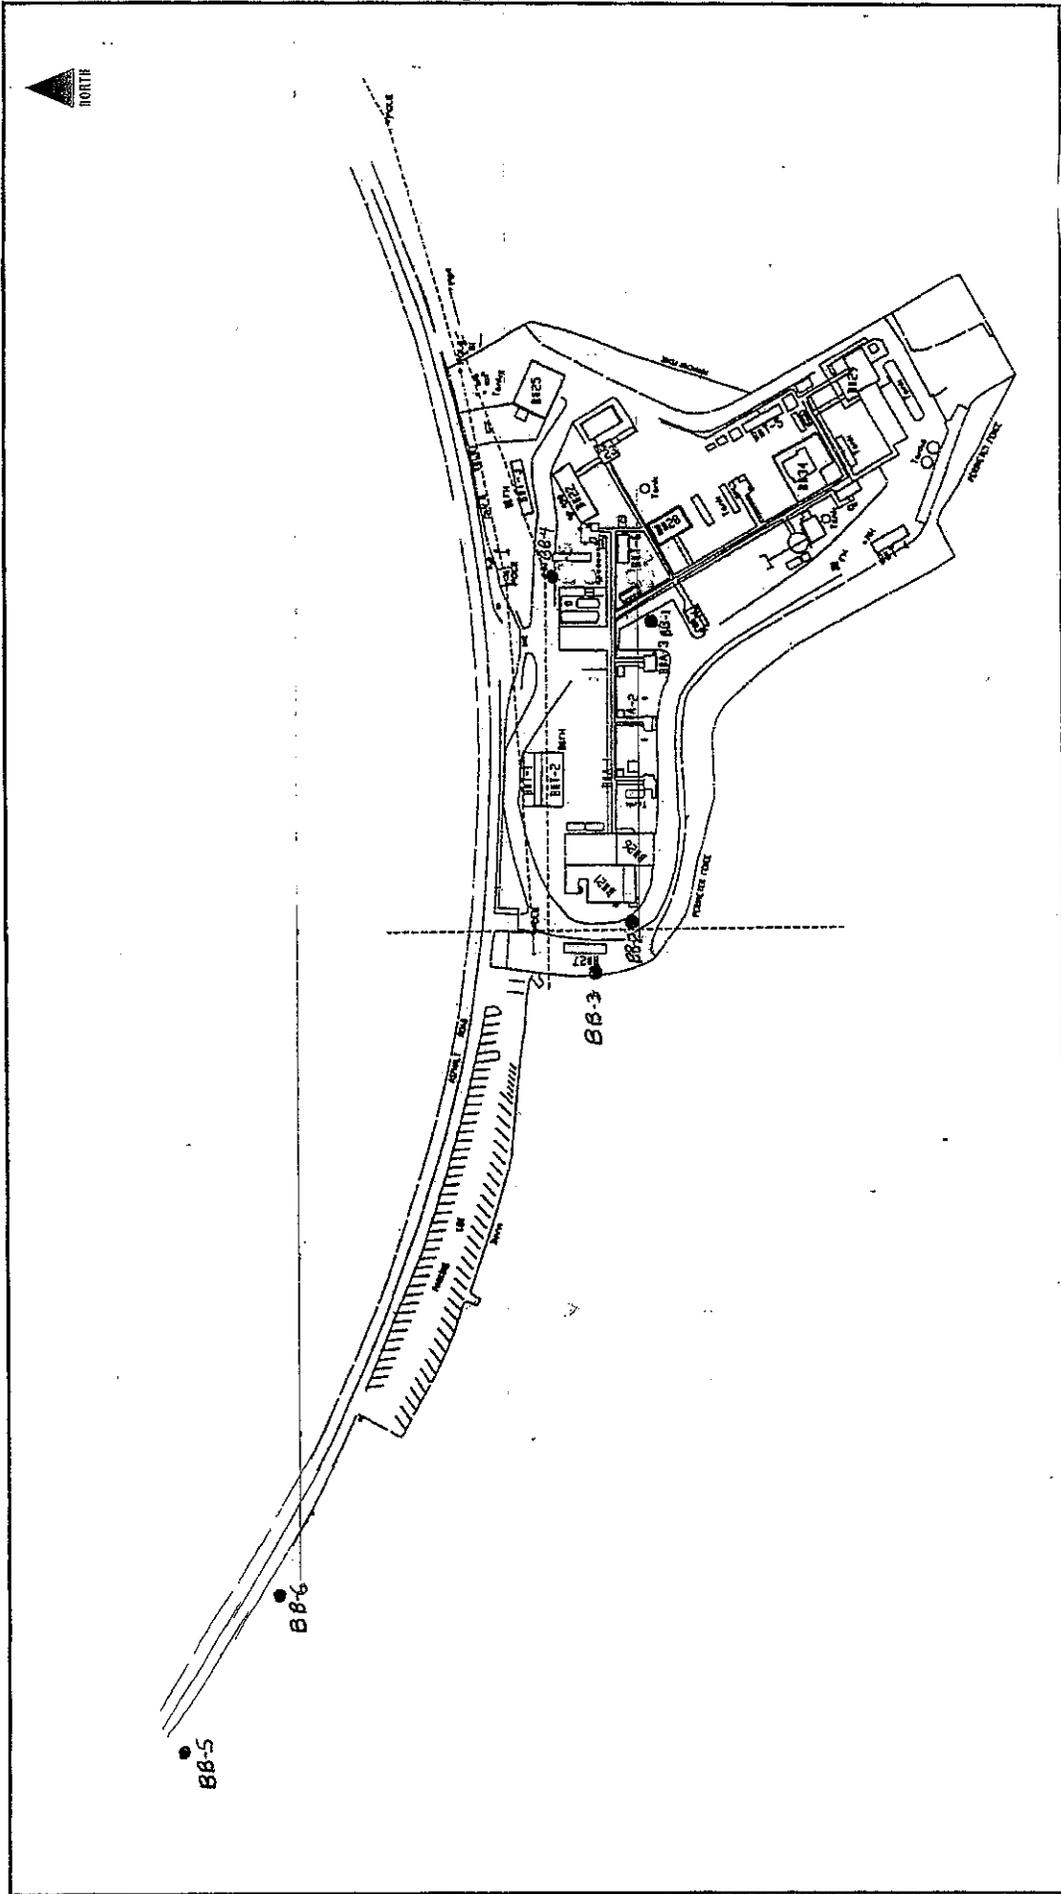
Figure 2

Plan of Area B with Soil Boring Locations

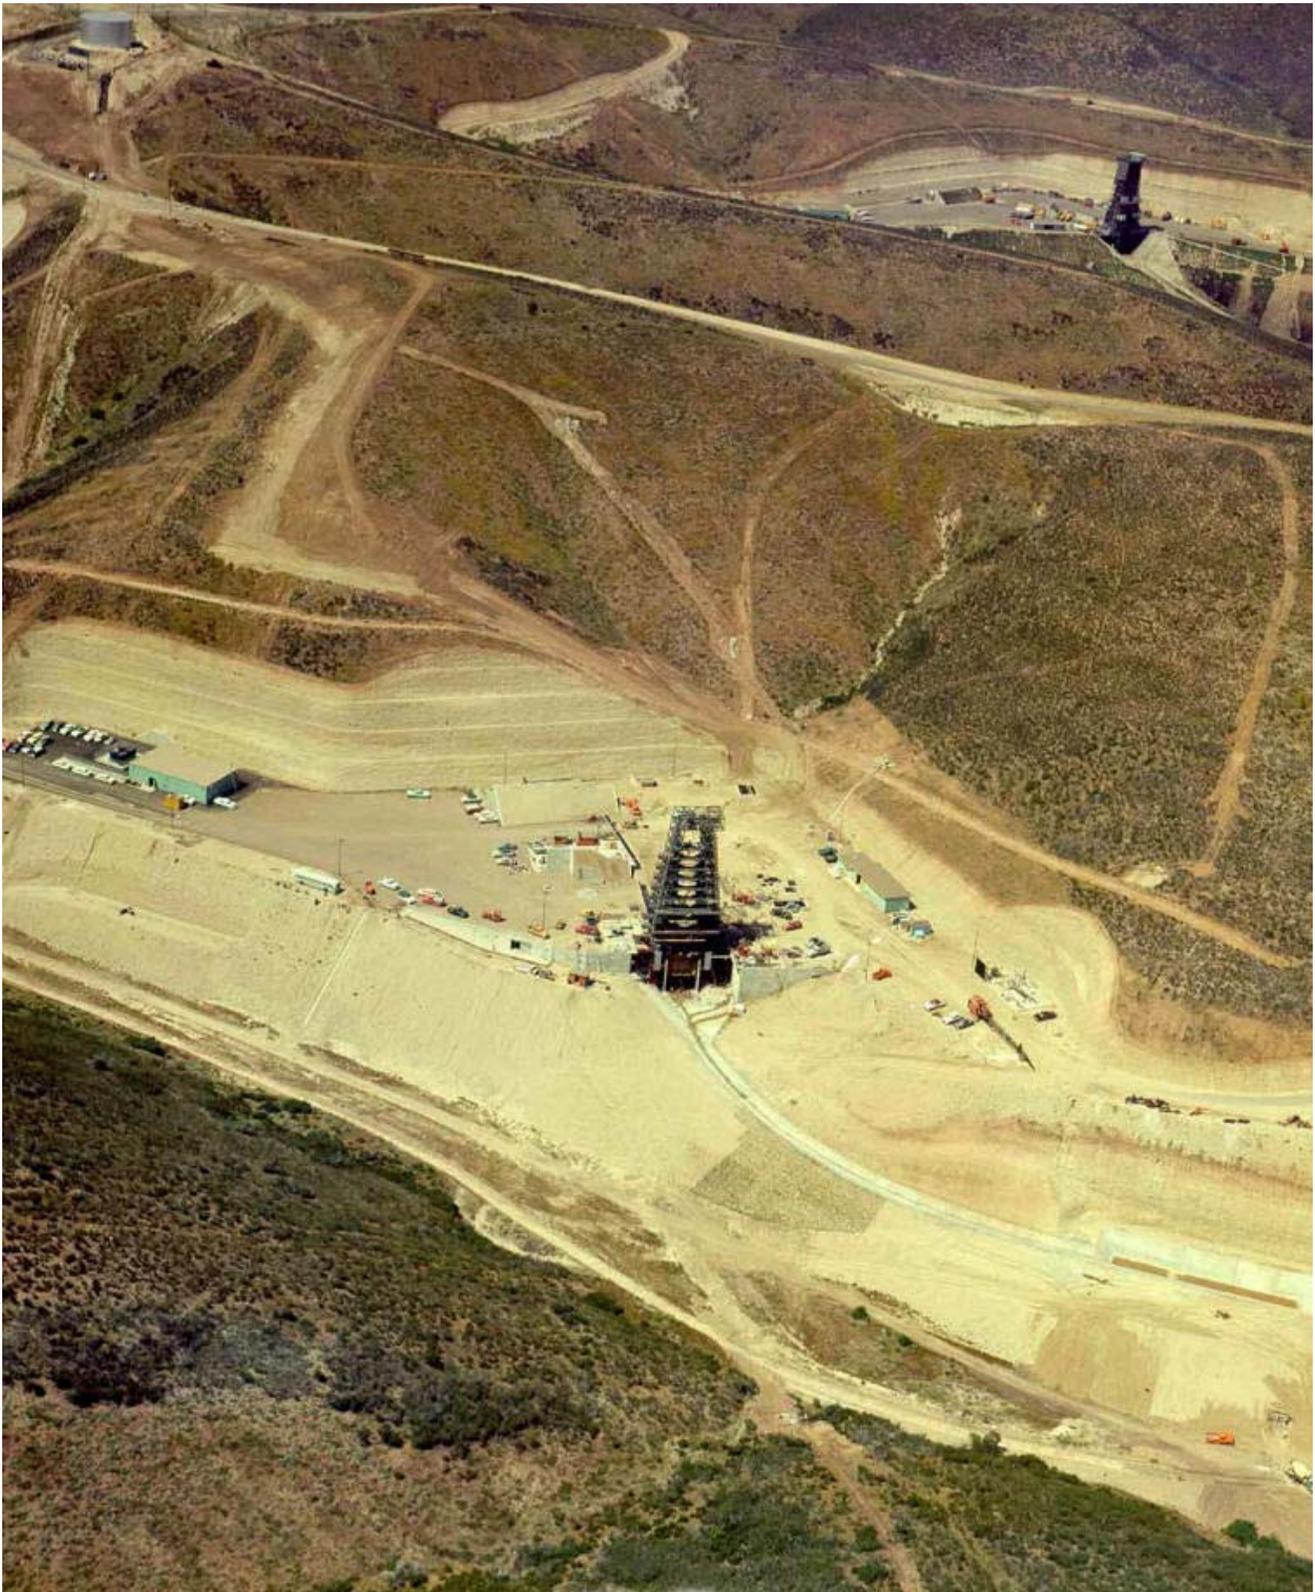
ASSEMBLY BUILDING

THE ASSEMBLY BUILDING WAS USED FOR PRE-FIRING CHECKOUT OF THE MISSILE SYSTEM PRIOR TO INSTALLATION OF THE MISSILE ON THE TEST STAND.
