Environmental Minor Project Refinement Form

Project Name: West of Devers Upgrade Project **Request Prepared By:** Sylvia Granados

Southern California Edison
West of Devers Upgrade Project
Proposed WSS-4-4X56-MPR-35 Wire Site
MPR #35

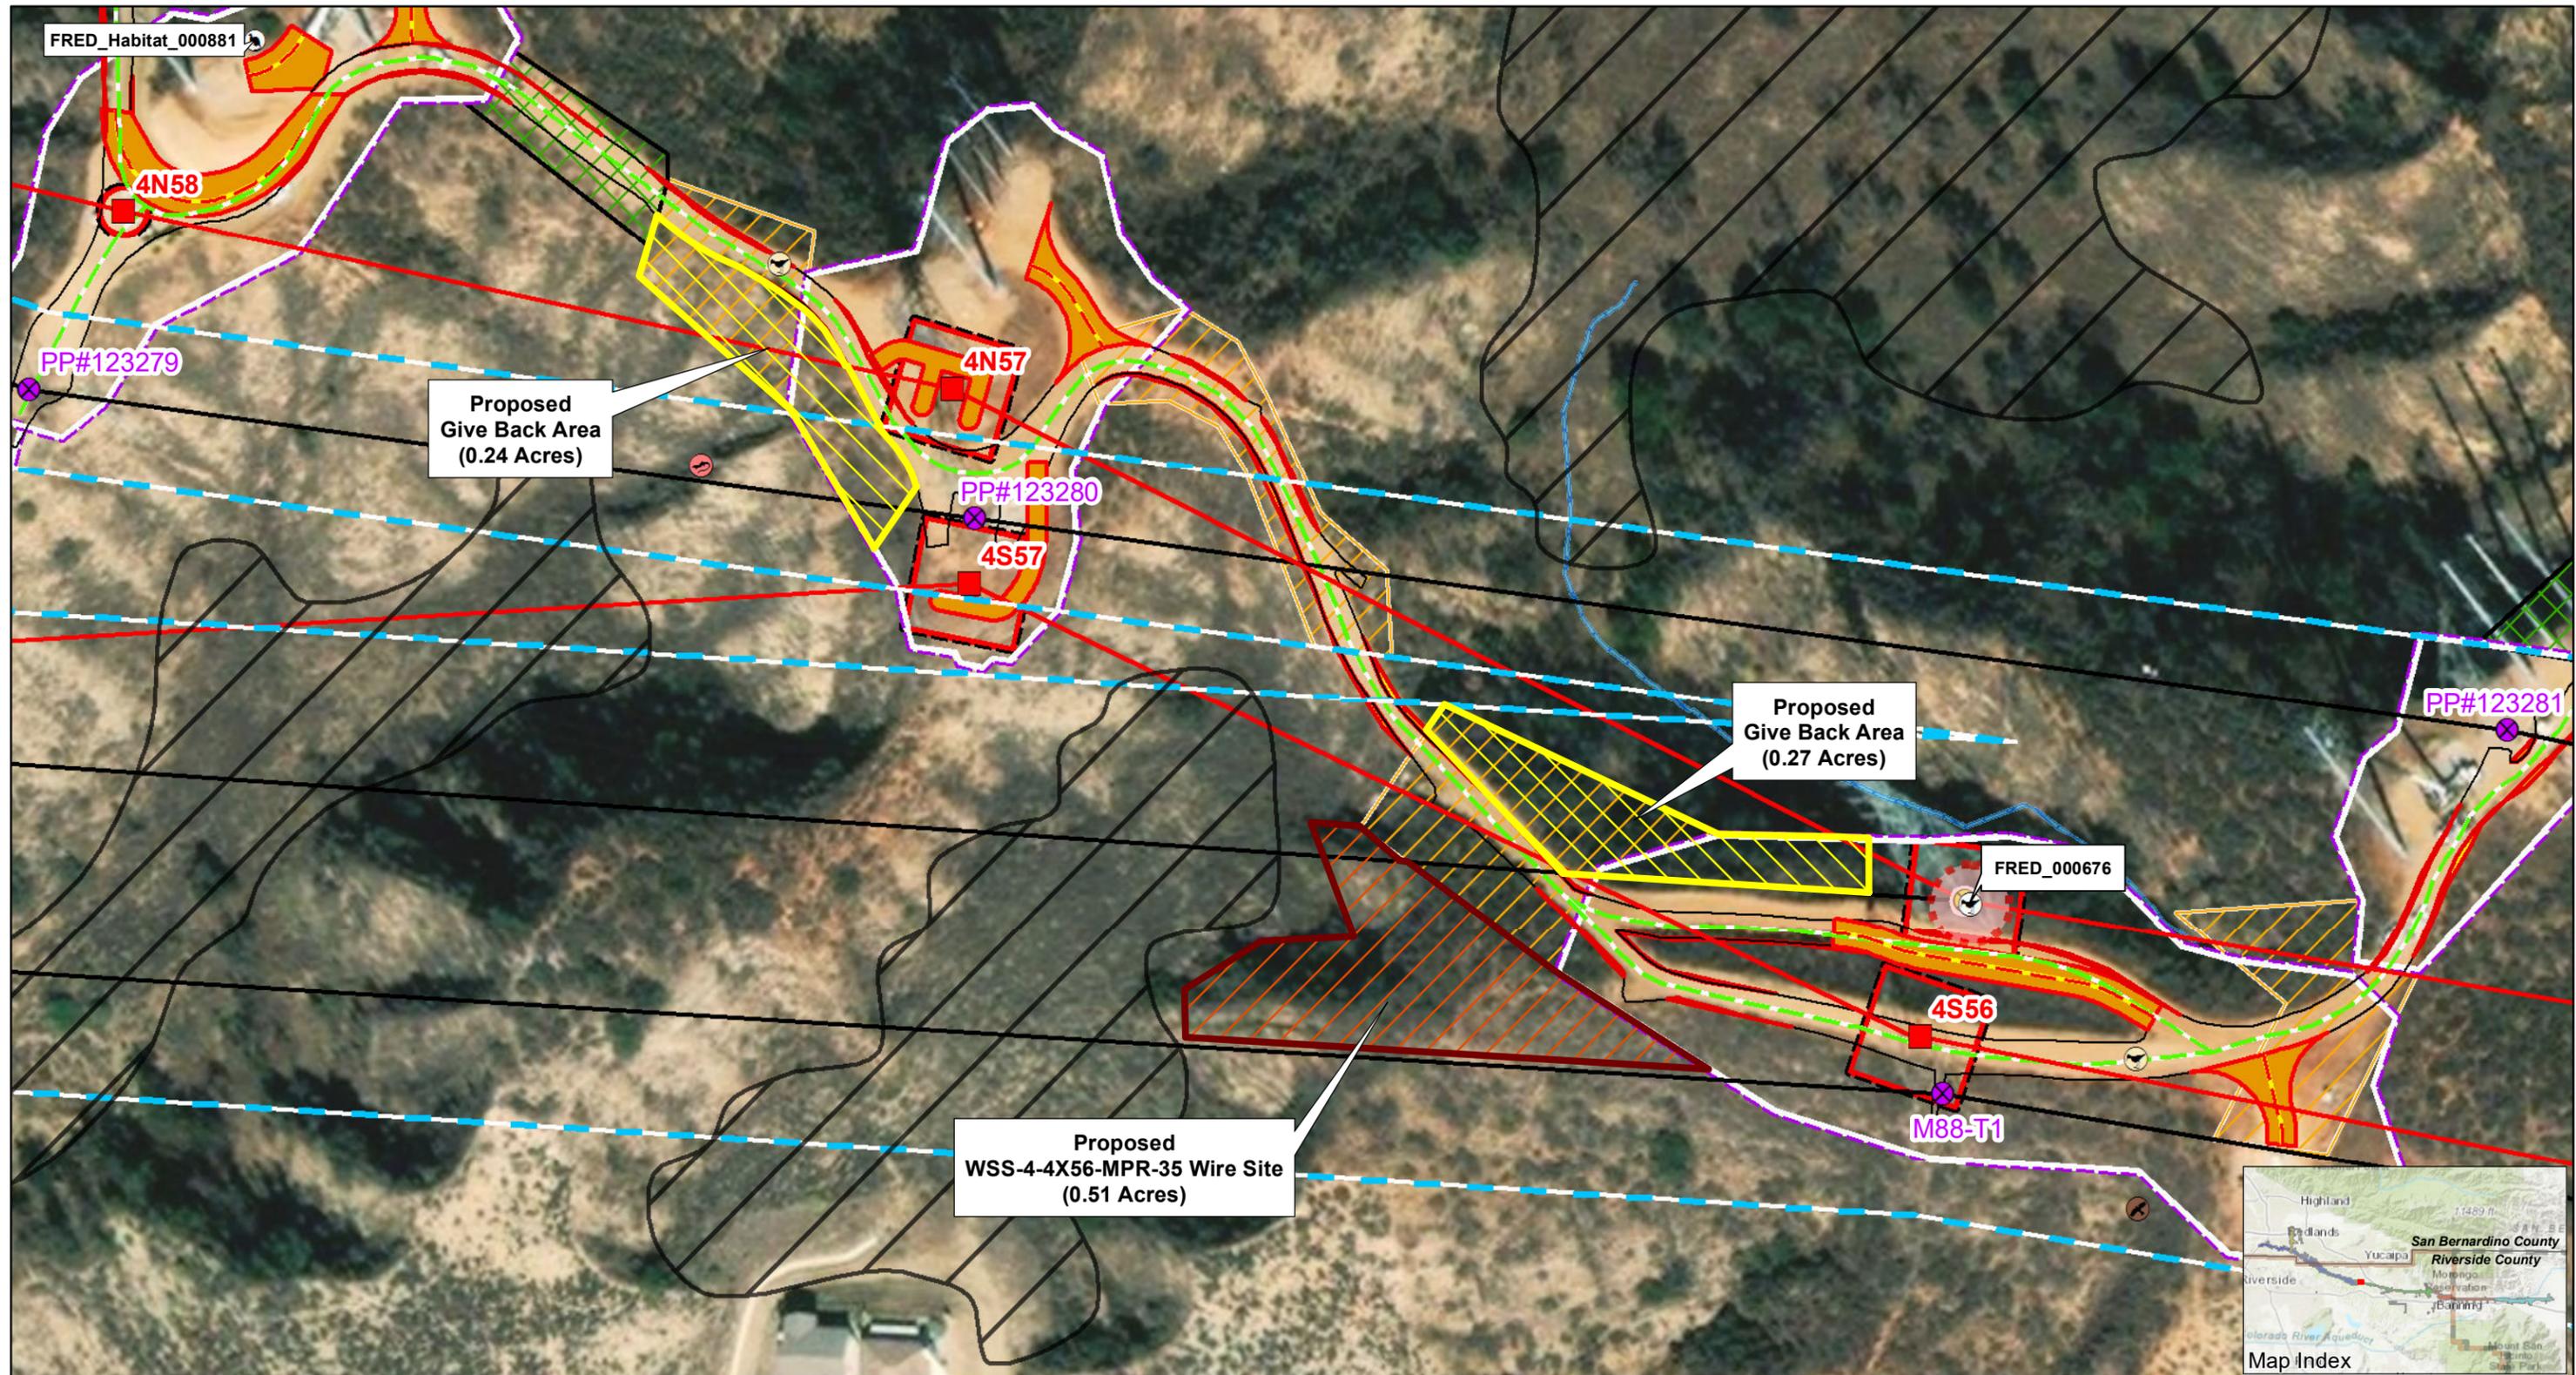
FIGURE 1

A new temporary 0.51-acre work area adjacent to the southwest side of Supersite 4X56 is required to provide adequate work space for material and equipment staging during construction, including wire stringing and wire wreck-out activities associated with Supersites 4X55 and 4X56, as shown on Figure 1.

The new work area consists of approximately 0.51-acre of chaparral, is owned and maintained by the Riverside Land Conservancy, and is located entirely within the SCE transmission line right-of-way.

As shown on Figures 1 and 3, active bird nests exist within the vicinity of WSS-4-4X56-MPR-35 (FRED_000676) and MAC-2-S-2N18-1 (FRED_ID000583), however no active nest buffers intersect the proposed work areas. Common raven nest (FRED_000676) is located approximately 200 feet northeast of WSS-4-4X56-MPR-35 and common raven nest (FRED_ID000583) is located approximately 290 feet northwest of MAC-2-S-2N18-1, well outside the existing nest buffers. With implementation of the NBMP, no impacts are anticipated.

Stephens' Kangaroo Rat – WSS-4-4X56-MPR-35 is located approximately 20 feet east of mapped suitable habitat for Stephens' kangaroo rat (SKR) (Figure 1). WSS-4-4X56-MPR-35 is located within the WR-MSHCP, where SKR are a covered species.

A Los Angeles pocket mouse (LAPM) species event (FRED_000881) was observed approximately 820-feet northwest of WSS-4-4X56-MPR-35 in February 2020 (Figure 1). LAPM are a covered species in the WR-MSHCP.

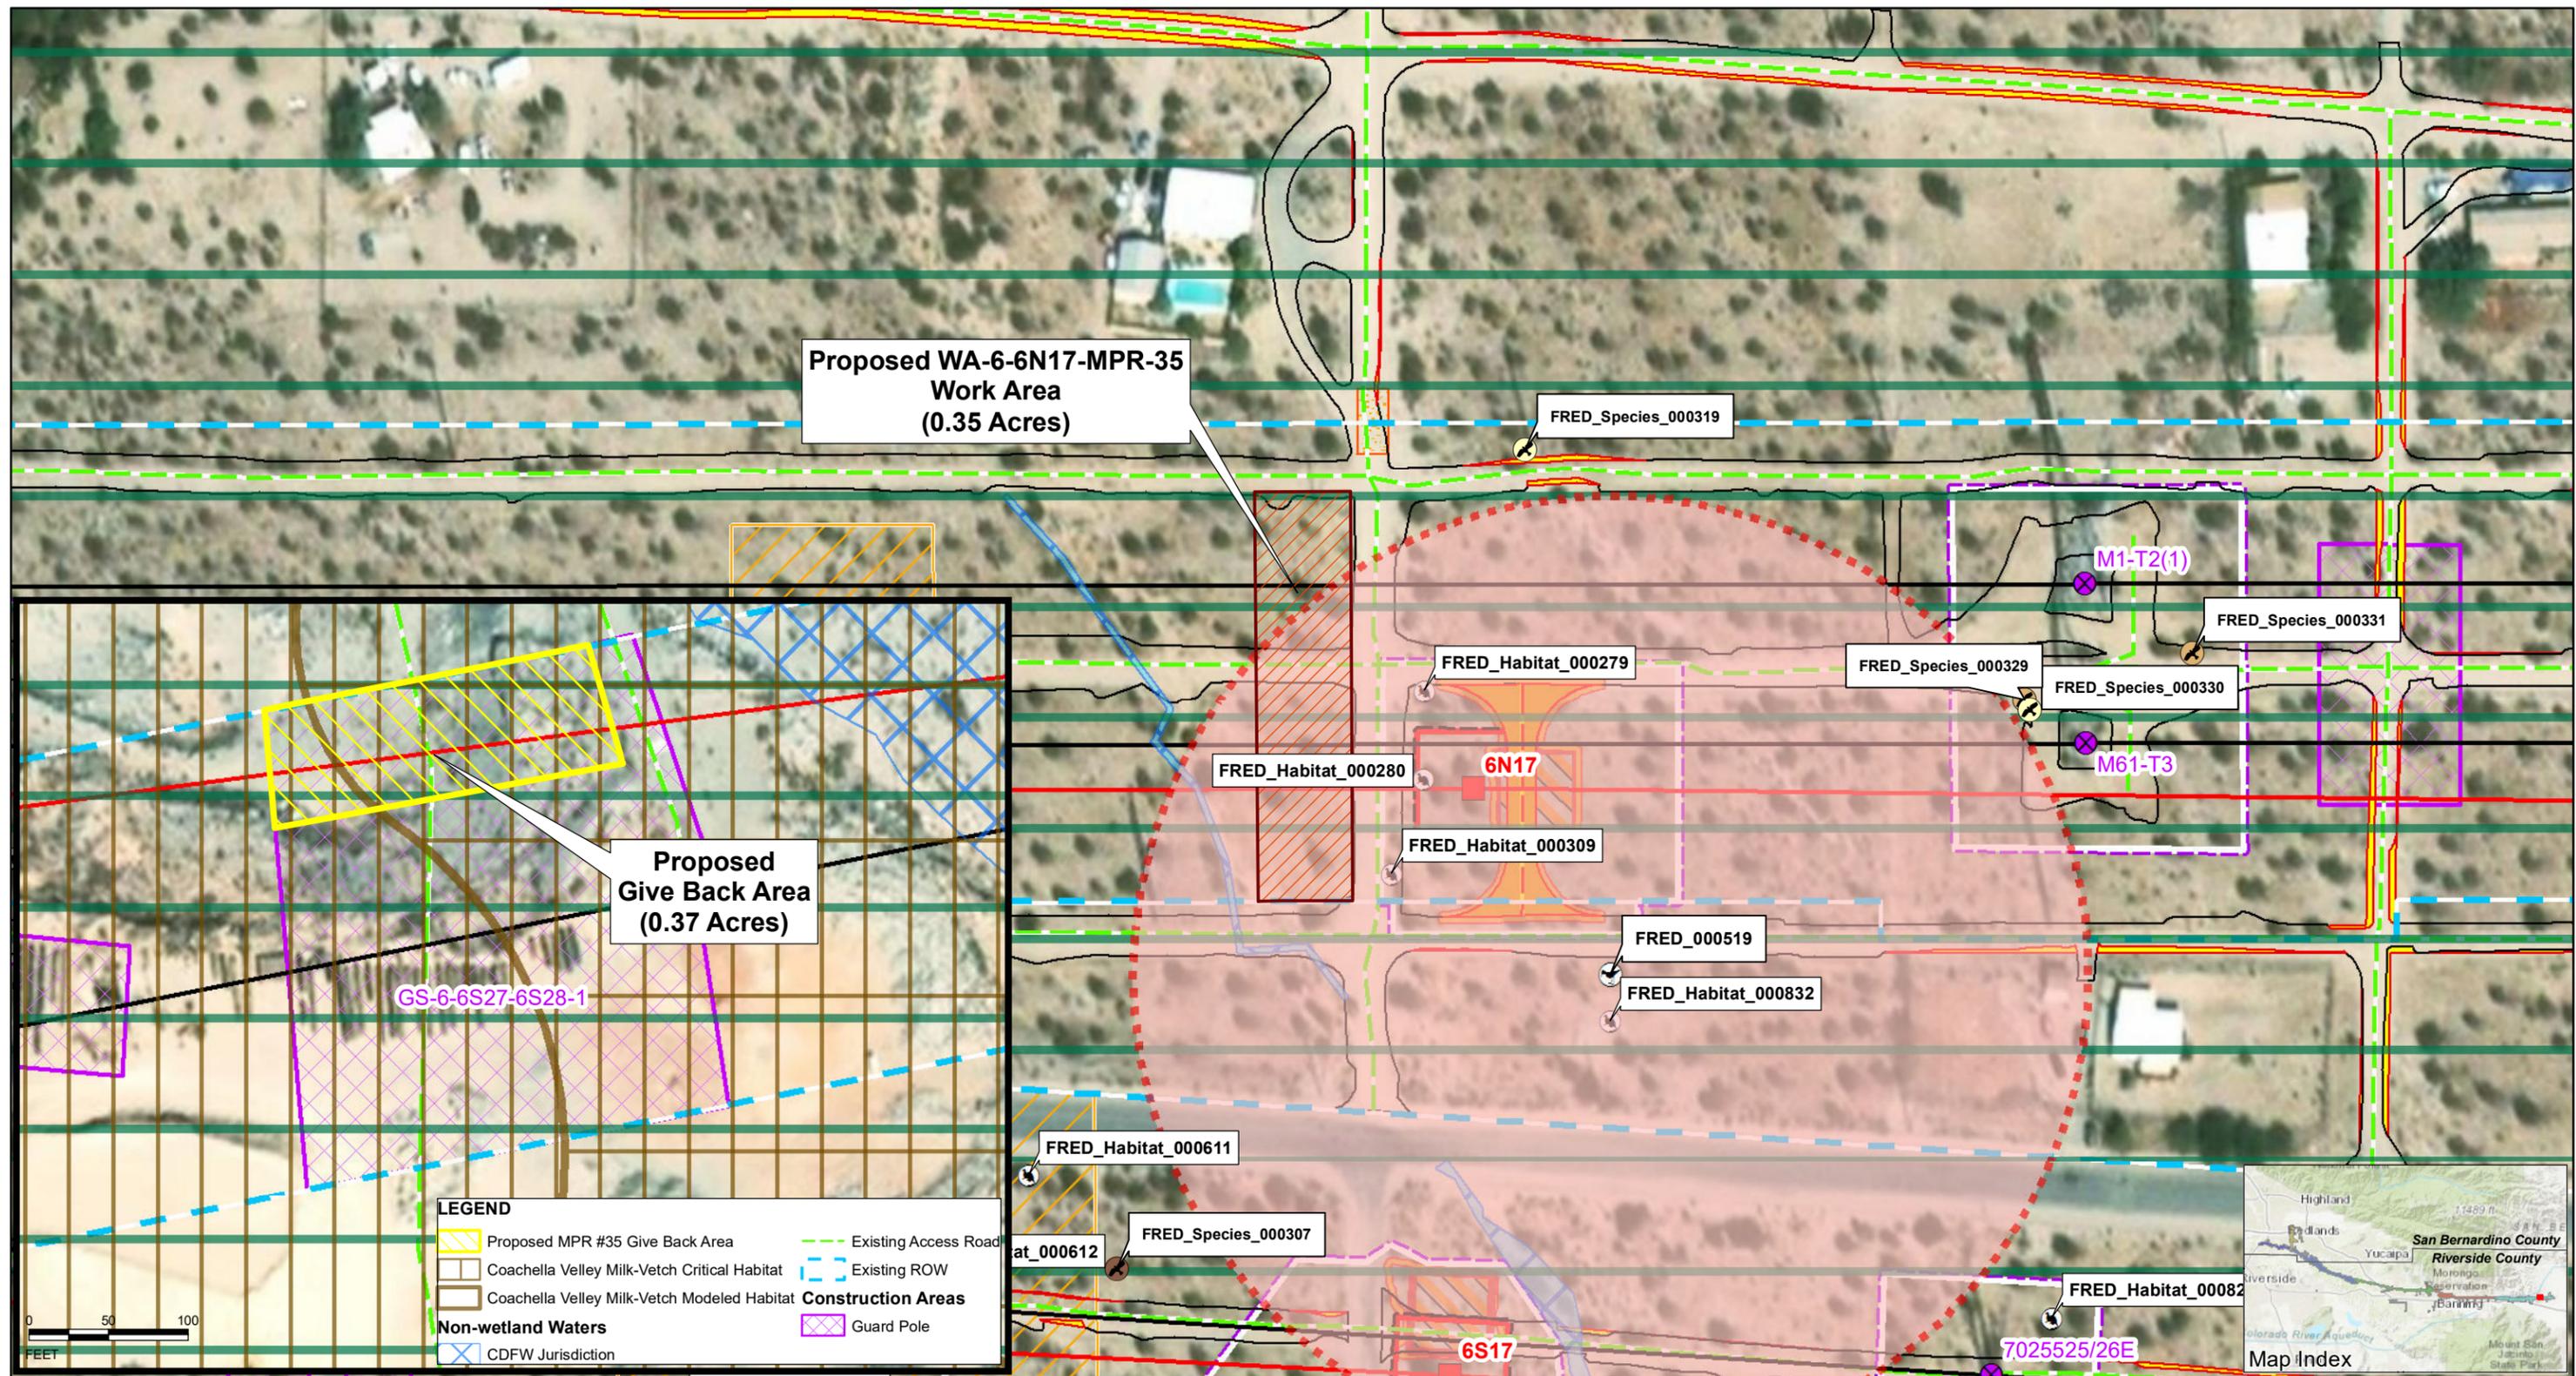
A 0.35-acre temporary work area west of Supersite 6N17 is required to provide adequate work space for material and equipment staging during construction, including wire stringing and wire wreck-out activities associated with the adjacent supersites, as shown on Figure 2.

The total temporary disturbance area associated with the new work area is approximately 0.04-acre of developed/disturbed land and 0.31-acre desert scrub. The land is owned by SCE and located entirely within the SCE transmission line right-of-way.

Desert Tortoise – New work areas WA-6-6N17-MPR-35 and WA-6-6N28-HLZ-MPR-35 are located within desert tortoise (DETO) modeled habitat (see Figures 2 and 4). No definitive signs of DETO have been observed in the new work areas during preconstruction surveys or protocol desert tortoise surveys covering these areas. With monitoring, no impacts are anticipated. To minimize temporal habitat loss, portions of previously approved work areas in DETO habitat, which were determined to no longer be necessary for construction, will be removed from the project data and avoided to offset mapped habitat impacts to WA-6-6N17-MPR-35 and WA-6-6N28-HLZ-MPR-35, as shown on see Figures 2 and 4.

WA-6-6N17-MPR-35 intersects an active burrowing owl buffer (FRED_000519). The nest is located approximately 30 feet south of the access road just north of 16th Ave, and approximately 170 feet southeast of WA-6-6N17-MPR-35 (Figure 2). The burrow is located under a concrete slab, with the mouth of the burrow is located on the north side of the slab. The nest location offers limited visual and acoustic buffers to ground sites in the general vicinity. If the 300-foot horizontal and 200-foot vertical avoidance buffers are not feasible during the breeding season (February 1 to August 31), SCE will notify CPUC, CDFW, BLM, and USFWS of a buffer reduction based on site-specific conditions such as distance to construction, type of disturbance activity, anticipated duration of the disturbance, microhabitat at the location of the nest, behavior of

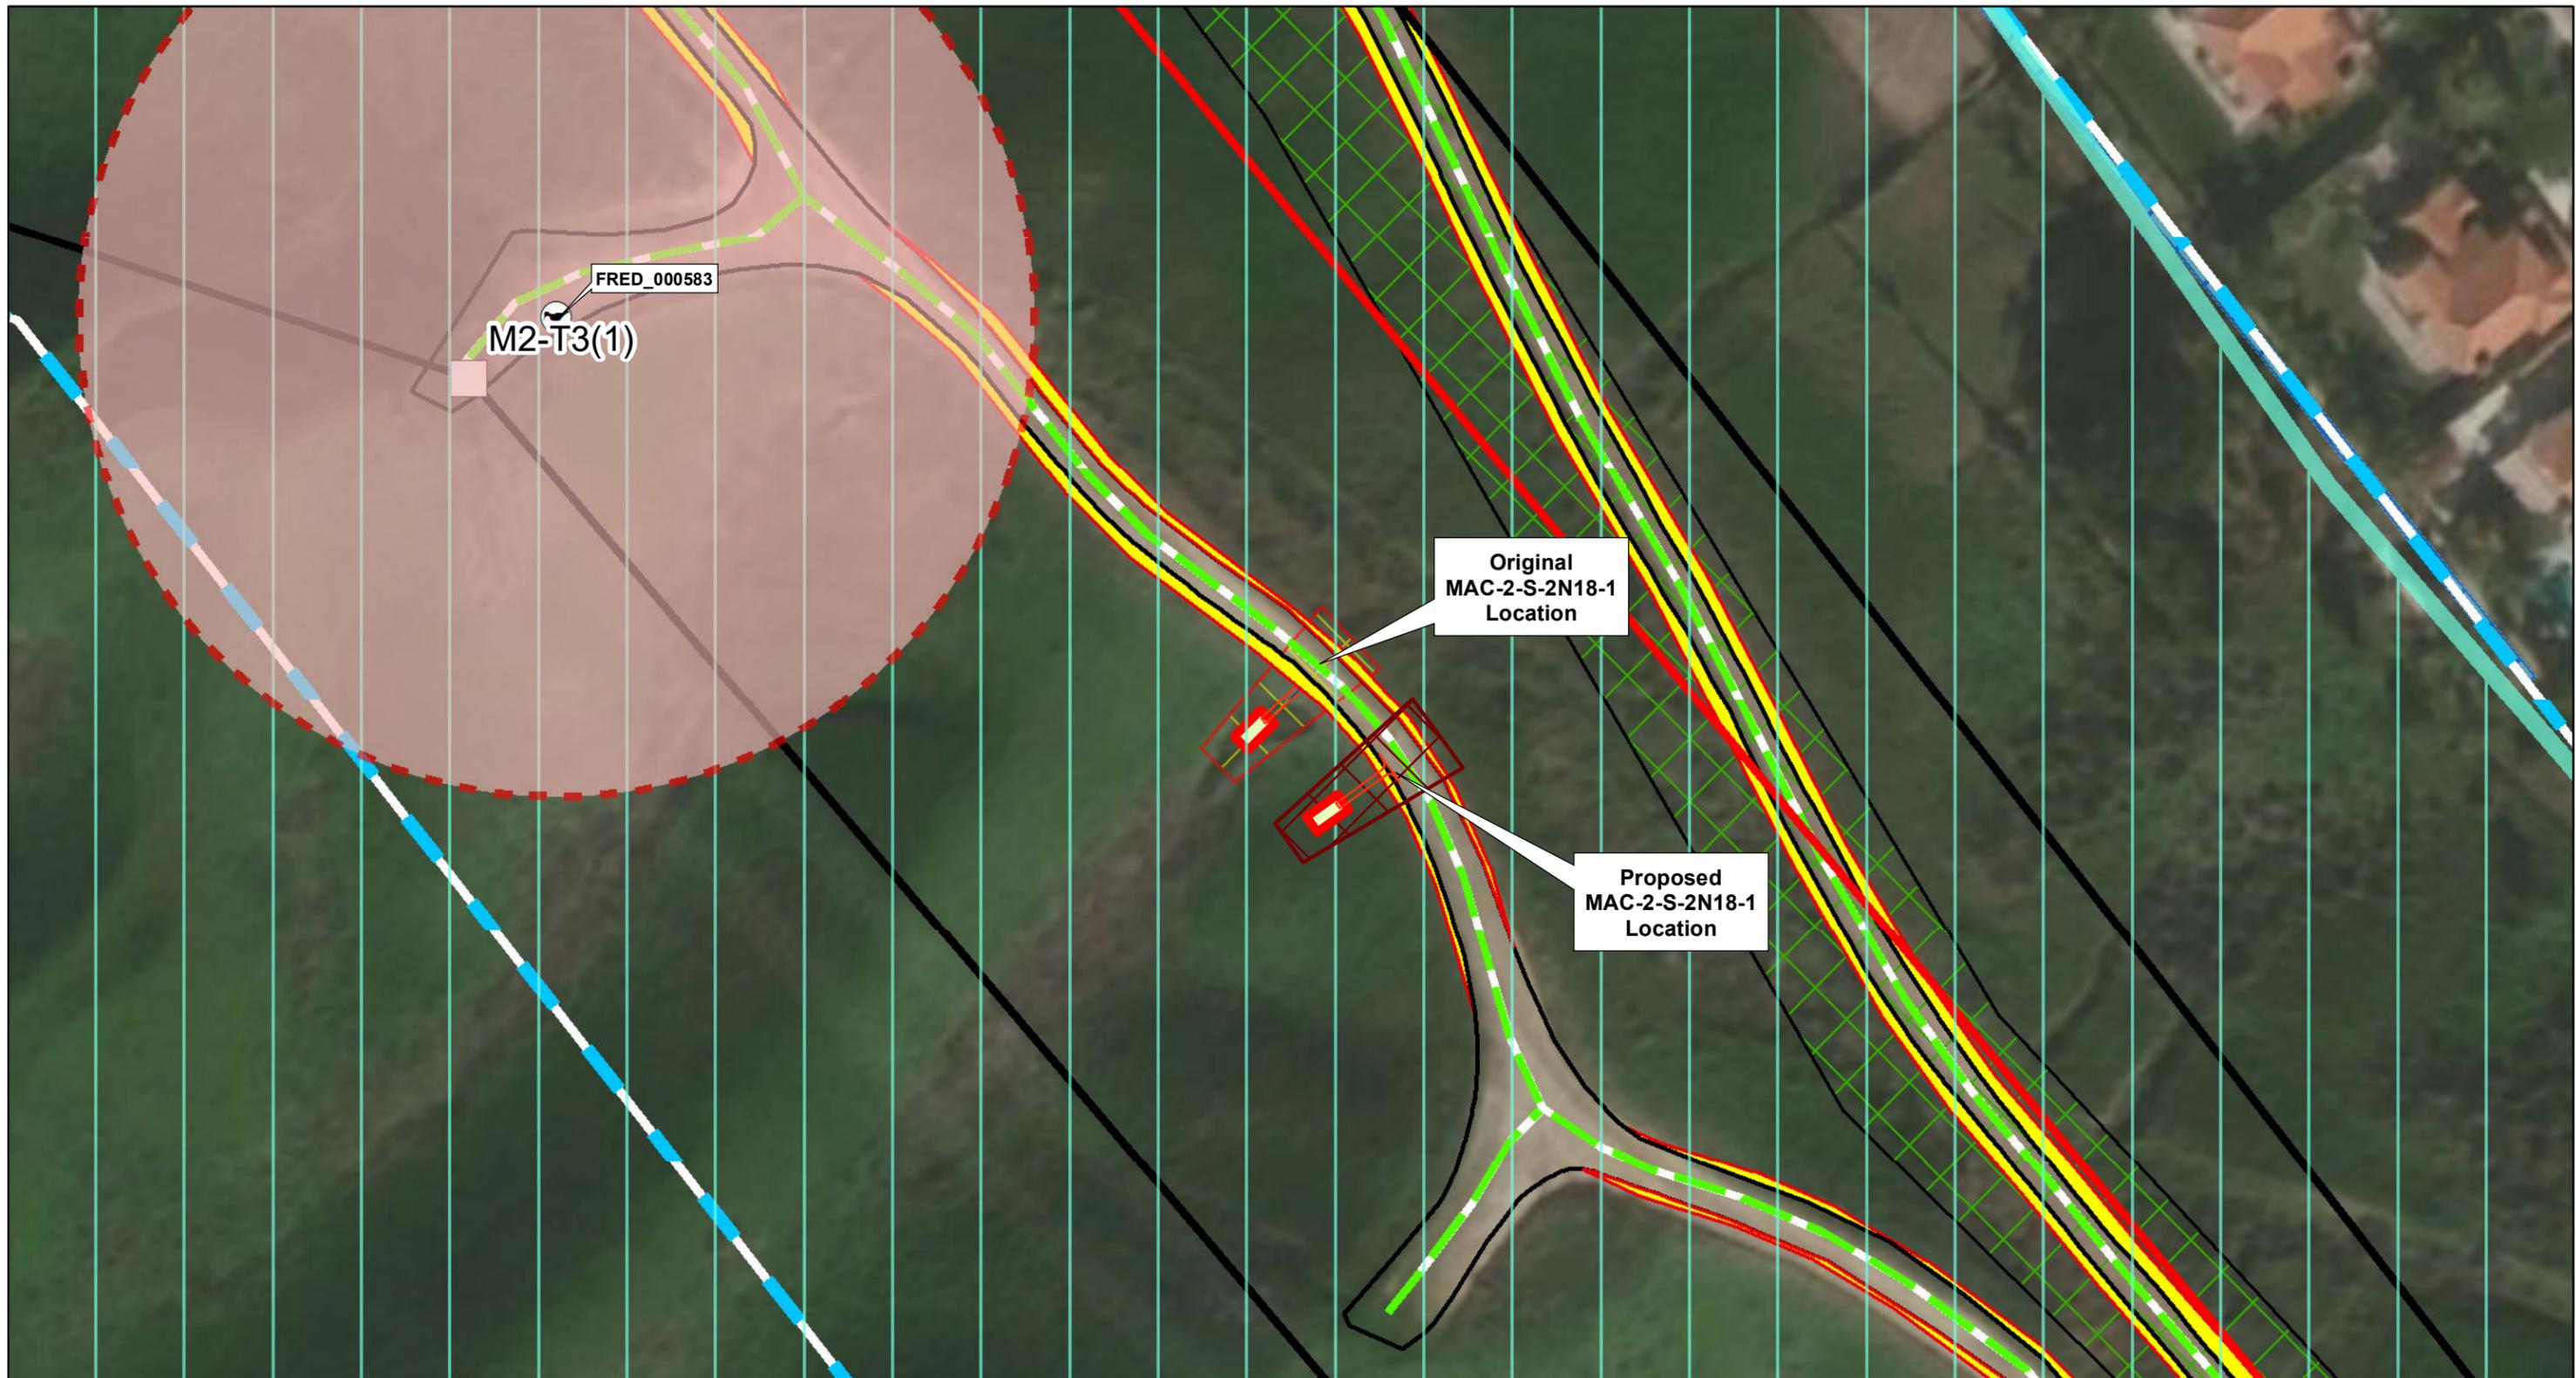
FIGURE 3

A new temporary 0.03-acre work area is required to relocate the originally planned position of MAC-2-S-2N18-1 approximately 18 feet southeast along the approved access road. The location of the mac drain has been re-designed to better capture and divert storm flow at the bend in the access road downstream to uplands, as shown on Figure 3.

The total temporary disturbance area associated with the new work area consists of approximately 0.02 acre of developed/disturbed land and 0.01 acre of grassland/forbland, which will be offset by the originally planned location of the mac drain, which will not be used, and is located in similar habitat. The land is privately owned and located entirely within the SCE transmission line right-of-way.

Southern California Edison
 West of Devers Upgrade Project
Proposed MAC-2-S-2N18-1 Relocation
 MPR #35

Coastal California Gnatcatcher – Both the originally planned location of MAC-2-S-2N18-1 and its relocated area, approximately 18 feet to the east, are within mapped Coastal California Gnatcatcher Suitable Habitat (CAGN) (Figure 3). In the history (2014-2018) of protocol surveys conducted for the project in this area, there have been no CAGN nests observed. Results were also negative during preconstruction surveys, including FRED ID 000110.

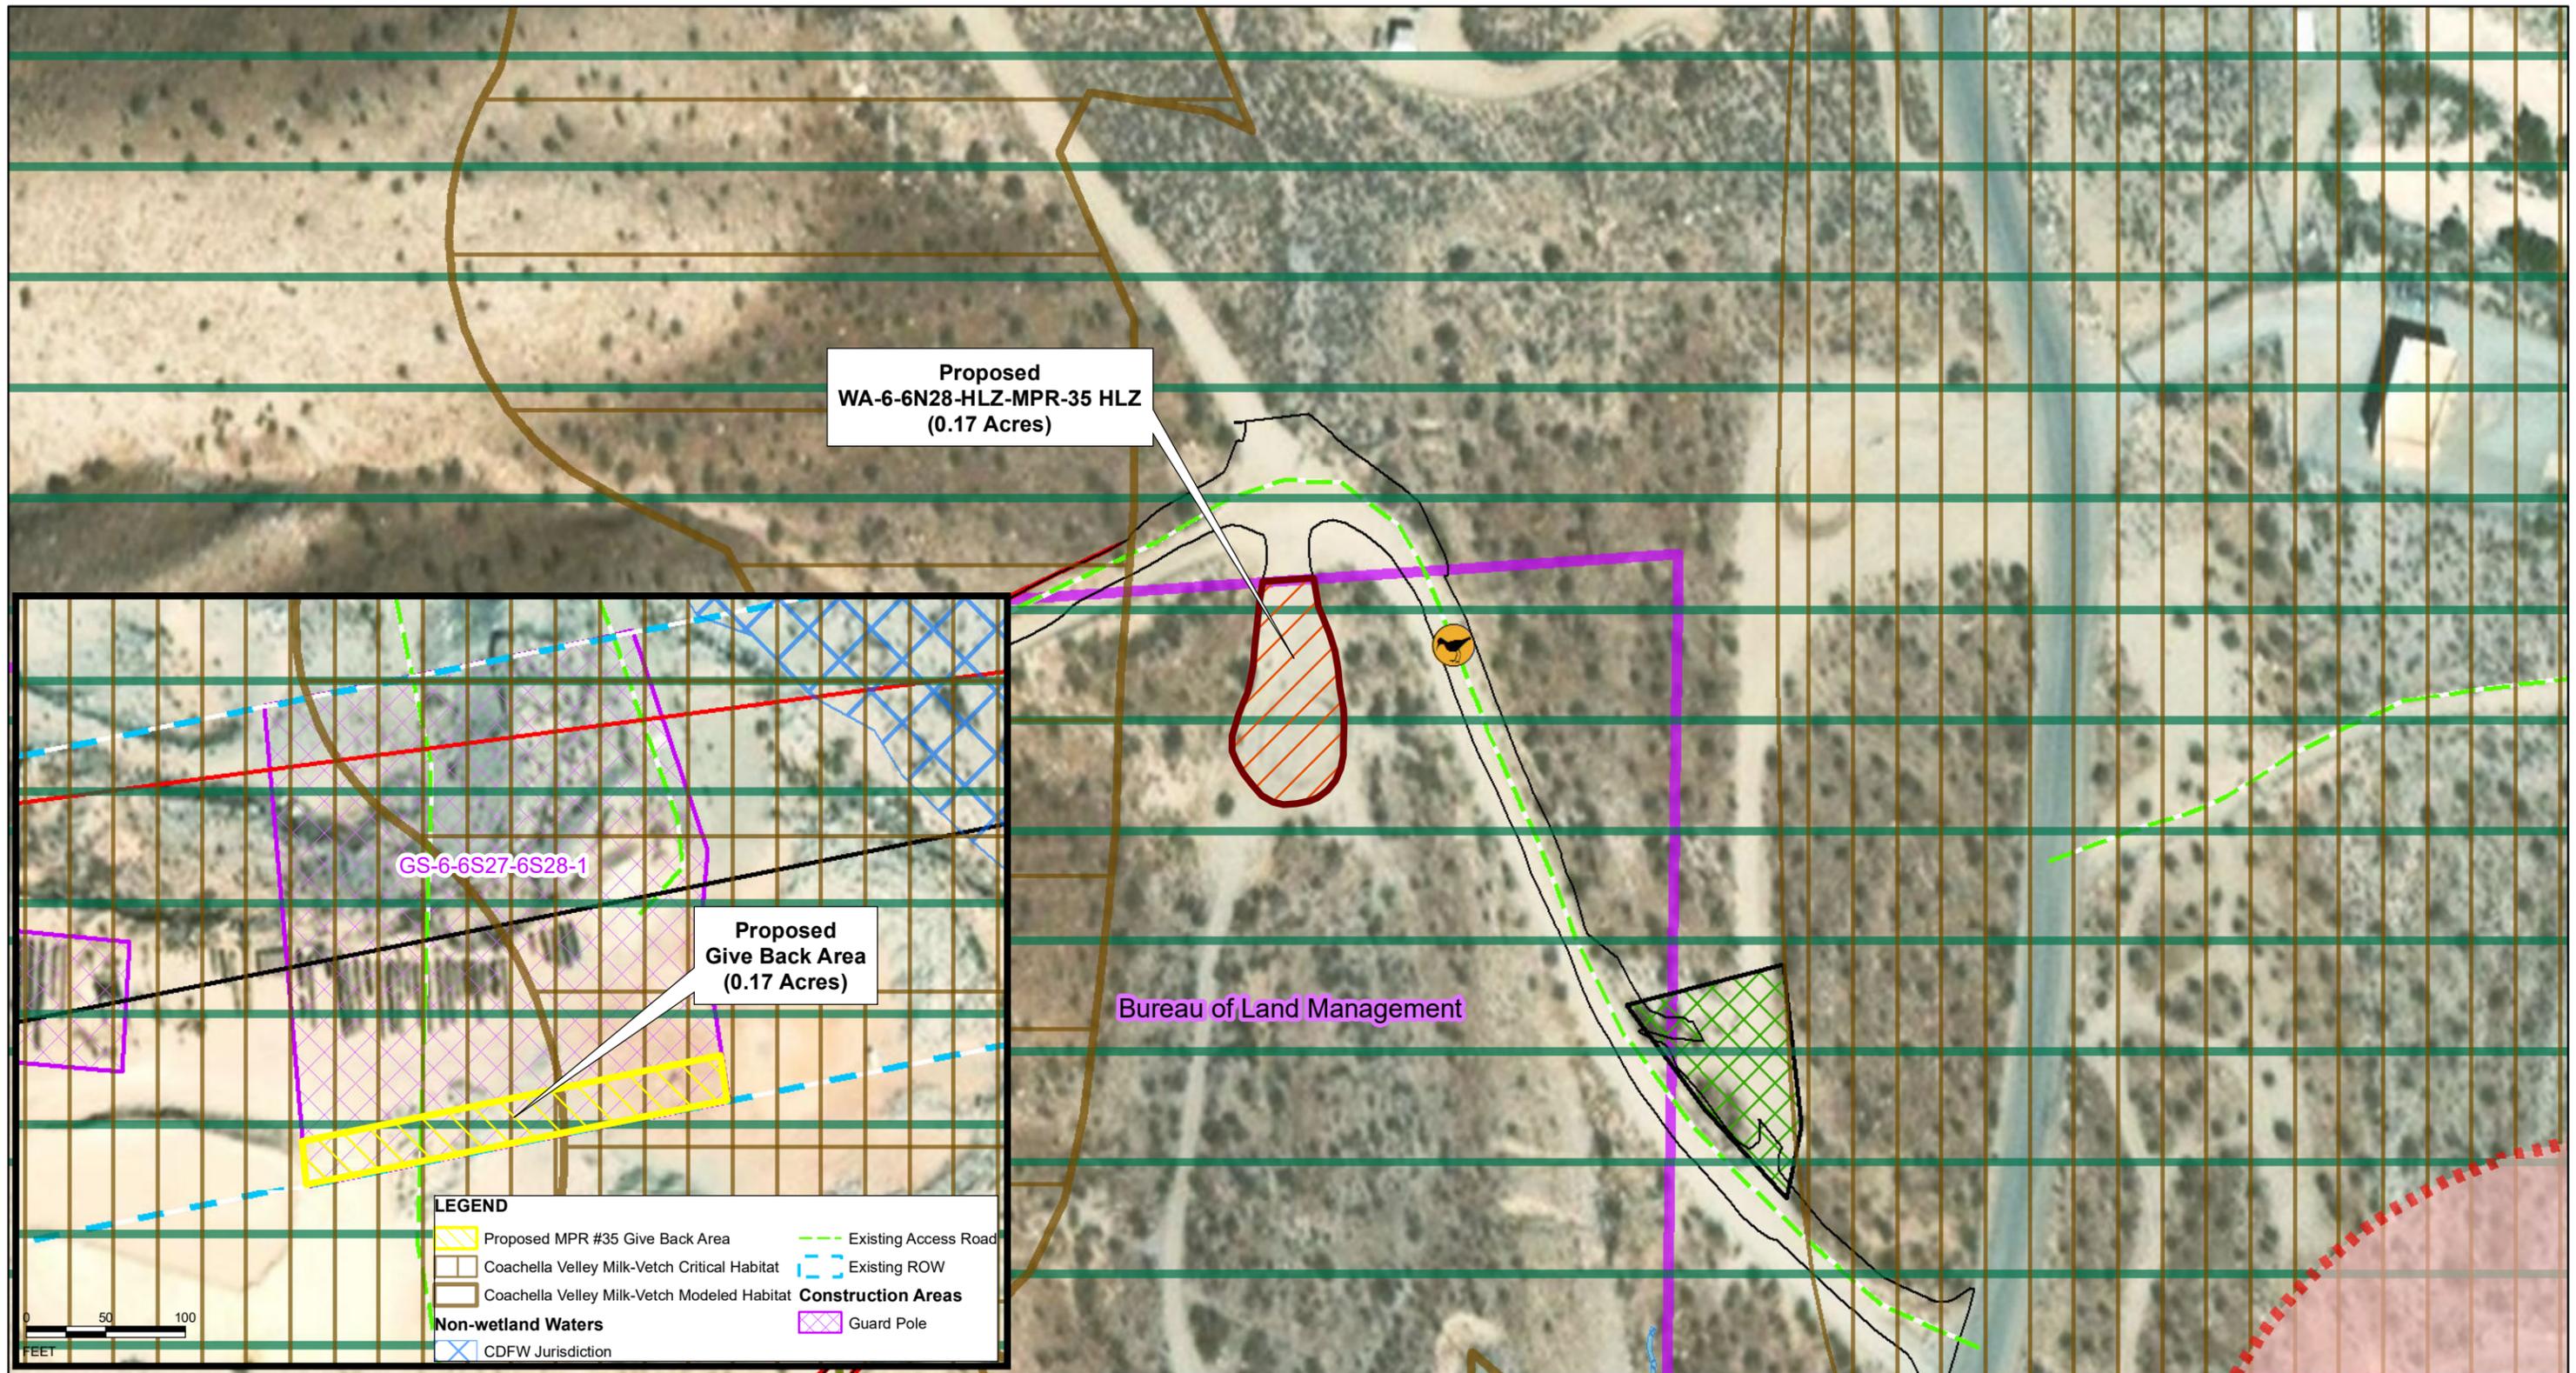
FIGURE 4

The 0.17-acre temporary work area is contiguous with an approved access road, located between MAC-6N28-1-NE and MAC-6N28-3-NE (MacCarthy drains). It was approved in TEWS 18 and is now required for continued project use as a helicopter landing zone, as shown on Figure 4. The temporary work area will be used to facilitate helicopter assisted activities associated with Segment 6 wire stringing and wreck-out, and as a staging area for construction vehicles, materials, and equipment. No ground disturbance will occur within the temporary work area, as it is a previously developed/disturbed unpaved access road turnout area. The temporary work area is devoid of vegetation and requires no site preparation to accommodate construction use.

The total temporary disturbance space associated with the new work area consists of approximately 0.17-acre of developed/disturbed land. The work area is located on lands managed by the U.S. Bureau of Land Management.

Southern California Edison
West of Devers Upgrade Project
Proposed WA-6-6N28-HLZ-MPR-35 HLZ
MPR #35

WA-6-6N28-HLZ-MPR-35 HLZ is located approximately 975 feet northwest of active barn owl burrow (FRED_000506), well outside of the 300-foot horizontal buffer shown in Figure 4. The nest is located in a south-facing cliffside approximately 35 feet above the ground. The nest height and location offers visual and acoustic buffers to ground sites near the nest. The nest is hidden within a cavity, therefore impacts to the nest are unlikely.

Special-status Plants – WA-6-6N28-HLZ-MPR-35 HLZ is located approximately 75 feet east of Coachella Valley Milk-Vetch (CVMV) (*Astragalus lentiginosus* var. *coachellae* [CVMV]; FE, CRPR 1B.2) Modeled Habitat in the Whitewater Canyon Conservation Area and approximately 275 feet west of CVMV Critical Habitat (Figure 4). Previous surveys for CVMV were negative.
