PROJECT MEMORANDUM
SCE WEST OF DEVERS (WOD) UPGRADE PROJECT

To: Billie Blanchard, Project Manager, CPUC
From: Vida Strong, Aspen Project Manager
Date: March 30, 2018
Subject: Monitoring Report #12: March 12 to March 25, 2018

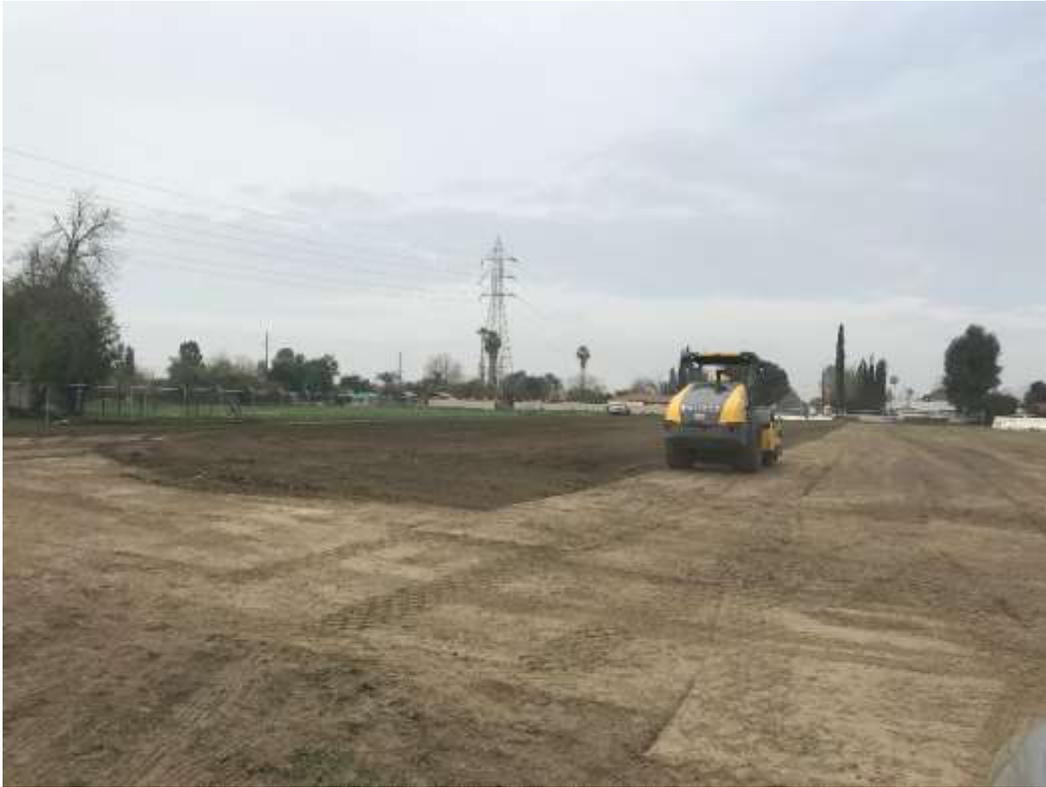
Photo 1 – Soil compaction occurring at the Mountain View MY (March 13, 2018).

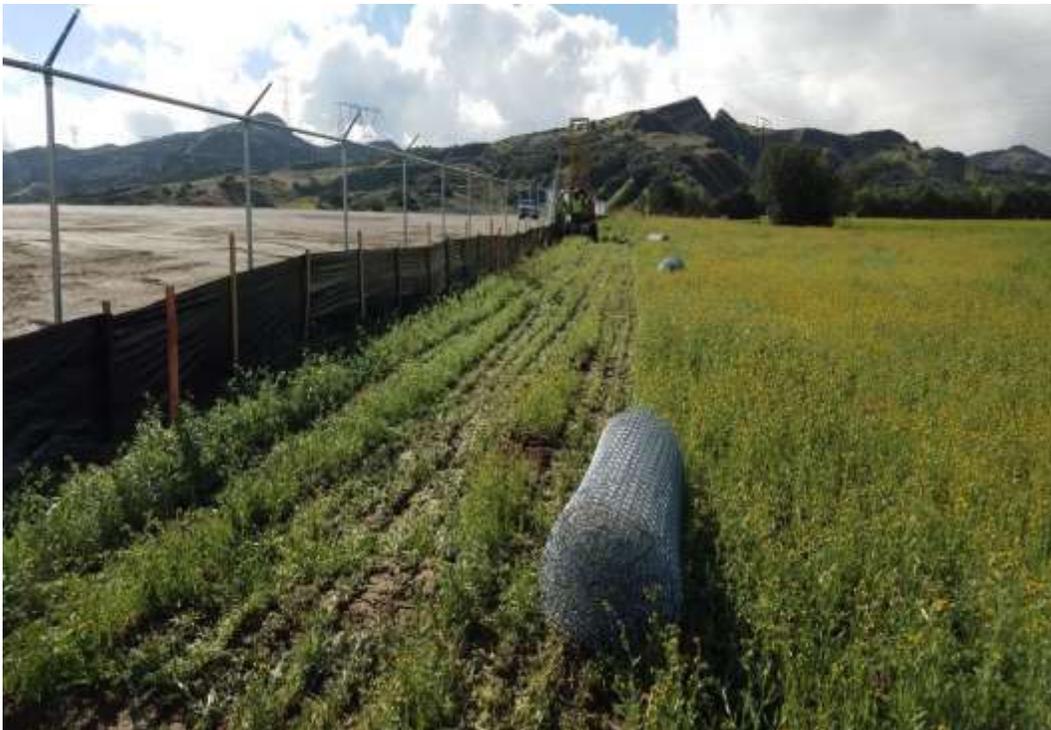
1. On March 23, the SCE Biological Monitor observed the fence installation crew working outside of approved disturbance limits at the southwest corner of the Poultry MY. Subsequently, the work resulted in equipment tracks over approximately 5100 square feet of ground in the unapproved area (see Photo 2). The SCE Biological Monitor immediately halted work and notified the crew of the issue and the crew relocated to a work area inside of the approved disturbance limits. No impacts to sensitive resources were observed or reported.

Photo 2 – Equipment tracks from work outside approved limits at the Poultry MY (photo courtesy of SCE FRED) (March 23, 2018).

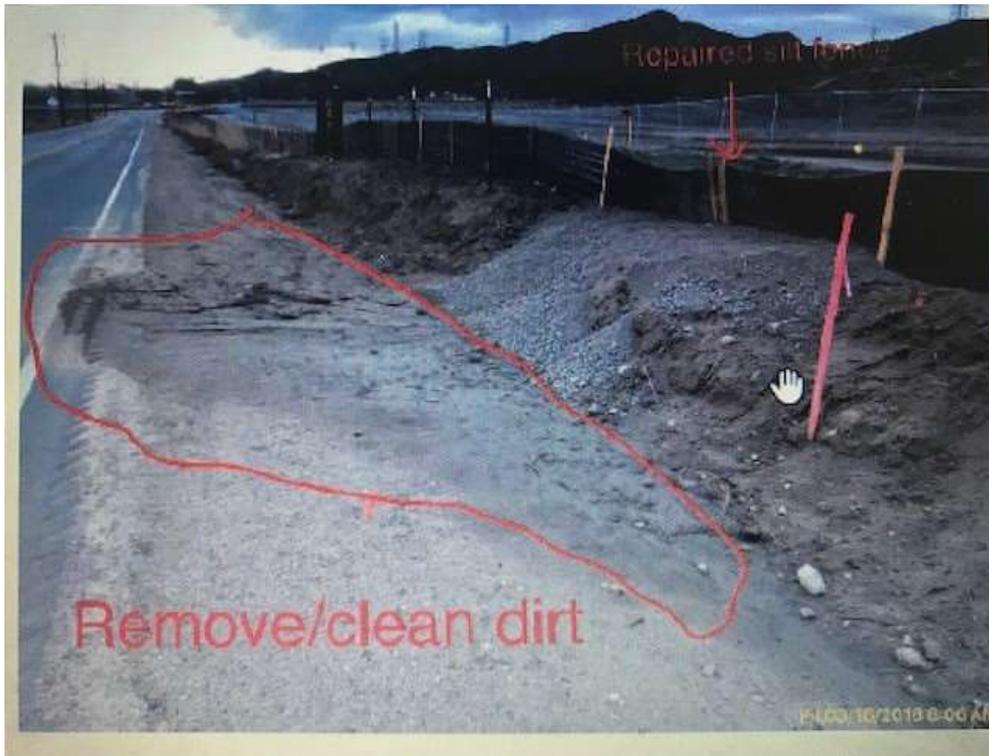
2. Two SWPPP maintenance items associated with NTP #1 were recorded during the monitoring period (see Photo 3). Each of these items was resolved and closed (see Photo 4). To date, there are no open SWPPP maintenance items associated with NTP #1.

Photo 3 – Offsite sedimentation from the Poultry MY along the shoulder of San Timoteo Canyon Road. Recorded as a SWPPP maintenance item by SCE inspector (photo courtesy of SCE FRED) (March 16, 2018).

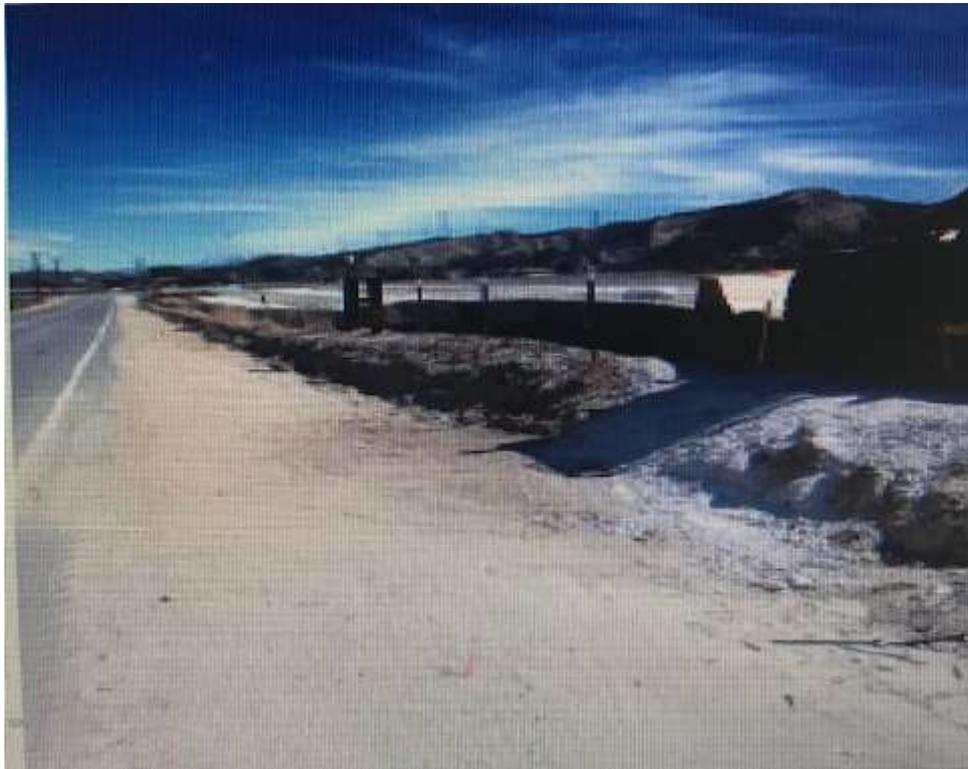
Photo 4 – SWPPP maintenance item along San Timoteo Canyon Road resolved after cleanup by crew (photo courtesy of SCE FRED) (March 19, 2018).

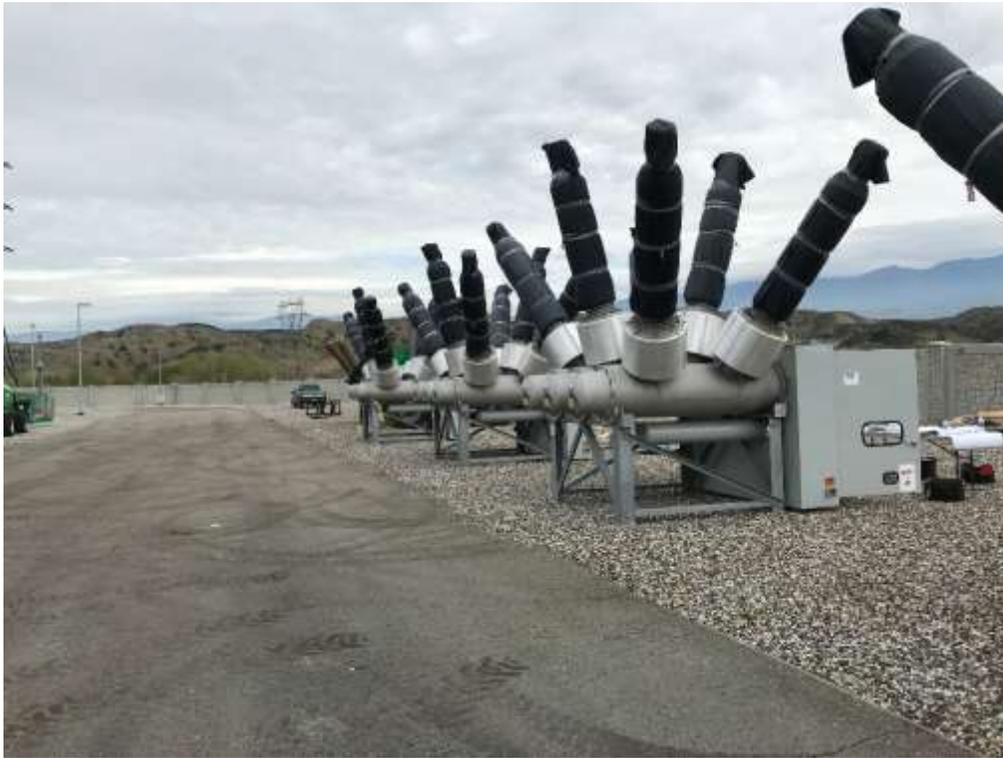
1. For the current substation construction activities, site supervision is being provided by Circle Wood Services and bus position replacement, reconductoring, and CCVT installation is being conducted by TTR Substations.
2. Work associated with the El Casco Substation upgrades included demolishing jumpers and installation of new breakers at bus positions (see Photo 5).

Photo 5 – New bus positions onsite and ready for installation at the El Casco Substation (March 21, 2018).
