PROJECT MEMORANDUM

SCE WEST OF DEVERS (WOD) UPGRADE PROJECT

To: Billie Blanchard, Project Manager, CPUC
From: Vida Strong, Aspen Project Manager
Date: September 20, 2018
Subject: Monitoring Report #32: September 10 to 16, 2018

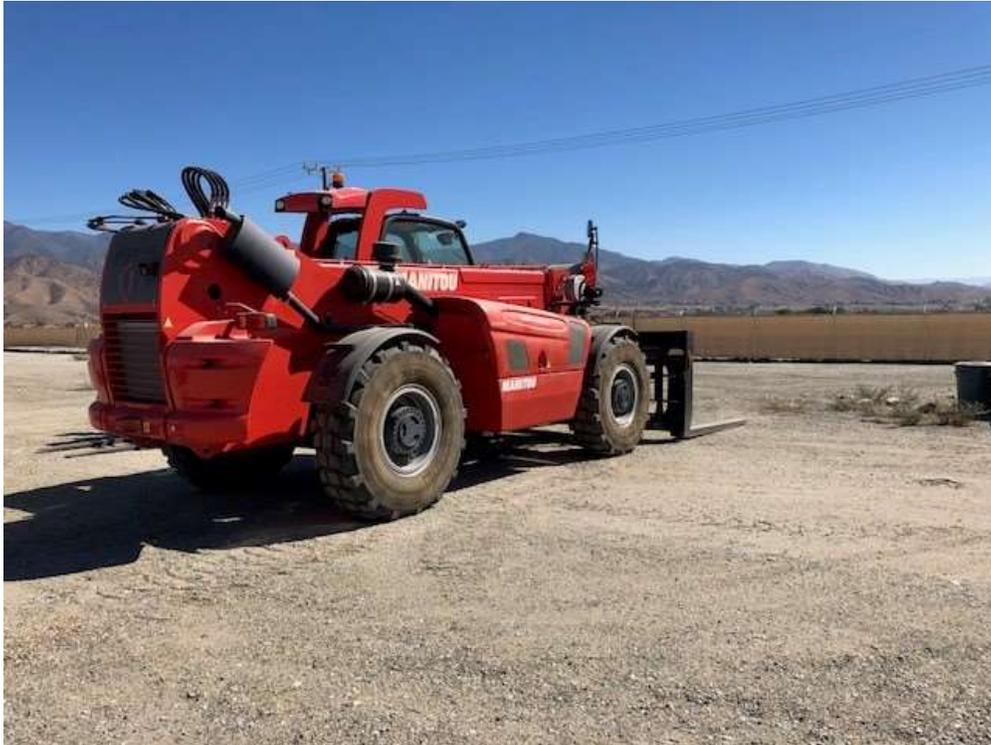
Photo 1 – Equipment located at the Match MY was missing documentation of compliance with air quality measures. (September 12, 2018).

1. CPUC EMs noted two forklifts staged at the Matich MY without Air Quality Compliance Stickers which document compliance with off road equipment air quality standards (see Figure 1). SCE recorded this as a Level 1 incident. At the Beaumont 2 MY, uncovered 2-inch diameter pipe was observed (see Figure 2). This conflicts with Mitigation Measure (MM) WIL-1b, Ensure Wildlife Impact Avoidance and Minimization. SCE documented this as a Level 1 incident. Also, at the Beaumont 2 MY, the CPUC EMs noted concrete residue on the ground near some foundation forms (see Figure 3). SCE was notified of the spill.

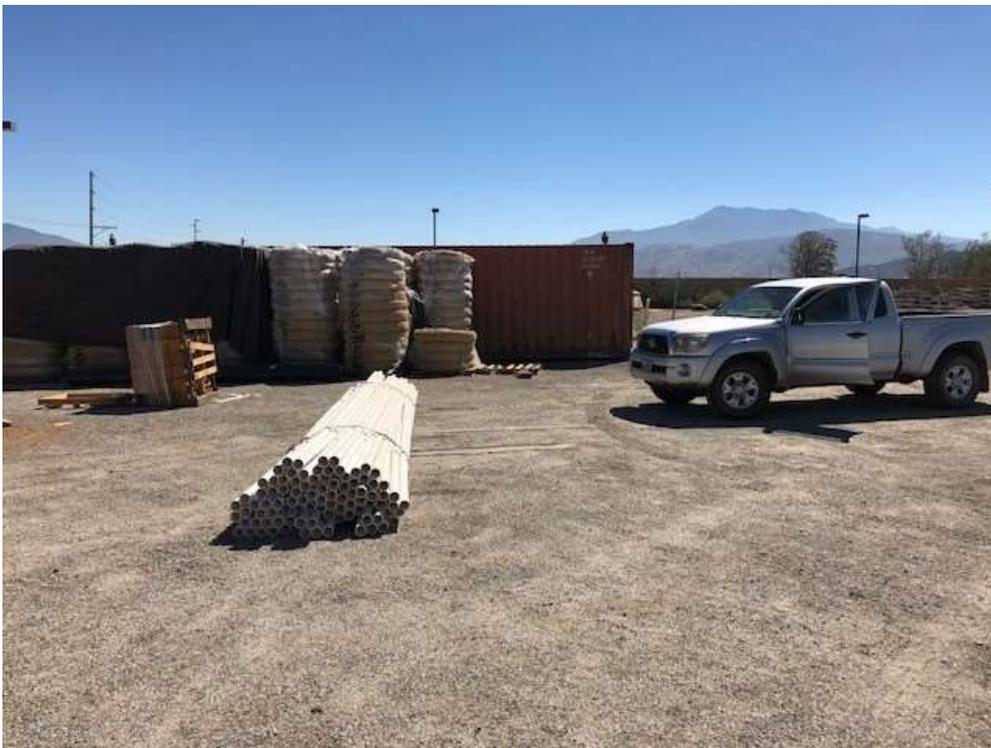
Photo 2 – Uncovered 2-inch pipe at Beaumont 2 MY (September 12, 2018).

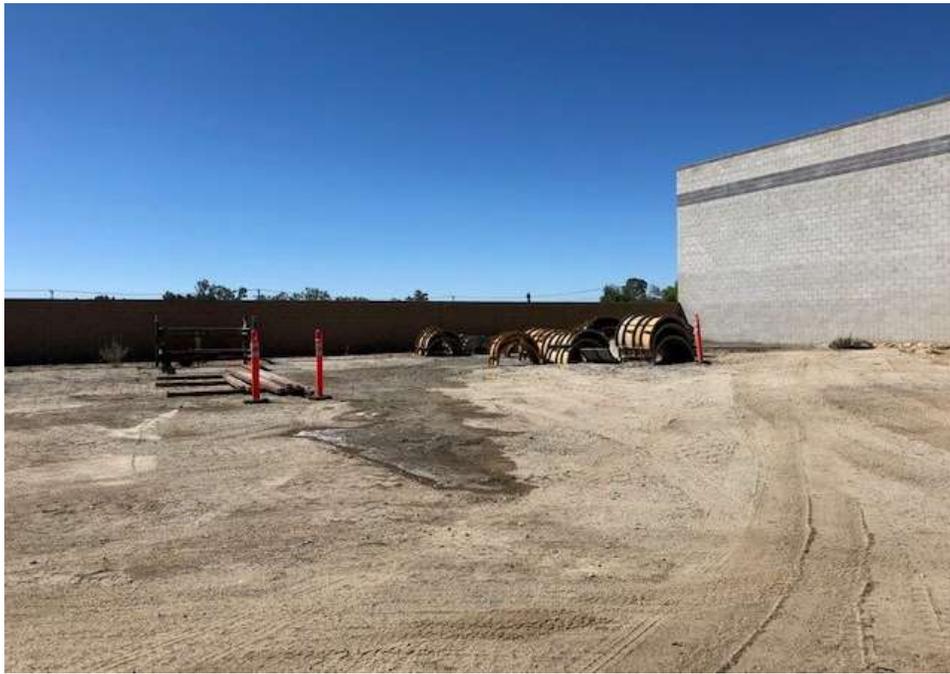
Photo 3 – Concrete wash residue at Beaumont 2 MY (September 12, 2018).

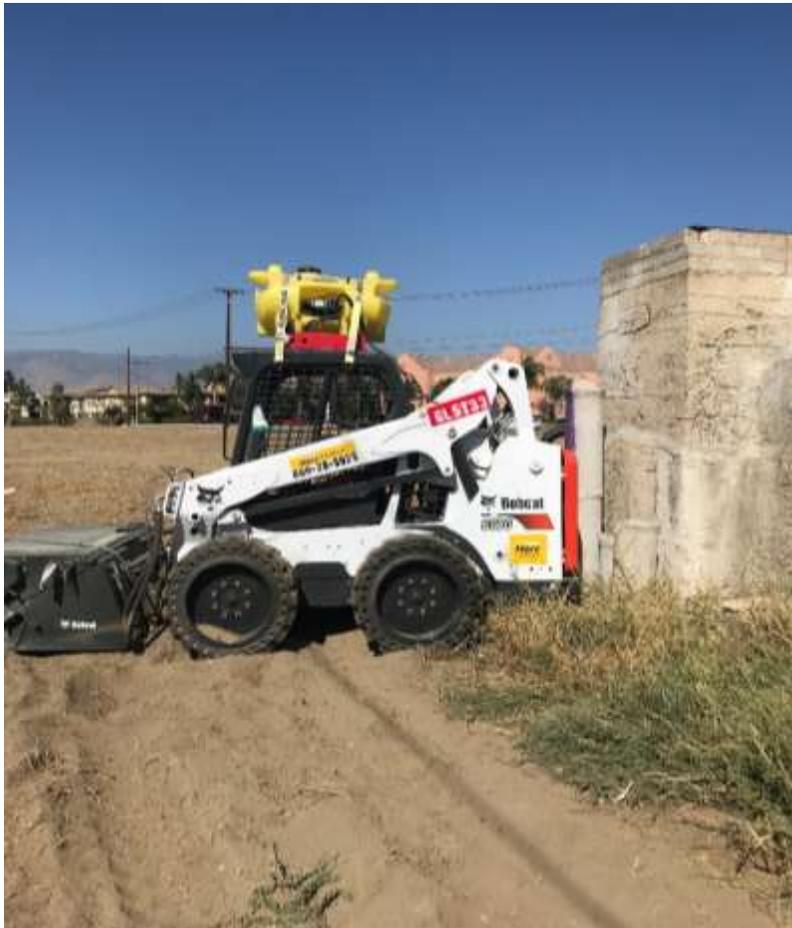
2. On September 11, the CPUC EMs observed equipment staged at the end of the day associated with the underground trenching work along Mission Road. A small dozer (bobcat) was parked on dry vegetation and was missing a drip pan (see Figure 4). The Fire Management Plan (Section 2.1.2.6) states, “Motor vehicles will not be parked or operated outside of cleared work areas, except for the specific purpose of clearing vegetation”. The project’s Environmental Monitor was notified, and a drip pan was placed under the equipment. Crews were also reminded not to park on dry vegetation because of fire danger.

Photo 4 – Equipment staged on dry vegetation along Mission Road (September 11, 2018).

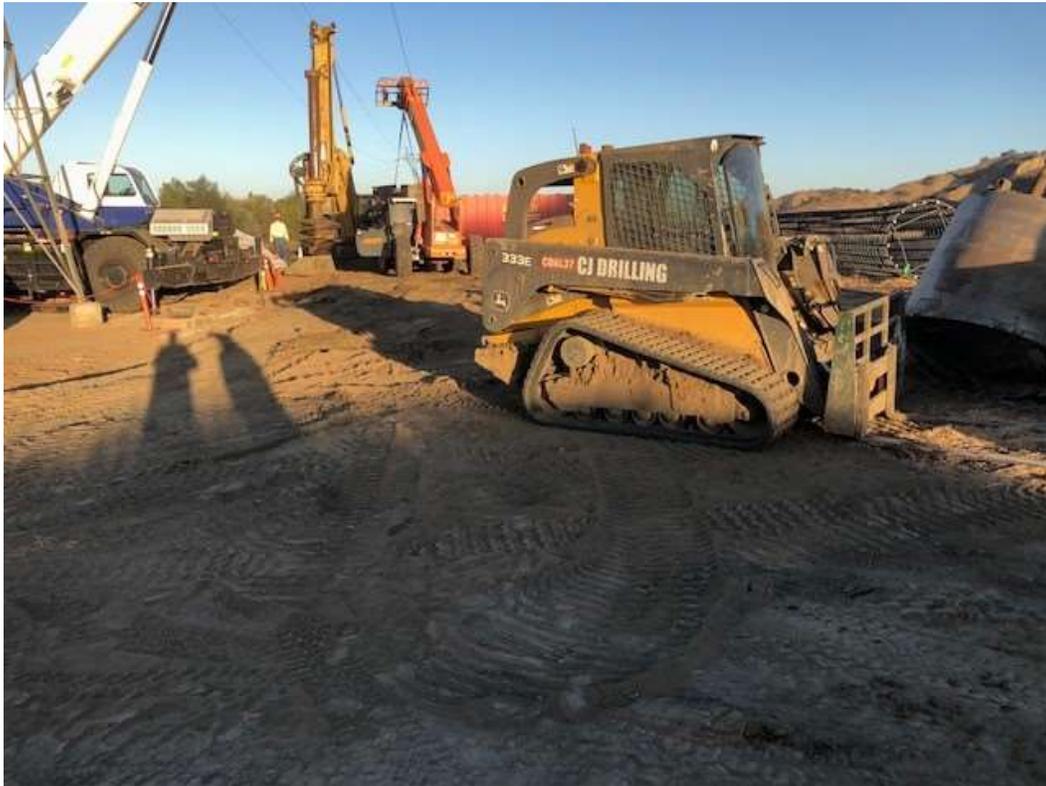
1. There was one SCE self-reported and no CPUC reported incidents documented for construction activities associated with NTP #4 throughout the monitoring period. On September 11, the CPUC EMs noted a small dozer (bobcat) idling for approximately 20 minutes at Site 4N61 (see Figure 5). SCE documented this as a Level 1 incident.

Photo 5 – Bobcat idling for more than 5 minutes conflicting with air quality emissions rules at Site 4N61 (September 12, 2018).
