PROJECT MEMORANDUM
SCE WEST OF DEVERS UPGRADE PROJECT

Date: October 1, 2018
To: Billie Blanchard, Project Manager, CPUC
From: Vida Strong, Aspen Project Manager
Subject: Monitoring Report #33: September 17 to 23, 2018

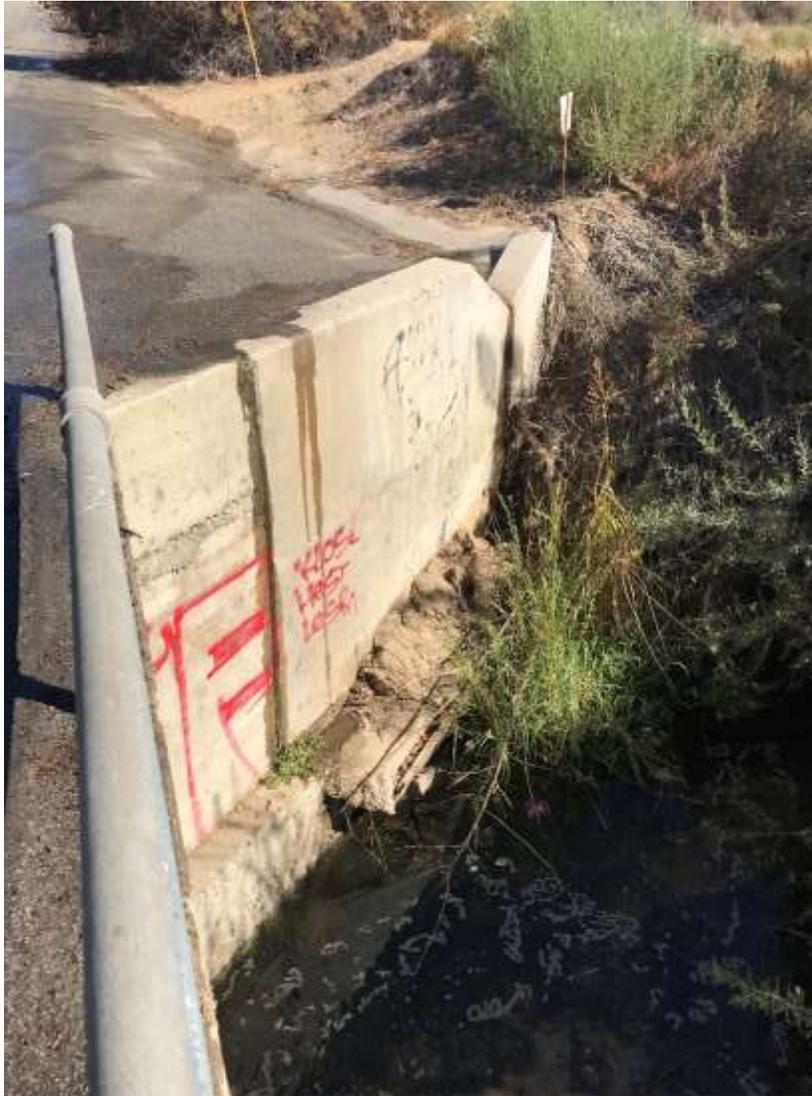
Photo 1 – Non-stormwater discharge into JD along Iowa Street from overwatering the road by subtransmission crews. No BMPs were present at the time. (September 18, 2018).

2. On September 18, while monitoring the grinding/paving work on Iowa Street, the CPUC EM observed a water truck from the paving operations watering Iowa Street over jurisdictional drainage (JD) ID #1038. No BMPs were in place, and this activity resulted in a discharge to the standing water in the drainage. The CPUC EM estimated less than 1-gallon of non-stormwater runoff entered the drainage. Once Project personnel were notified, BMPs were brought to the site (see Figures 1 and 2). Additionally, the water truck driver was advised to discontinue watering at this location.

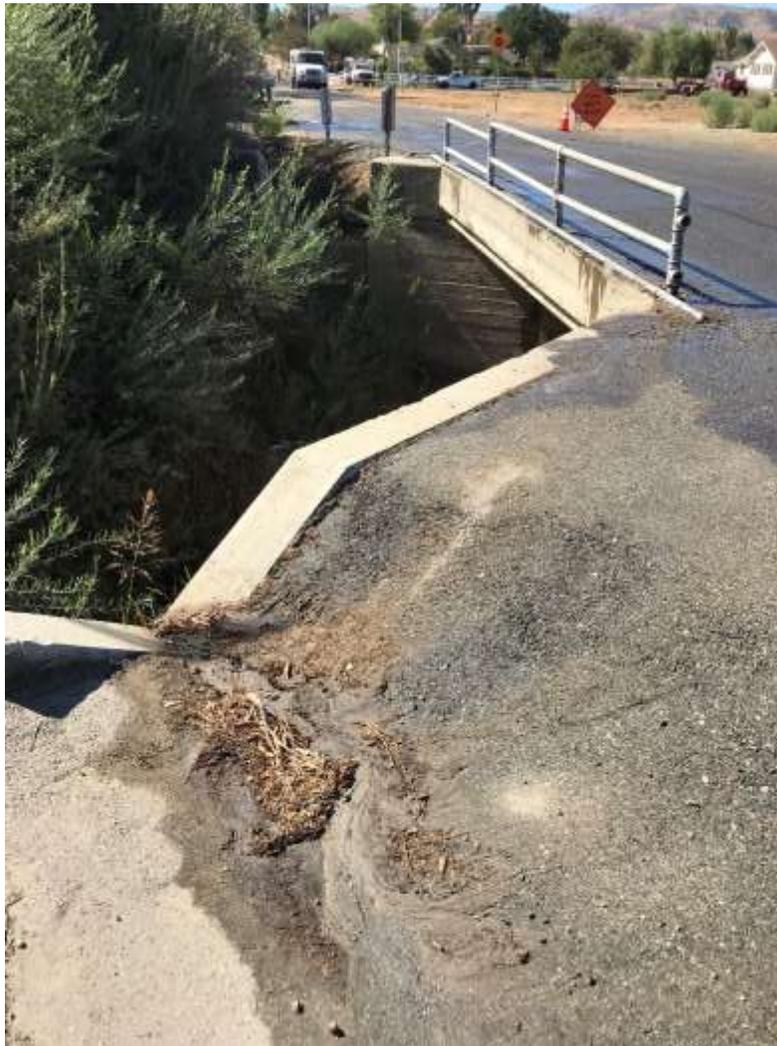
Photo 2 – Non-stormwater discharge into JD along Iowa Street from overwatering the road by subtransmission crews. No BMPs were present at the time. (September 18, 2018).

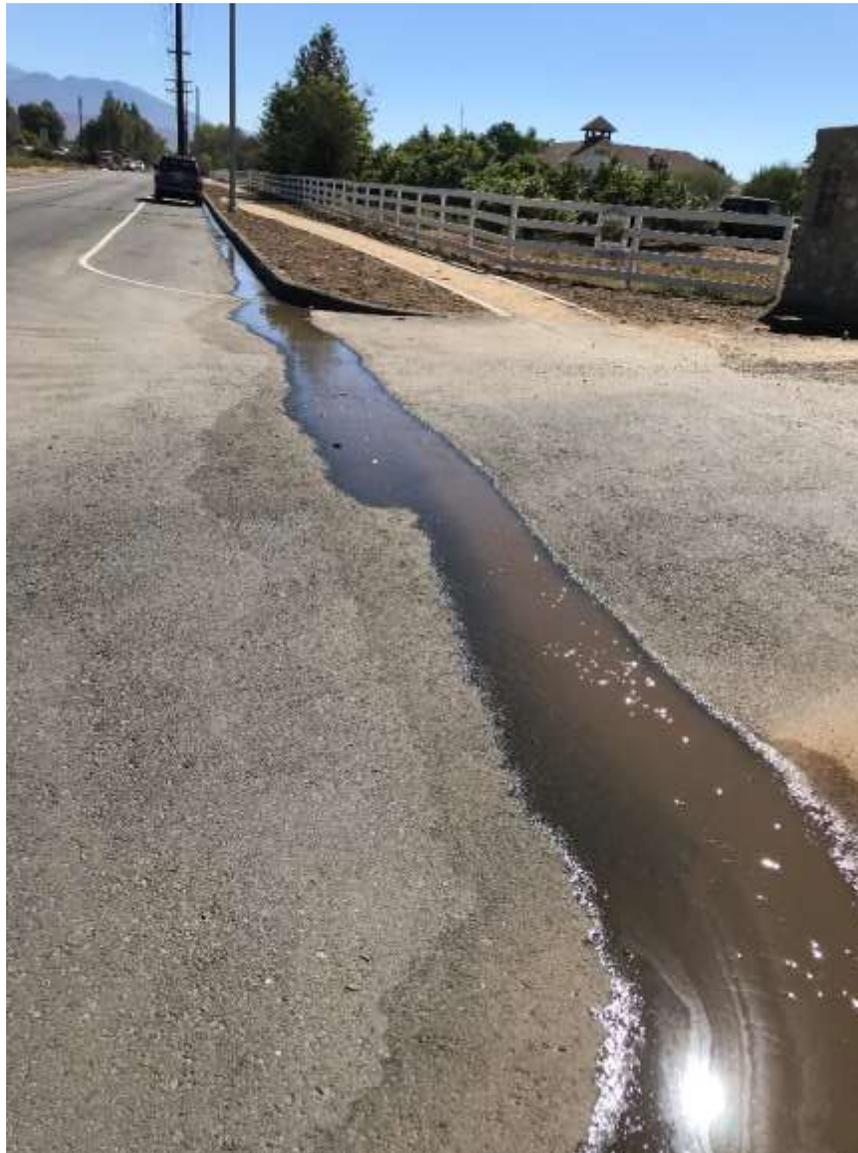
3. On September 18, non-stormwater from a water truck supporting paving operations flowed approximately 1,000-feet from work area down Orange Avenue. No BMPs were in place along this block at the time (see Figures 3).

Photo 3 – Non-stormwater discharge flowing approximately 1000-feet down Orange Avenue. No BMPs were present (September 18, 2018).

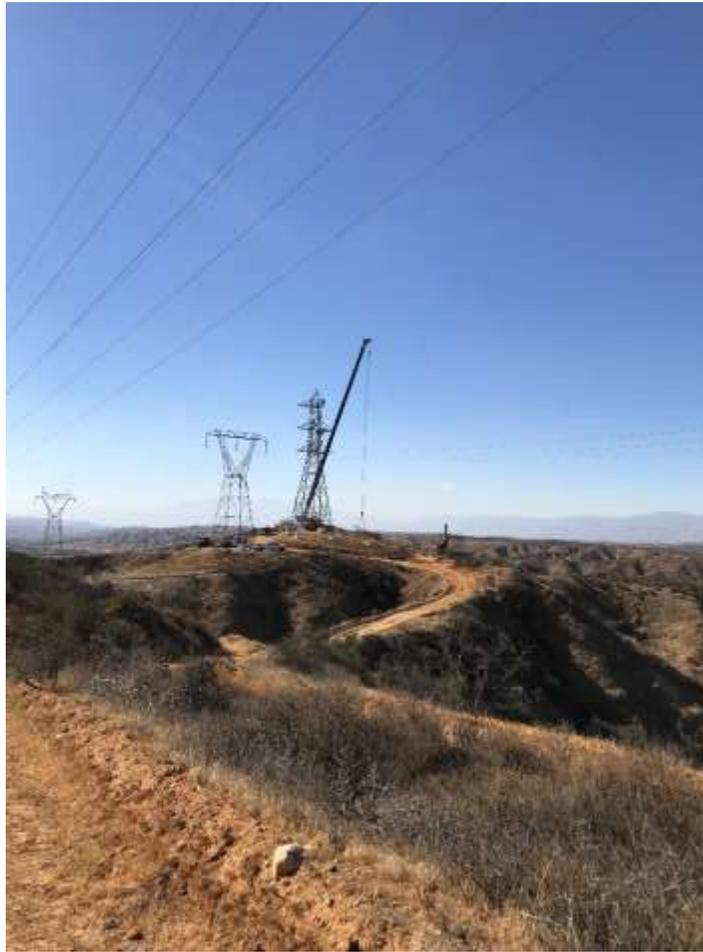
4. Work associated with Segment 4 included tower assembly at Sites 4N57, 4N59, 4N60, 4N61, and 4N62, and at Shoofly structures 409, 411, and 417 (see Figure 4). Foundation drilling and pouring occurred at Sites 4N63, 4N64, 4N58 and at Shoofly locations 409-420. Mowing occurred at Wire Sites.

Photo 4 – Tower assembly at 4N57 (September 18, 2018).

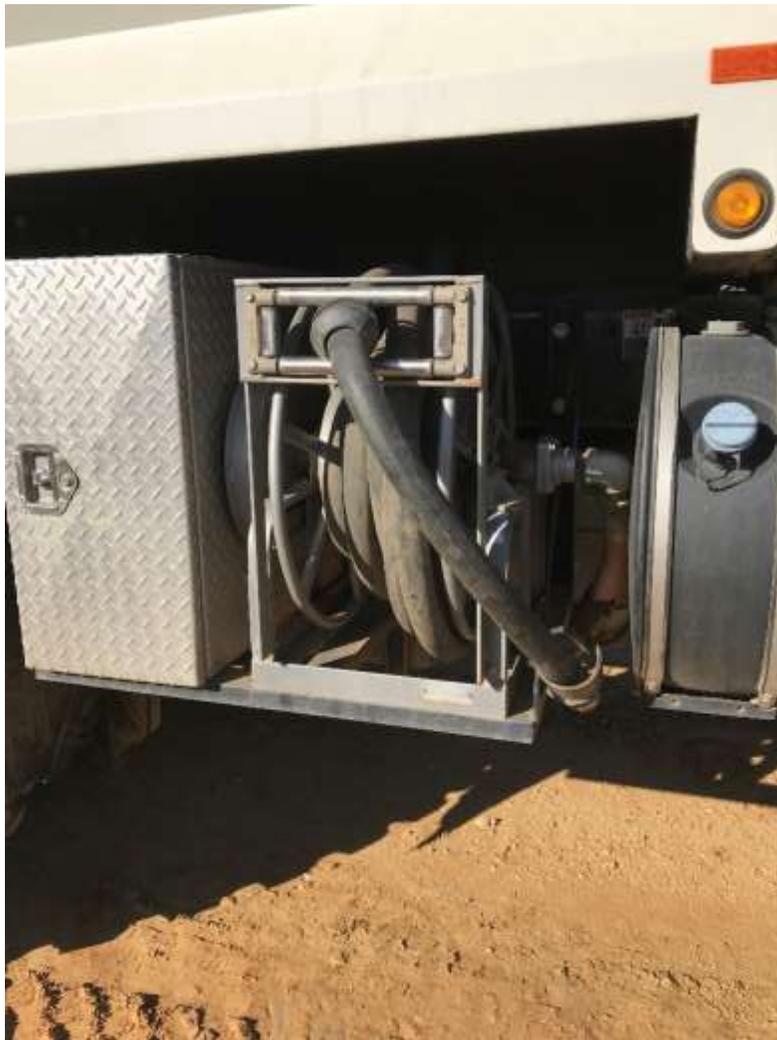
3. After the incident above, the CPUC EM conducted an inspection of the water truck that arrived to Sites 4N57 and SF414. The water truck did not contain the proper hose as required in the approved Fire Management Plan. The Plan states that "Water trucks and trailers shall meet the following specifications: a combination straight stream-fog nozzle with 300 feet of 1-inch fire hose." Instead, the truck only had approximately 40-feet of hose (see Figure 6). This incident was documented as a Level 1 Incident by the CPUC EM and provided to SCE.

Photo 6 – Insufficient hose on water truck near Palmer Avenue. Per the approved Fire Management Plan, 300-feet of 1-inch hose is required (September 18, 2018).

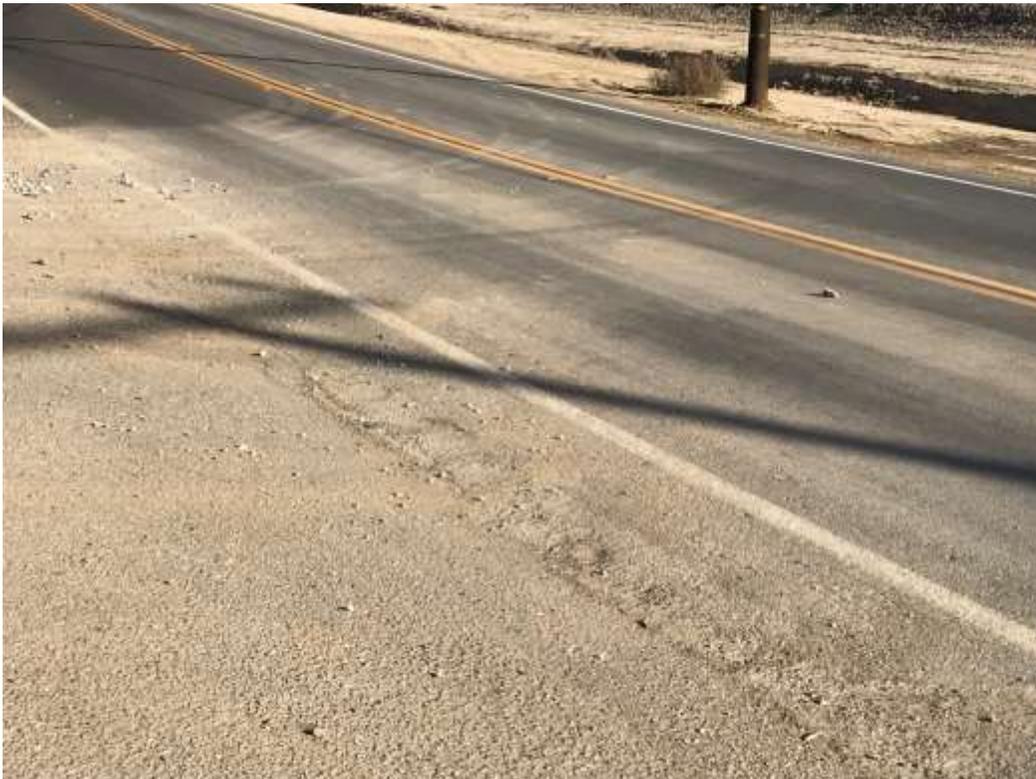
5. On September 18, the CPUC EM noted several 4-inch rocks tracked onto San Timoteo Canyon Road that had been kicked onto the road from the stabilized entrance (rocks and shaker plate) placed by construction crews at the access road to Site 3X33 (see Figure 7). Further, smaller rocks were observed in the roadway outside of the entrance to the Poultry Yard. SCE was immediately notified and the materials were removed from the busy road. SCE reported that a non-project crew had been using the entrance to Site 3X33 kicking the rocks into the road and that the stabilized entrance would either be removed or maintained by the Project.

Photo 7 – 4-inch rock tracked onto San Timoteo Canyon Road from a stabilized entrance to Site 3X33 (September 20, 2018). The track out was attributed to another utility working on an unrelated project, but the BMP was installed by the West of Devers Project and will be maintained or removed.
