PROJECT MEMORANDUM
SCE WEST OF DEVERS UPGRADE PROJECT

Date: December 19, 2018
To: Billie Blanchard, Project Manager, CPUC
From: Vida Strong, Aspen Project Manager
Subject: Monitoring Report #44: December 10 to December 16, 2018

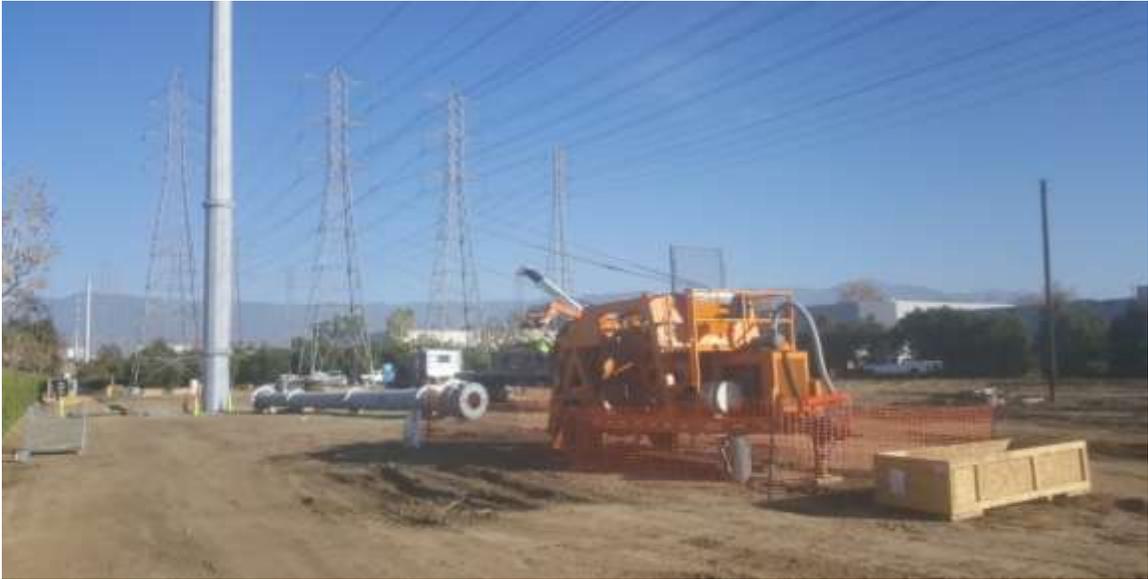
Photo 1 – Wire stringing in Segment 1; part of the current outage work (Move 1).

2. Work associated with Segment 1 included foundation drilling/pouring, vegetation removal, tower wreck-out and new tower assembly, shoofly installation, and wire installation, all part of the current outage, Project Move 1 (see Photos 1 and 2).

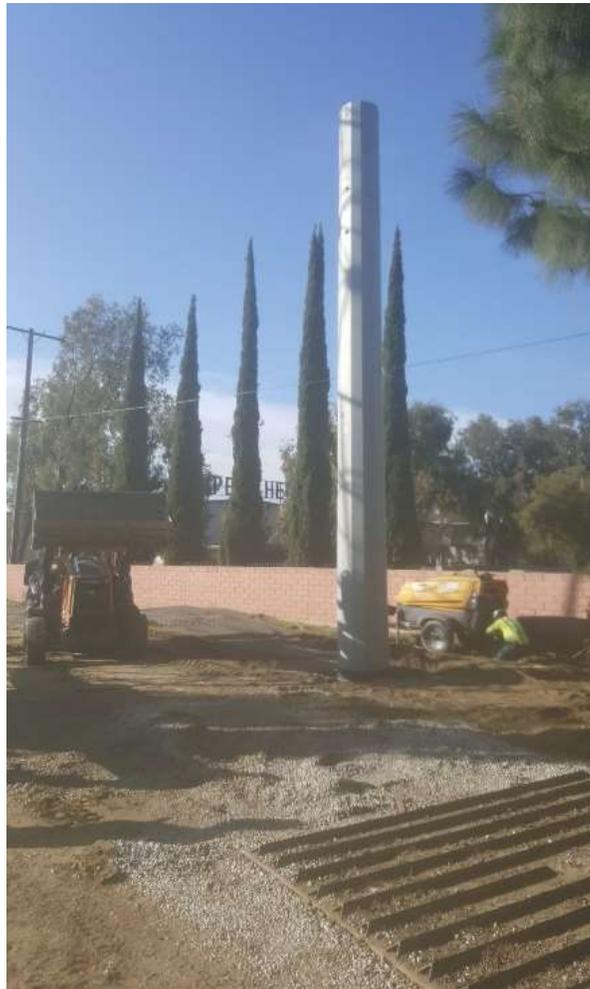
Photo 2 – Shoofly pole installation in Segment 1; part of the current outage (Move 1).

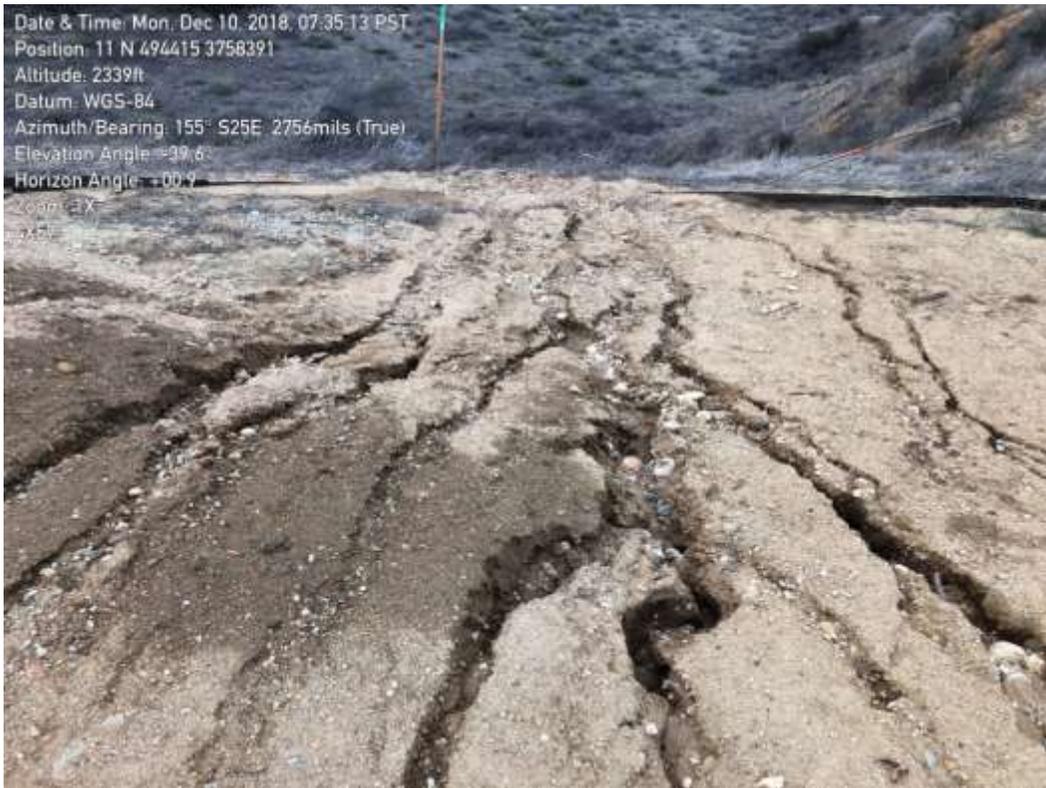
3. SCE provided documentation for local jurisdiction approval (Loma Linda and Redlands) for weekend work associated with the I-10 freeway crossing.
4. There were thirteen SWPPP maintenance items associated with NTP #4 for sediment removal due to the prior week's storms (see Photos 3 and 4).

Photo 3 – Erosion observed at Tower 57, Segment 4 after the prior week’s storm. Photo courtesy of SCE.

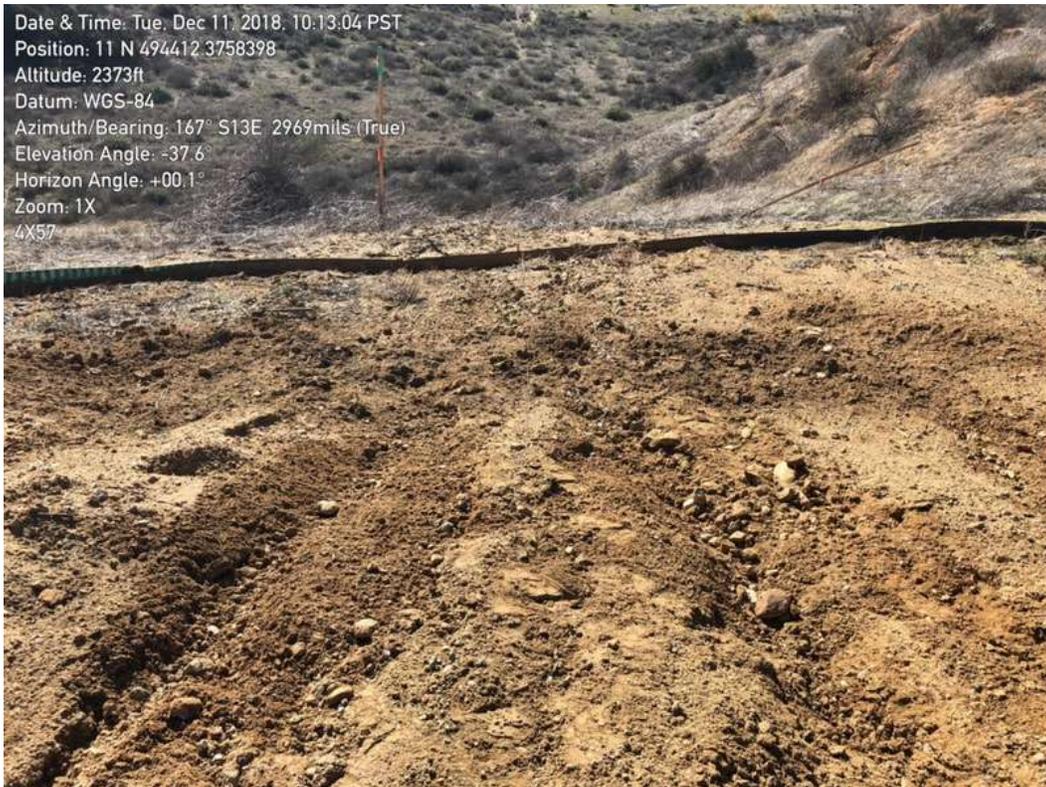
Photo 4 – Erosion maintenance after site clean-up at Tower 57, Segment 4. Photo courtesy of SCE.

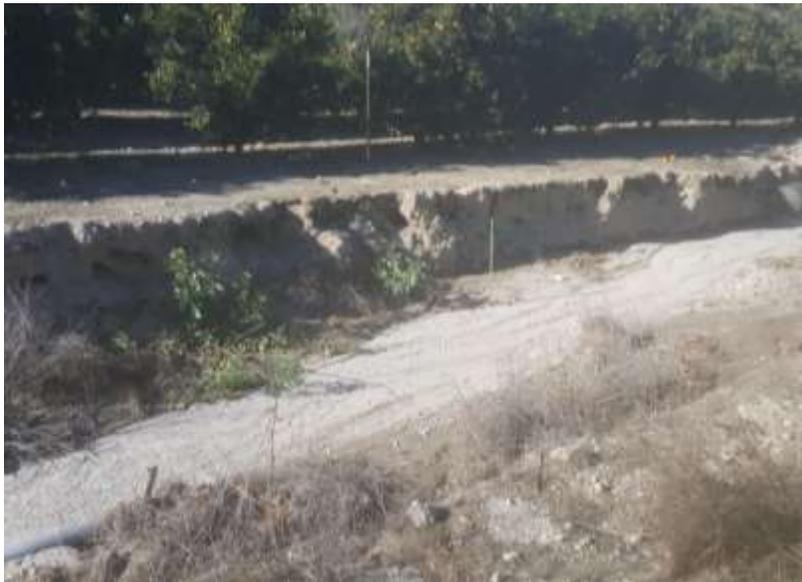
5. The CPUC EM identified a previously unidentified drainage while conducted staking verifications in Segment 3 (see Photo 5). The disturbance limits were staked and included portions of the unpermitted drainage. SCE has subsequently informed the CPUC that the drainage would be completely avoided.

Photo 5 – Unidentified drainage discovered by CPUC EM while conducting work limits staking verification. SCE has indicated that the unpermitted drainage feature will be avoided.

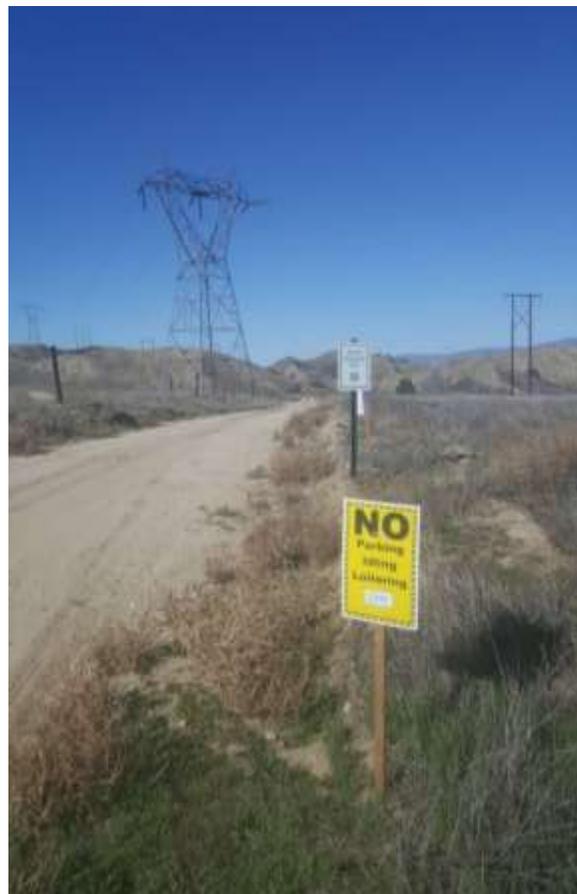
6. There were no reportable (> 1 gallon) spills associated with NTP #4 identified during the monitoring period.
7. One red-tailed hawk nest was identified during the reporting period in Segment 3 (see Photo 6). The nest was subsequently monitored and determined to be inactive. SCE sent nest notification to the resource agencies and the nest was removed after several observations.

Photo 6 – Staking indicating an Environmentally Sensitive Area (ESA) for the red-tailed hawk nest found in Segment 3. After determined to be inactive, the nest was later removed and the staking was taken down.
