PROJECT MEMORANDUM
SCE WEST OF DEVERS UPGRADE PROJECT

Date: January 31, 2019
To: Billie Blanchard, Project Manager, CPUC
From: Vida Strong, Aspen Project Manager
Subject: Monitoring Report #47: January 13 to January 19, 2019

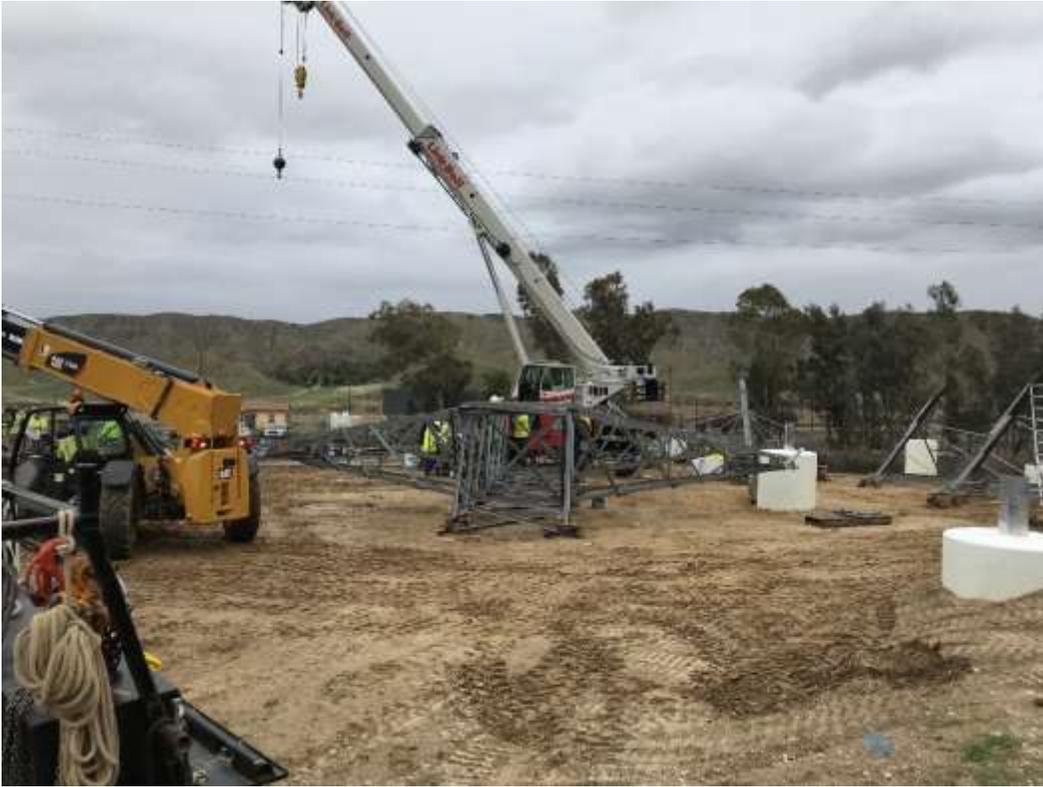
Photo 1 – Tower assembly at Site 3X22, Segment 3.

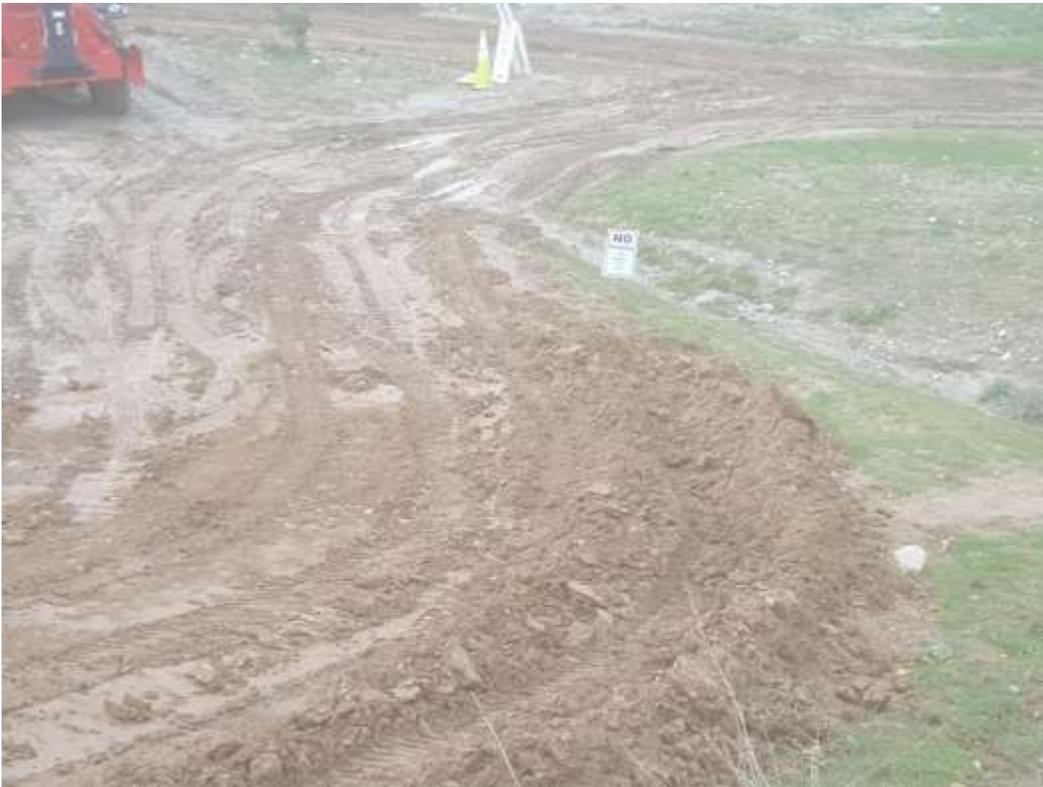
Photo 2 – Access road maintenance near Site 3X59 during wet conditions, Segment 3. ESA signage of the nearby jurisdictional drainage can be seen in the photo.

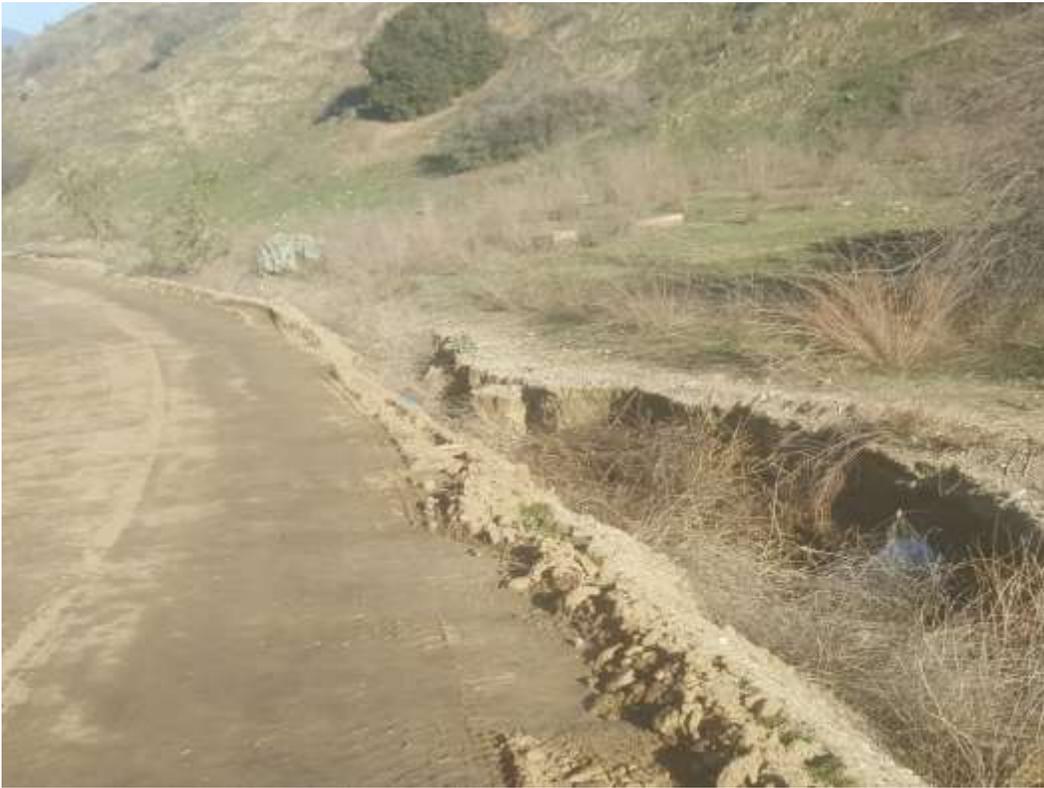
2. The CPUC EM identified a previously unidentified drainage east of Segment 3, Site 3X50 (see Photo 3). The CPUC EM reported the drainage to SCE and they have determined that the drainage feature in question is not a jurisdictional feature.

Photo 3 – Previously unidentified drainage near Site 3X55, Segment 3, reported to SCE by CPUC EM. SCE determined that the feature is not jurisdictional.

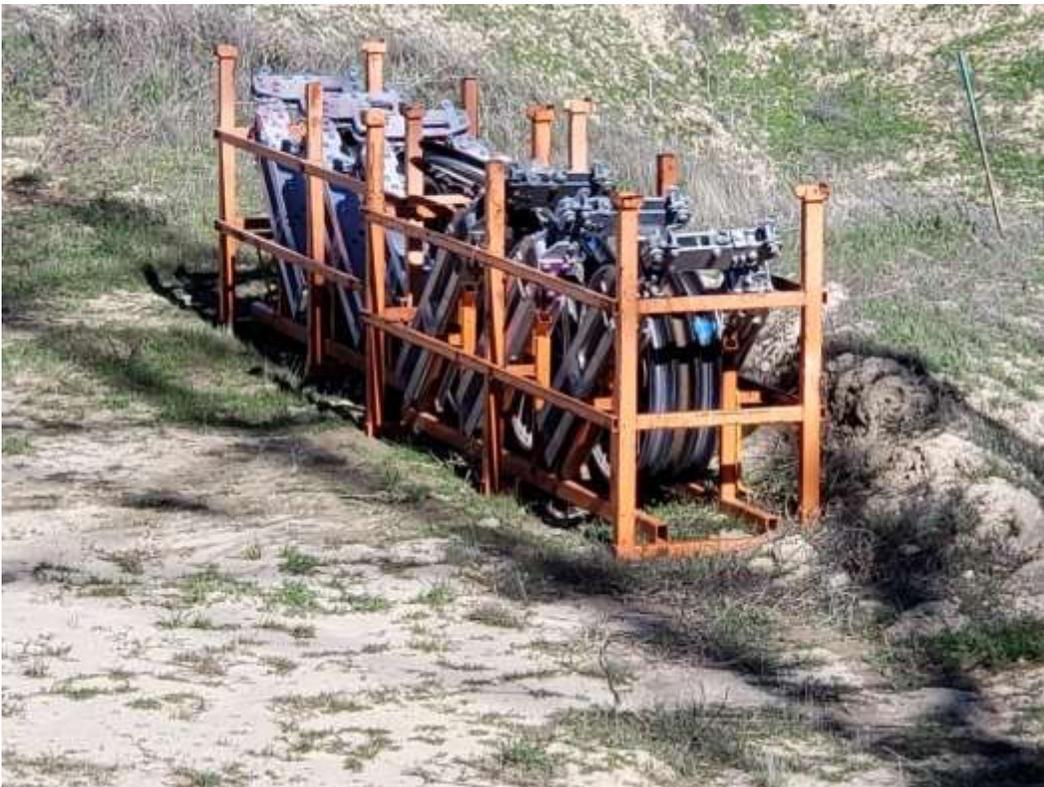
3. The CPUC EM noted that some equipment was delivered to Segment 3 Site 3X22 with uncovered holes (see Photo 4). Per Mitigation Measure WIL-1b, all pipes or other construction materials or supplies will be covered or capped in storage or laydown areas in order to prevent wildlife entrapment. The observation was reported to SCE.

Photo 4 – Uncovered holes potentially creating a wildlife entrapment hazard near Site 3X22, Segment 3. These were reported to SCE and the pipe ends were covered.

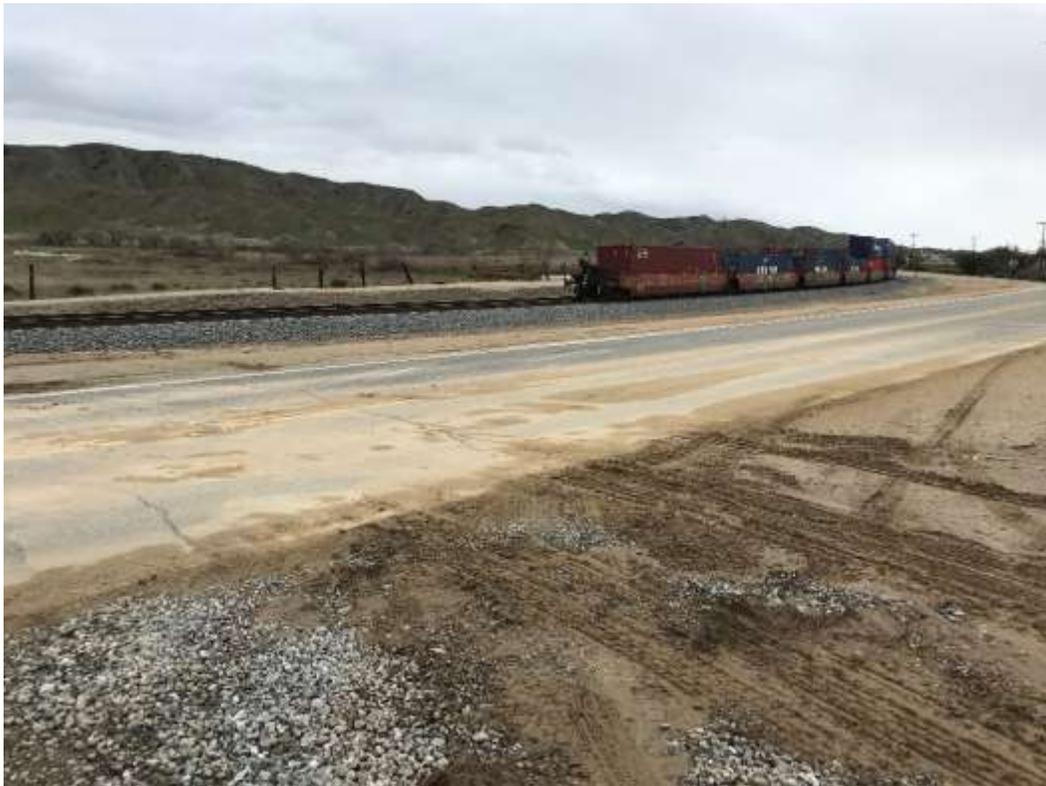
6. Track out and maintenance of the stabilized construction entrance was observed by the CPUC EMs on January 15 (see Photo 5). The issues were reported to SCE. A street sweeper was dispatched to the location and additional rock was added to the entrance.

Photo 5 – Track out onto San Timoteo Canyon Road and the stabilized construction entrance to Site3X22, Segment 3. A sweeper was dispatched to clean up the street and maintenance of the stabilized entrance included addition of more rock.
