PROJECT MEMORANDUM
SCE WEST OF DEVERS UPGRADE PROJECT

Date: February 26, 2019
To: John Forsythe, Project Manager, CPUC
From: Vida Strong, Aspen Project Manager
Subject: Monitoring Report #51: February 10 to February 16, 2019

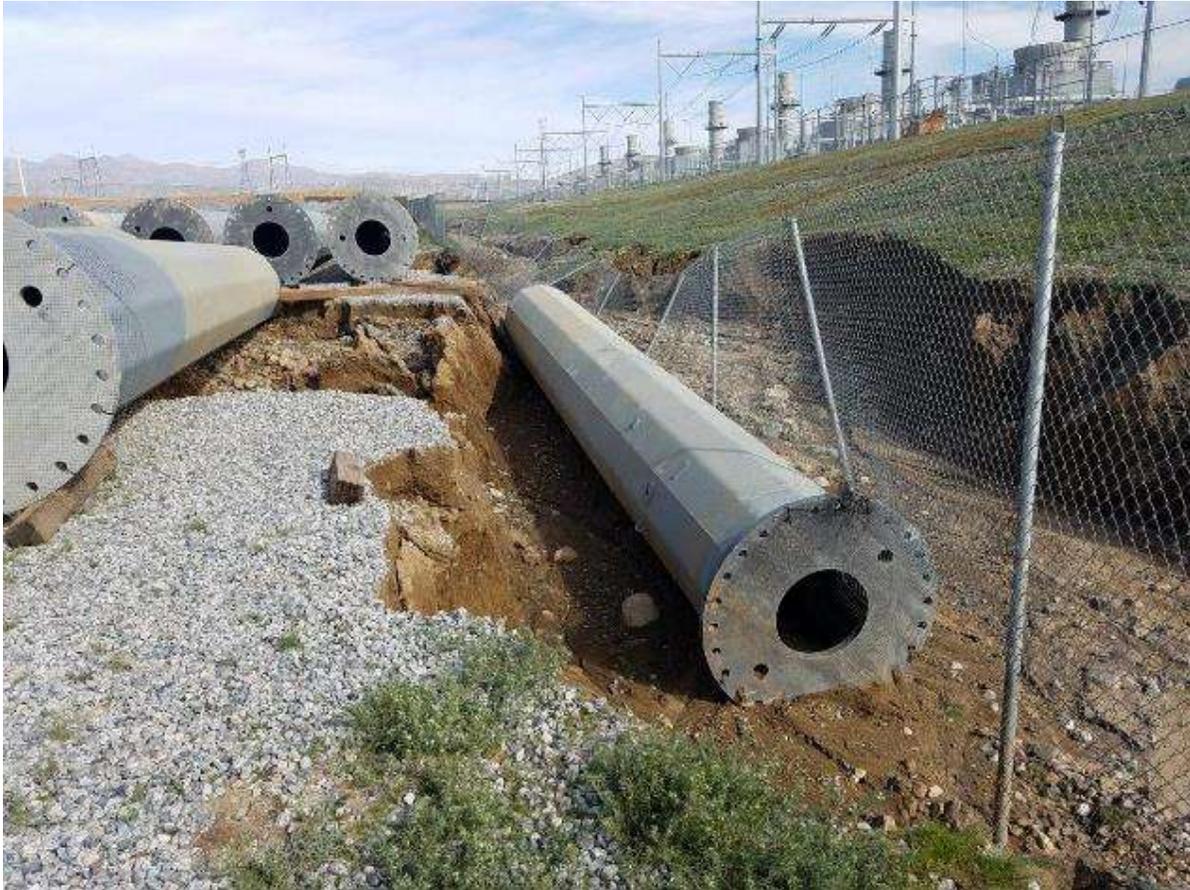
Photo 1 – TSP slid off cribbing and into unapproved drainage along east fence of Devers MY (February 15, 2019) (photo courtesy of SCE).

1. There was one SCE self-reported incident and no CPUC incidents documented for construction activities associated with NTP #1 throughout the monitoring period. On February 15, the SCE Biological Monitor observed a tubular steel pole (TSP) that had slid outside of approved work limits due to saturated conditions at the Devers MY (see Photo 1). The TSP entered a jurisdictional feature immediately adjacent to the eastern fence line of the material yard. SCE reported that no impacts to sensitive resources were identified as a result of this incident.

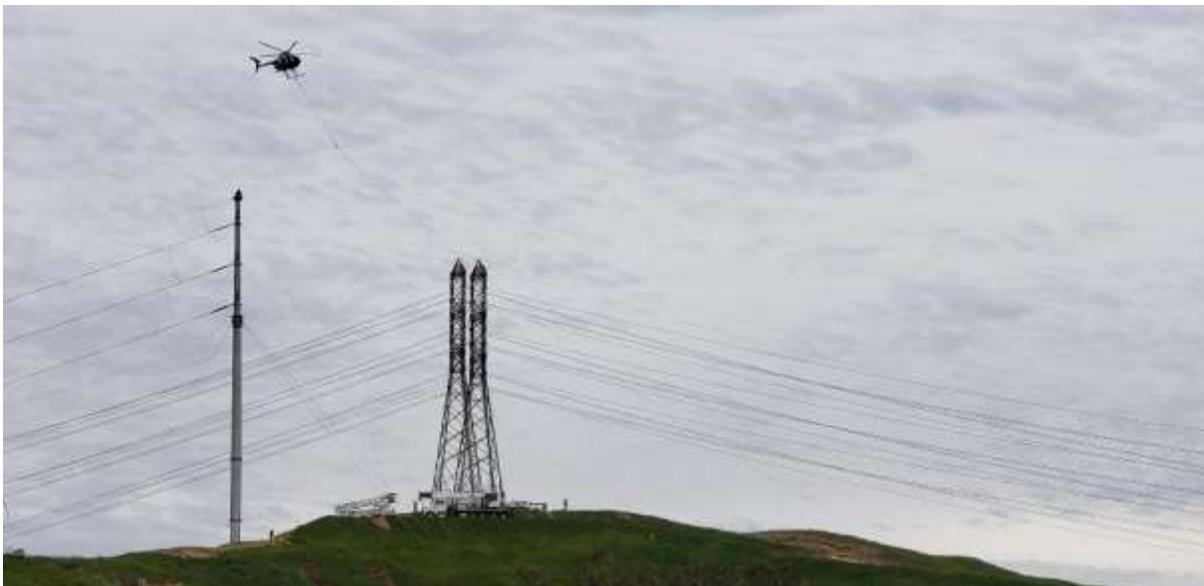
Photo 2 – Wire stringing activities between Site 3N02 and El Casco Substation (Segment 3; February 12, 2019).

3. Work associated with Segment 2 included installation of BMPs at Sites 2X10, 2X11, and 2X12.
4. Work associated with Segment 3 included access road grading/maintenance at numerous locations along the alignment. Vegetation removal was conducted at Sites 3X31 and 3X40. Grading activities were performed at Sites 3N03, 3N04, 3X03, 3X32, 3X40, 3X42, 3X64, and 3X65. Drilling operations were conducted at Sites 3N03, 3N04, 3X06-07, 3X33, 3X37, 3X38, and 3X63. Activities associated with wreck-out of existing towers occurred at Sites 3X13, 3X14, 3X16, 3X17, and 3X24 through 3X29. Tower assembly occurred at Sites 3N02, 3N03, 3N04, 3S04, 3X06-07, 3X14, 3X29, 3X55, 3X57, 3X59, and 3X61. Wire stringing activities were conducted at Site 3N02 (see Photo 2).

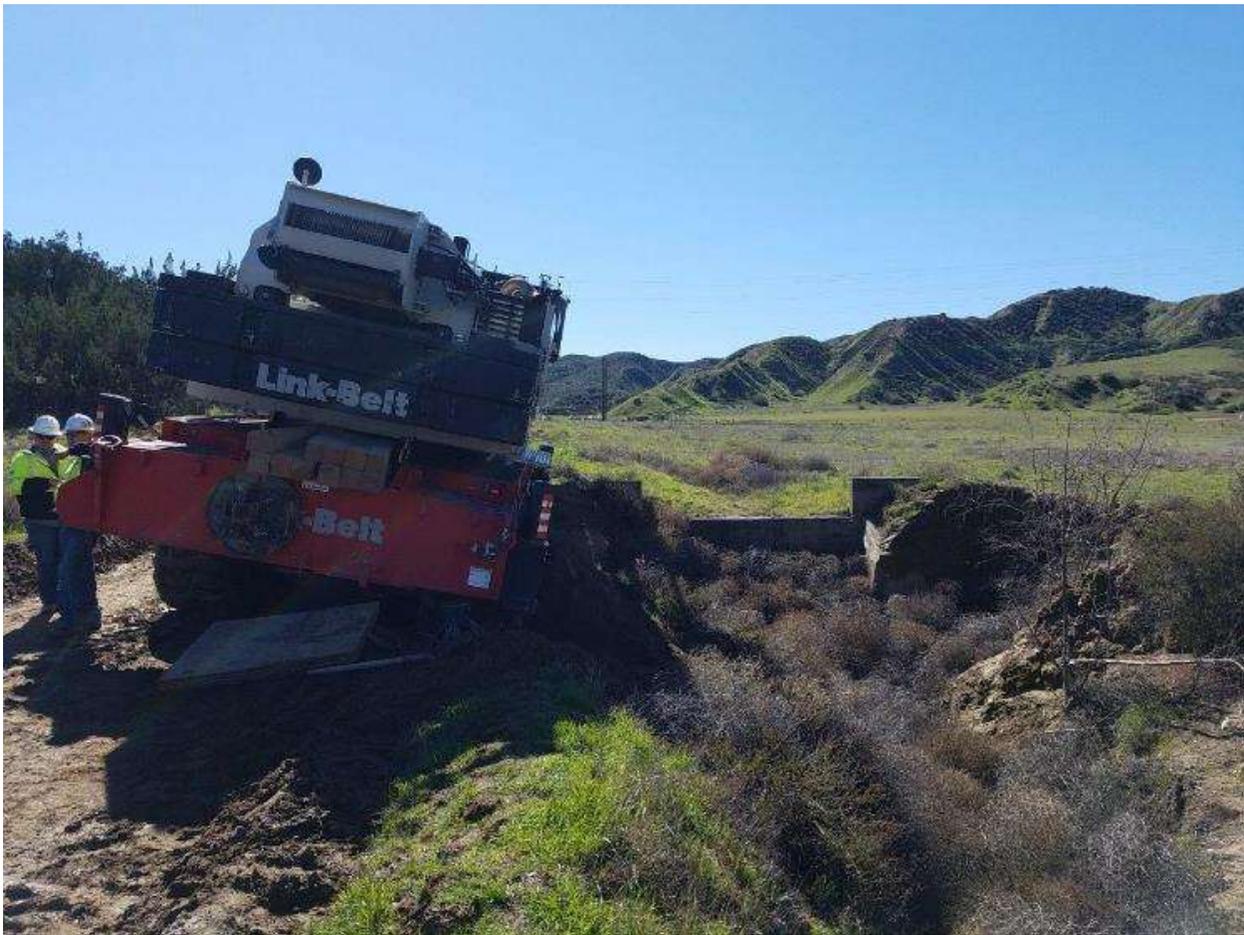
Photo 3 – Crane slid off access road to Site 3X06-07 into an unapproved area (Segment 3; February 11, 2019) (photo courtesy of SCE).

1. Two SCE self-reported compliance incidents and two CPUC compliance incidents were documented for construction activities associated with NTP #4 during the monitoring period. On February 11, the SCE Biological Monitor observed a project crane that had slid off the access road to Site 3X06-07 and into an unapproved area (see Photo 3). In order to safely extract the crane, equipment was staged in an additional unapproved area adjacent to the location of the incident. According to SCE, no sensitive resources were impacted and the affected areas were recorded using a Trimble instrument; however, the quantity of impacted area was not included in SCE's Incident Report. On February 12, the SCE Biological Monitor and CPUC Lead Compliance Monitor observed excess fugitive dust generated by project vehicles along the access road to Site 3X06-07. On February 12, the CPUC Lead Compliance Monitor and CPUC Compliance Monitor observed offsite sediment discharge into a jurisdictional feature along the access road to Site 3X06-07 at a low point in the shoulder where recent grading, dewatering, fill import had occurred (see Photo 4). The incident was relayed to the SCE Biological Monitor; however no self-reported incident was generated. Additional BMPs were installed at the location by the end of the day, but had been overwhelmed by sediment laden water during a subsequent observation by the CPUC Monitors on February 14.

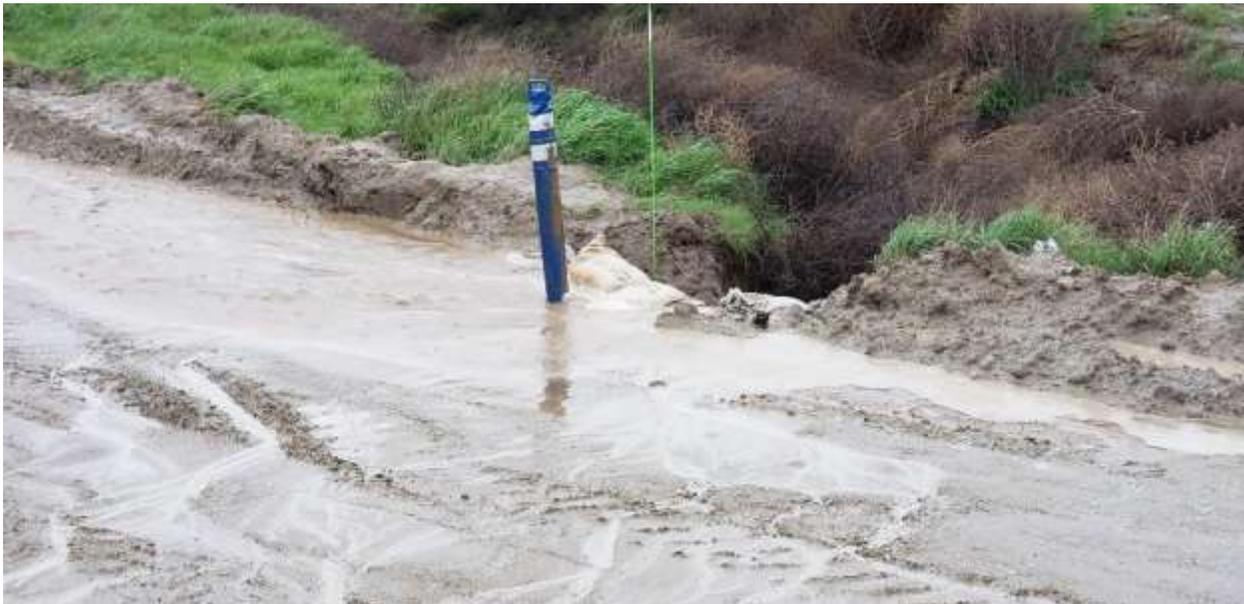
Photo 4 – Offsite sedimentation into jurisdictional feature along the access road to Site 3X06-07 (Segment 3; February 14, 2019).

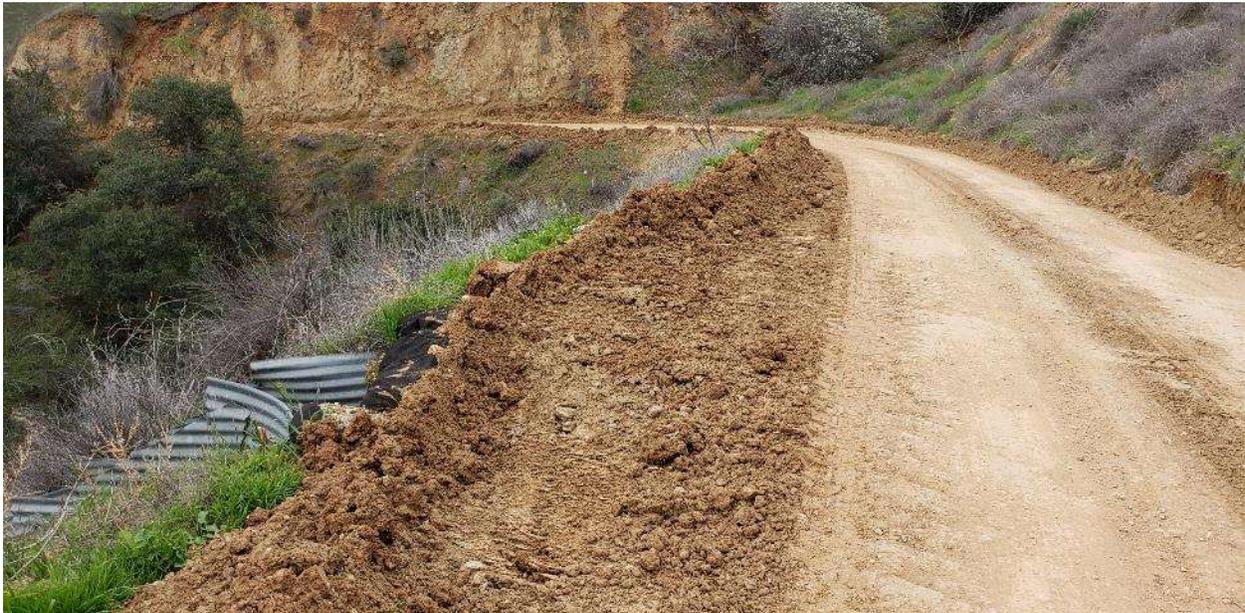
Photo 5 – MacCarthy drain blocked as a result of grading along Segment 3 access road (Segment 3; February 13, 2019).

2. The CPUC EM noted locations along Segment 3 where access road grading had resulted in the blockage of MacCarthy drains and notified SCE (see Photo 5). Subsequently, the drains were cleared by construction crews.

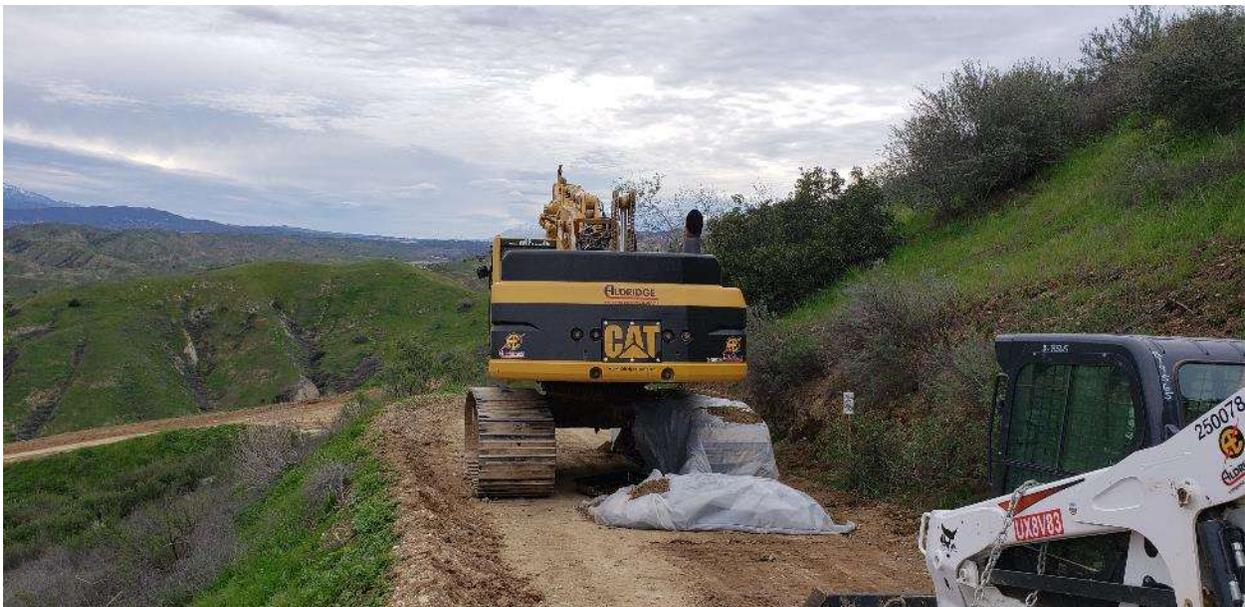
Photo 6 – Tracks of excavator covered to contain hydraulic fluid as a result of a reportable spill along the access road between Sites 3X37 and 3X38 (Segment 3; February 13, 2019).

6. One reportable (> 1 gallon) and two non-reportable (< 1 gallon) spills associated with NTP #4 were identified during the monitoring period. According to SCE's Spill Report, the reportable spill occurred along the access road between Sites 3X37 and 3X38 and consisted of approximately 1.5 gallons of hydraulic fluid (see Photo 6). Contaminated soils were contained and removed offsite. According to SCE's Spill Reports, the two non-reportable spill occurred at Sites 3X38 and 3X39 and consisted of approximately 4 pints and one-half gallon of hydraulic fluid. Contaminated soils were contained and removed offsite.
