**PROJECT MEMORANDUM**  
**SCE WEST OF DEVERS UPGRADE PROJECT**

**Date:** March 1, 2019  
**To:** John Forsythe, Project Manager, CPUC  
**From:** Vida Strong, Aspen Project Manager  
**Subject:** Monitoring Report #52: February 17 to February 23, 2019

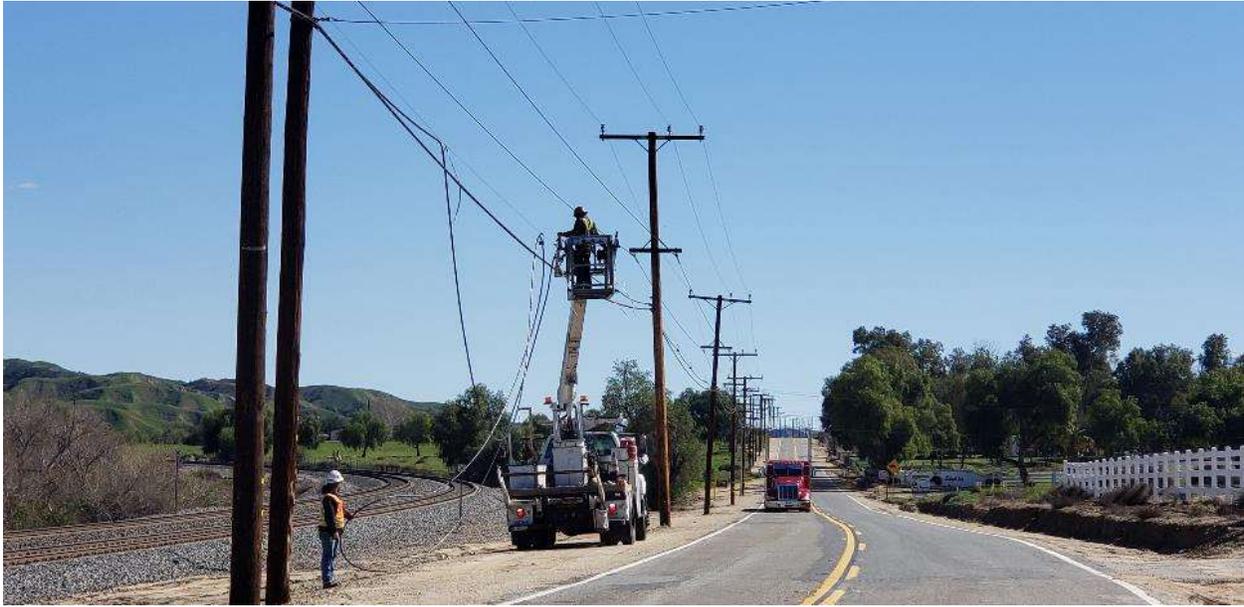
Photo 1 – SCE crew installing telecom fiber along San Timoteo Canyon Road for the El Casco Connection (February 19, 2019).

3. Telecom work associated with the El Casco Connection included installation and clipping of fiber optic line along San Timoteo Canyon Road (see Photo 1).
4. As of the closing of this monitoring period, the construction progress of components associated with NTP #3 is as follows:
  - For distribution components, all 19 12-kV poles have been framed, all 12 12-kV underground vaults have been installed, and 7430 feet of 12-kV duct bank (conduit) and 10,670 feet of 12-kV conductor wire has been installed.
  - For subtransmission components, 119 of 119 66-kV LWTSPs have been erected, 19 of 19 TSPs have been erected, and 25,610 feet of 66-kV wire has been installed. Both the Timoteo and Tennessee circuits have been energized. Wreck-out of the existing subtransmission infrastructure is underway.

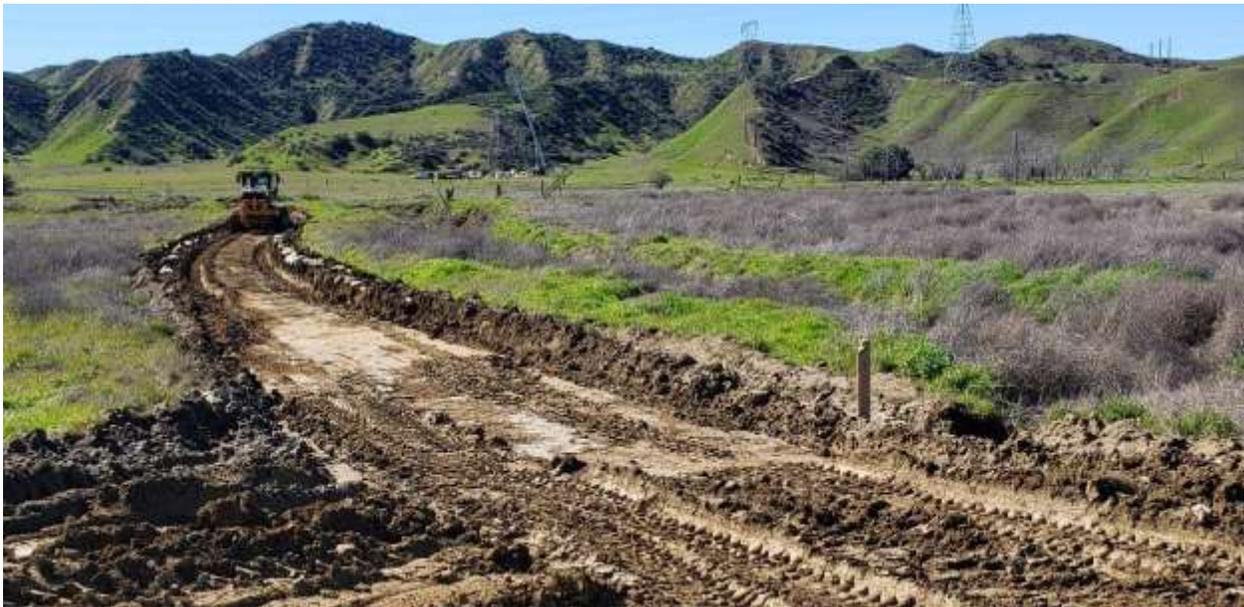
Photo 2 – Access road grading along Segment 3 (February 19, 2019).

4. Work associated with Segment 3 included access road grading/maintenance at numerous locations along the alignment (see Photo 2). BMP installation occurred at Sites 3X48 and WSS-3-MPR-24. Vegetation removal was conducted at Sites 3X31, 3X40, 3X53, 3X64, 3X65, and WSS-3-MPR-24. Grading activities were performed at Sites 3X31, 3X32, 3X39, 3X40, 3X42, 3X43, 3X44, 3X53, 3X64, and 3X65 (see Photo 3). Foundation installations were conducted at Sites 3X33, 3X35 thru 3X41, 3X62, and 3X64. Tower assembly occurred at Sites 3N03, 3N04, 3X06-07, 3X39, 3X41, 3X51, 3X57, 3X59, 3X62, and 3X63. Tower removal activities were performed at Sites 3X06-07, 3X08, 3X10, 3X12, 3X13, 3X14, 3X16, 3X17, and 3X65. Wire stringing activities were conducted between El Casco Substation and Site 3X10.

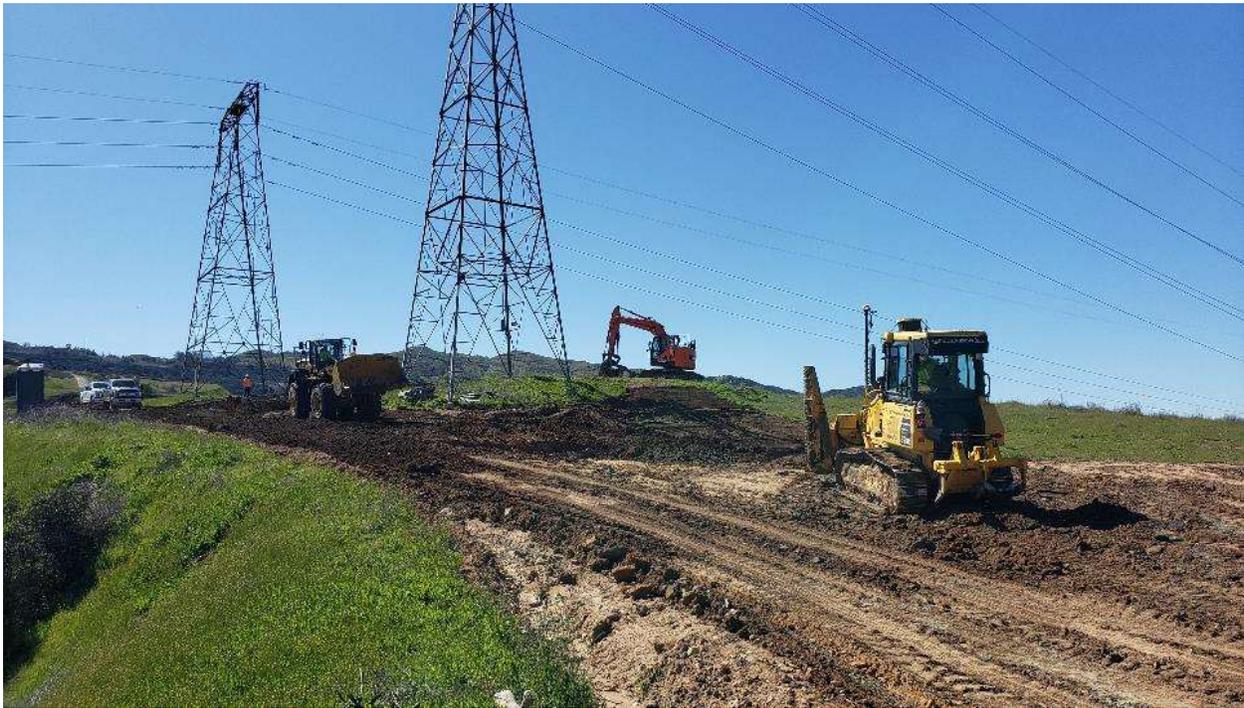
Photo 3 – Grading at Site 3X40 (Segment 3; February 19, 2019).

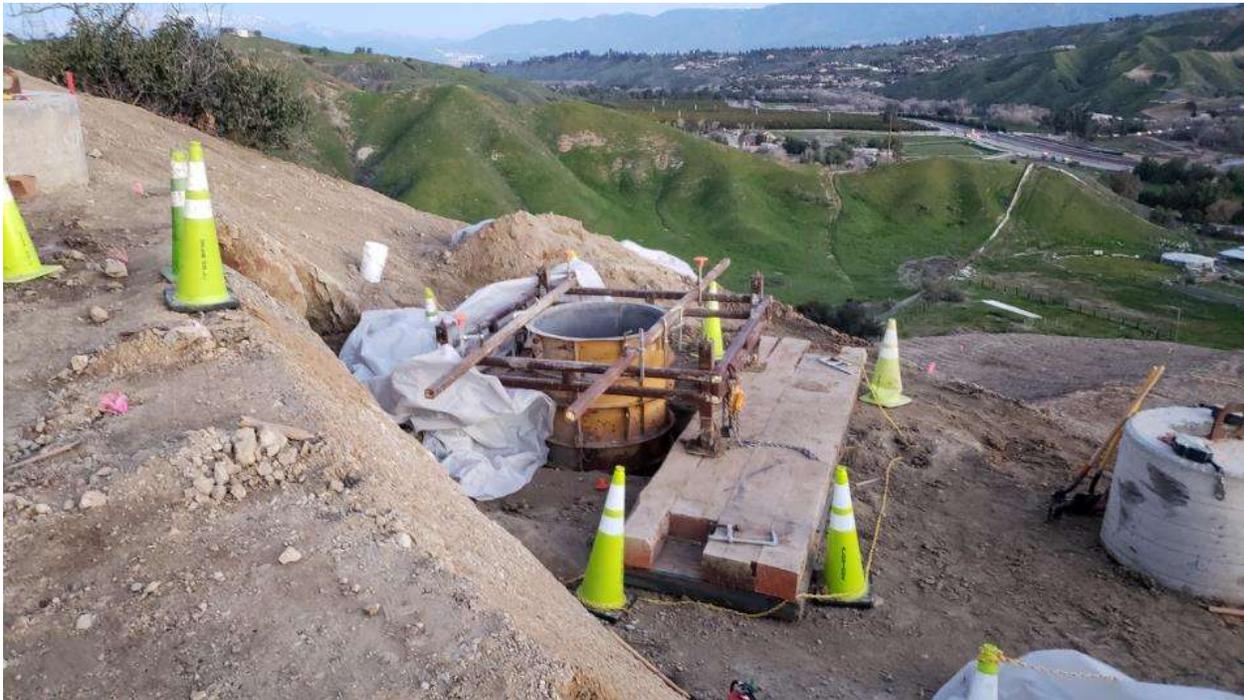
1. One SCE self-reported compliance incident and no CPUC compliance incidents were documented for construction activities associated with NTP #4 during the monitoring period. On February 19, the SCE Biological Monitor observed four foundation excavations that were uncovered, increasing the risk of wildlife entrapment at Site 3X37 (see Photo 4). According to SCE, the excavations had been covered the previous day, but high winds caused them to blow off overnight. SCE's Weekly Compliance Report states that the issue was relayed to construction management and discussed with crews at subsequent tailboard meetings.

Photo 4 – Uncovered foundation excavations observed at Site 3X37 by SCE Biological Monitor (Segment 3; February 19, 2019) (photo courtesy of SCE).

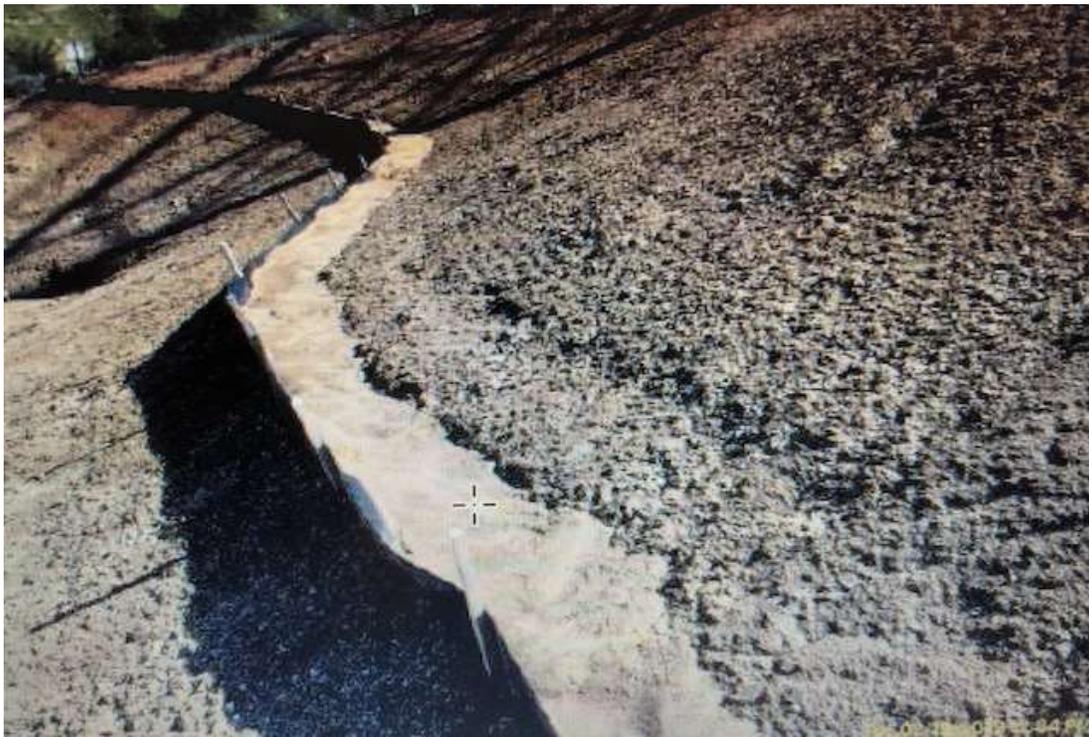
4. Eleven SWPPP maintenance items were presented in the SCE Weekly Compliance Report associated with NTP #4 during the monitoring period. These items were recorded in Segments 3 and 4, and included the removal of excess sediment accumulated on BMPs, excessive trackout, and the repairs of erosion damage at work sites (see Photos 5 and 6). According to SCE's Weekly Compliance Report, seven of the issues had been resolved at the time of this report. As of the closing of the monitoring period, because of site accessibility issues, there are four overdue SWPPP maintenance items or corrective actions associated with NTP #4.

Photo 5 – Excess sediment accumulating along BMPs at Site 3X21 (Segment 3; February 19, 2019) (photo courtesy of SCE).

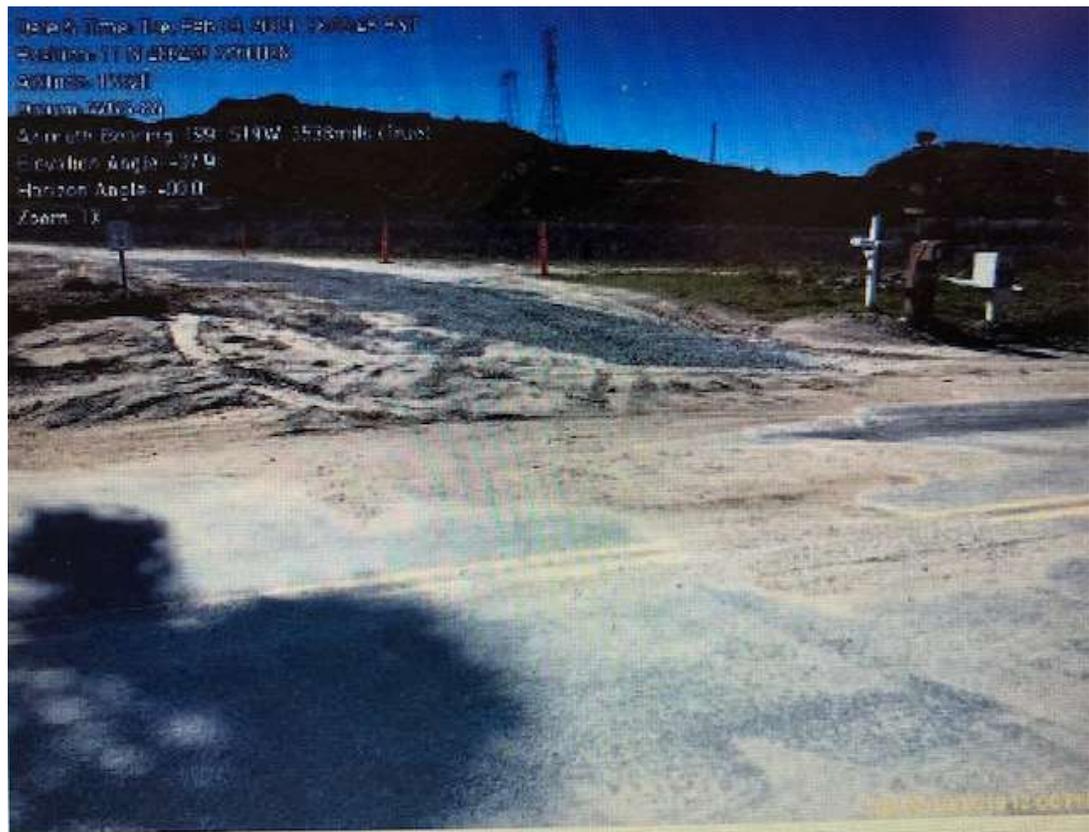
Photo 6 – Excessive trackout along San Timoteo Canyon Road near Site 3X22 reported by SCE (Segment 3; February 19, 2019) (photo courtesy of SCE).
