PROJECT MEMORANDUM
SCE WEST OF DEVERS UPGRADE PROJECT

To: John Forsythe, Project Manager, CPUC
From: Vida Strong, Aspen Project Manager
Date: July 18, 2019
Subject: Monitoring Report #71: June 30 to July 13, 2019

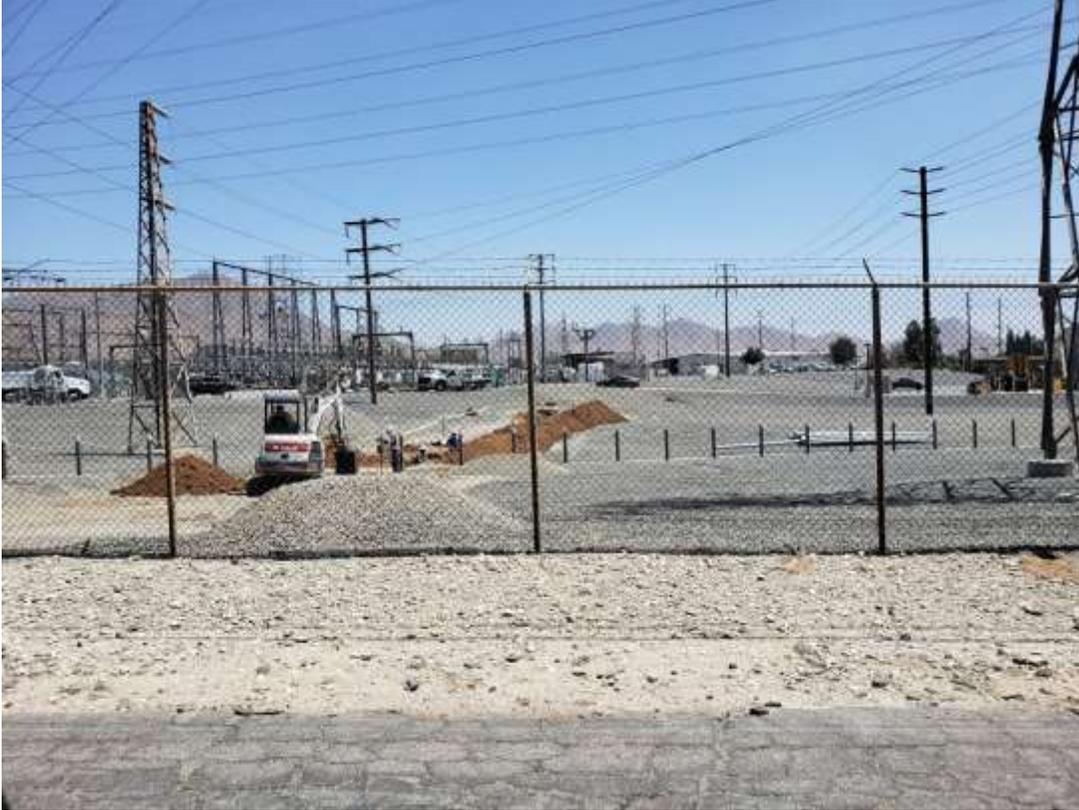
Photo 1 – Trenching activities at the Vista Substation (July 9, 2019).

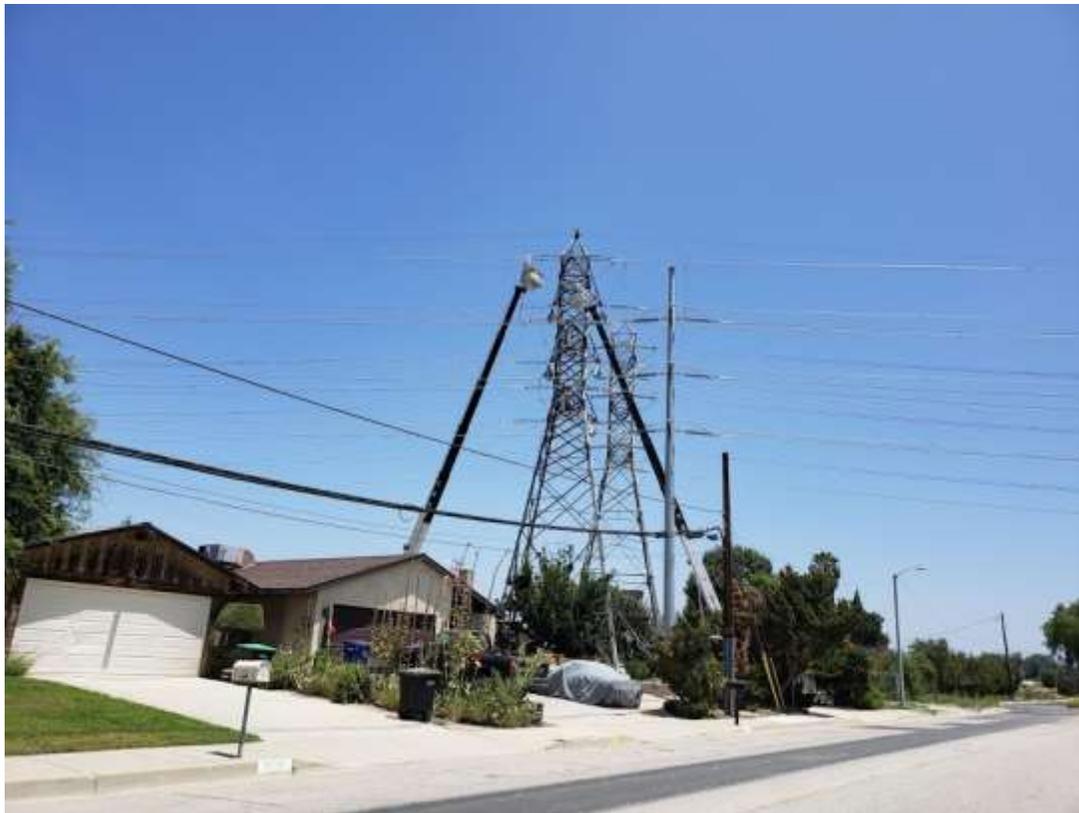
Photo 2 – Wire stringing activities on Segment 1 (July 9, 2019).

2. Work associated with Segment 1 during the monitoring period included: Climbing guard installation at Construction Areas 1X03 and 1X06; and wire pulling activities at Construction Areas 1X03 through 1X25 and associated wire stringing sites (see Photo 2).

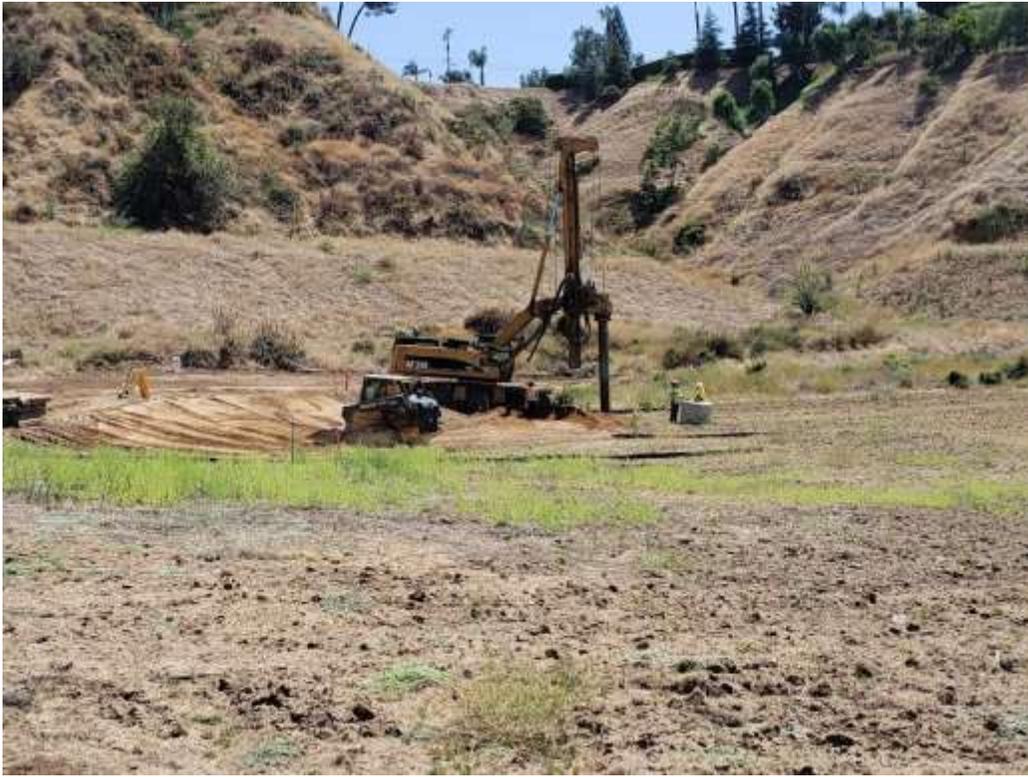
Photo 3 – Foundation activities on Segment 2 (July 10, 2019).

3. Work associated with Segment 2 included: Vegetation clearing and grading at Construction Areas 2N01, 2X18, and 2X22; grading and soil import at Construction Area 2X32; soil export at Construction Area 2X22; potholing at Construction Area 2X30; foundation work at Construction Areas 2X18, 2X20, 2X29, and 2X30 (see Photo 3); BMP installation and maintenance at Construction Areas 2X16, 2X17, and 2X22; and access road maintenance from Construction Areas 2X15 to 2X20 and 2X20 to 2X32.

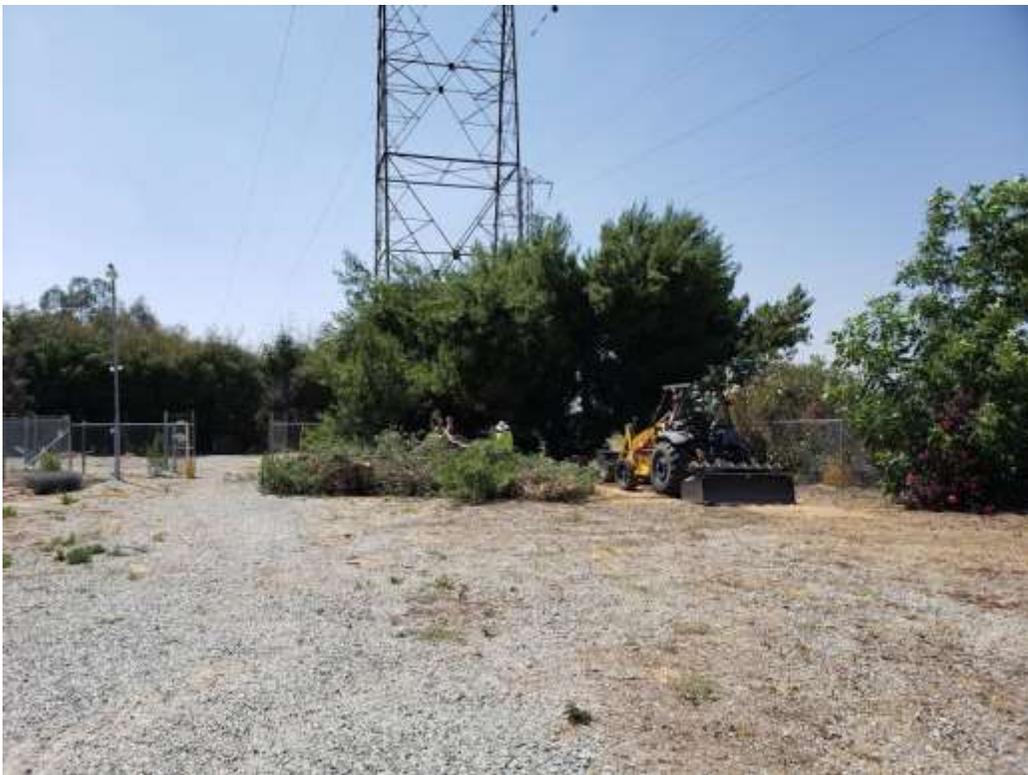
Photo 4 – Vegetation and fence removal on Segment 4 (July 8, 2019).

5. Work activities associated with Segment 4 included: BMP installation at Construction Areas 4X12-NE, 4X12, 4X13, 4X14, 4X15, 4X16, 4X17, PP123333, SR-4X17-4X18, 4X18, and M20-T3; vegetation trimming, fence and green waste removal at Construction Area 4X44 (see Photo 4); grading at Construction Areas 4X42 and 4X43; and hydroseed watering at Construction Areas 4N59, 4N60, 4N61, and 4N63.

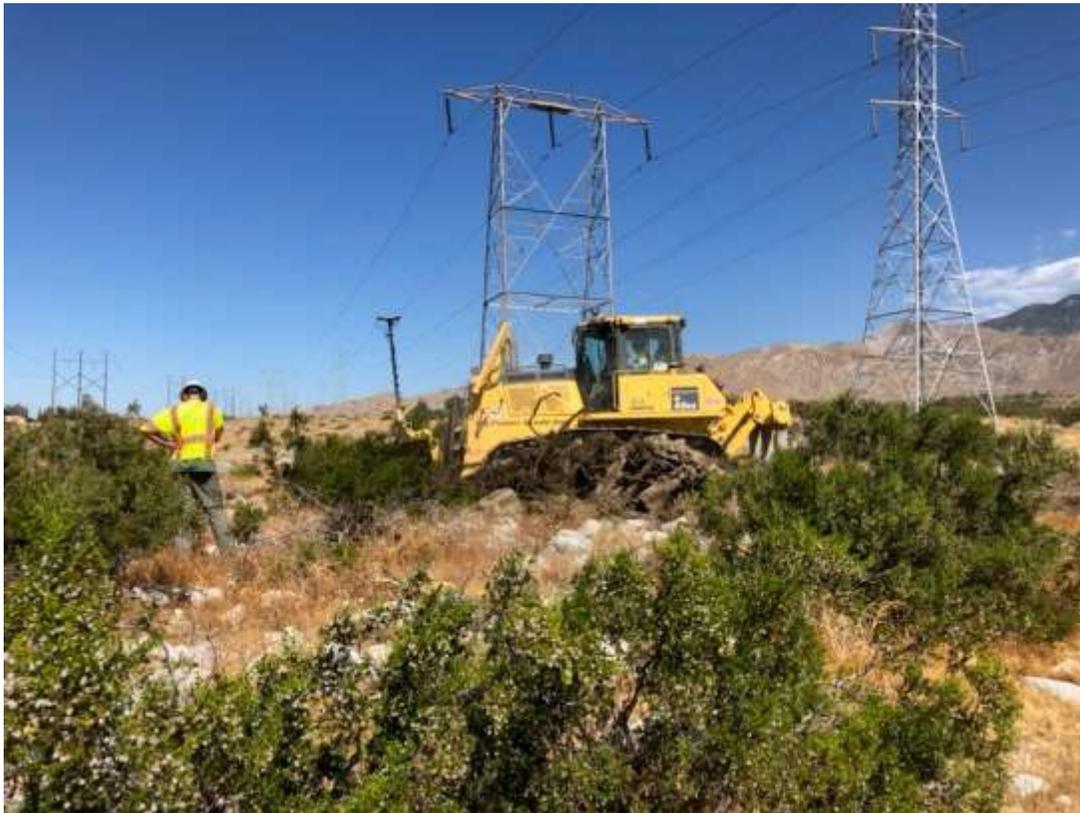
Photo 5 – Vegetation clearing and grading on Segment 6 (July 11, 2019).

7. Work associated with Segment 6 (non-BLM lands) included: Grading and soil import at Construction Areas 6S28-S and 6S33; material export at Construction Areas 6S28-S, 6S33, 6S35, 6S36, 6S37, 6S40, 6X42, and 6X44; clearing, grubbing, and grading at Construction Areas 6S35, 6S36, 6S37, 6S39, 6S40, 6N43, 6S43, 6X44, and 6X45 (see Photo 5); foundation work at Construction Areas 6N26 and 6S28A; and road maintenance from Construction Area 6X29 to 6X31 and 6X40 to 6X43.

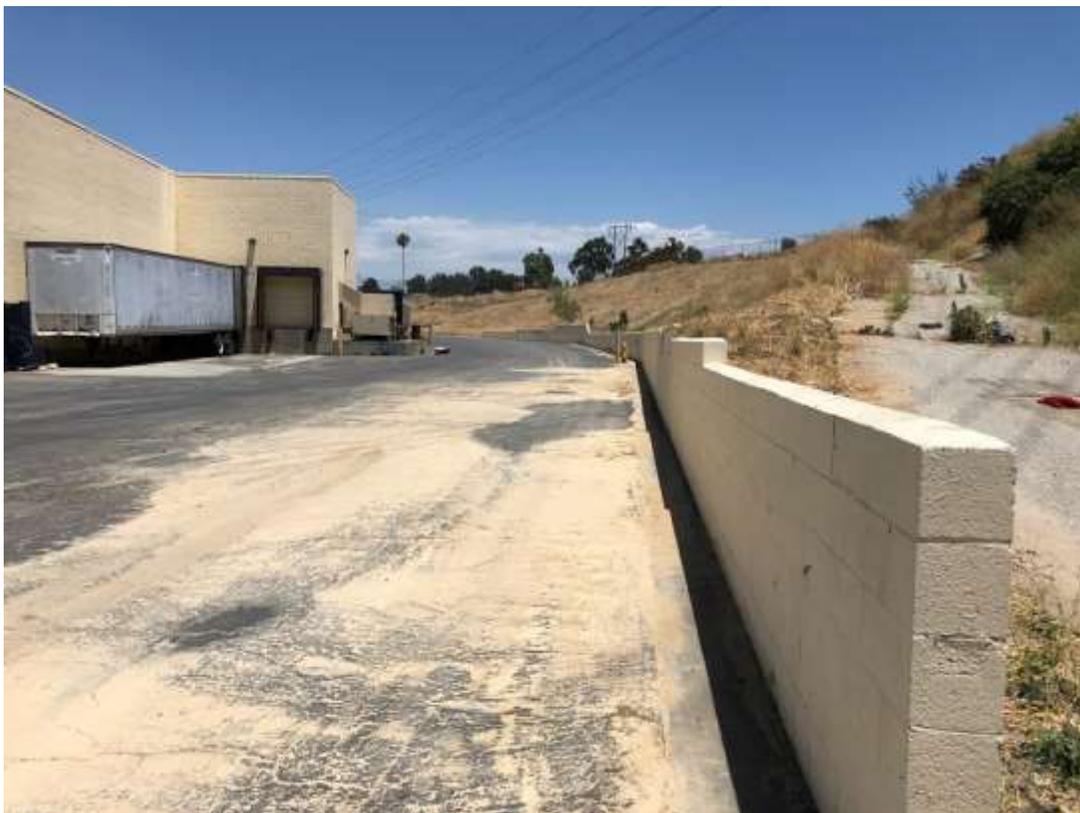
3. On July 11 during foundation excavations at Construction Area 2X30, the crew reached a depth of approximately 4-feet when the auger made contact with an unmarked portion of an 18-inch residential service water line. The crew had previously identified the USA Dig Alert markings and blue identification flags placed by the underground utility agency, which incorrectly identified the location of the underground waterline approximately 10-feet outside the radius of the planned drill hole. Once ruptured, the excavation overflowed onto the 2N30 work site, along an existing access road, and onto the south end of a paved shopping center parking lot. The construction crews contacted the water company to shut off the water, cleaned up the deposited sediment, and stabilized the site and access road (see Photo 6). The SWRCB and CDFW were notified of the discharge. The utility fixed the water line the same day and foundation excavations at Construction Area 2X30 are currently on hold until the foundation can be relocated to avoid the line.

Photo 6 – Sediment deposits from water line break at 2N30 prior to clean-up (July 11, 2019).
