PROJECT MEMORANDUM
SCE WEST OF DEVERS UPGRADE PROJECT

To: John Forsythe, Project Manager, CPUC
From: Vida Strong, Aspen Project Manager
Date: October 3, 2019
Subject: Monitoring Report #82: September 23 to September 29, 2019

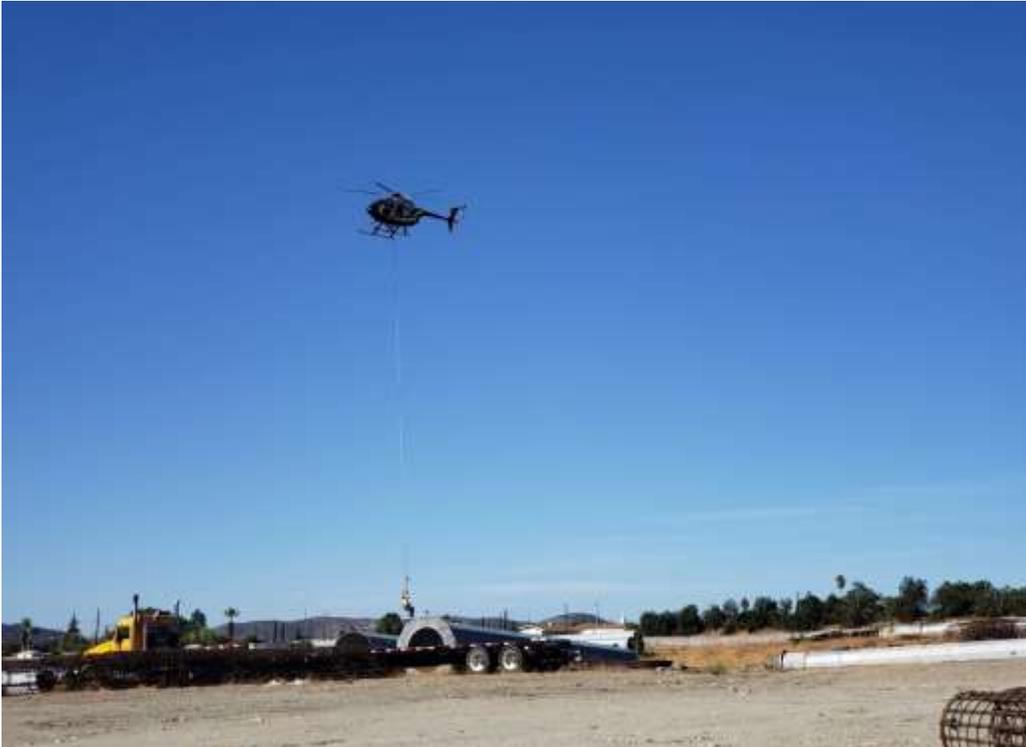
Photo 1 – Helicopter activities within the Match MY for wire stringing on Segment 5 (September 24, 2019).

3. The Matich MY is being utilized by Barnard Construction primarily for tubular steel pole (TSP) storage. Work associated with the Matich MY included material/equipment deliveries throughout the monitoring period. Helicopter operations occurred out of the Matich Yard throughout the monitoring period (see Photo 1).

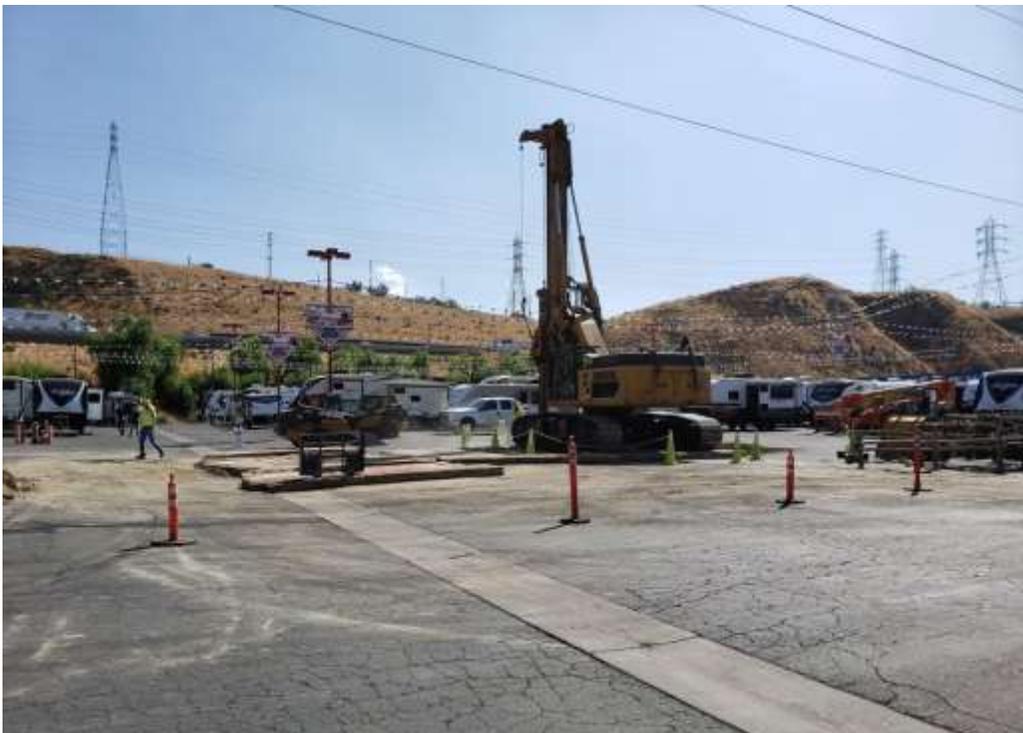
Photo 2 – Foundation drilling at Construction Area 2N34, Segment 2 (September 23, 2019).

2. There were no work activities associated with Segment 1 during the monitoring period.
3. Work associated with Segment 2 included: Foundation activities at Construction Areas 2X33, 2X34 (see Photo 2), 2X35, and 2X36; and BMP maintenance at 2X30 and 2X32.

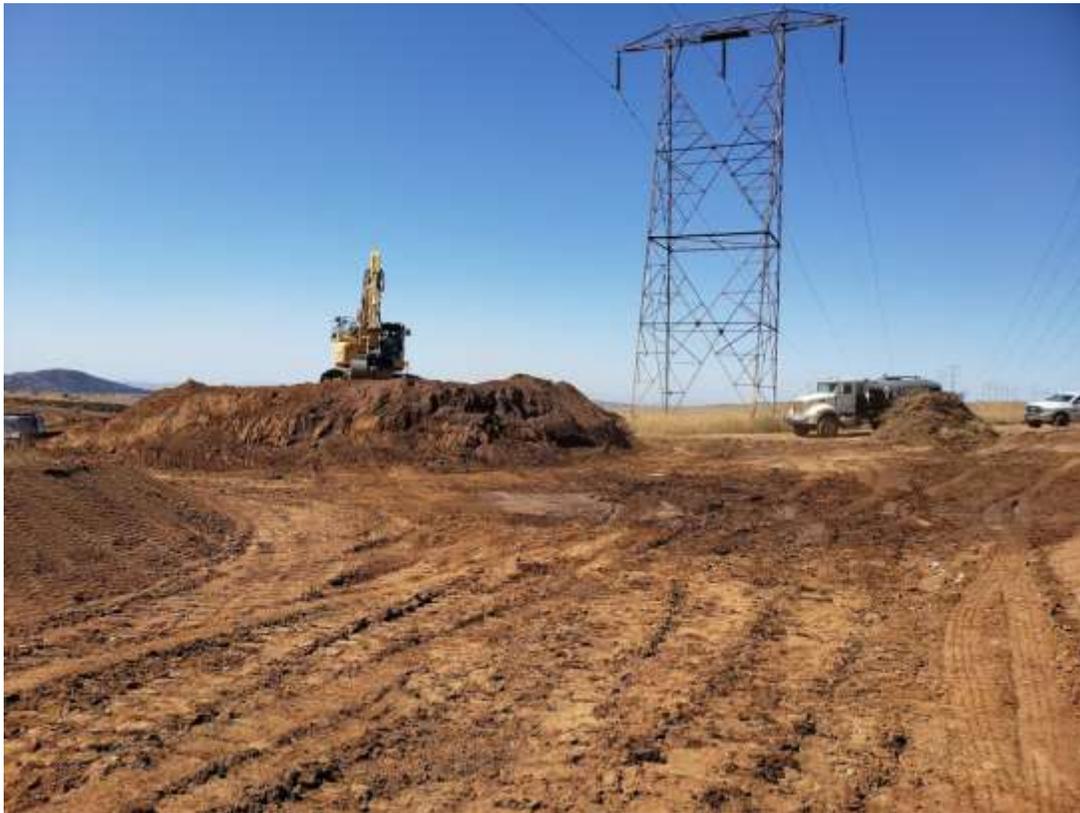
Photo 3 – Grubbing and grading activities at Construction Area 4X06, Segment 4 (September 23, 2019).

5. Work associated with Segment 4 included: Vegetation clearing at Construction Areas 4X07, and 4X14 through 4X17; grubbing and grading at Construction Areas 4X05 through 4X09 (see Photo 3), 4X14, 4X15, 4X18, 4X19, and 4X32; BMP installation at Construction Areas 4X05 through 4X09; material export from Construction Area 4X50 to 4X32; and hydroseed watering at Construction Areas 4N59, 4N60, 4N61, and 4N63.

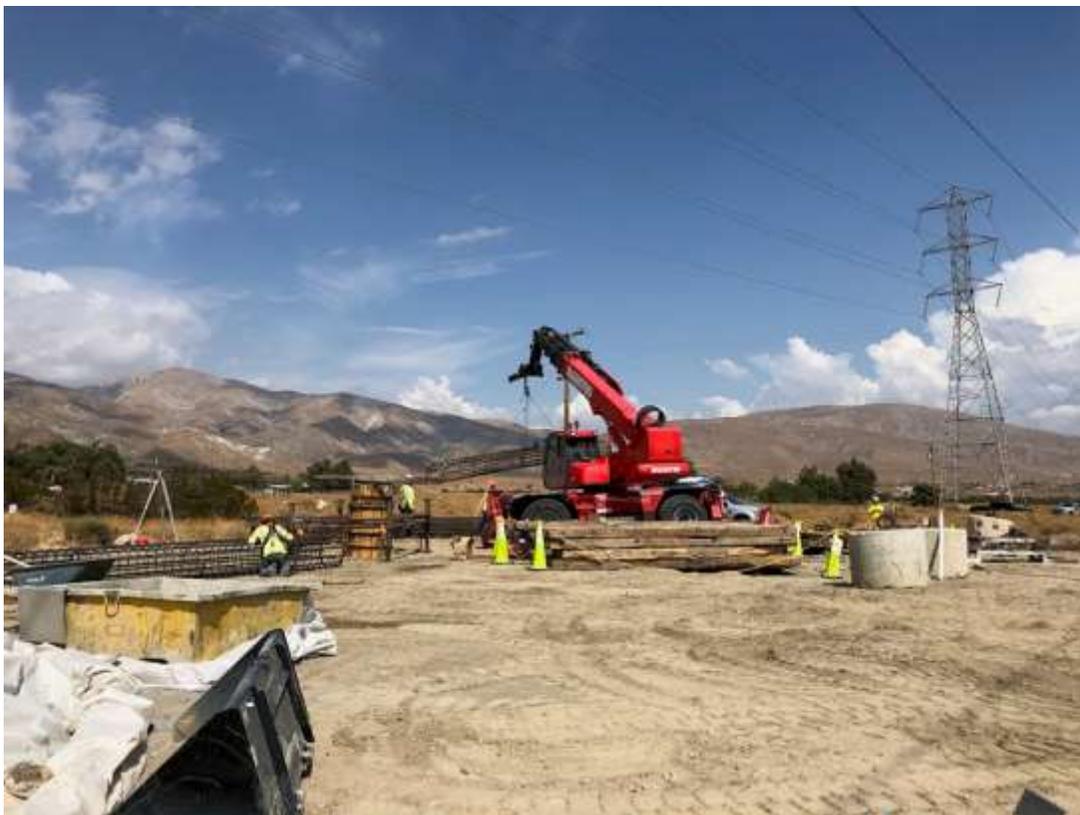
Photo 4 – Foundation concrete pour preparation at Construction Area 6X46, Segment 6 (September 26, 2016).

7. Work associated with Segment 6 (non-BLM lands) included: Foundation activities at Construction Areas 6X12, 6X13, 6X41 through 6X44, 6X46, and 6X47 (see Photo 4); foundation removal at Construction Areas 6N09 and 6N27; tower assembly at Construction Areas 6X15 through 6X23 and 6S27; BMP maintenance at Construction Areas WSS-6 -6S26-MPR-29 and 6X45; and slurry export from Construction Areas 6S36 and 6S37.

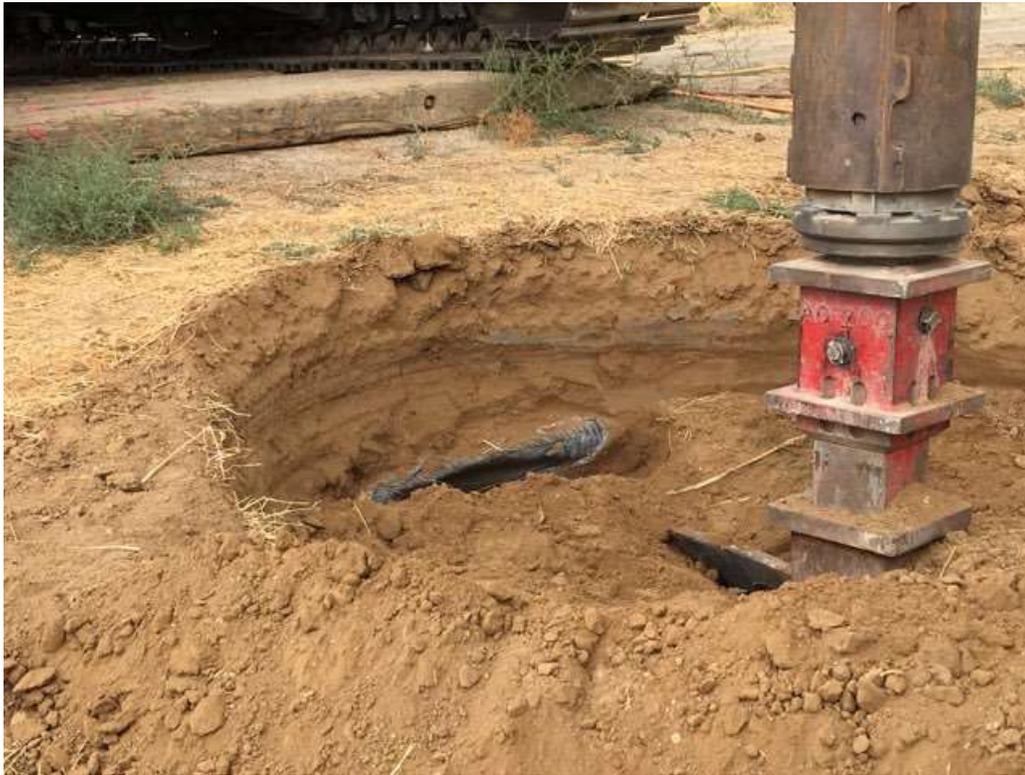
8. On September 27, an underground utility strike occurred on Segment 2 at Construction Area 2N36 during drilling activities (see Photo 5). The strike happened about 2 feet below ground and it was determined to be an abandoned water pipe and telecom line. There were no injuries and no fluid leaked from the pipe. Blue Stake Utilities will be verifying the location of the abandoned lines before further drilling activities can proceed.

Photo 5 – Utility strike at Construction Area 2N36, Segment 2 (September 27, 2019)
(Photo courtesy of SCE).

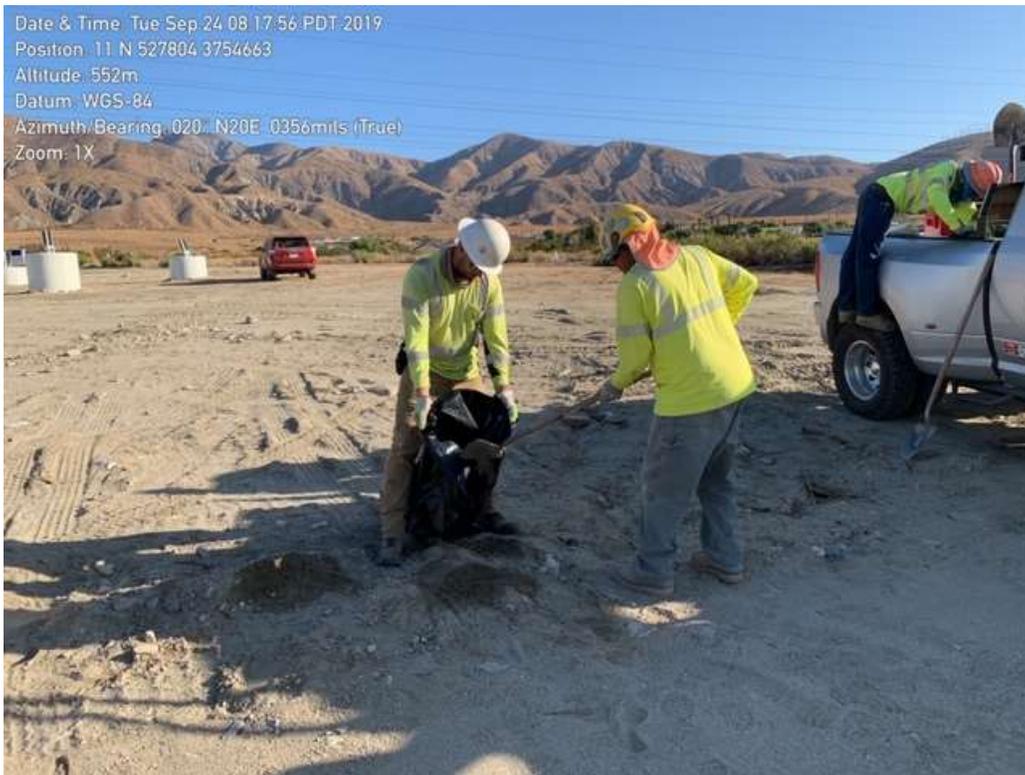
10. There was one reportable (>1 gallon) and no non-reportable (<1 gallon) spills associated with NTP #4 identified during the monitoring period. On September 24, a spill was identified at Construction Area 6S42, although it was unclear whether the spill was project-related or not. Construction crews cleaned up the spill by collecting impacted soils into an ECO pan and hauling it to the Beaumont 2 MY for disposal at an SCE approved facility (see Photo 6).

Photo 6 – Spill cleanup at Construction Area 6S42, Segment 6 (September 24, 2019)
(Photo courtesy of SCE).
