PROJECT MEMORANDUM
SCE WEST OF DEVERS UPGRADE PROJECT

To: John Forsythe, Project Manager, CPUC
From: Vida Strong, Aspen Project Manager
Date: November 14, 2019
Subject: Monitoring Report #88: November 4 to November 10, 2019

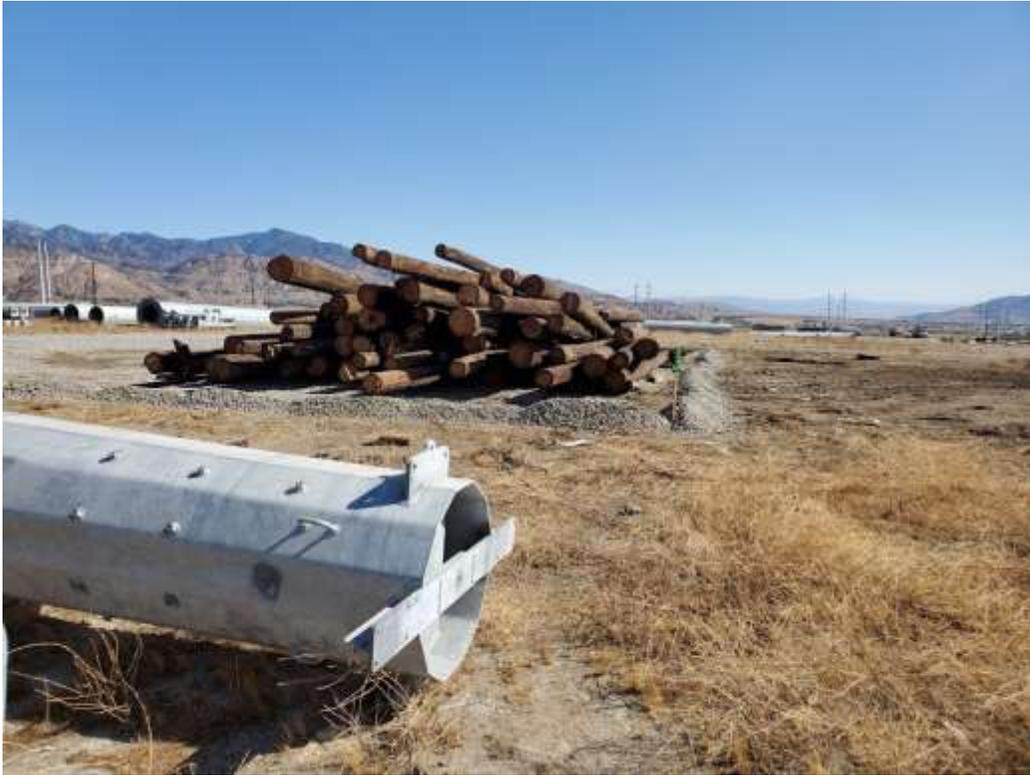
Photo 1 – Treated wood poles on cribbing with rock berm at Match MY (November 12, 2019).

Level 1 Incident	SWPPP	09-25-19	Segment 6	The disposal of slurry at tower sites in Segment 6.
Level 1 Incident	SWPPP	10-22-19	Devers, Match, and Poultry MY	Improper storage of treated wood poles.

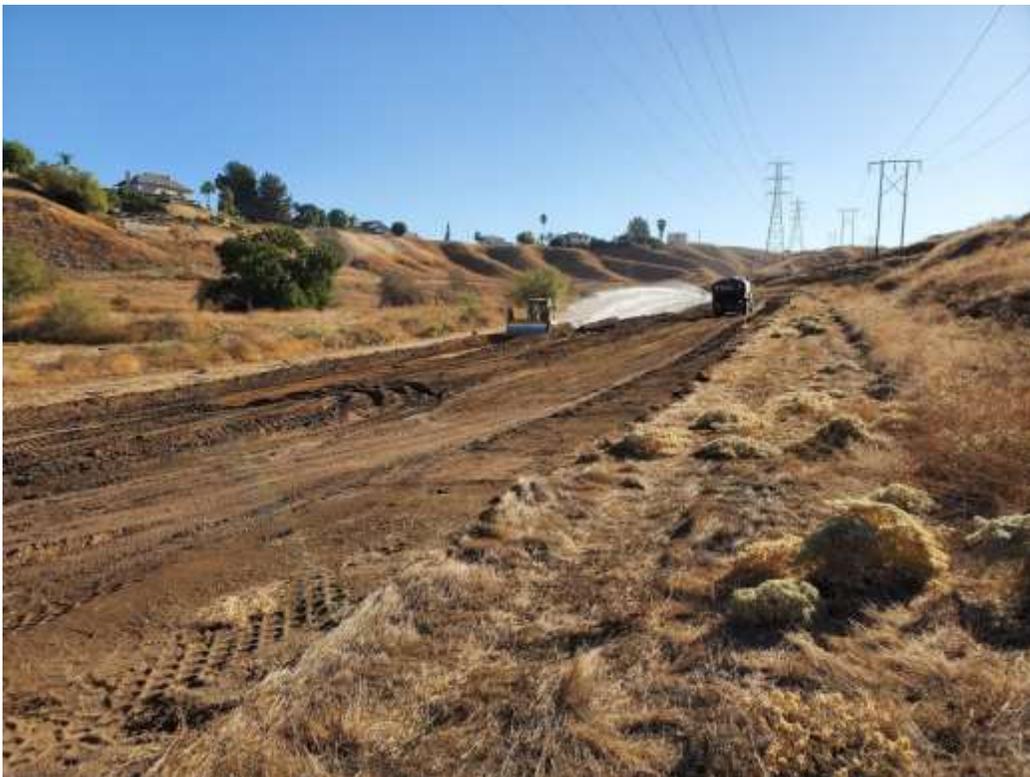
Photo 2 – Grading activities at WSS-2-2N26-1-MPR-28, Segment 2 (November 5, 2019).

2. There were no work activities associated with Segment 1 during the monitoring period.
3. Work associated with Segment 2 included: Tower assembly at Construction Areas 2N12 and 2N22; vegetation clearing and grading at Construction Areas WSS-2N14-1-MPR-31, WSS-2N14-2-MPR-31, WSS-2-2N26-2-MPR-28, and 2N32 (see Photo 2); BMP maintenance at Construction Area 2N32; grounding installation at Construction Areas 2N01, 2N22, and 2N36 through 2N38 (see Photo 3); wire wreck-out activities at Construction Areas 2N01 through 2N14; and installing anchors and guard structures at Construction Areas GS-2-W-2N32 and GS-2-E-2N32.

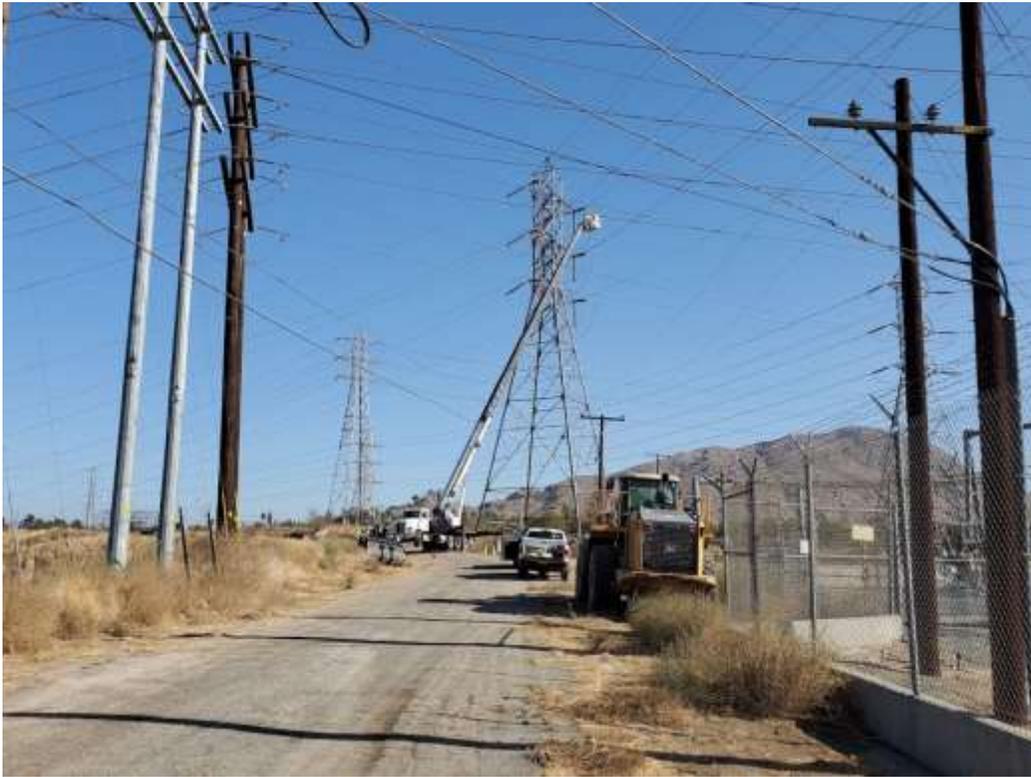
Photo 3 – Grounding installation at Construction Area 2N36, Segment 2
(November 4, 2019).

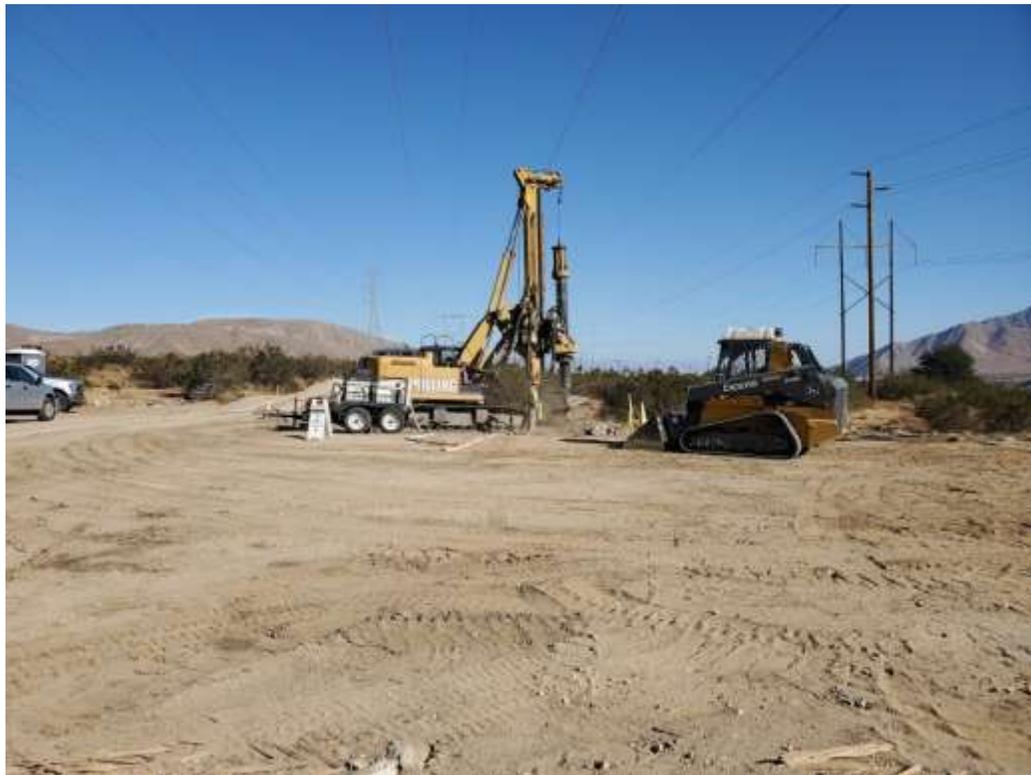
Photo 4 – Foundation activities at Construction Area 5X01, Segment 5
(November 5, 2019).

6. Work associated with Segment 5 (which includes sites within Morongo lands along Segment 5 as reported by SCE) included foundation activities at Construction Areas 5X01 through 5X04 (see Photo 4), 5X06, 5X07, 5X09, 5X10, and 5X11; and BMP maintenance at Construction Area 5X37.

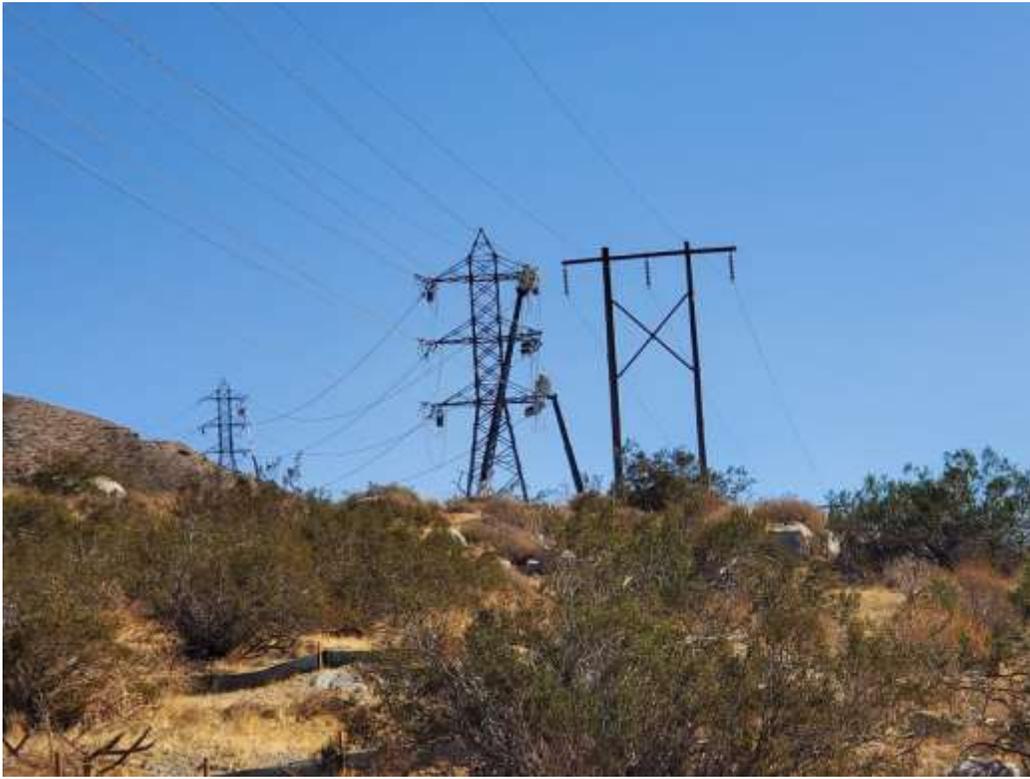
Photo 5 – Wire stringing activities at Construction Area 6S30, Segment 6 (November 4, 2019).

7. Work associated with Segment 6 (non-BLM lands) included: Foundation activities at Construction Areas 6X09, 6X10, 6X22, 6N27, and 6X48; tower assembly at Construction Areas 6X10, 6N26, and 6N27; BMP maintenance at Construction Areas 6S27, T252, WSS-6-6S26-1-MPR-29, 6S26, WSS-6-6S26-2-MPR-29, 6S25, and 6X24; and wire stringing activities from Construction Area 6S26 through 6S41 (see Photo 5).
