**PROJECT MEMORANDUM**  
**SCE WEST OF DEVERS UPGRADE PROJECT**

**To:** John Forsythe, Project Manager, CPUC  
**From:** Vida Strong, Aspen Project Manager  
**Date:** January 21, 2021  
**Subject:** Monitoring Report #144: January 11 to 17, 2021

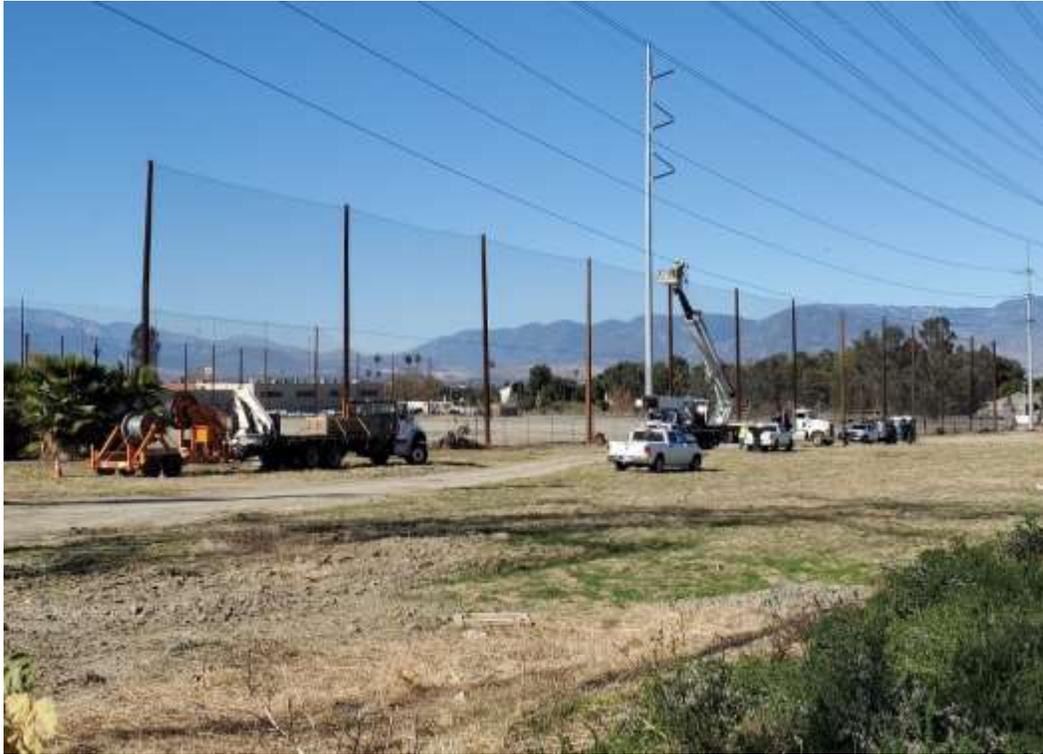
Photo 1 – Wire wreck-out activities at Construction Areas 1X10 through 1X11, Segment 1 (January 14, 2021).

2. Work activities associated with Segment 1 included wire wreck-out activities (ground) at Construction Areas 1X03 through 1X27 (see Photo 1) and shoofly tower wreck-out at Construction Areas 1X04-1X05 (SF103 and SF104), 1X20, 1X21, and 1X25 (see Photo 2).

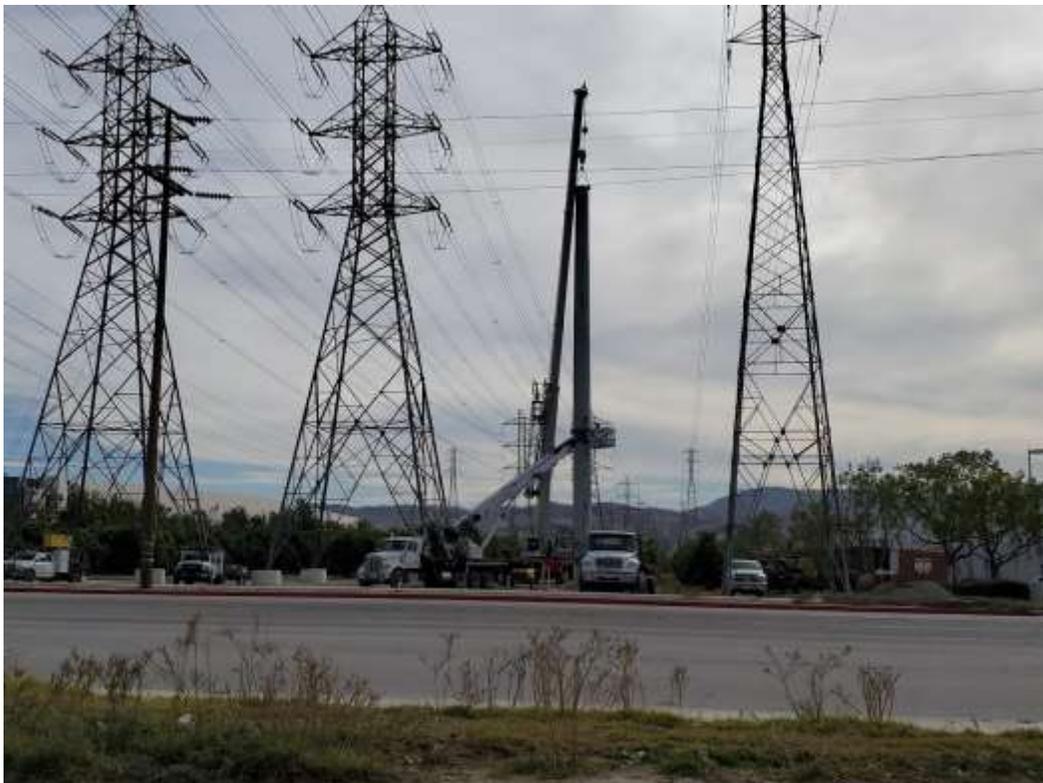
Photo 2 – Shoofly tower wreck-out at Construction Area 1X25, Segment 1 (January 13, 2021).

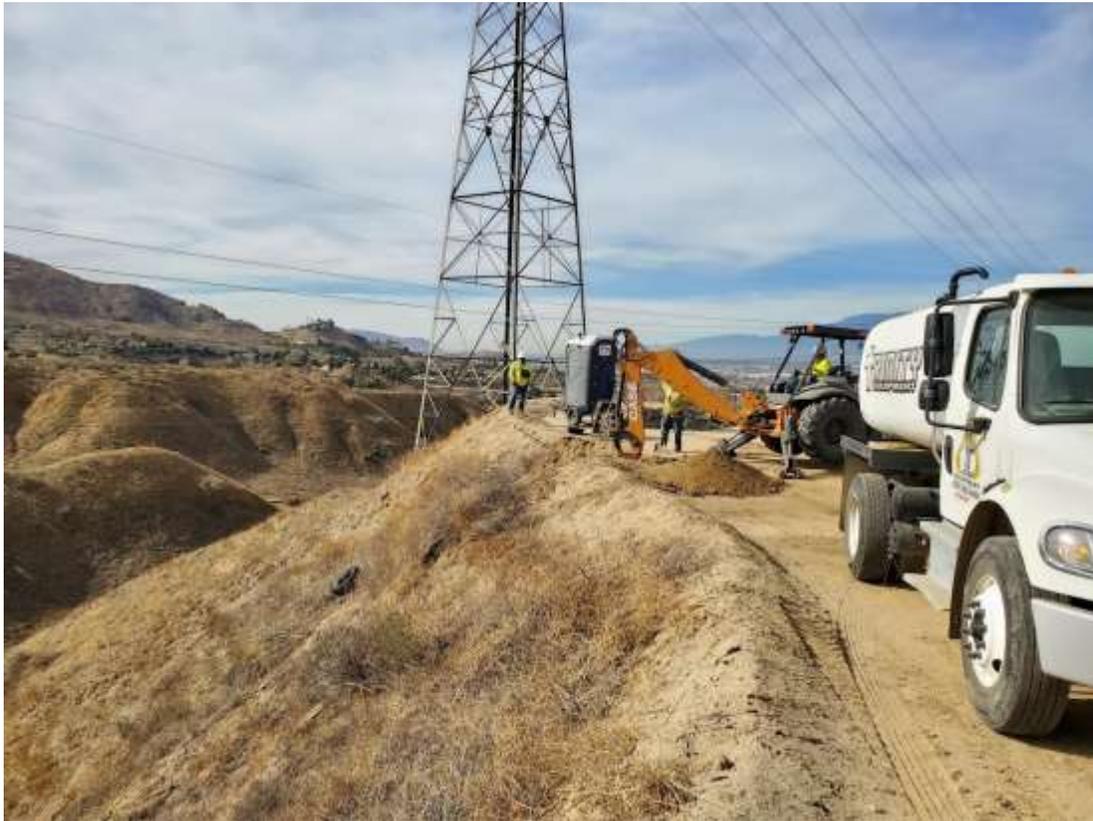
Photo 3 – MAC drain replacement at Construction Area 2N17, Segment 2 (January 13, 2021).

3. Work activities associated with Segment 2 included: Wire wreck-out activities (ground) at Construction Areas 2N01-WSS through 2N05; MAC drain installation at Construction Area 2N04; MAC drain replacement at Construction Area 2N17 (see Photo 3); hydroseed watering at Construction Areas 2N06 through 2N10, 2N12 through 2N16, 2N18, and 2N32; and BMP maintenance at Construction Area 2N18.

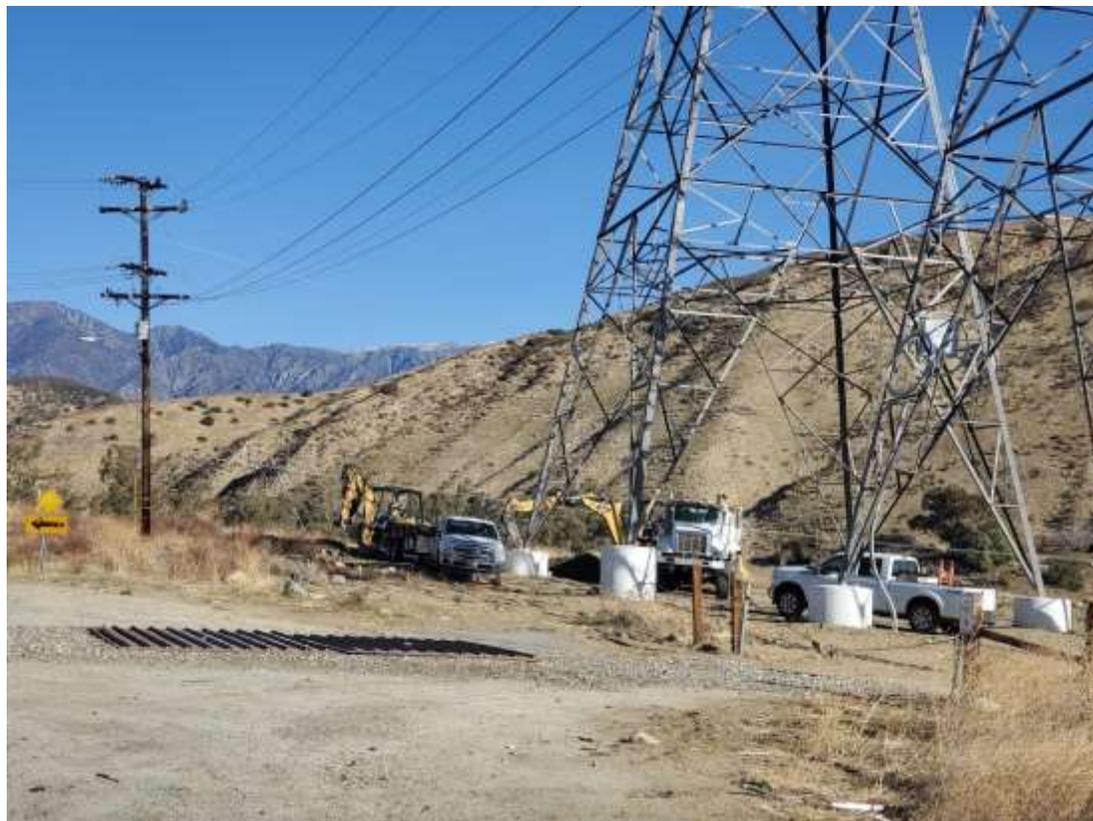
Photo 4 – Foundation wreck-out at Construction Area 4X01, Segment 4 (January 12, 2021).

5. Work associated with Segment 4 (including Construction Areas 4X12 and 4X13 within Morongo Lands as reported by SCE) included foundation wreck-out at Construction Areas 4X01 through 4X05 (see Photo 4), and BMP maintenance at Construction Area 4X13.

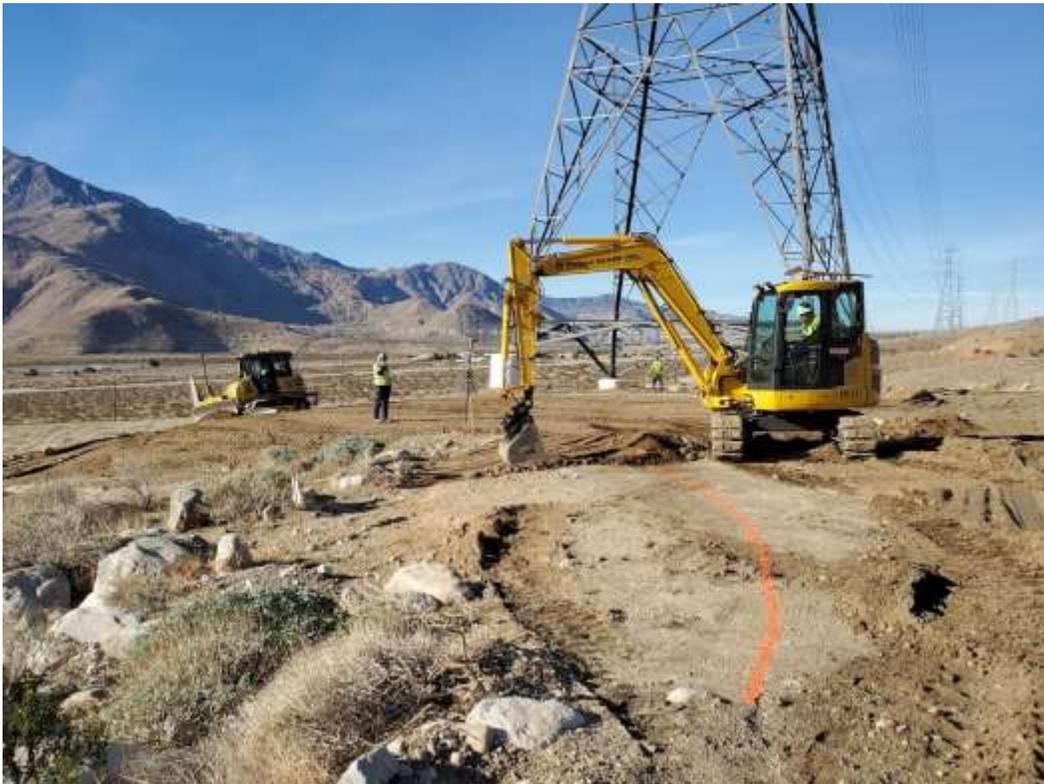
Photo 5 – Site restoration at Construction Area 6N35, Segment 6 (January 13, 2021).

7. Work associated with Segment 6 (non-BLM lands) included: Site restoration activities at Construction Areas 6N32, 6N34, 6X36 through 6X41, and SS-6-6S34-1-MPR29 (see Photo 5); scarification activities at Construction Area 6N18 and 6X19 through 6X21; hydroseed application at Construction Areas 6N16, 6S16, 6N17, 6S17, 6N18, 6X19 through 6X21, M62-T1, and M1-T2; hydroseed watering at Construction Areas 6X11, M60-T3, 6X12, M61-T1, 6X13, 6X14, 6N15, 6S15, 6N16, 6S16, 6S17, and 6N17; access road maintenance between Construction Areas 6N34 and 6N35; and BMP maintenance at Construction Areas 6S29, 6S30, 6S31, 6S31A, 6S32, 6S41, and 6N41.

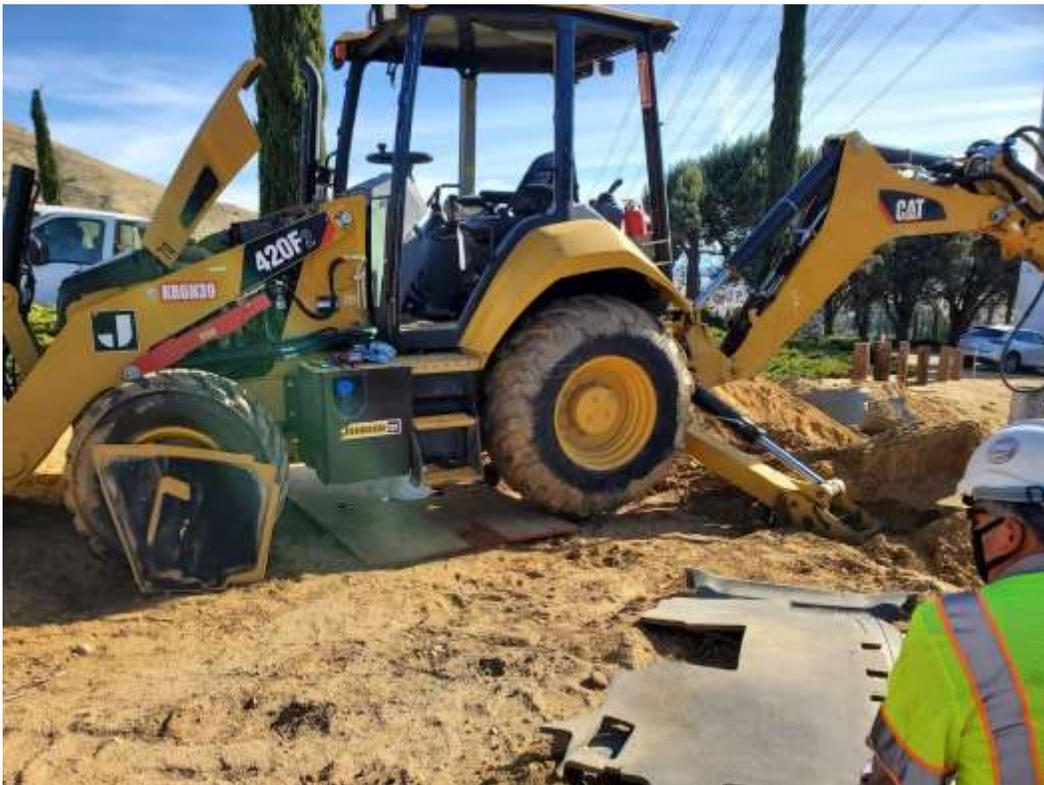
2. There was one reportable (>1 gallon) and no non-reportable (<1 gallon) spills associated with NTP #4 identified during the monitoring period on Segment 4. On January 12, the backhoe operator noticed a drop in hydraulic pressure during foundation wreck-out at Construction Area 4X02 and immediately shut down the equipment. Once the leak had been identified, the operator began creating a berm to keep the fluid from running downslope and the crew worked to contain the spill which was estimated at about 2 gallons. Once the equipment was repaired on January 13, the backhoe was removed from the site and all impacted soil was placed into plastic bags and the spill kit bucket then hauled to the Poultry MY for offsite disposal at an SCE approved waste facility. The CPUC EM visited the site on January 13 and 14 and to observe the clean-up efforts and confirmed that all impacted soils had been removed (see Photo 6).

Photo 6 – Spill clean-up at Construction Area 4X02, Segment 4 (January 13, 2021).
