PROJECT MEMORANDUM
SCE WEST OF DEVERS UPGRADE PROJECT

To: John Forsythe, Project Manager, CPUC
From: Vida Strong, Aspen Project Manager
Date: March 26, 2021
Subject: Monitoring Report #153: March 15 to 21, 2021

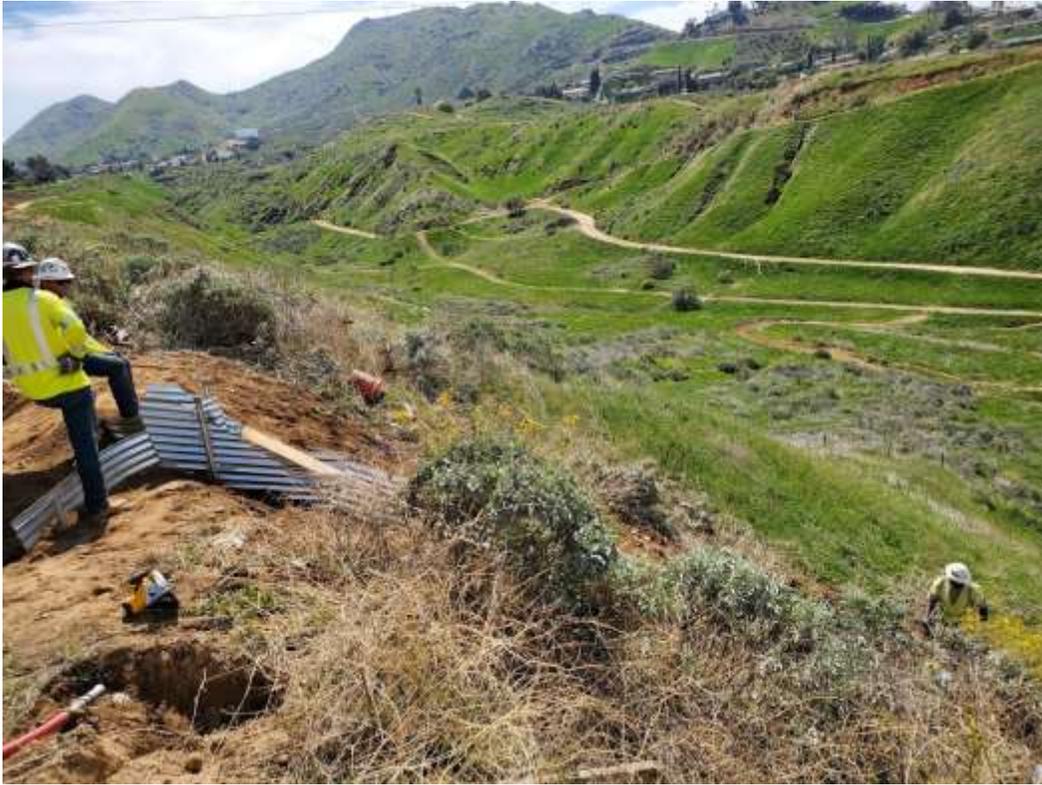
Photo 1 – MAC drain installation at Construction Area 2N25, Segment 2 (March 17, 2021).

2. Work activities associated with Segment 1 included green waste haul-off at Construction Area 1X08.
3. Work activities associated with Segment 2 included MAC drain vegetation clearing and installation at Construction Area 2N25 (see Photo 1).

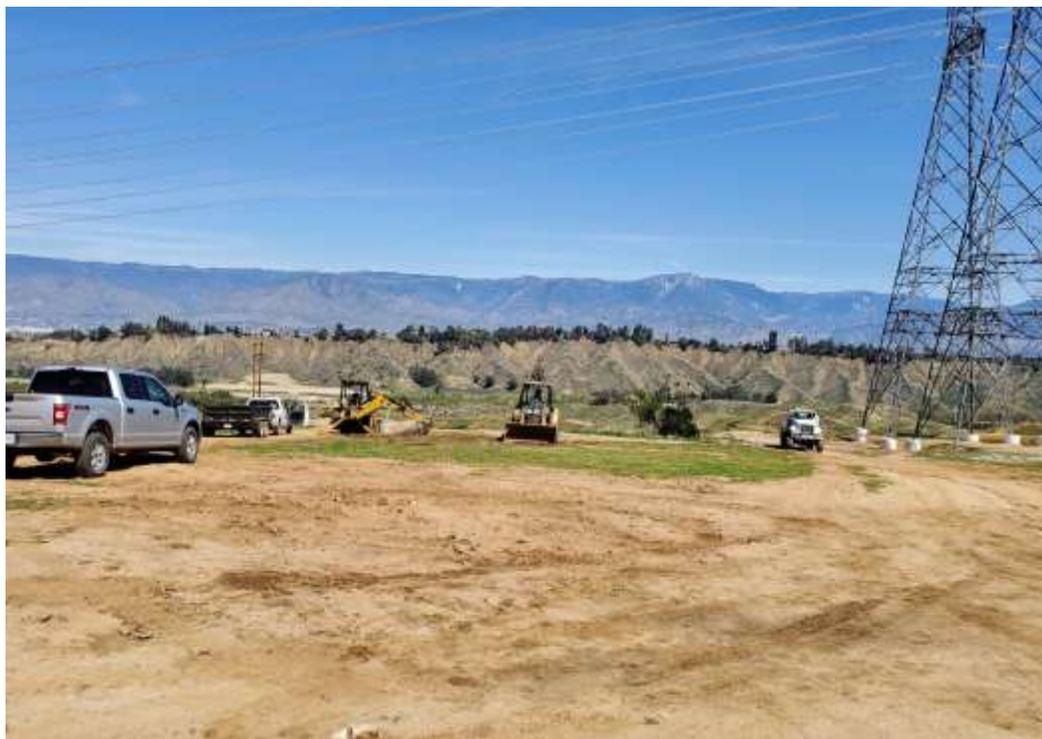
Photo 2 – Foundation wreck-out activities at Construction Area 3X51, Segment 3 (March 19, 2021).

4. Work activities associated with Segment 3 included: Tower wreck-out activities at Construction Areas 3S01, 3S02, 3S04, and 3X06-07; foundation wreck-out and tower shearing at Construction Areas 3X50, 3X51 (see Photo 2), M37-T3, 3X56, 3X59, 3X61, 3X63, and 3X65; and BMP maintenance at Construction Areas 3X55 and 3X57.

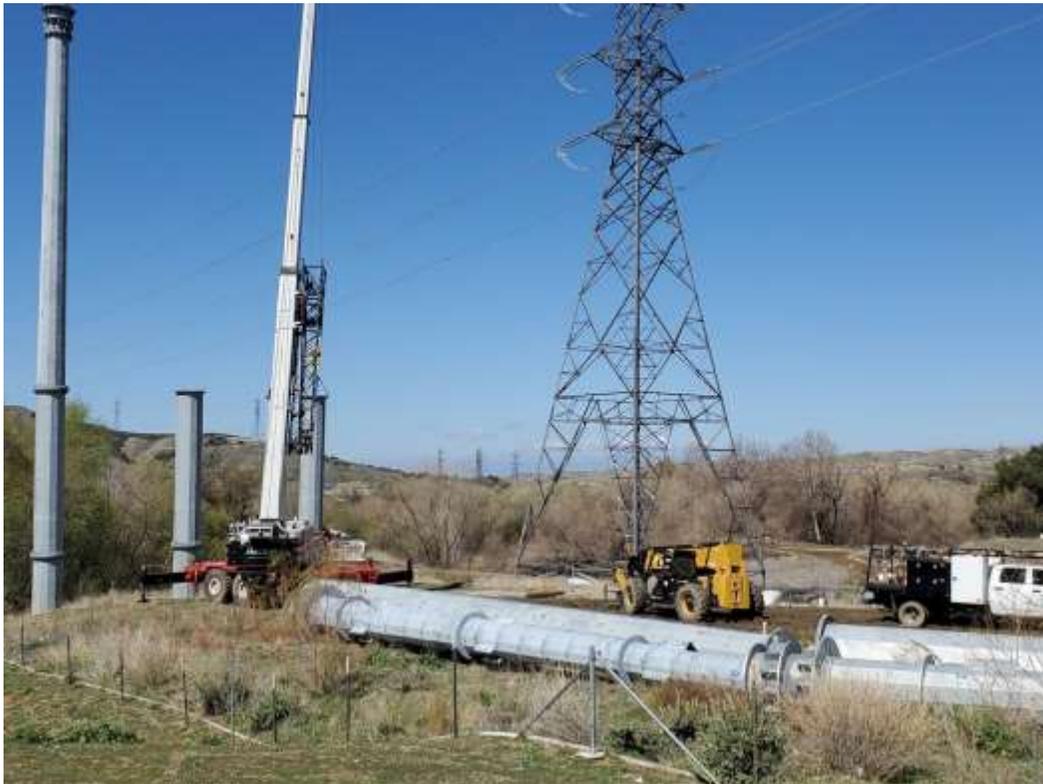
Photo 3 – Shoofly tower wreck-out at Construction Area 4S60, Segment 4 (March 16, 2021).

5. Work associated with Segment 4 (including Construction Areas 4X12 and 4X13 within Morongo Lands as reported by SCE) included: Tower wreck-out activities at Construction Areas 4X55, 4X56, 4S58, and 4S60 (see Photo 3); jumper removal at Construction Areas 4X55 and 4X56; anchor removal at Construction Area 4X55; site restoration and foundation compaction at Construction Areas 4X01, 4X03, 4X04, and 4X08 through 4X10 (see Photo 4); rip-rap installation and maintenance at wet crossing on the access road to Construction Area 4X04; and access road maintenance from Palmer Road through Construction Area 4S58.

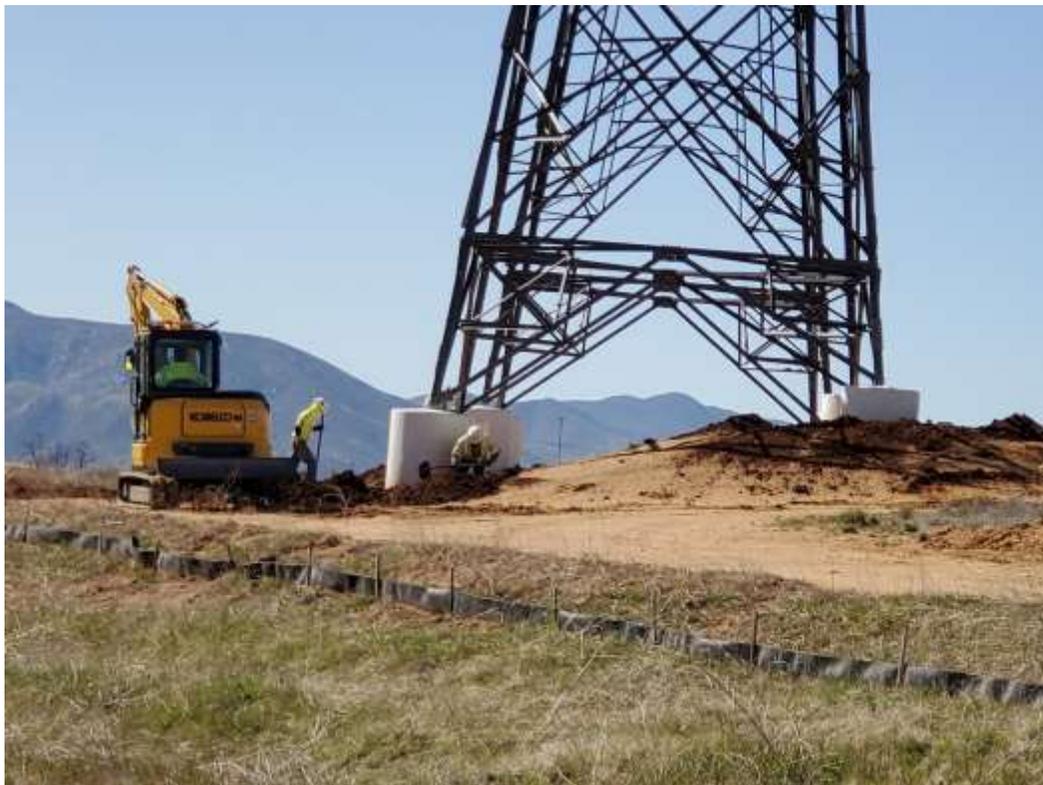
Photo 4 – Site restoration and foundation compaction at Construction Area 4X08, Segment 4 (March 19, 2021).

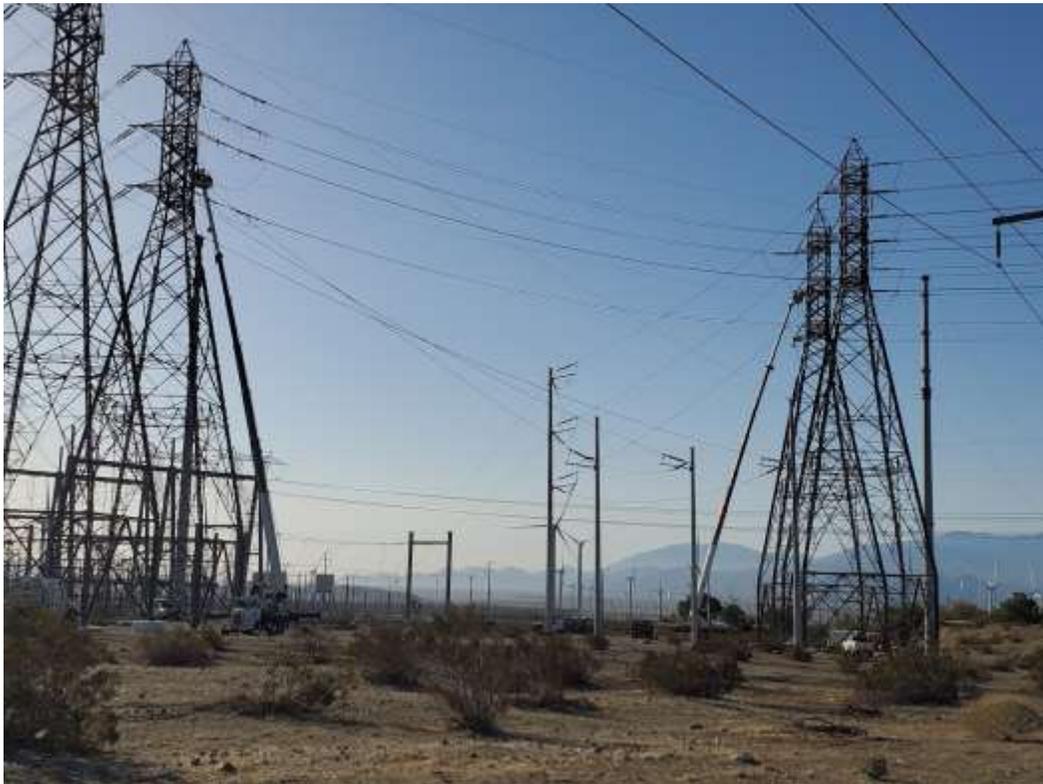
Photo 5 – Wire stringing activities at Construction Area 6X09-6X10, Segment 6 (March 19, 2021).

7. Work associated with Segment 6 (non-BLM lands) included: Wire stringing activities (ground and helicopter) at Construction Areas 6X07 through 6X10 (see Photo 5); vegetation clearing at Construction Area 6X08; backfilling at Construction Area T270; site scarification activities at Construction Area M66-T3 (M6-T2); hydroseed application at Construction Areas 6N32, 6N34, 6N37, SWA-6-6S39-MPR-29, T235, 6N40, 6S41, and M66-T4; vegetation clearing and grading at Construction Areas 6X11, 6N26, 6N27, and WSS-6-6N26-6N27; and access road maintenance at Construction Areas 6N28 to 6N32, 6S32 to 6S32, and 6X21 to 6N27.

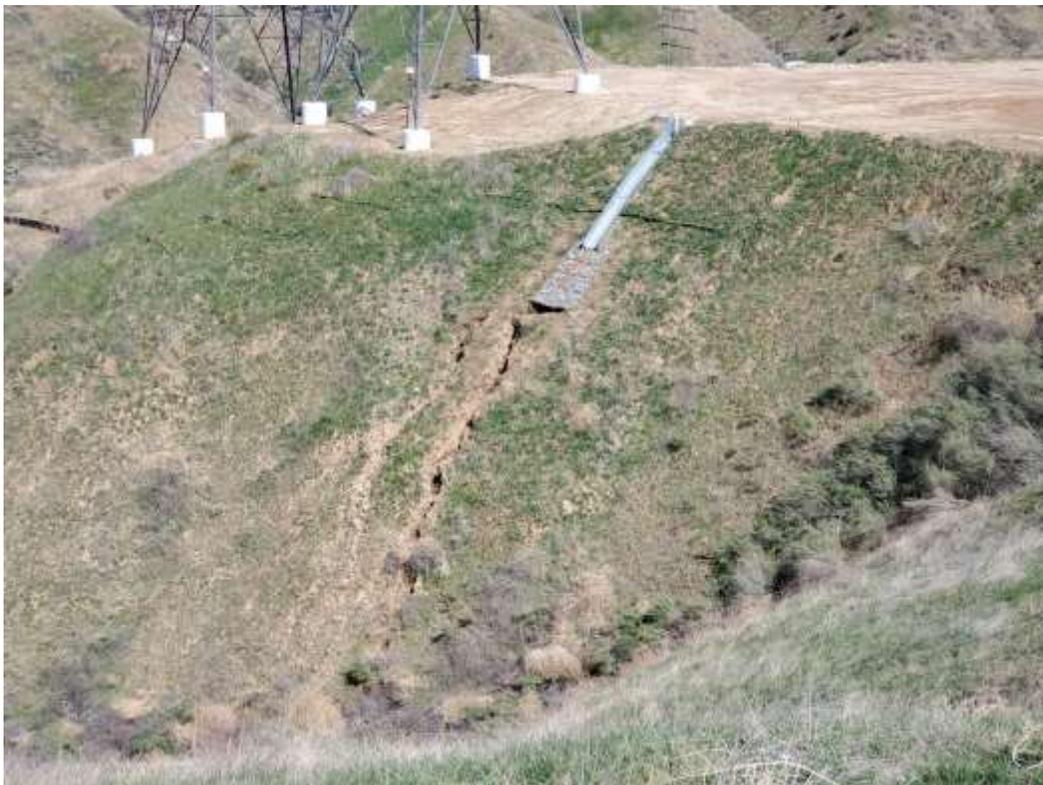
4. During the subject monitoring period, the CPUC EM observed several construction-related MAC drains with significant erosion downslope of the drain and dissipator, including at Construction Areas 3X64, 3X65, and 4X06 (see Photos 6 through 8, respectively). The issue was discussed with SCE during the biweekly meeting on March 18 as the erosion due to deficient run-off controls at these locations were not documented in the SWPPP inspection reports. SCE stated that the MAC drains will be reviewed for possible changes in design but was unsure how to document the erosion issues and will investigate and revisit the issue at the next biweekly meeting.

Photo 6 – Erosion downslope of MAC drain at Construction Area 3X64, Segment 3 (March 16, 2021).

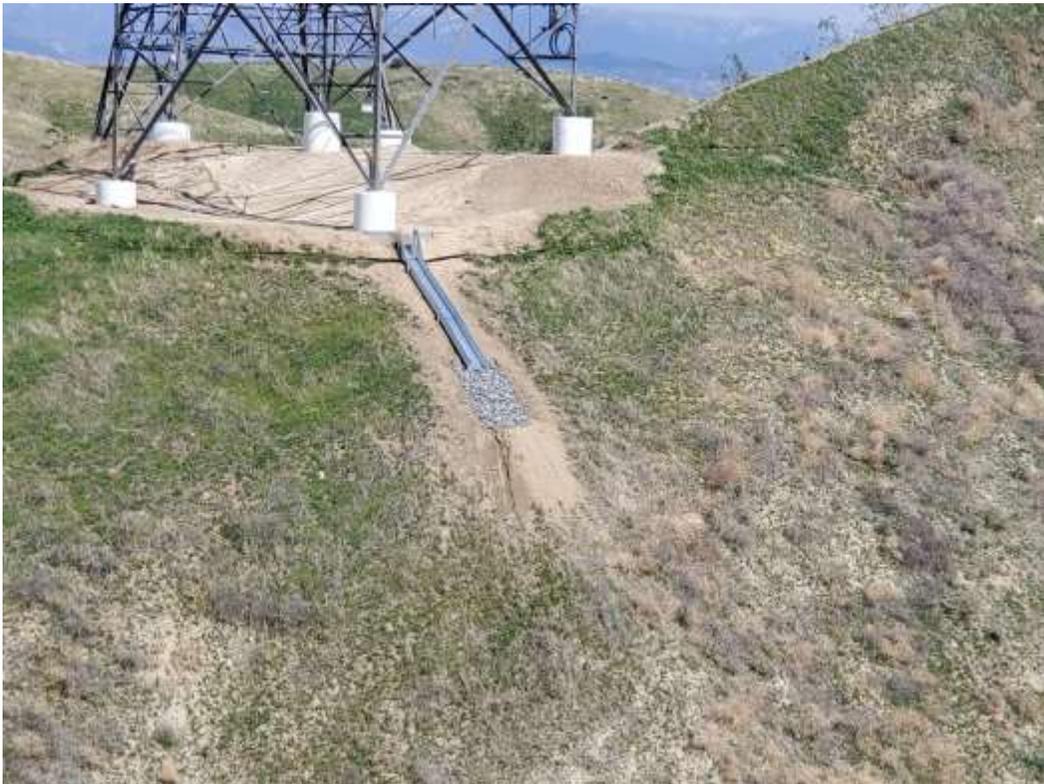
Photo 7 - Erosion downslope of MAC drain at Construction Area 3X65, Segment 3 (March 16, 2021).

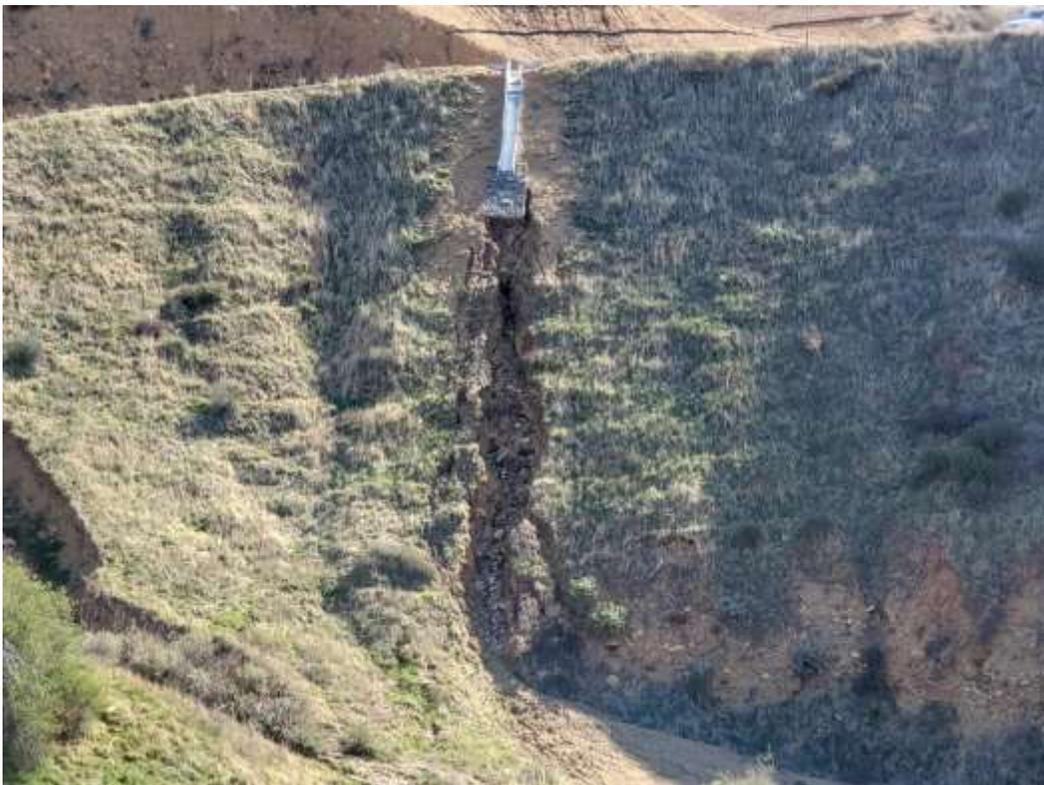
Photo 8 - Erosion downslope of MAC drain at Construction Area 4X06, Segment 4 (March 19, 2021).
